Mayfield Road is listed in the Shire's road hierarchy as a local distributor – rural road which is mainly used by the rural property owners as well as being a link to the Shire of Murray to the north. The current road width is 4.5 metres and has been flagged for road widening to increase the carriageway to a minimum of 6 metres in width.

2. Project Brief

As part of the 2020/21 works budget funds have been allocated to carry out road widening along Mayfield Road within 5.45 to 6.10 straight line kilometres (SLK). Funds have been sourced through the Federal Government Roads to Recovery Program therefore it is imperative the works are completed within the 2020/21 financial year as carry forwards under that funding model are discouraged.

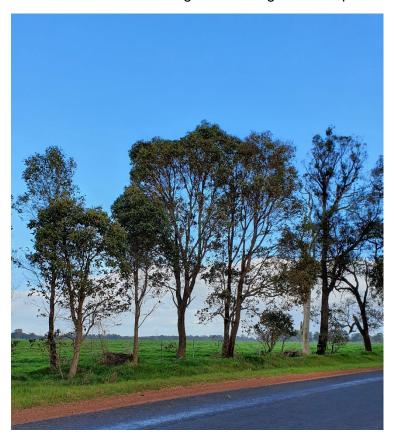
Tree ID	Description	Trunk (m)	Canopy (m)	Additional Information
5141	Corymbia Calophylla	0.4	8	No signs of nesting or hollow points.
5142	Corymbia Calophylla	0.3	7	No signs of nesting or hollow points.
5143	Corymbia Calophylla	0.3	7	No signs of nesting or hollow points.

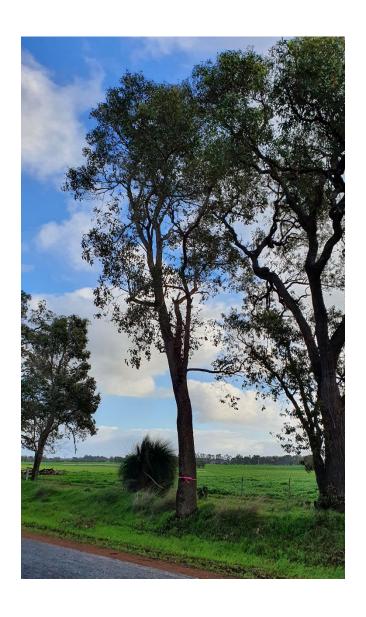
Tree ID	Description	Trunk (m)	Canopy (m)	Additional Information
5144	Corymbia Calophylla	0.4	8	No signs of nesting or hollow points.

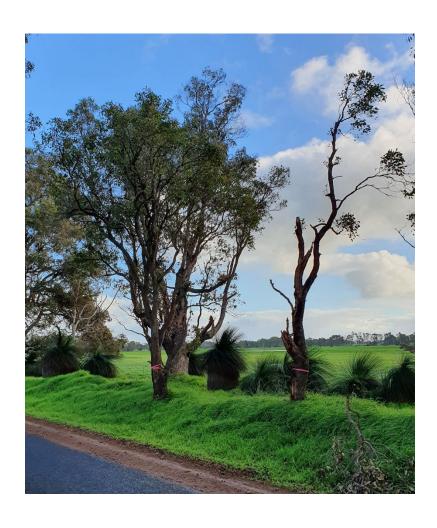
Tree ID	Description	Trunk (m)	Canopy (m)	Additional Information
5146	Corymbia Calophylla	0.3	7	Tree is damaged and has no obvious signs of nesting or hollow points.
5147	Corymbia Calophylla	0.3	7	No signs of nesting or hollow points.

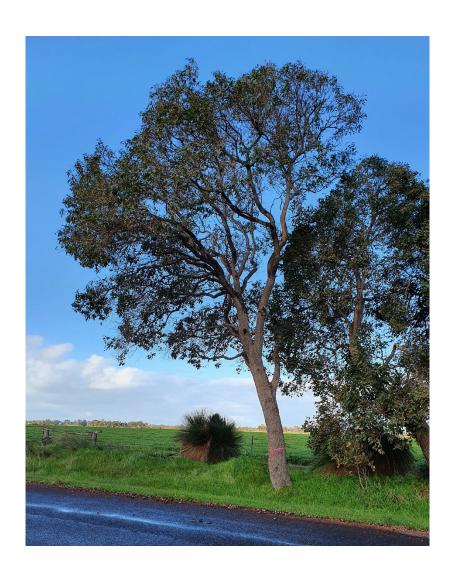
T	ree ID	Description	Trunk (m)	Canopy (m)	Additional Information
5	5148	Corymbia Calophylla	0.4	8	No signs of nesting or hollow points.

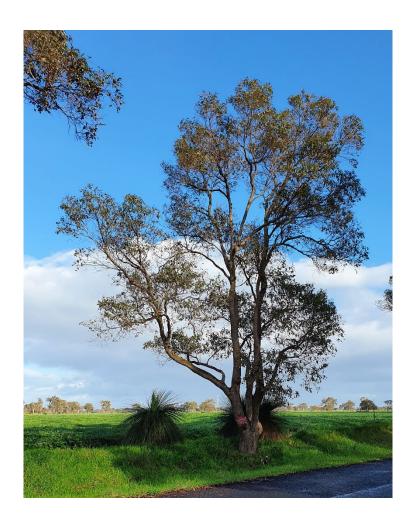
Tree ID	Description	Trunk (m)	Canopy (m)	Additional Information
5149	Corymbia Calophylla	0.4	8	No obvious signs of nesting or hollow points.

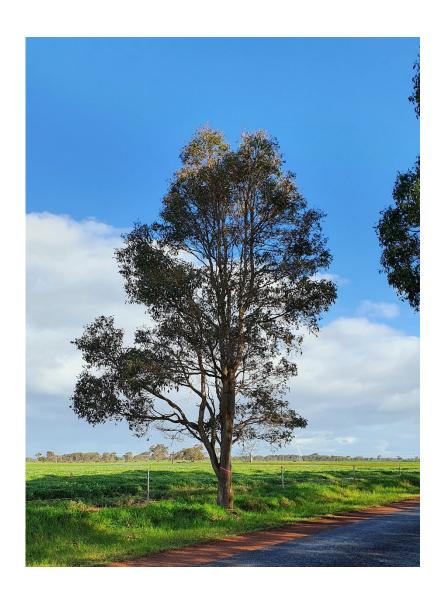
Tree ID	Description	Trunk (m)	Canopy (m)	Additional Information
5150	Corymbia Calophylla	0.3	7	No obvious signs of nesting or hollow points.

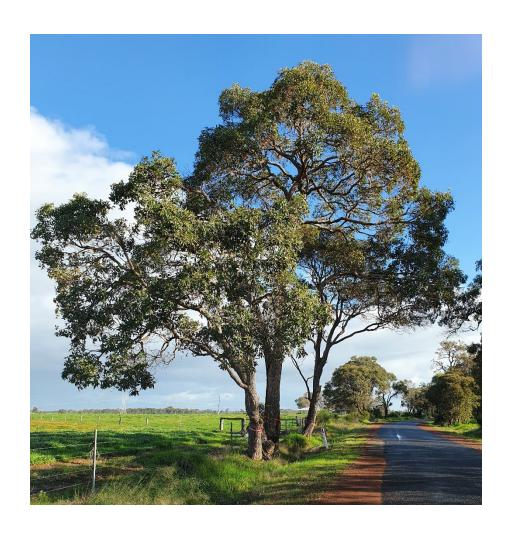
Tree ID	Description	Trunk (m)	Canopy (m)	Additional Information
5154	Corymbia Calophylla	0.3	7	No obvious signs of nesting or hollow points.
5155	Corymbia Calophylla	0.3	7	No obvious signs of nesting or hollow points.
5156	Corymbia Calophylla	0.5	10	No obvious signs of nesting or hollow points.

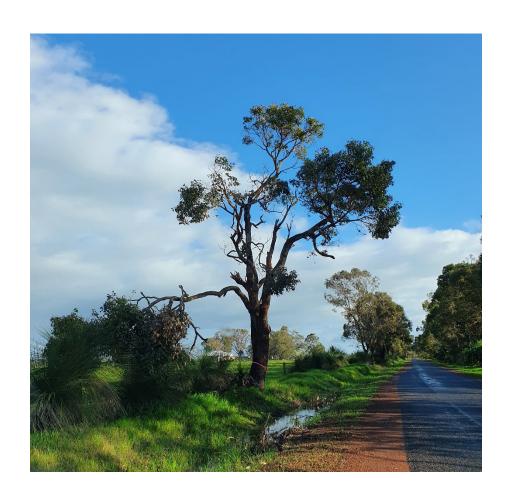
Tree ID	Description	Trunk (m)	Canopy (m)	Additional Information
5158	Corymbia Calophylla	0.5	10	No obvious signs of nesting or hollow points. Tree has dropped limbs and is within the curve sight lines

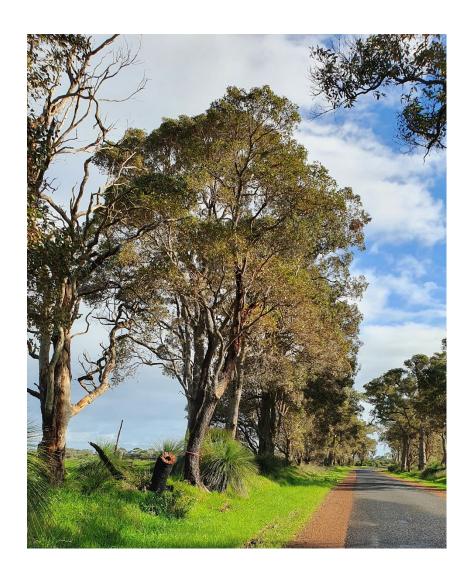
Tree ID	Description	Trunk (m)	Canopy (m)	Additional Information
5160	Corymbia Calophylla	0.4	8	No obvious signs of nesting or hollow points.

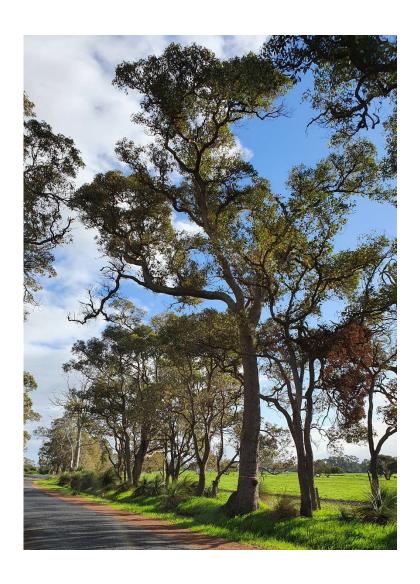
Tree ID	Description	Trunk (m)	Canopy (m)	Additional Information
5161	Corymbia Calophylla	0.7	14	No obvious signs of nesting or hollow points.

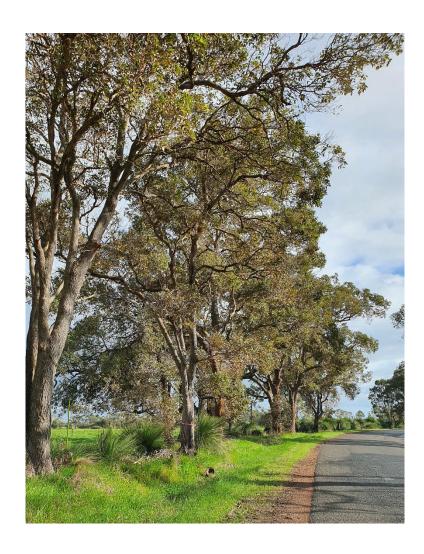
Tree ID	Description	Trunk (m)	Canopy (m)	Additional Information
5162	Corymbia Calophylla	0.4	8	No obvious signs of nesting or hollow points.
5163	Corymbia Calophylla	0.3	7	No obvious signs of nesting or hollow points.

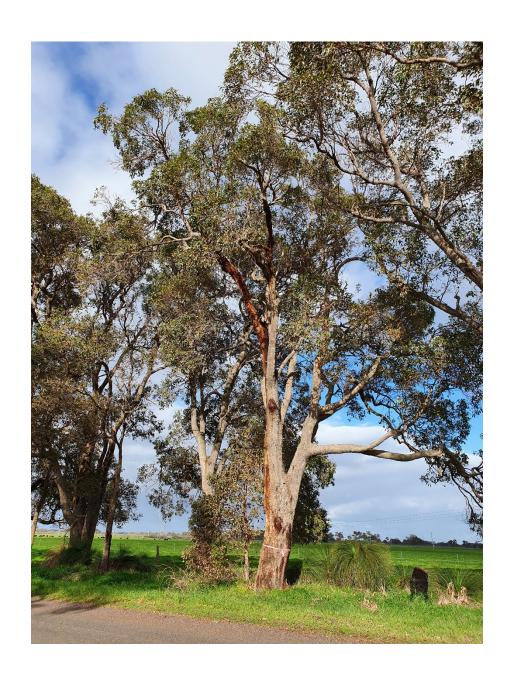
Tree ID	Description	Trunk (m)	Canopy (m)	Additional Information
5164	Corymbia Calophylla	0.7	14	No obvious signs of nesting or hollow points. Tree is within 2.5m of the edge of seal, on a bend and growing within the table drain.

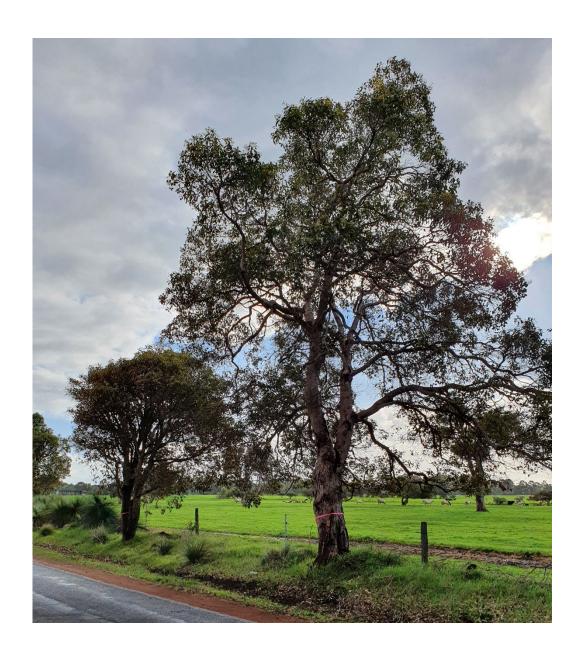
Tree ID	Description	Trunk (m)	Canopy (m)	Additional Information
5165	Corymbia Calophylla	0.5	10	No obvious signs of nesting or hollow points.
5166	Corymbia Calophylla	0.4	8	No obvious signs of nesting or hollow points.

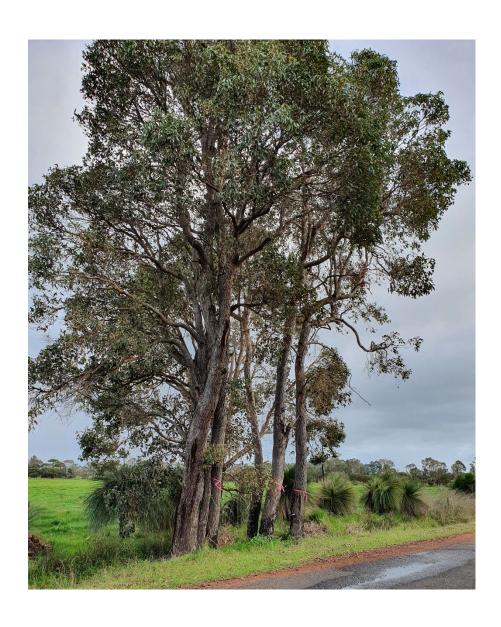
Tree ID	Description	Trunk (m)	Canopy (m)	Additional Information
5167	Corymbia Calophylla	0.3	7	No obvious signs of nesting or hollow points.
5168	Corymbia Calophylla	0.3	7	No obvious signs of nesting or hollow points.
5169	Corymbia Calophylla	0.4	8	No obvious signs of nesting or hollow points.

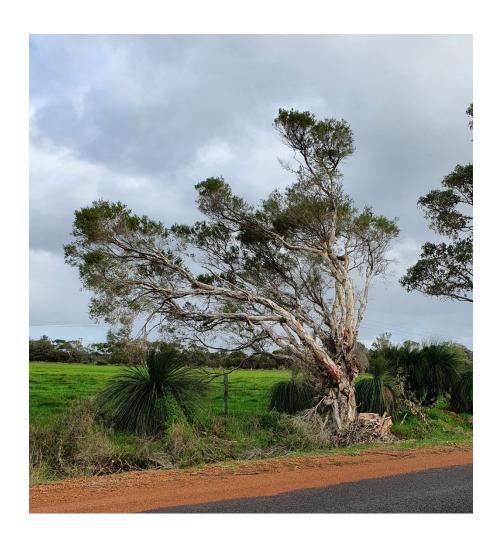
Tree ID	Description	Trunk (m)	Canopy (m)	Additional Information
5170	Melaleuca Raphiophylla	0.4	8	No obvious signs of nesting or hollow points.

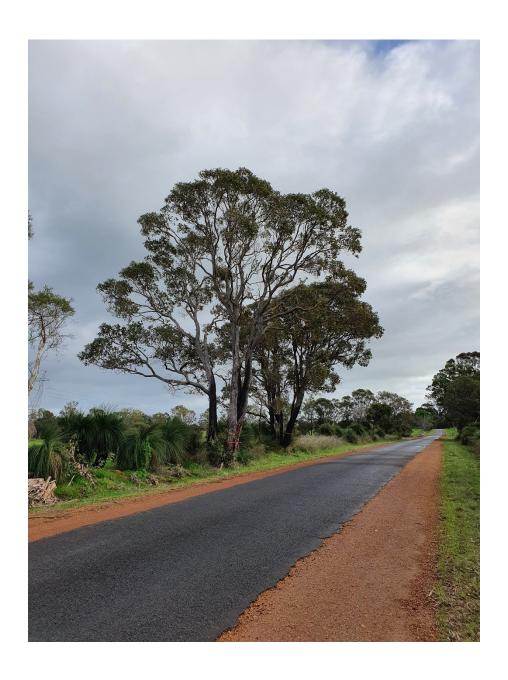
Tree ID	Description	Trunk (m)	Canopy (m)	Additional Information
5171	Corymbia Calophylla	0.6	12	No signs of nesting or hollow points
5172	Corymbia Calophylla	0.6	12	No signs of nesting or hollow points

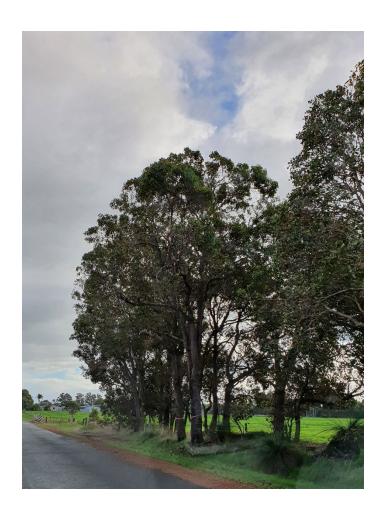
Tree ID	Description	Trunk (m)	Canopy (m)	Additional Information
5173	Corymbia Calophylla	0.4	8	No signs of nesting or hollow points
5174	Corymbia Calophylla	0.5	10	No signs of nesting or hollow points
