Clearing Permit

Nanga Road

SLK 0.37 – 2.02

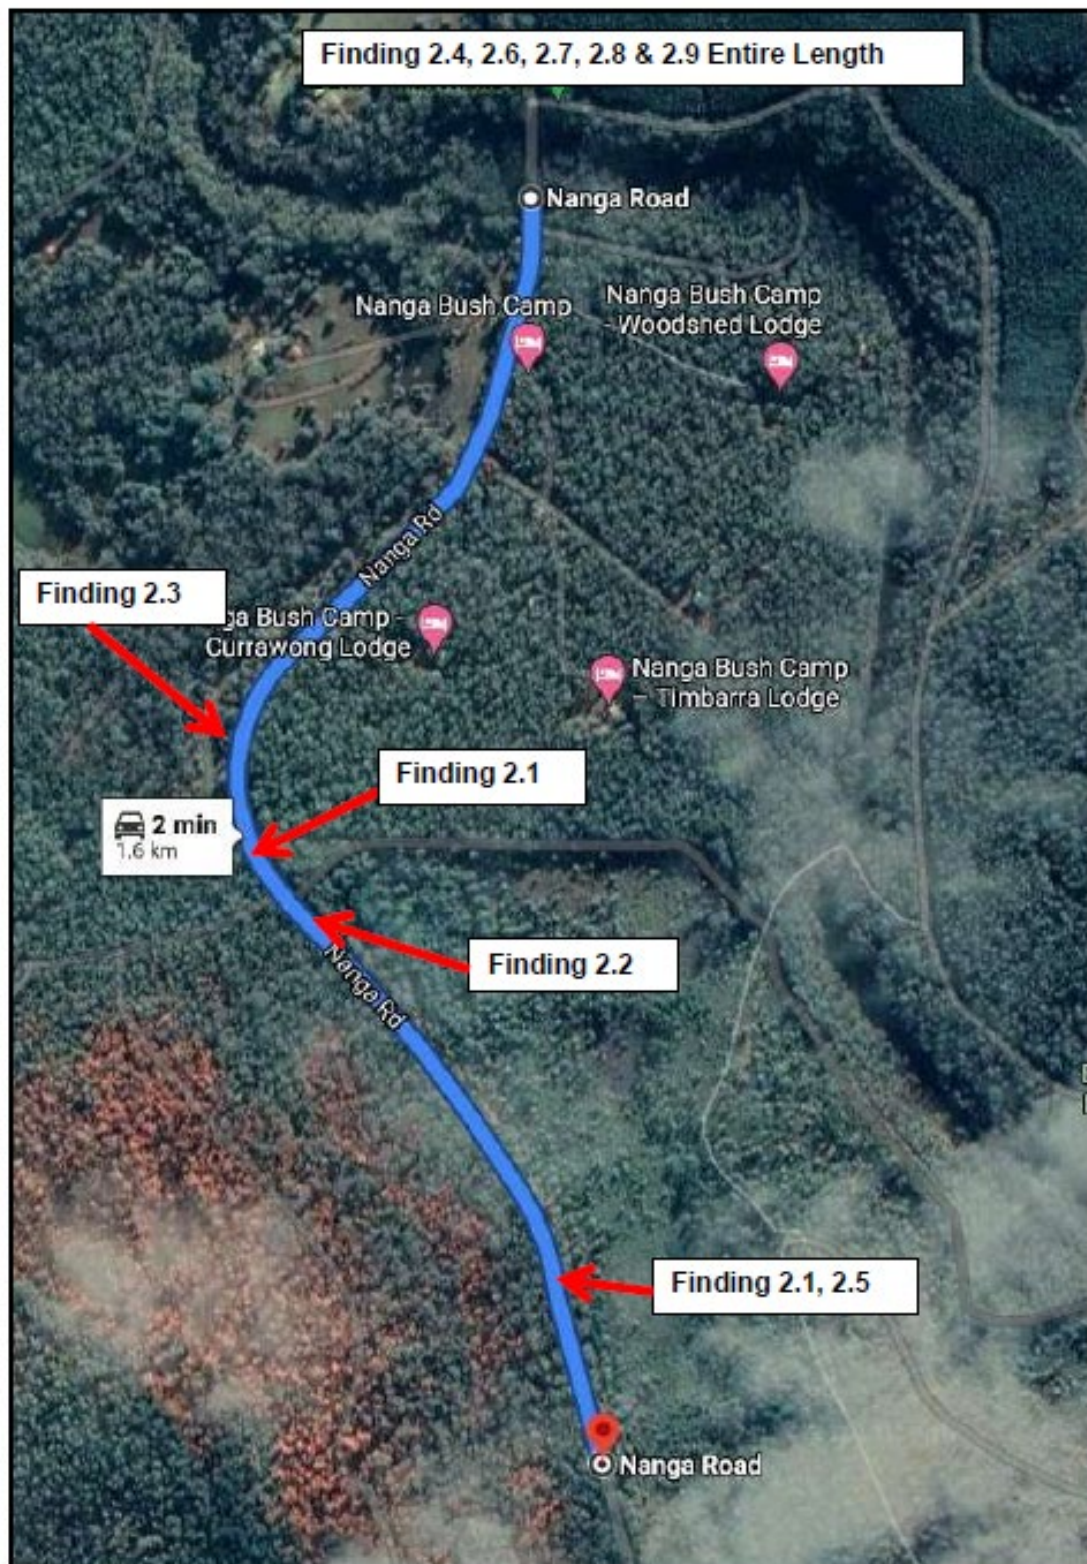
** The Map above shows Nanga Road running north to south and identifies the finding locations as per item 2 of this document.*

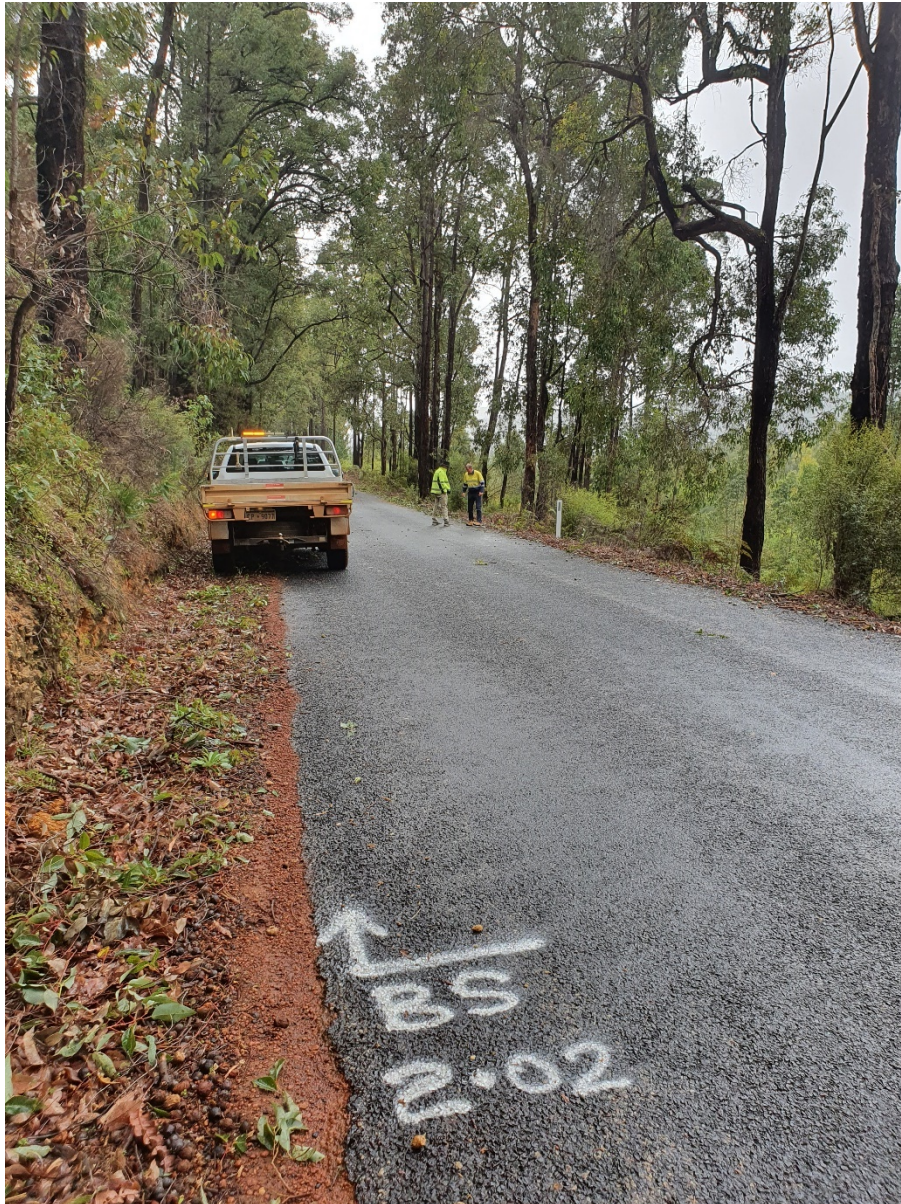
SLK 2.02 Vegetation on south bound lane to be mulched. Limited vegetation on north bound lane due to road verge batter however the table drain on the side of the road will be cleared and some vegetation growing down the batter will be mulched to prevent sight issues as per road safety report recommendations.

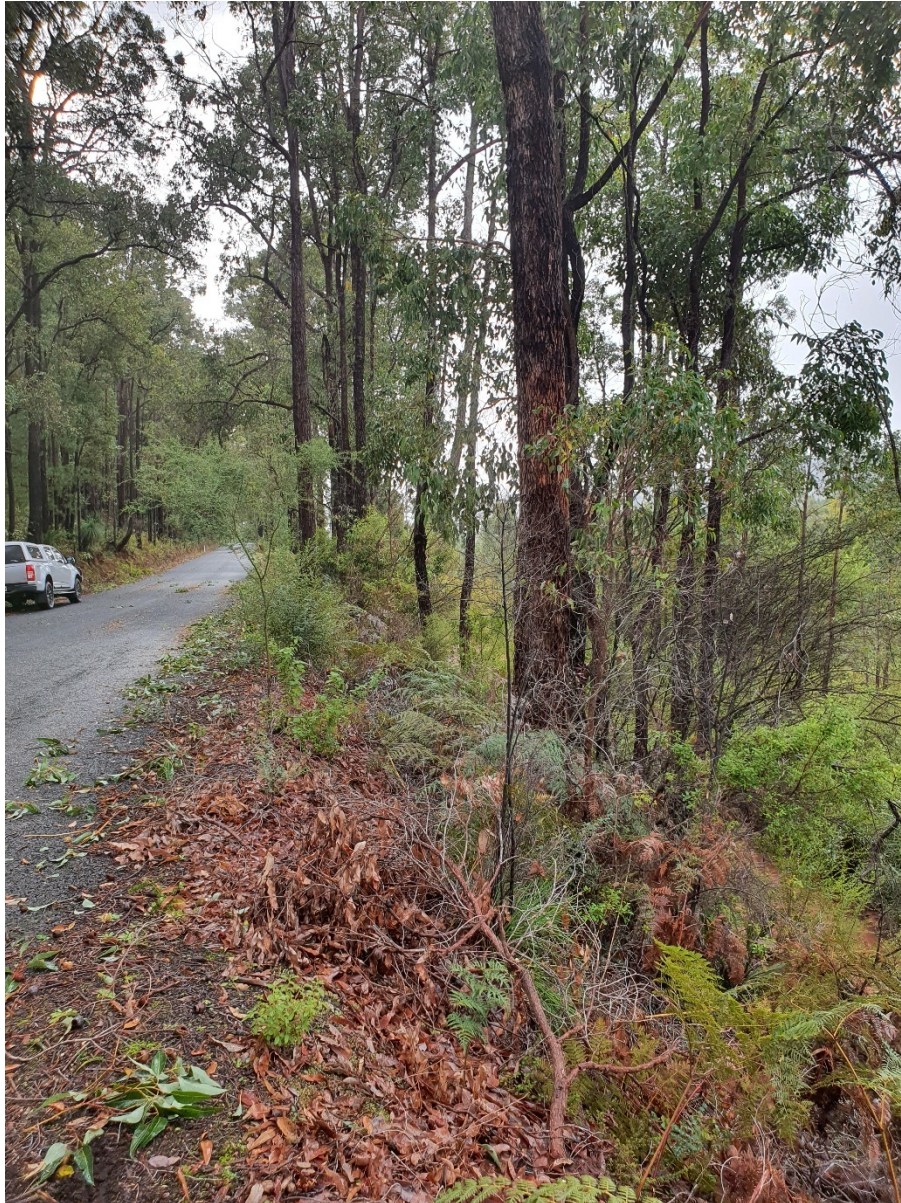
The image above shows the deep descent in the road verge batter on the south bound lane. These areas will have vegetation mulched with native trees growing within 1.6m of the edge of seal removed to allow for barriers to be installed as per *Austroads Guide to Road Design Part 6: Roadside Design, Safety and Barriers*.

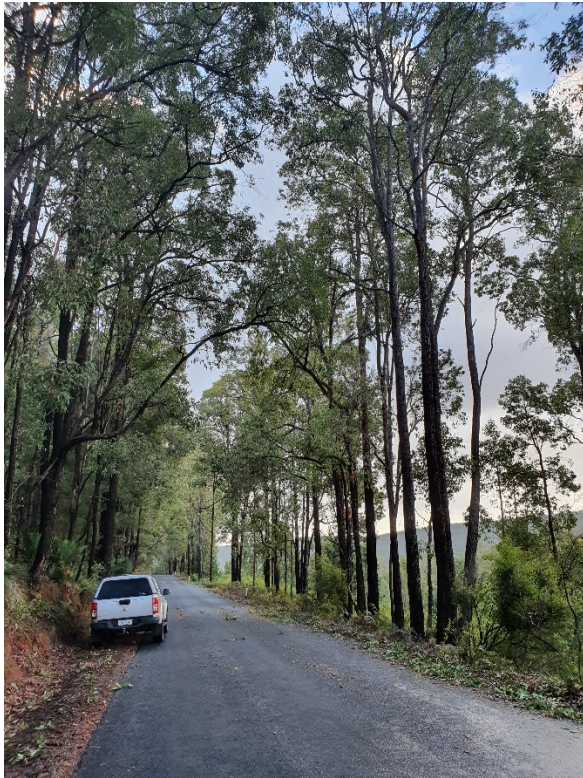
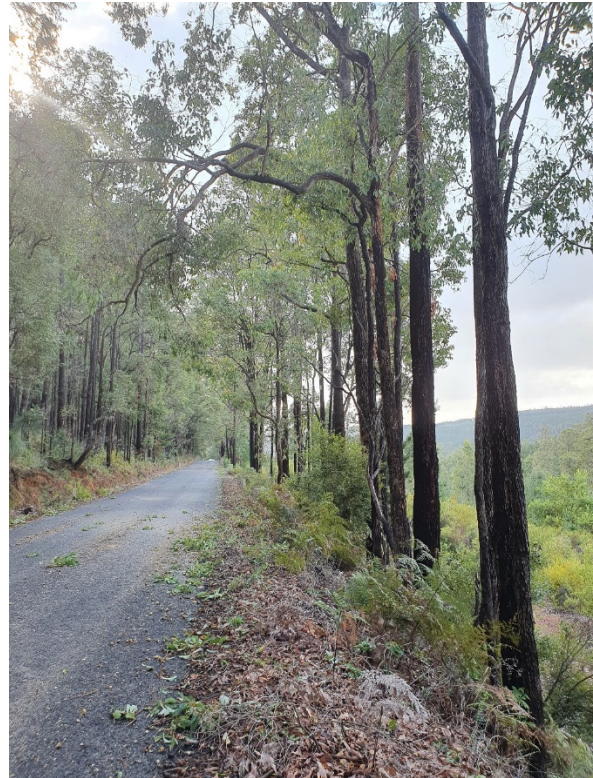
SLK 2.0 – The vegetation within 1.6 metres from the edge of seal on the south bound lane will be mulched and removed to allow for barrier installation as per *Austroads Guide to Road Design Part 6: Roadside Design, Safety and Barriers*. The deep descent of the south bound lane road verge will limit clearing.

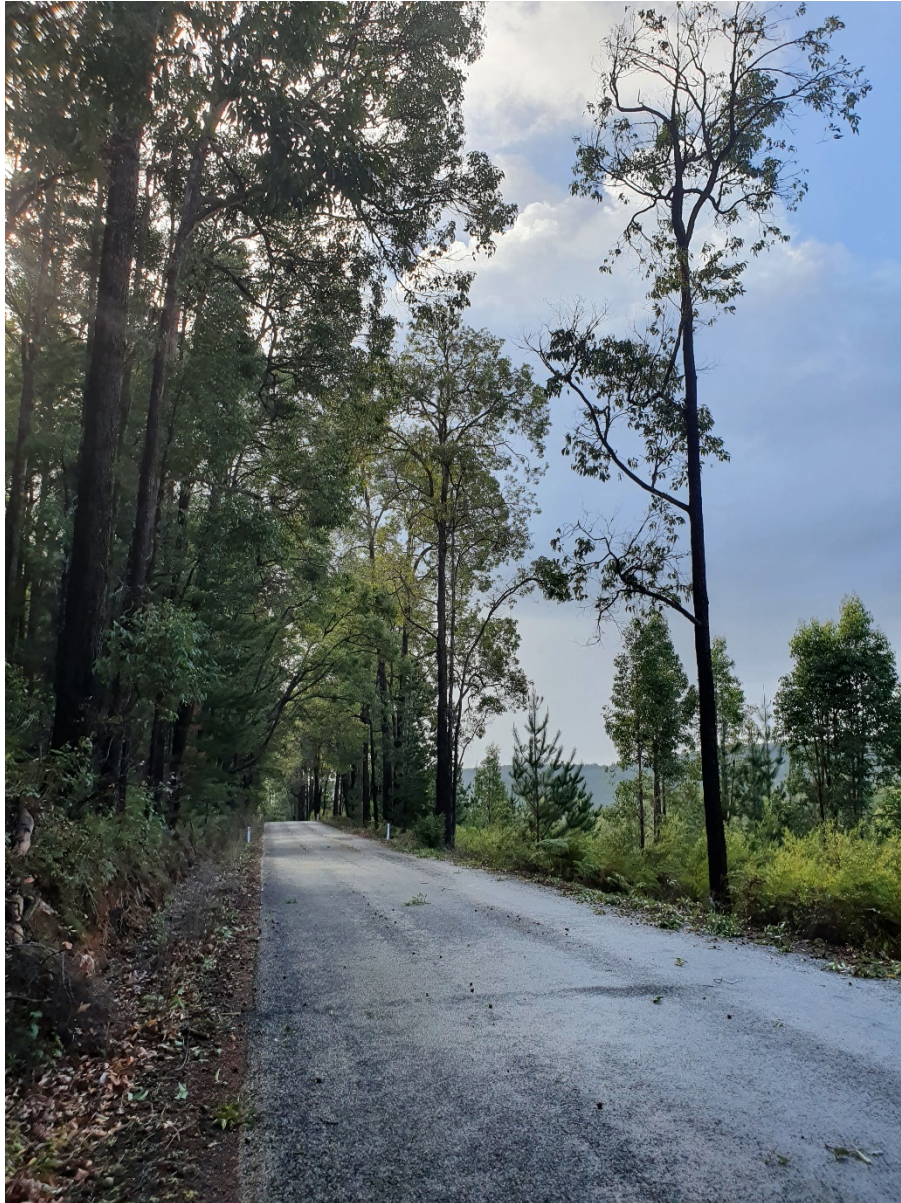
SLK 1.8 The vegetation on the south bound lane is limited and therefore minor vege clearing will be carried out to allow for sight lines to guideposts and advanced warning signs. The vegetation on the north bound lane will require some pruning with two or three trees that are leaning towards the road near the guidepost which may require removal.

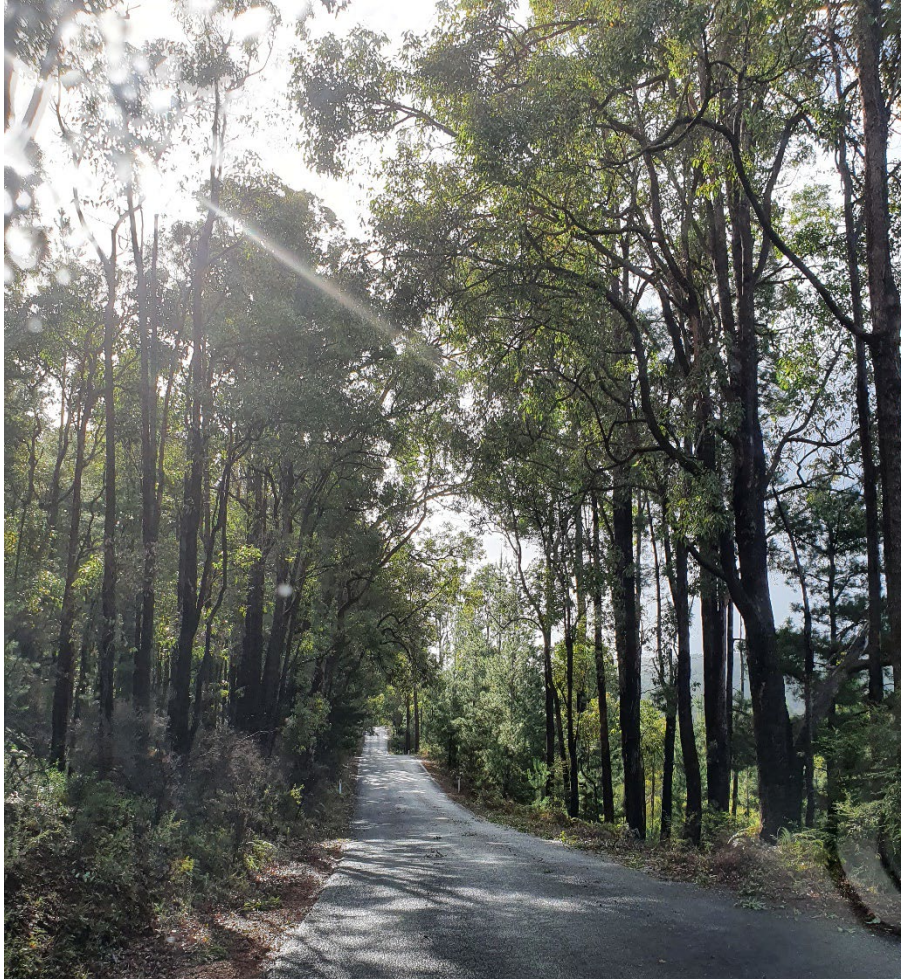
Vegetation will require mulching to allow for sight lines to guide posts and advanced warning signs as per the Road Safety Audit recommendation 2.6 and *Austroads Guide to Road Design Part 6B: Roadside Environment*.

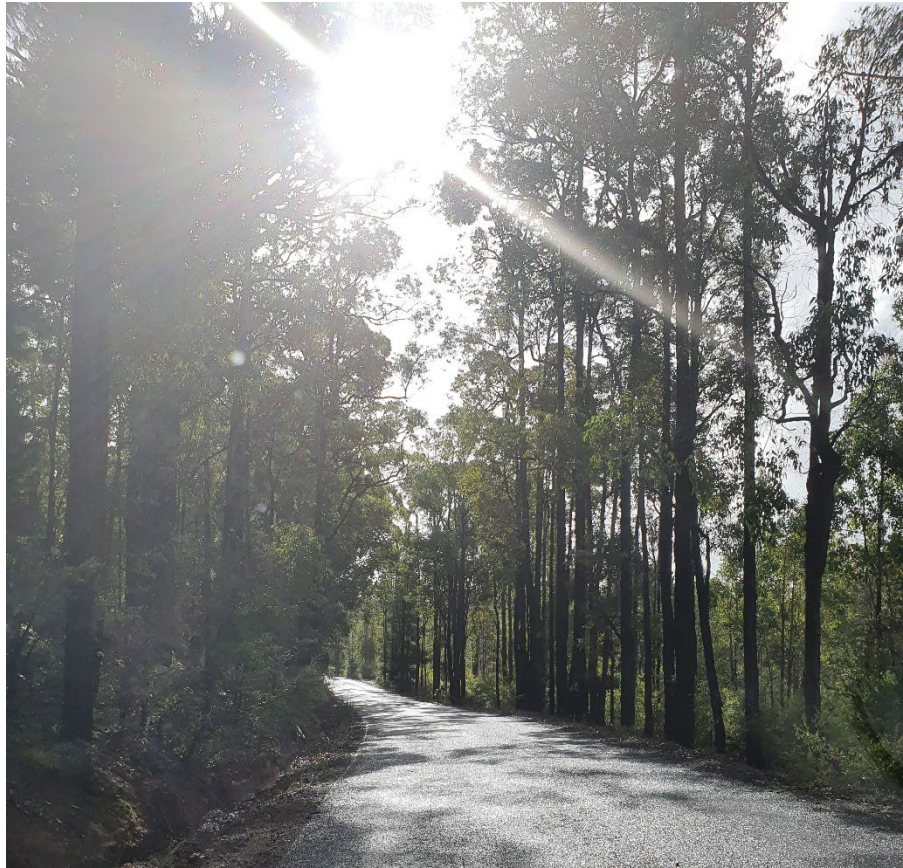
Approaching the bend as per Finding 2.1 and 2.5 of the site plan. Vegetation on both the north and south bound lanes will require mulching to ensure sight lines to guide posts and advanced warning signs are suitable. In addition barriers will be installed on the south side lane which 1.6 metres clearance as per *Austroads: Guide to Road Design Part 6 – Roadside Design Safety and Barriers (2010)*.

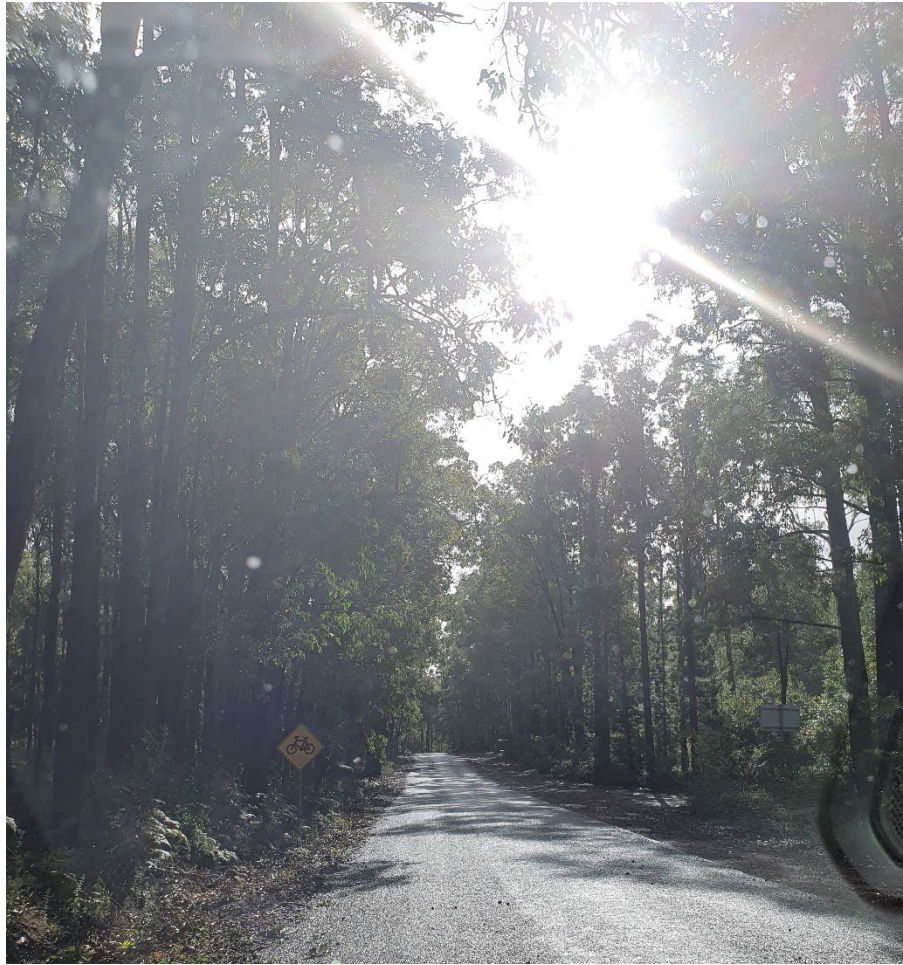
This section is leading up to the Mundi Bidi trail near finding 2.1 and 2.2 on the site plan. The advanced warning sign identified is becoming obstructed with the native vegetation. This section will require mulching of ground cover to allow for suitable vision of guidepost and advanced warning signs as per *Austroads Guide to Road Design Part 6B: Roadside Environment*.

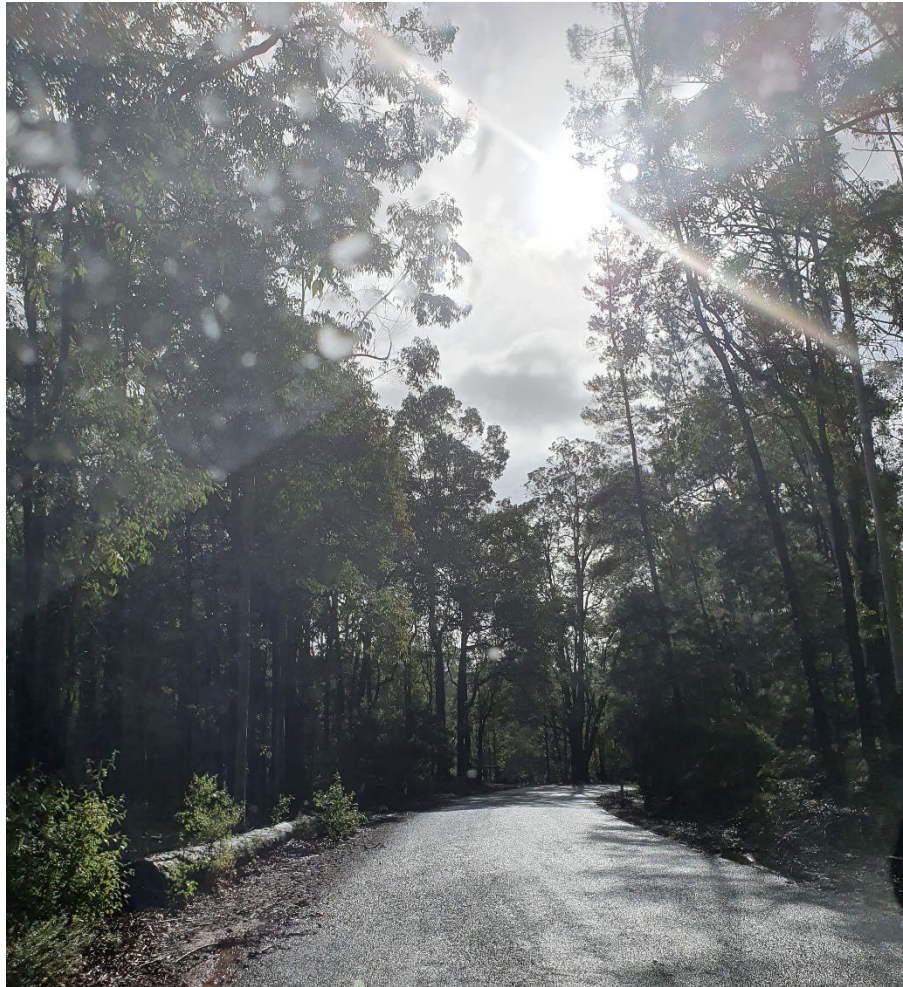
The section identified in the above photo is near finding 2.3 of the site plan. The isolated substandard curve causes sudden speed reduction which may catch a driver unaware. The ground cover vegetation will be mulched to ensure sight lines to guideposts and advanced warning signs are improved.

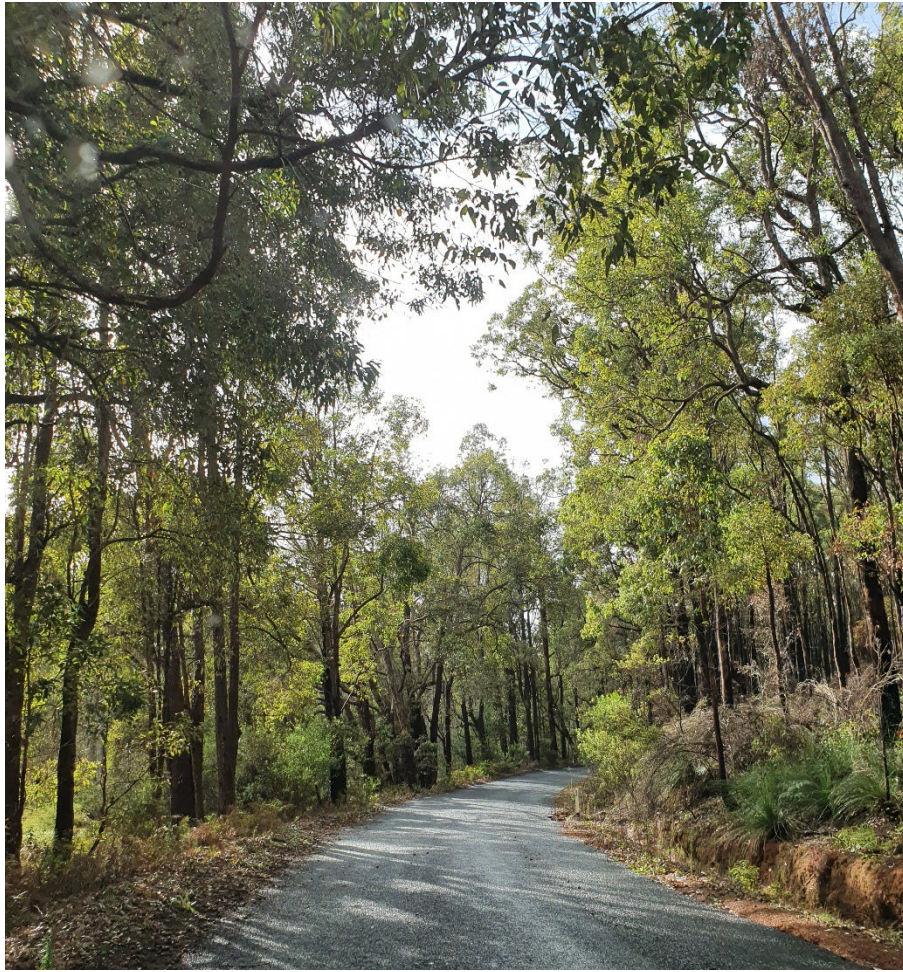
This section is the end of the curve as per finding 2.3 of the site plan and will require minor vegetation mulching of the ground cover along the north and south bound lane to improve sight lines to the guide posts.

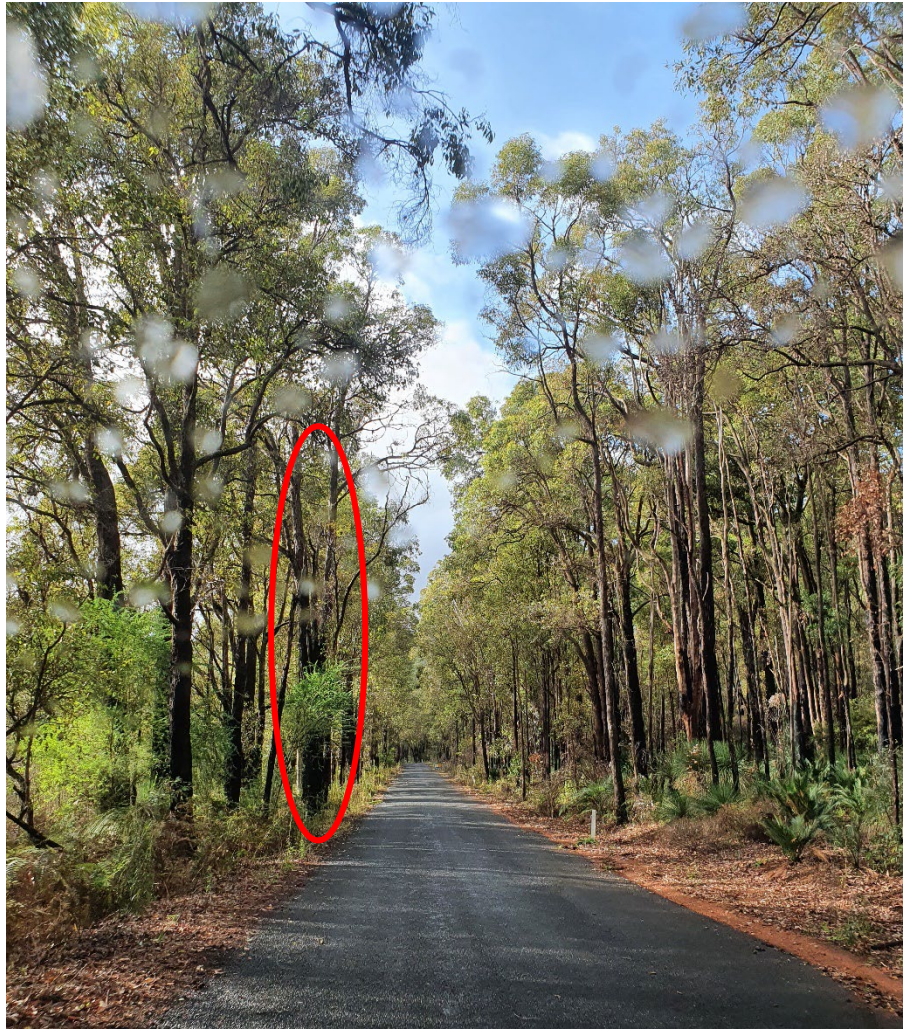
The road verge batters are reasonably flat and therefore no safety barriers are required, however the sight lines to of guideposts and advanced warning signs is substandard and therefore ground cover vegetation will require mulching to improve vision as per the Road Safety Audit recommendation item 2.6. In addition to the mulching it is likley that established native trees within 600m of the edge of seal may be removed as identified in the above image.

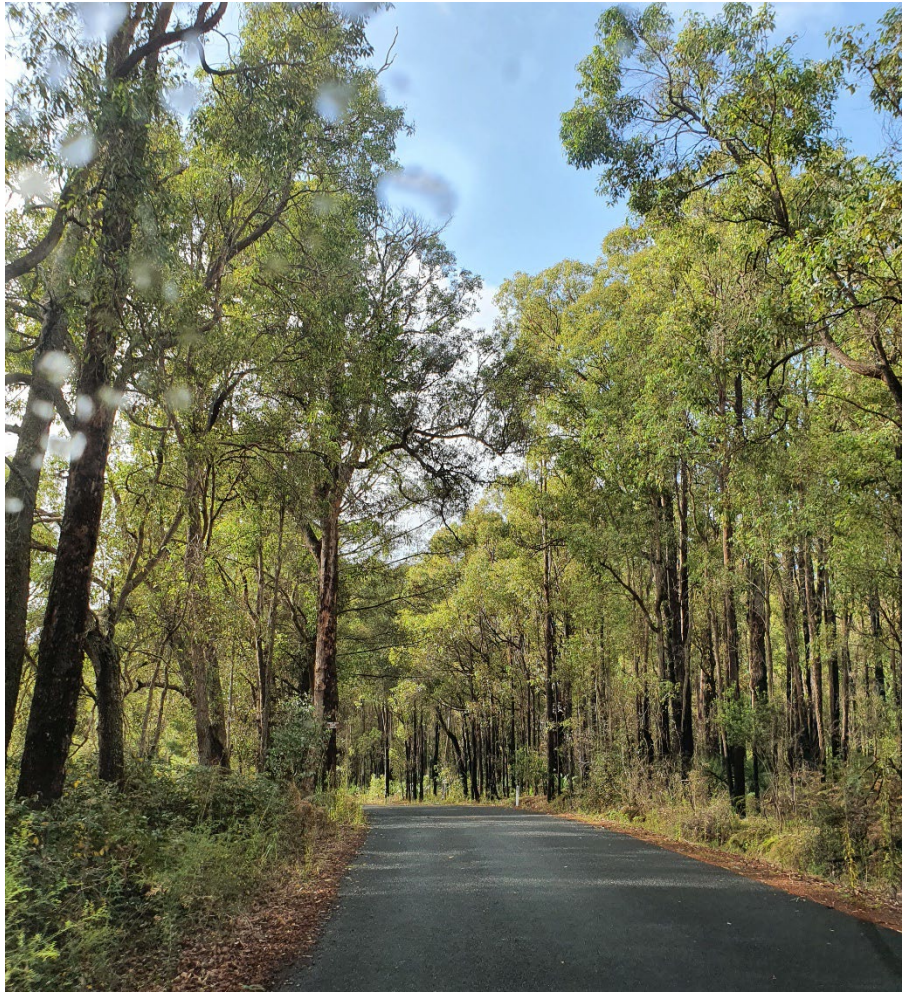
SLK 0.30 to 0.37 the native vegetation on both the north and south bound lanes requires mulching to ensure adequate sight lines to guideposts and advanced warning signage as per the Road Safety Audit recommendation 2.6.
