Reconnaissance Vegetation Survey

Lot 7 Runnymede Road, Wellesly

July 2022

REPORT PREPARED BY
LUNDSTROM ENVIRONMENTAL CONSULTANTS PTY LTD

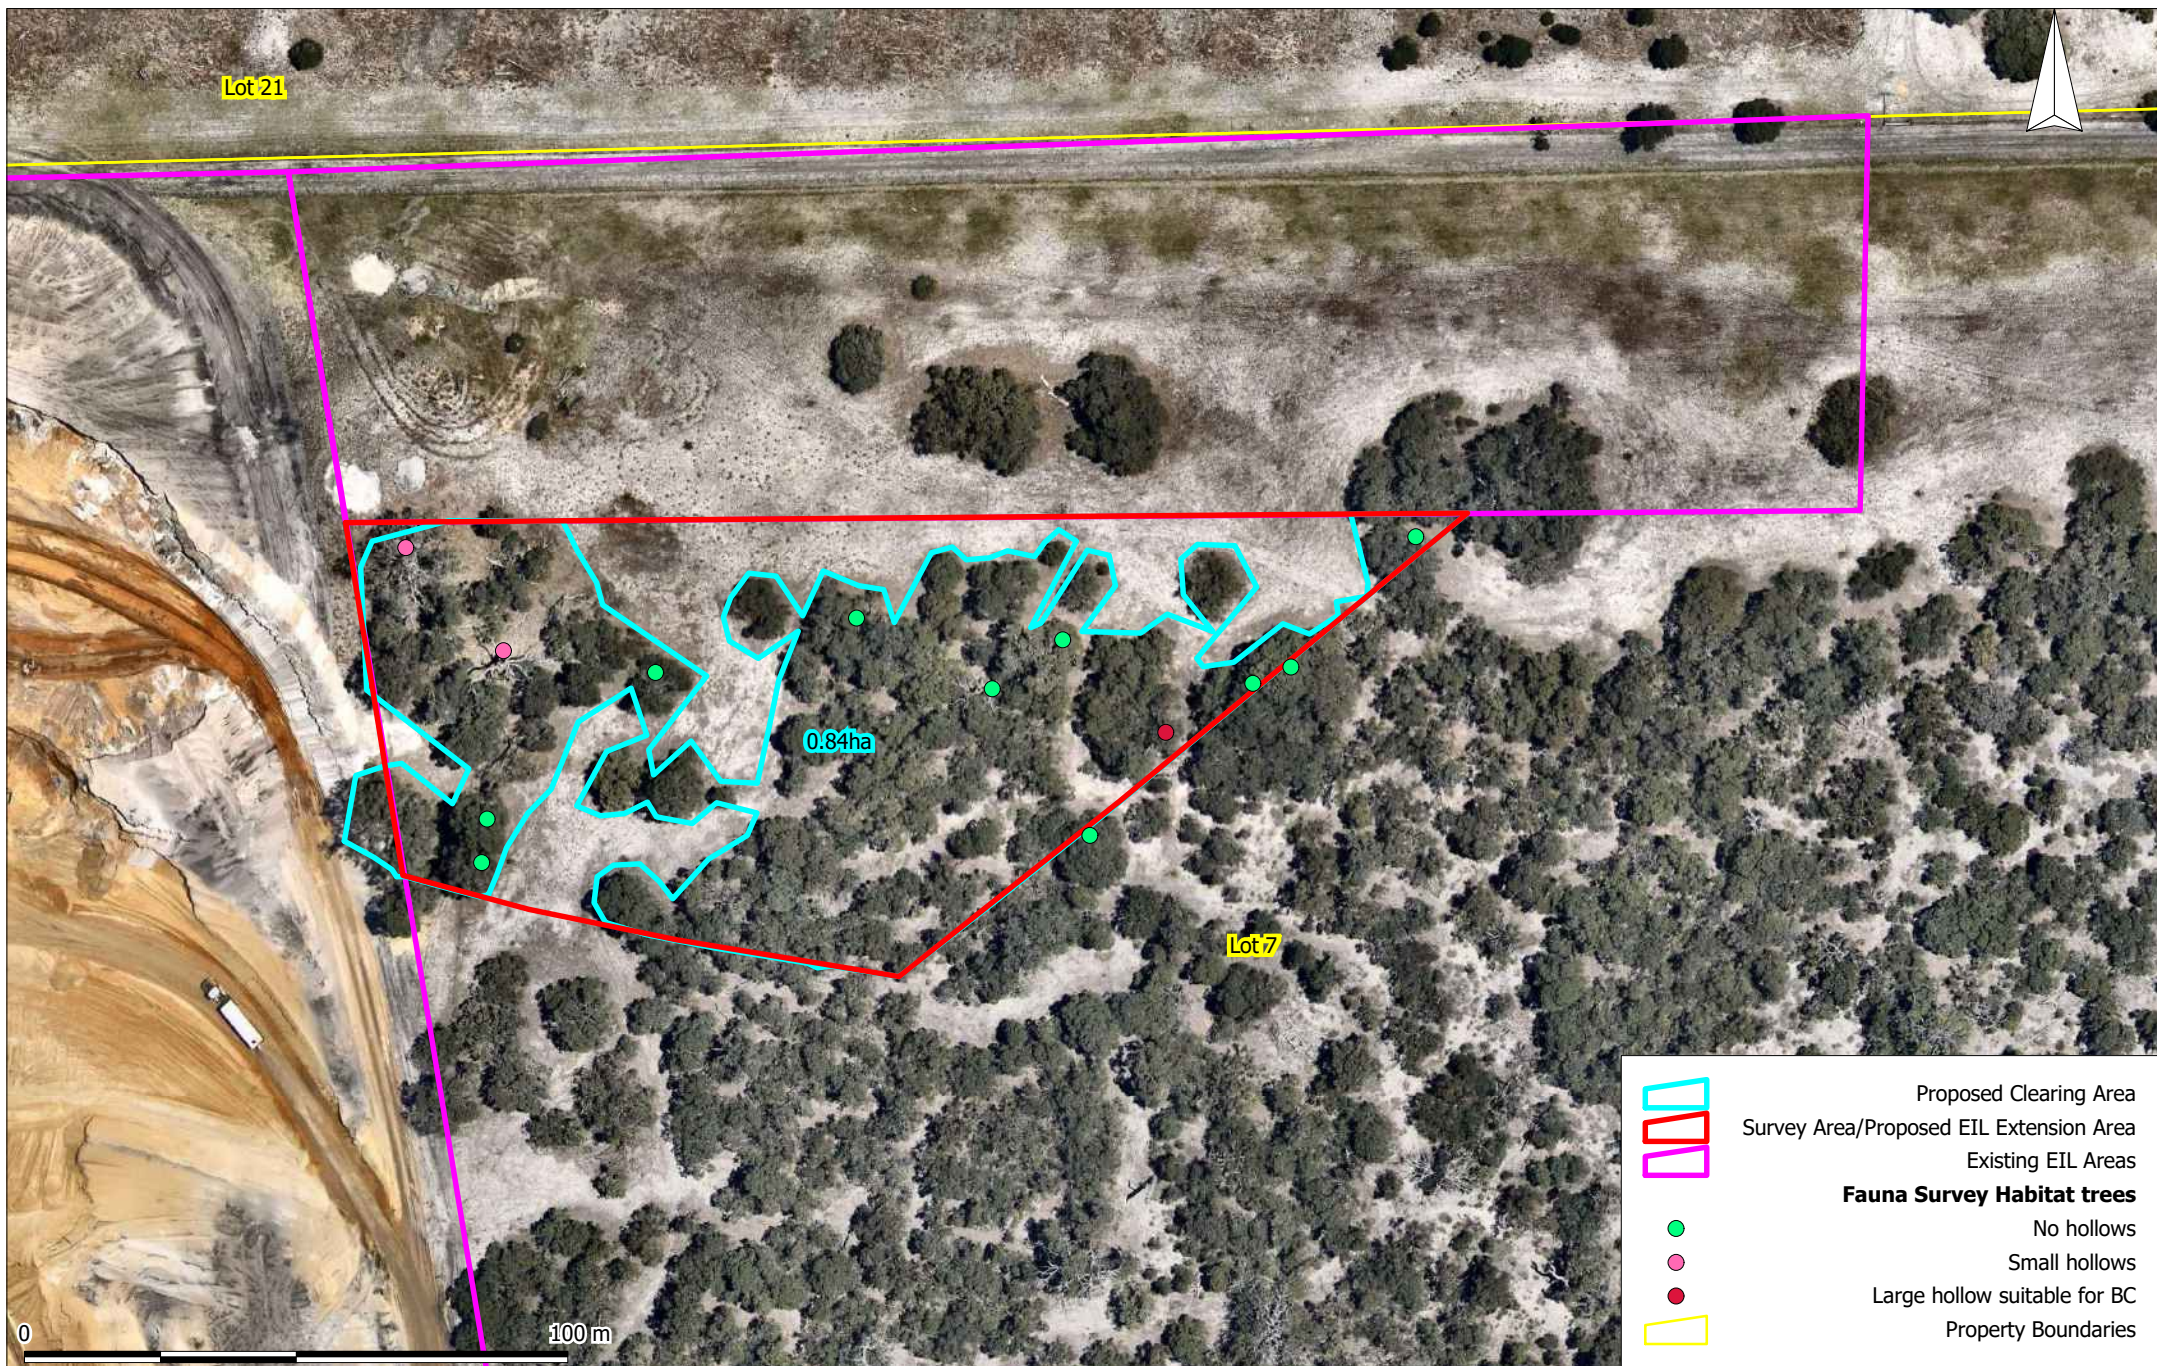
**Figure 1:
Survey Area**

In summary, the fauna survey which covers this area shows that there is one tree with a hollow suitable for black cockatoo nesting (not used), two trees with small to medium hollows, and a total of nine trees with a DBH>50cm only. Figure 1 illustrates the location of these trees.

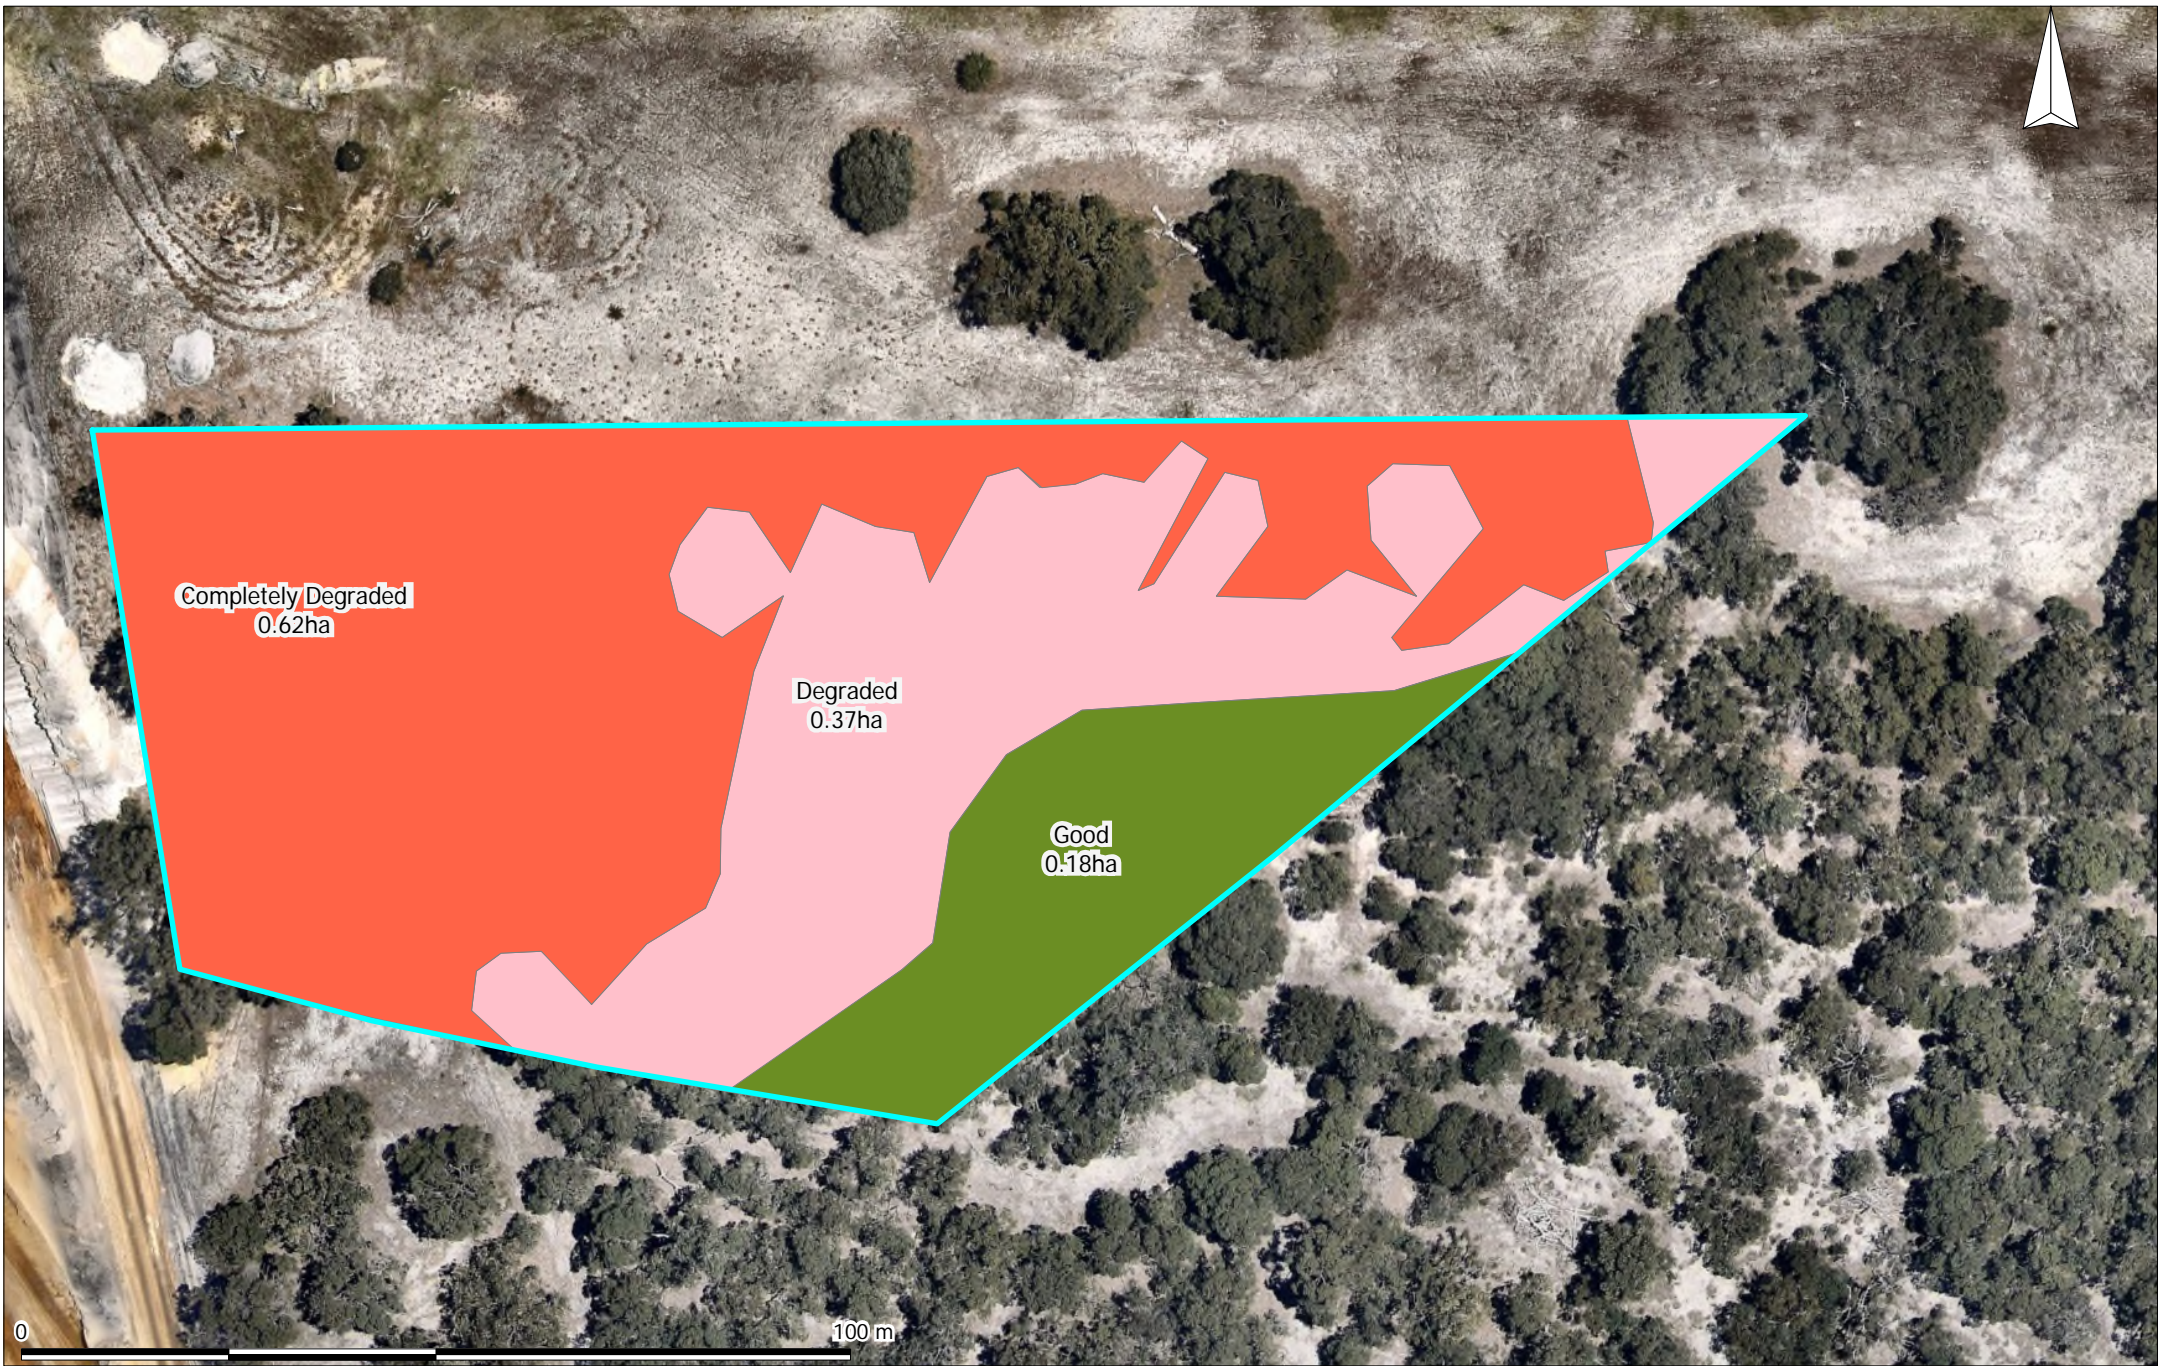
**Figure 2:
Vegetation Condition**

The condition of vegetation was assessed and coarsely mapped as transitioning from east to west as 'Good' to 'Degraded' to predominately 'Completely Degraded' (see Figure 2) using the vegetation condition scales outlined in Keighery (1994). Photographs were taken of the typical vegetation condition (see Appendix 1). The vegetation condition extent/area in hectares is summarised in Table 1. A description of the condition scale is summarised in Table 2.

Condition	Area (ha)	% of 1.2ha
Completely Degraded	0.62	53%
Degraded	0.37	32%
Good	0.18	15%
Total	1.17	100%

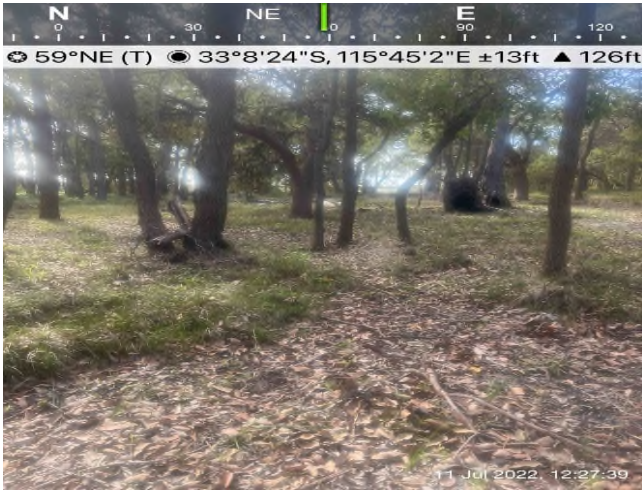
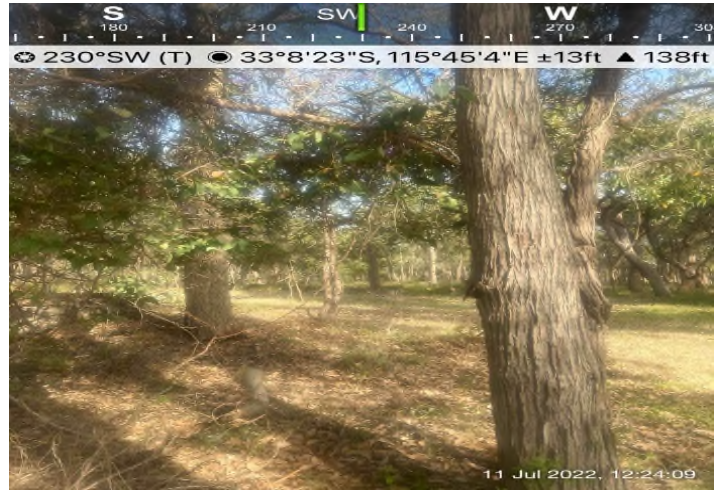
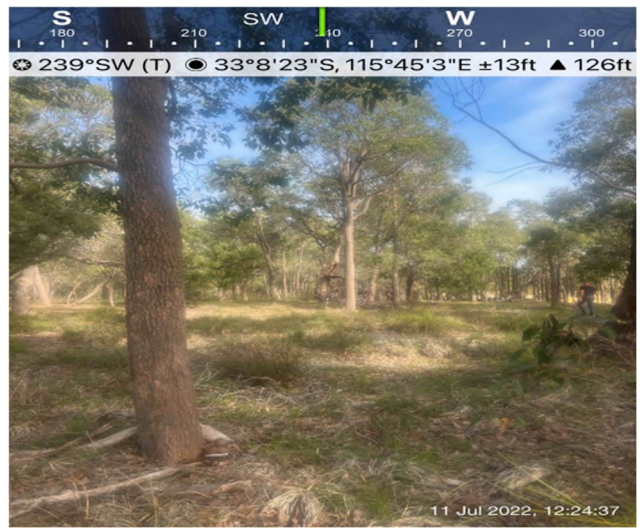
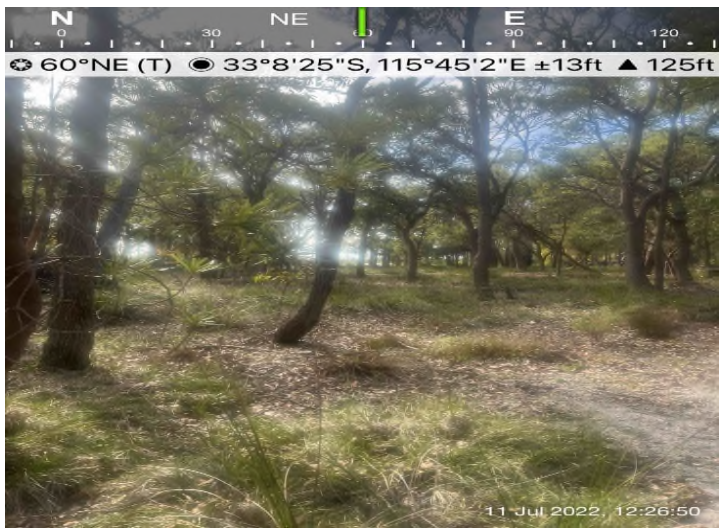
Areas of Degraded vegetation within the middle of the 1.2ha area

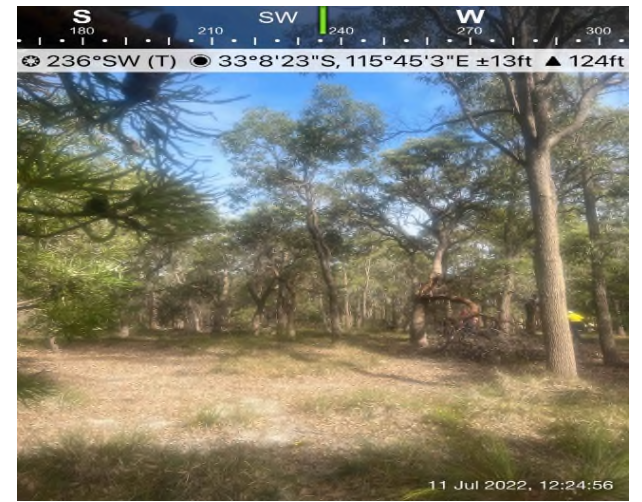
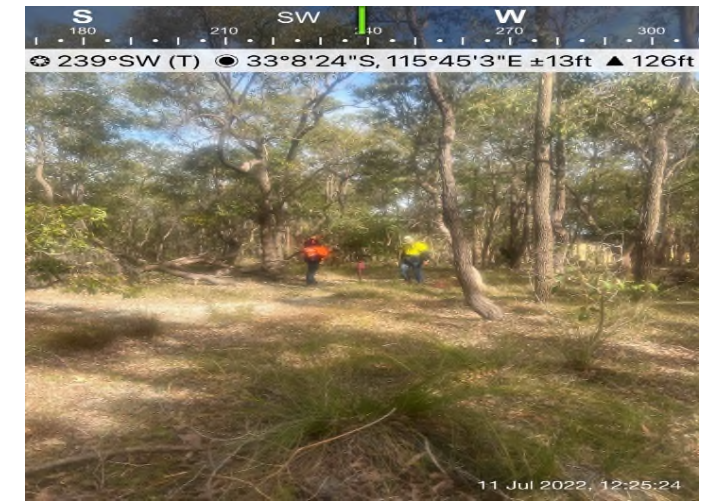
Area of Good vegetation condition in the southeast of the proposed clearing footprint
