Lights Road Upgrade Fauna Habitat Assessment Report

Subject: *Fauna Habitat Assessment Report for Lights Road upgrade – for native vegetation clearing permit application*

File Ref: PROJ.ENG. 22_23 LIGHTS ROAD – SLK 0.03-0.83

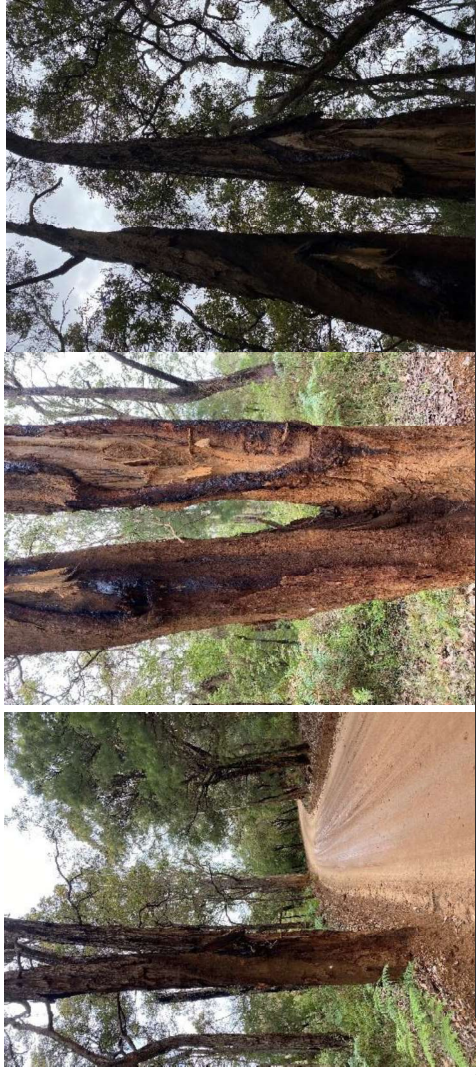
Tree ID: 10a

(sustained damage)
