**ATTACHMENT 5 – Photos of the clearing permit application area and surrounding area**

All photographs were taken during a site inspection on 4 July 2022.

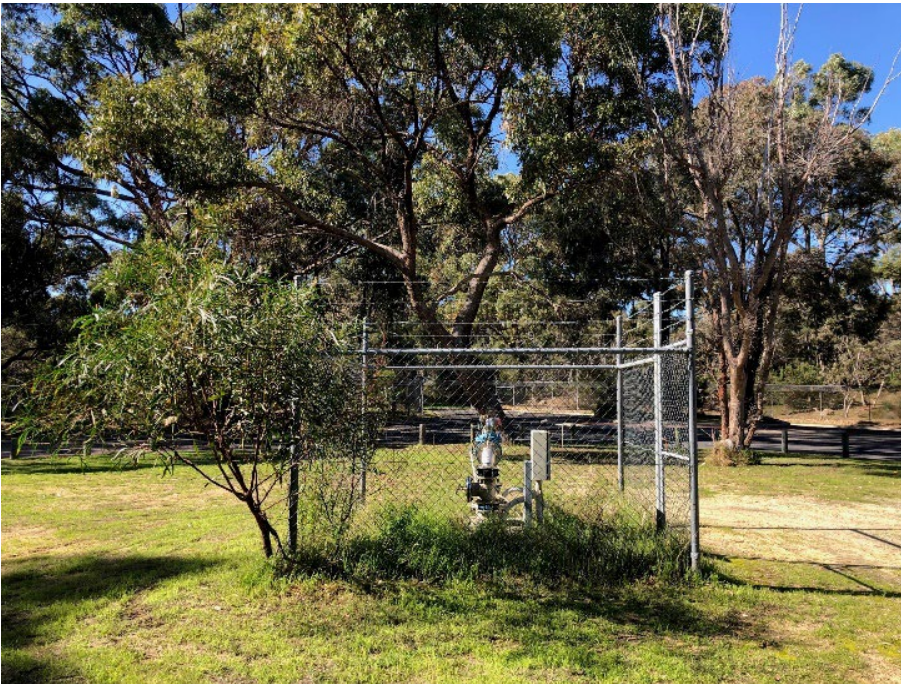
Plate 1: Geothermal groundwater bore (GWL 182271). The bore is, outside of clearing permit area however is included as it shows the commencement location for the pipeline.

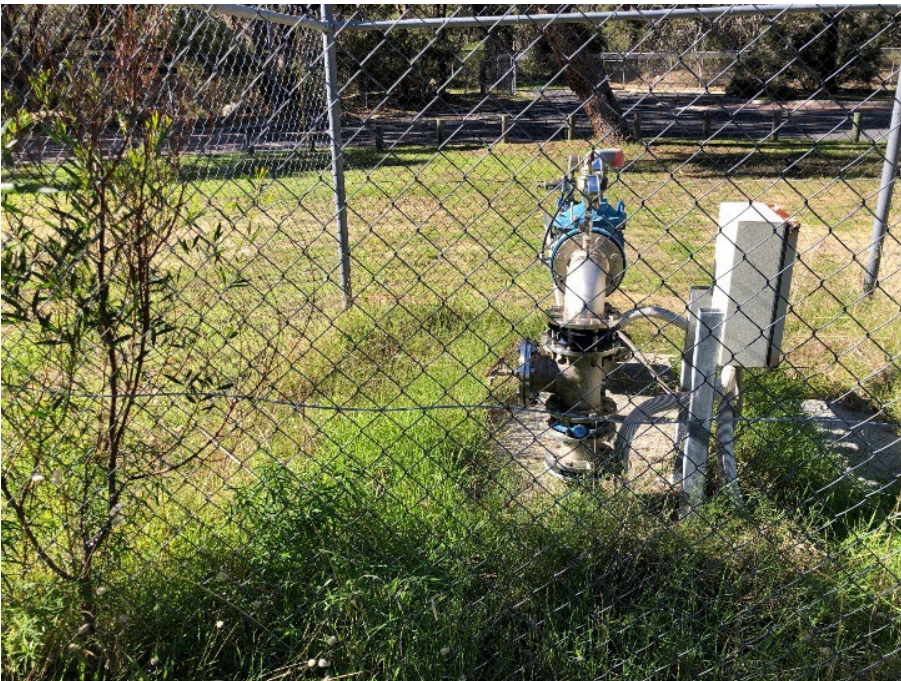
Plate 2: Close-up photo of the geothermal groundwater bore (GWL 182271).

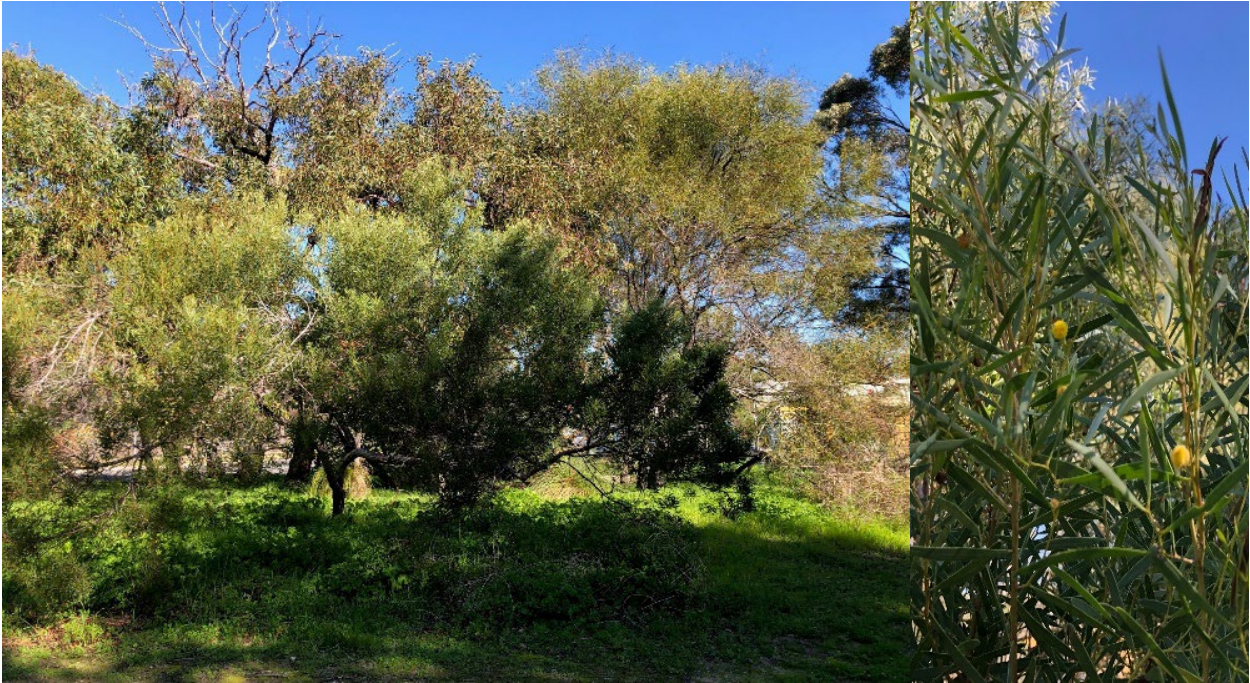
Plate 3: Photo of *Acacia cyclops* situated on the northern section of the remnant native vegetation patch (clearing permit area).

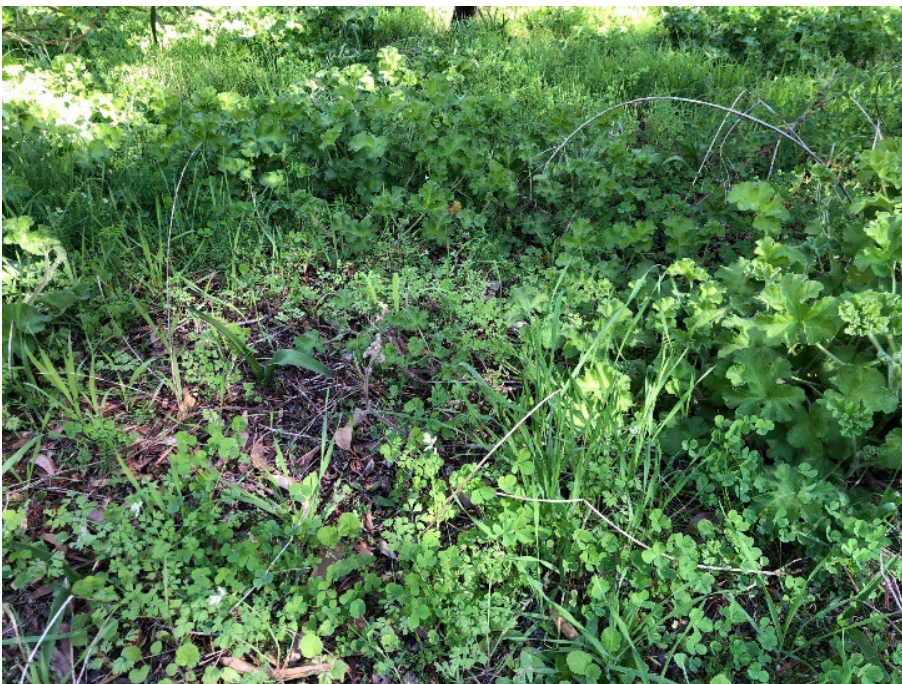
Plate 4: Photo of the ground cover, comprising of weed species, within the clearing permit area. The species include Rose Pelargonium, Yellow Soldiers, and other Grassy Weeds.

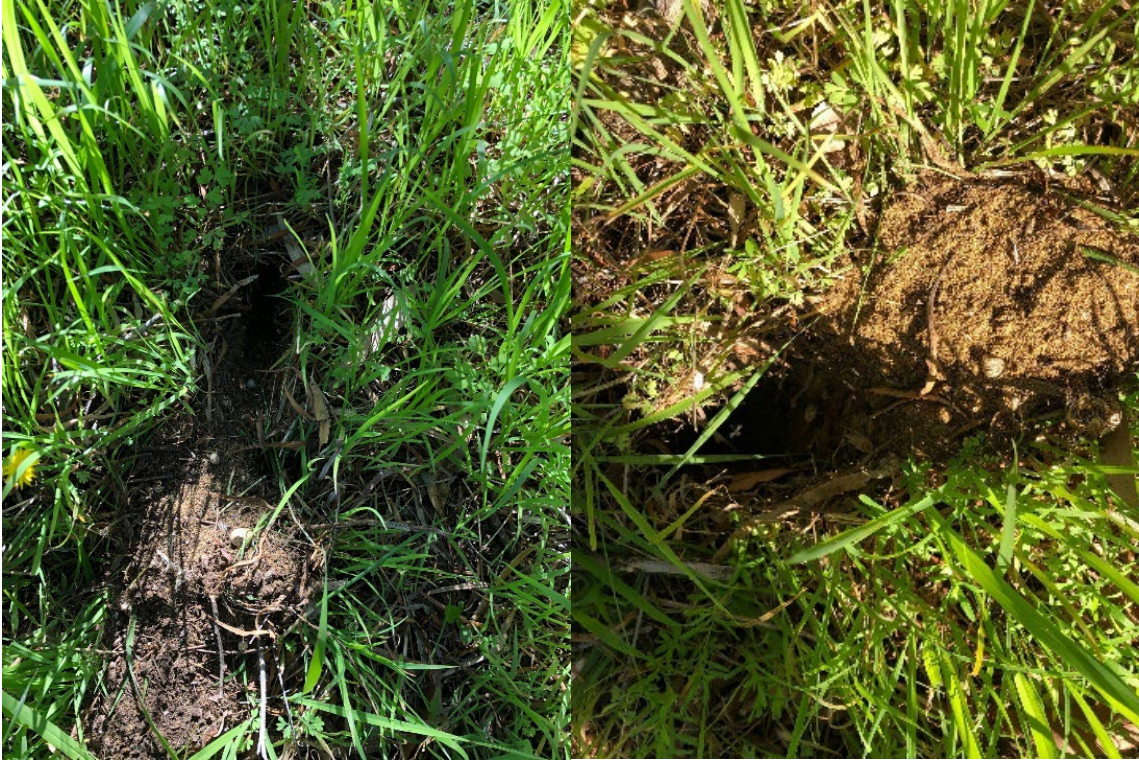
Plate 5: Recent Quenda diggings observed within the clearing permit area.

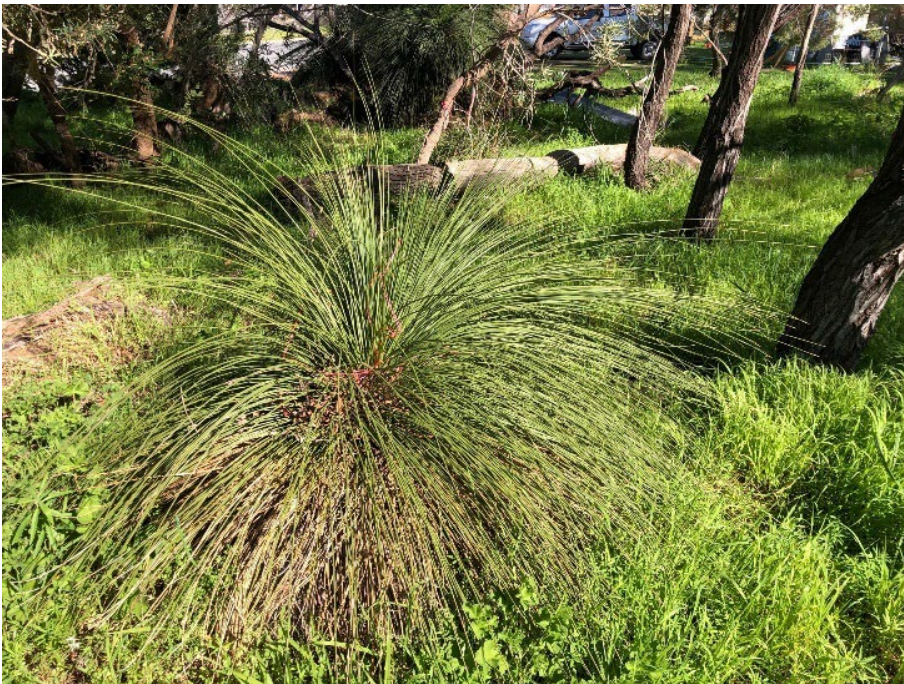
Plate 6: Grass Tree (*Xanthorrhoea preissii*) marked for clearing within the clearing permit area.

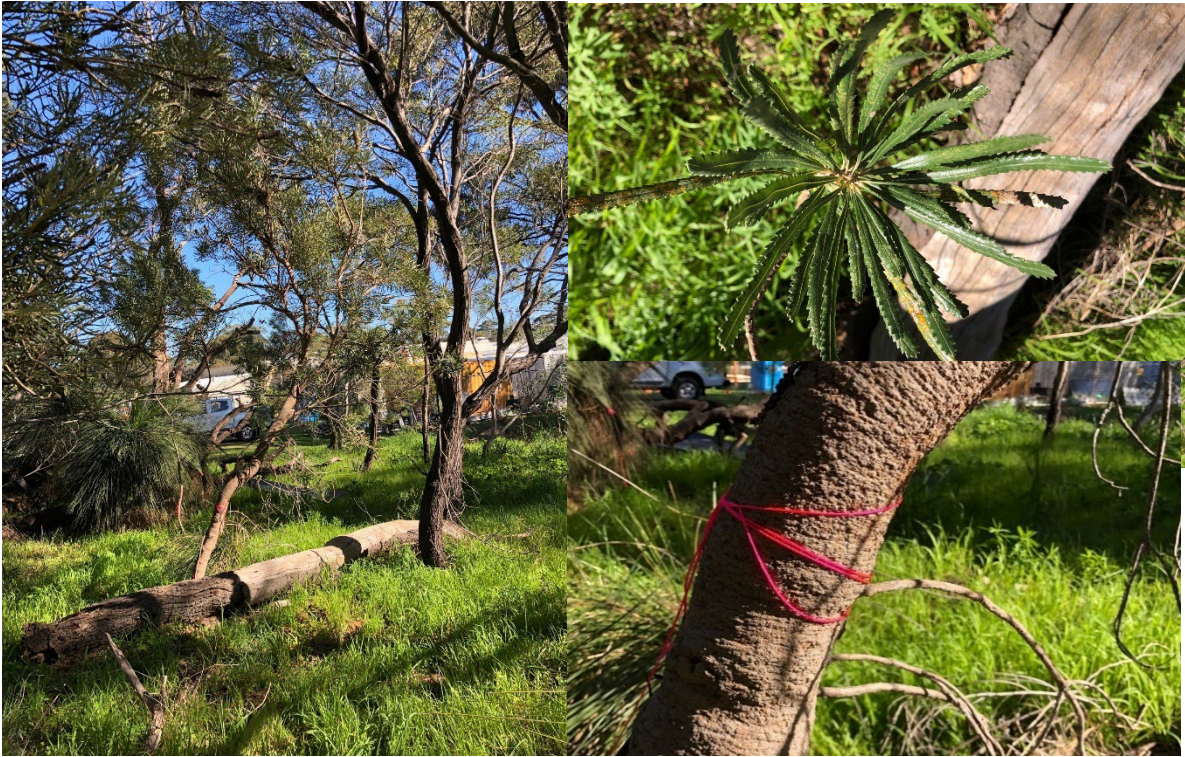
Plate 7: Slender Banksia (*Banksia attenuata*) within the clearing permit area.

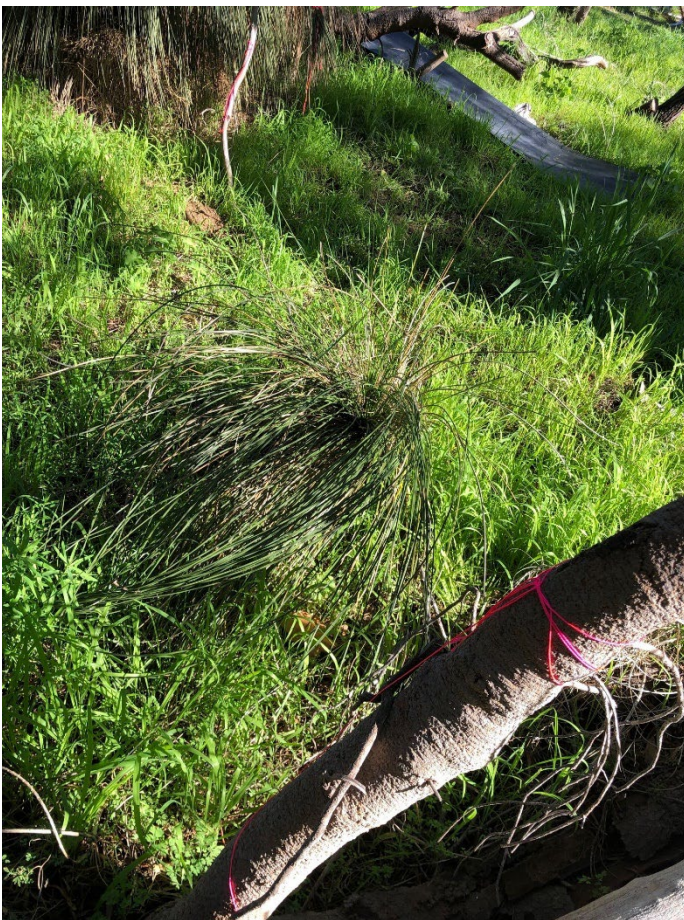
Plate 8: Small Grass Tree (*Xanthorrhoea preissii*) within the clearing permit area.

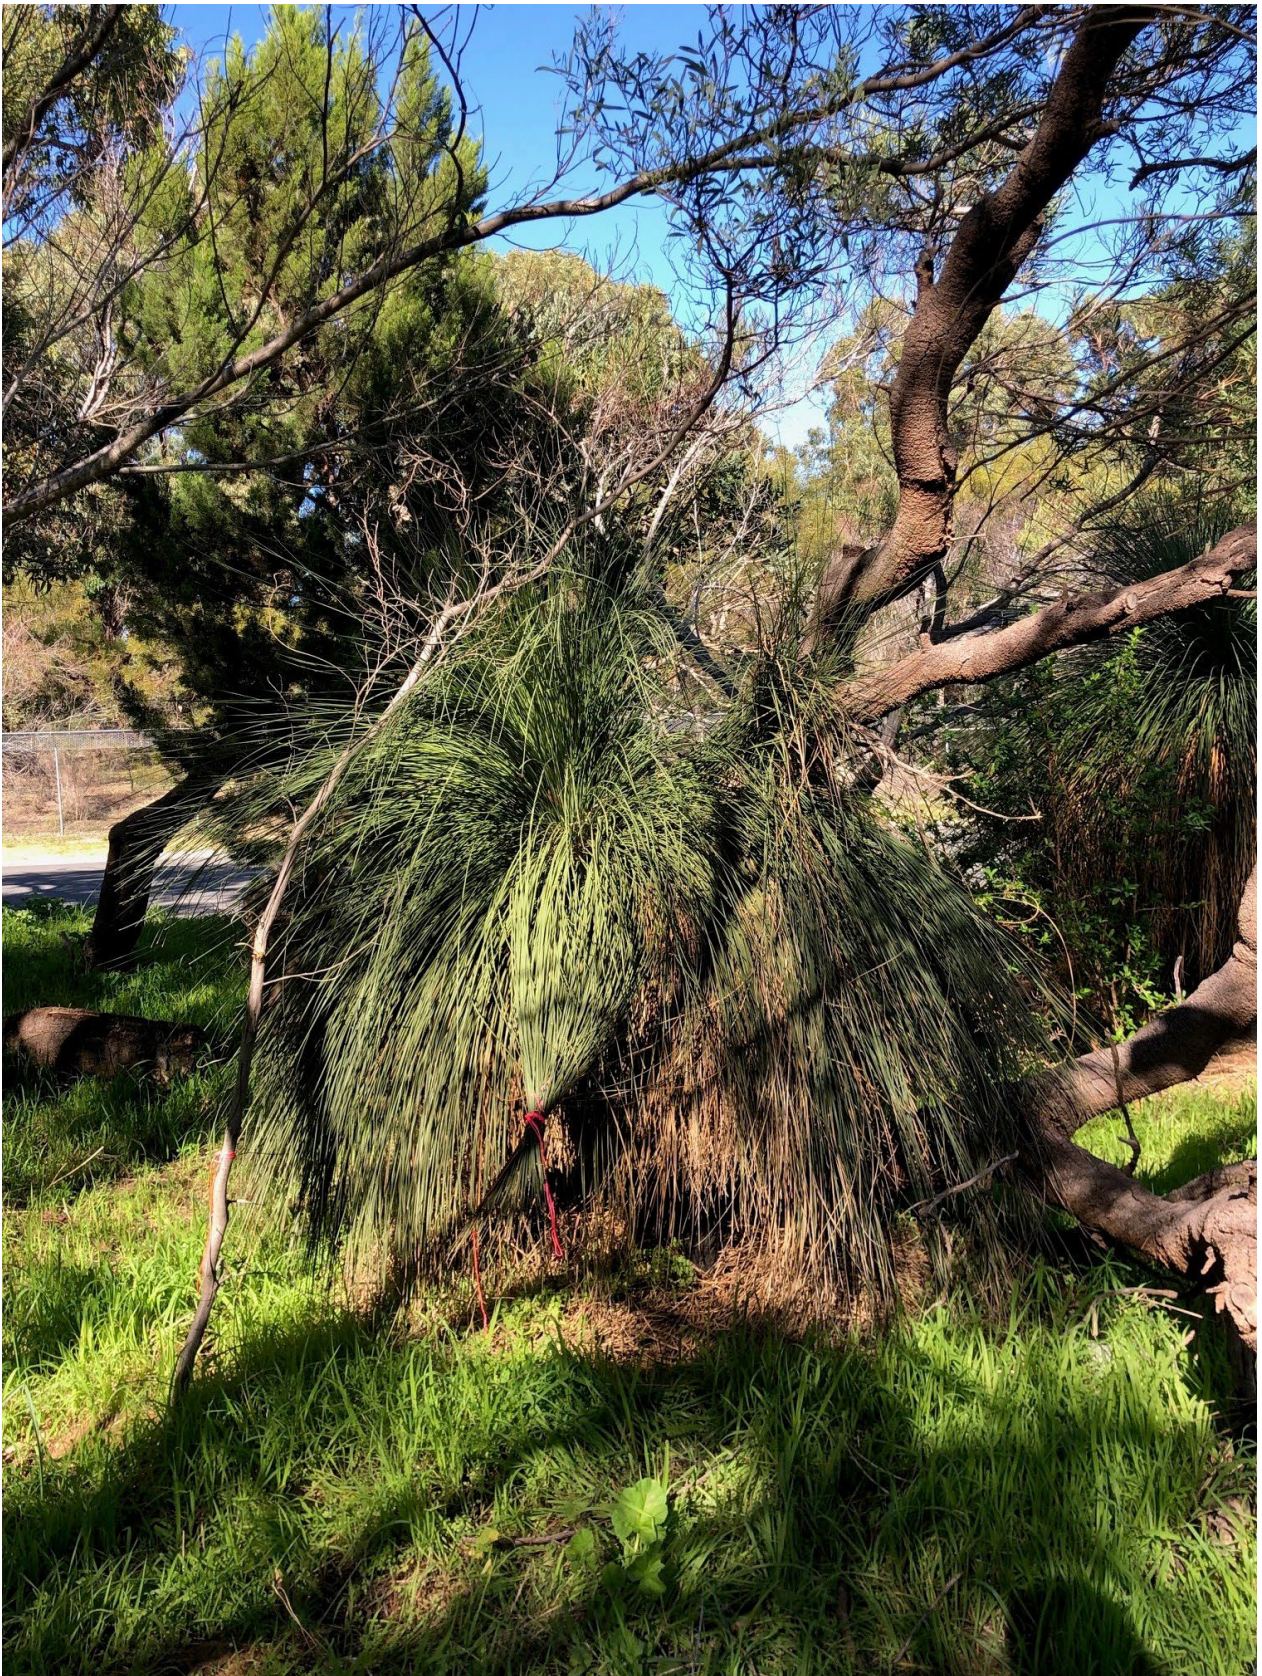
Plate 9: Large grass tree (*Xanthorrhoea preissii*) and *Acacia salinga*.

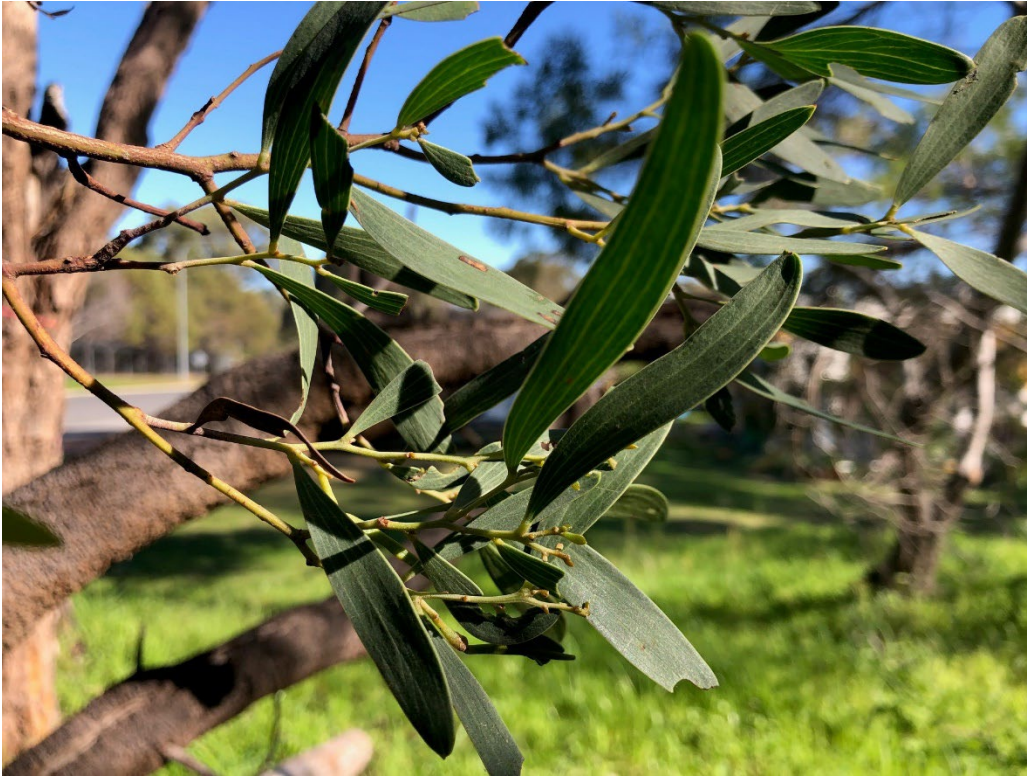
Plate 10: Close-up of *Acacia saligna* within the clearing permit area.

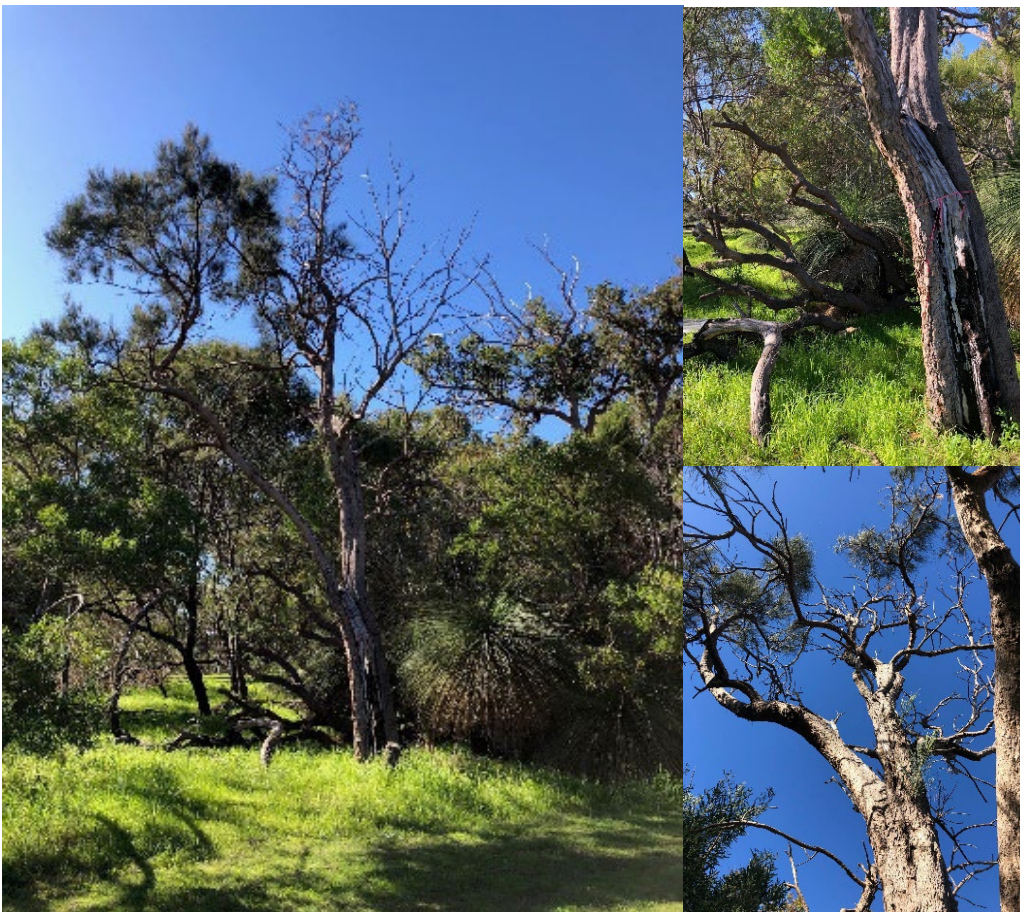
Plate 11: Sheoak (*Allocasuarina fraseriana*) within the clearing permit area, photos from the south of the pipeline route looking north.

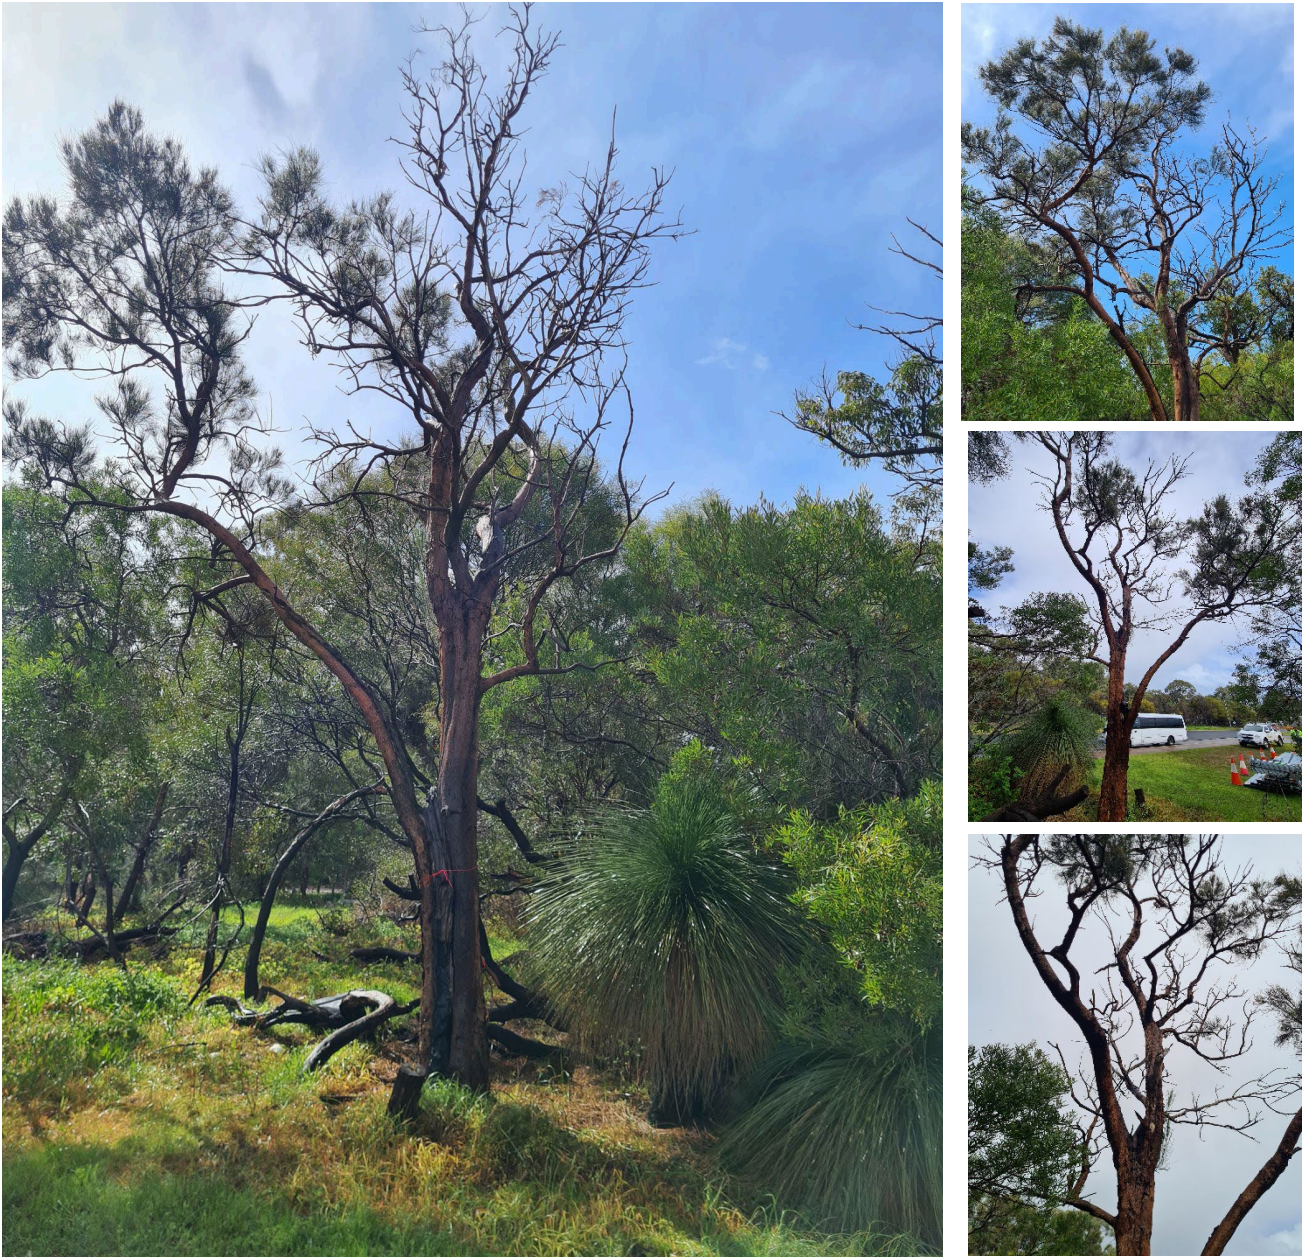
Plate 12: Rotational 360 degree view of the Sheoak (*Allocasuarina fraseriana*) within the clearing permit area to demonstrate the only mature tree impacted does not have any nesting hollows.

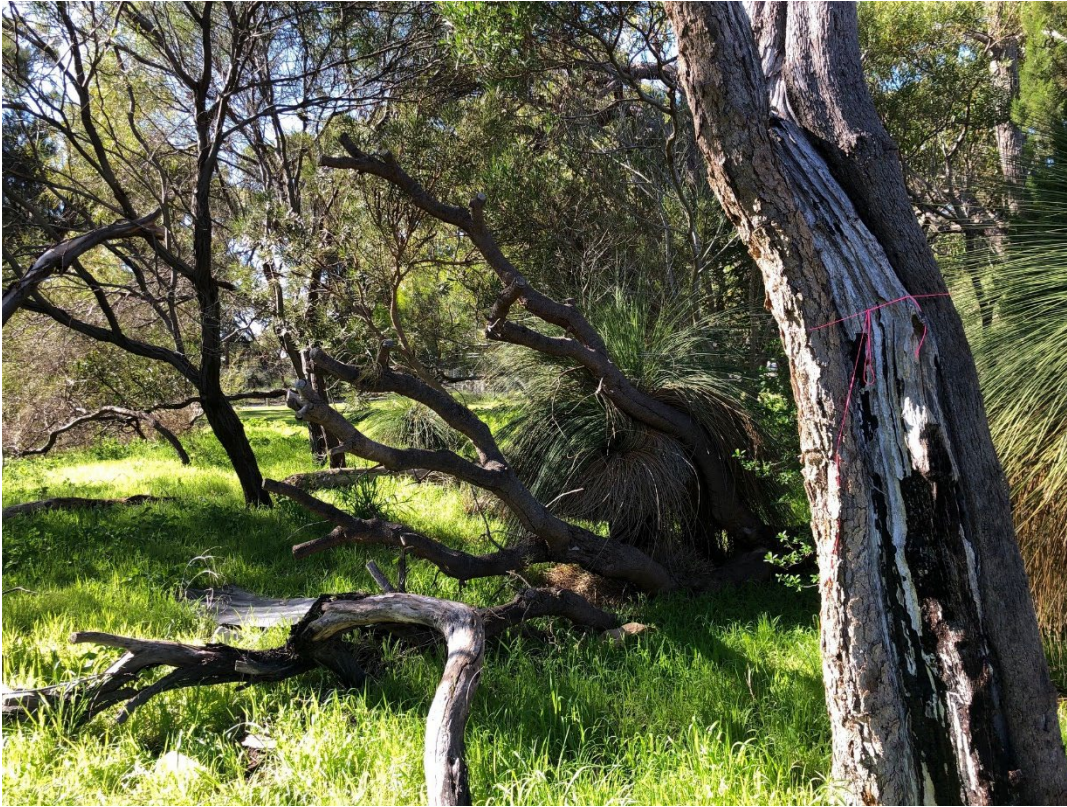
Plate 13: General image of the clearing permit area with fallen habitat trees (dead).

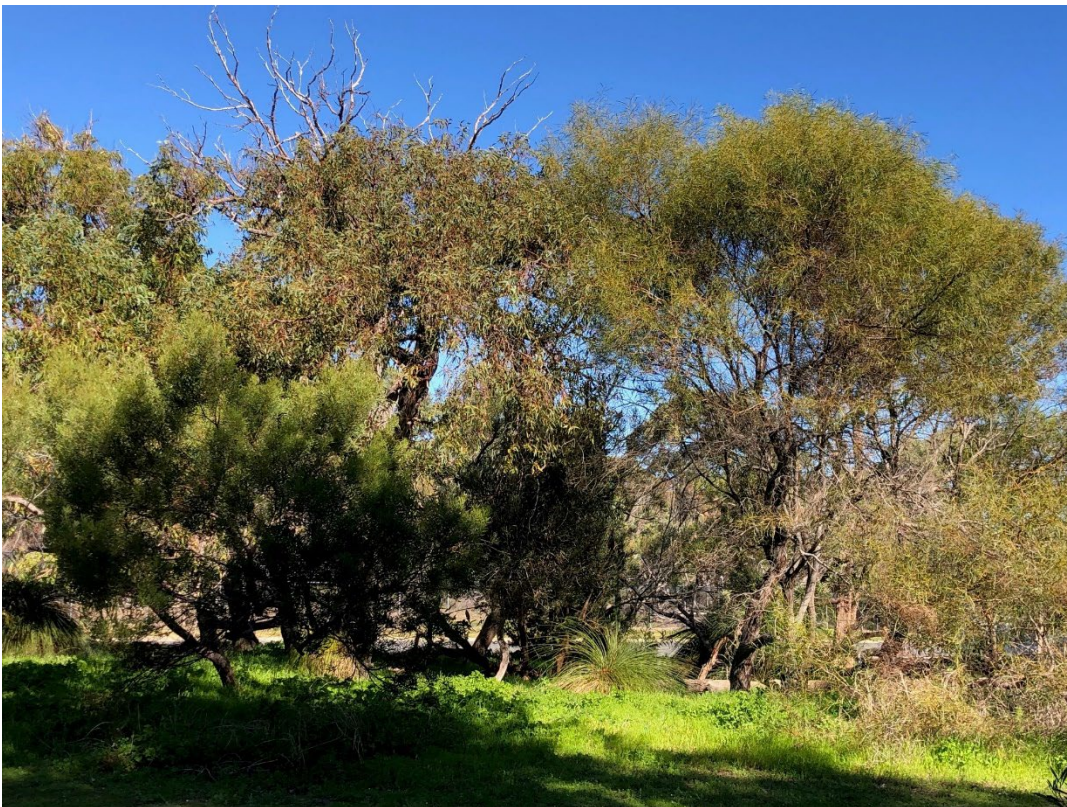
Plate 14: General view of the native vegetation patch from the north looking south.

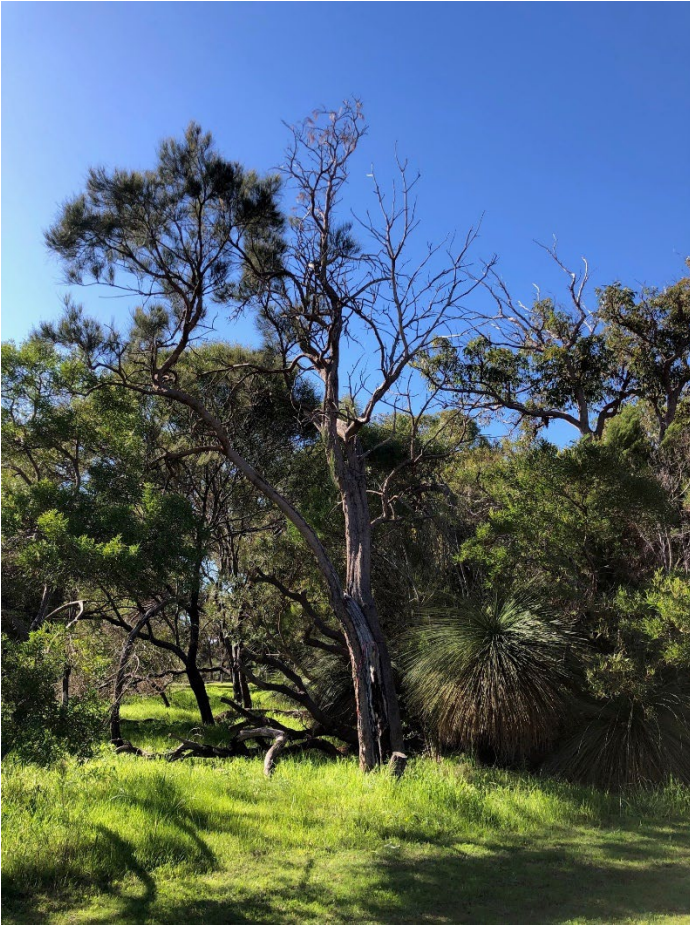
Plate 15: General view of the native vegetation patch from the south looking north.

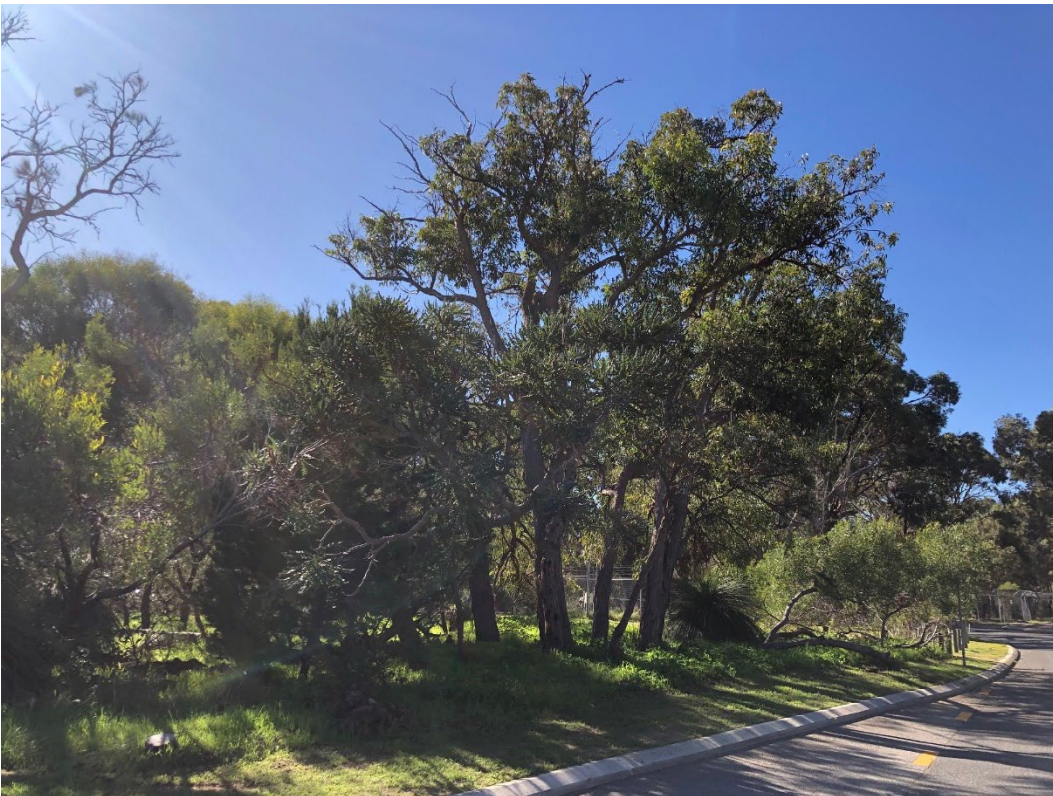
Plate 16: General view of the native vegetation patch from the road to the east.
