## PHOTOS OF TREES PROPOSED TO CLEAR (CPS 9937/1)

**Total: 31 trees** (indicated by red arrows), **including:** 10 Acacia trees.

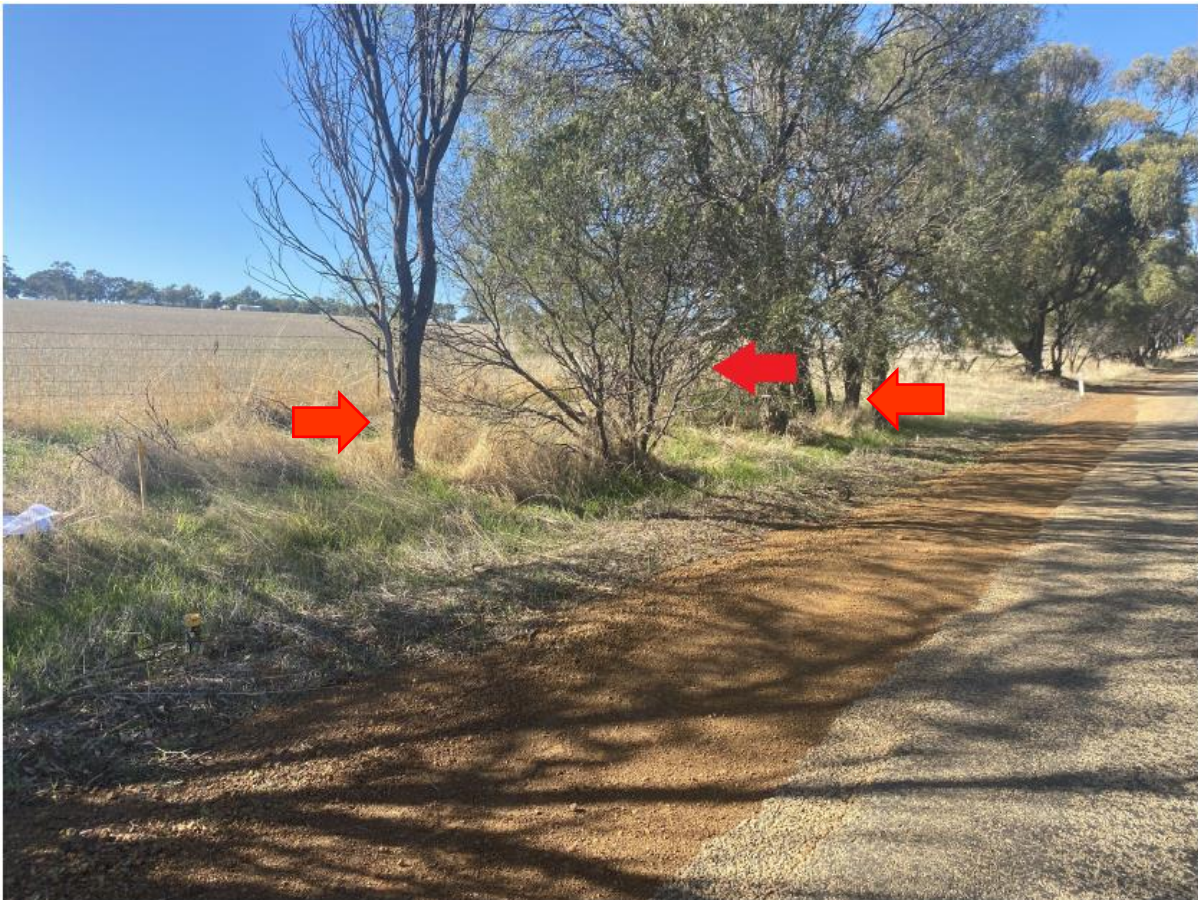
**ID 1 – Photo 1&2:** 7 Acacia trees (5m high), unhealthy with varying proportion of dead matters  
1 Acacia tree (4m)

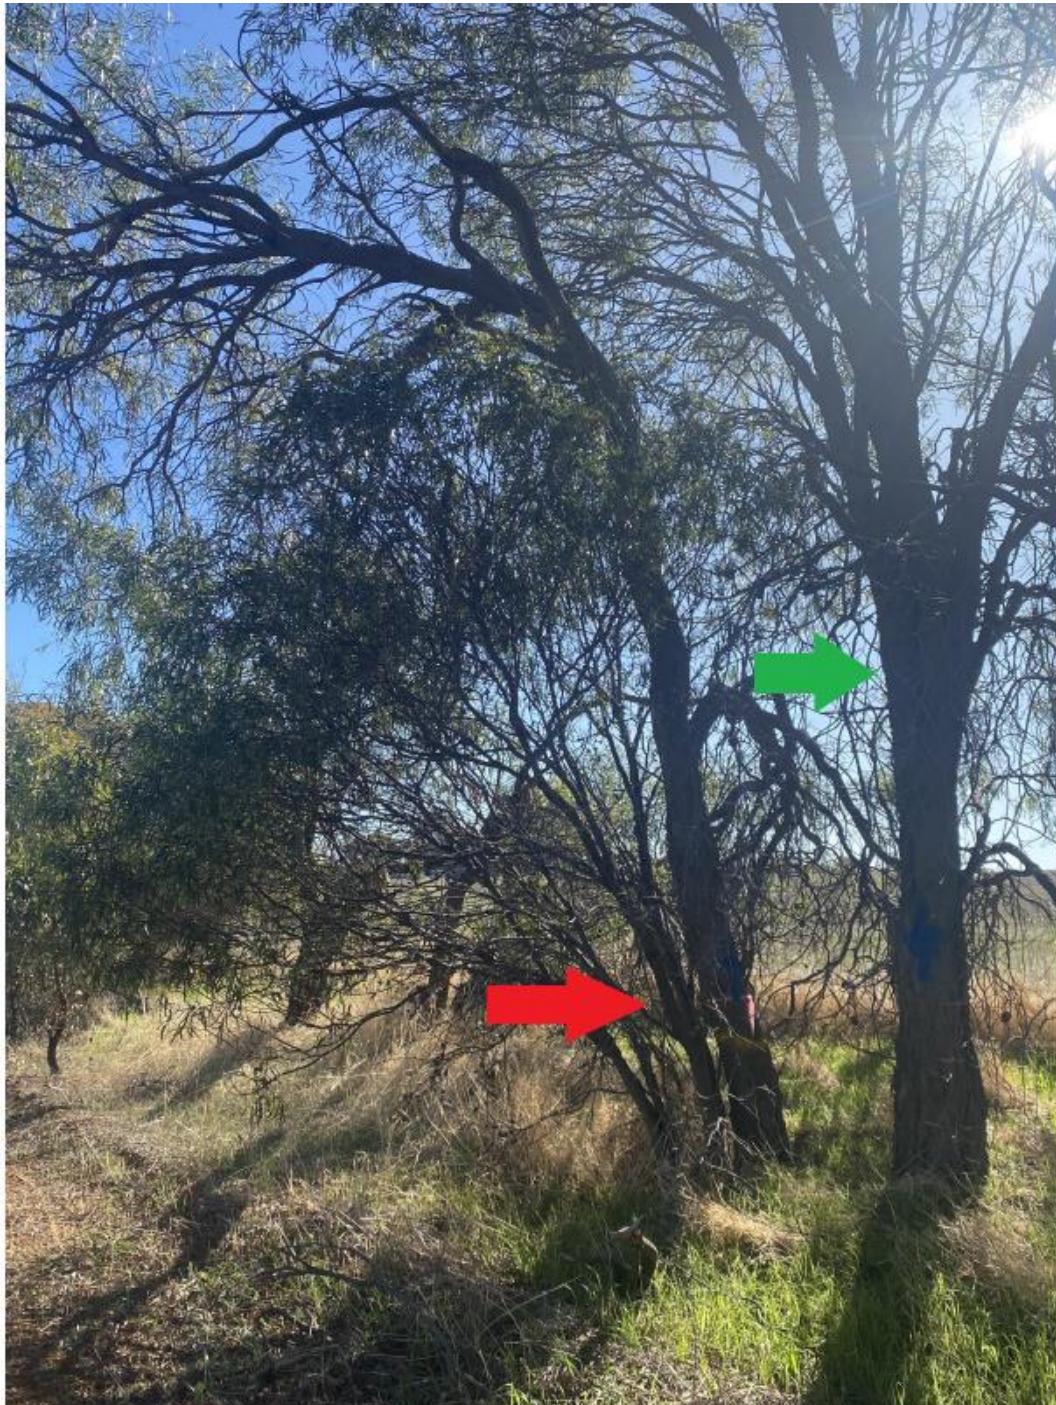
**ID 2 – Photo 3:** 1 Acacia, unhealthy within proposed drainage area

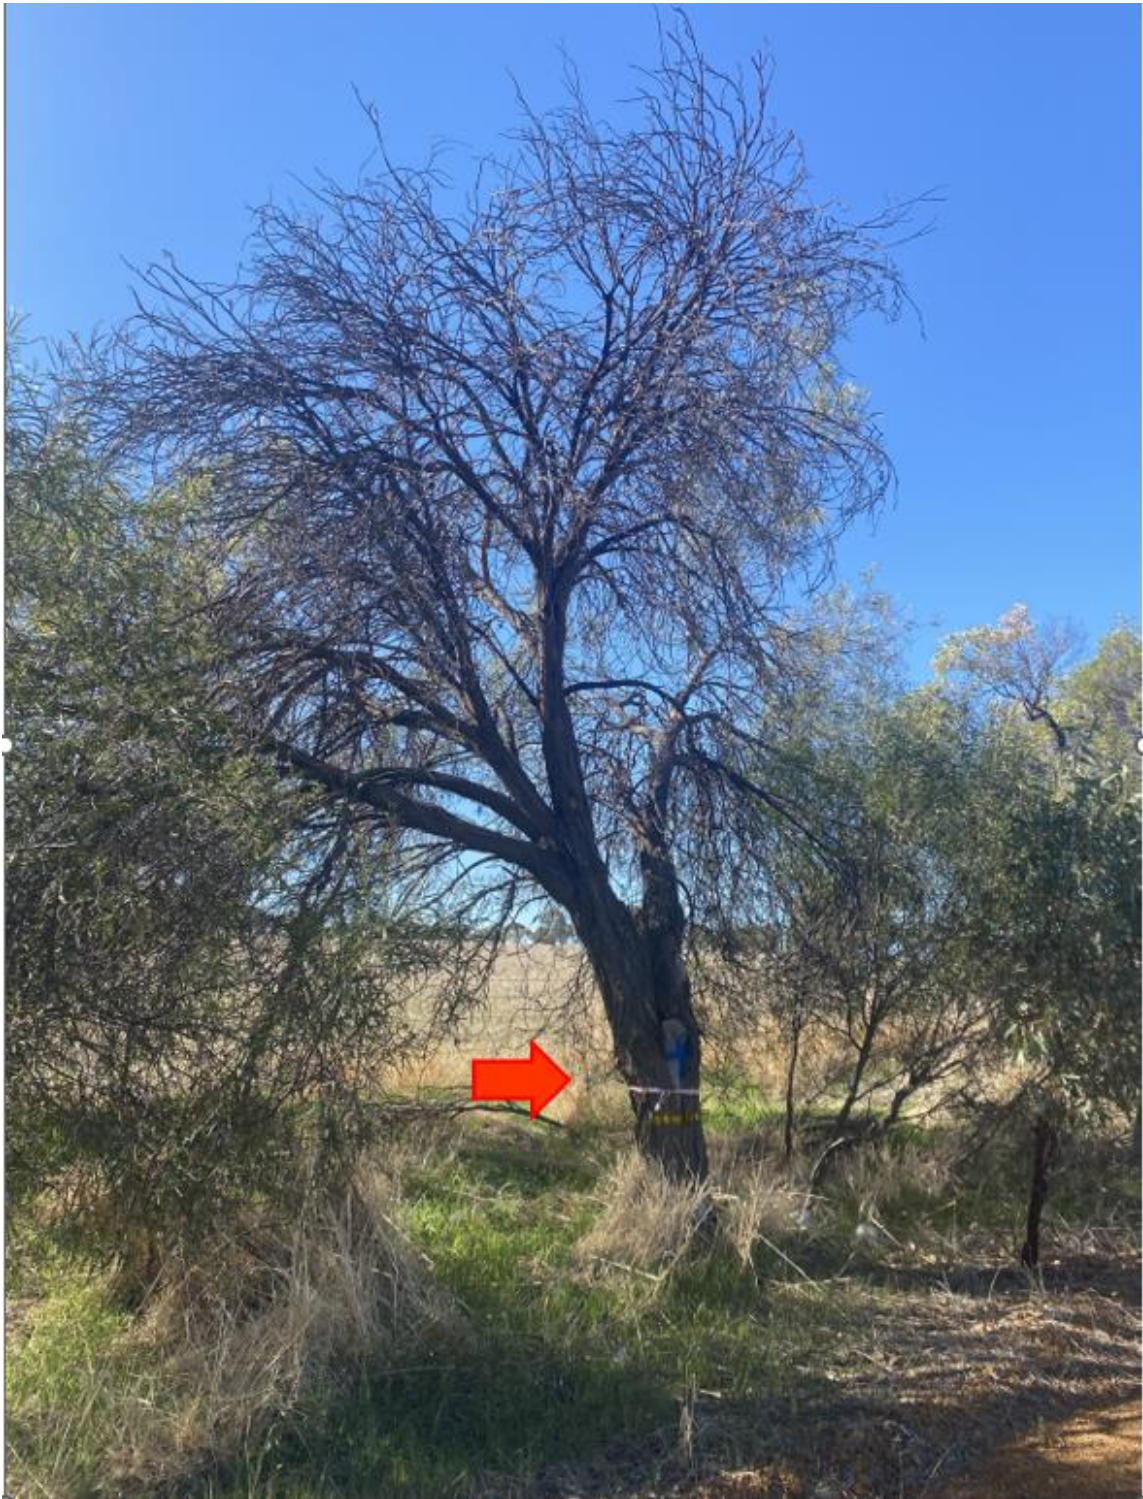
**ID 3 – Photo 4:** 1 Acacia, unhealthy, within proposed drainage area

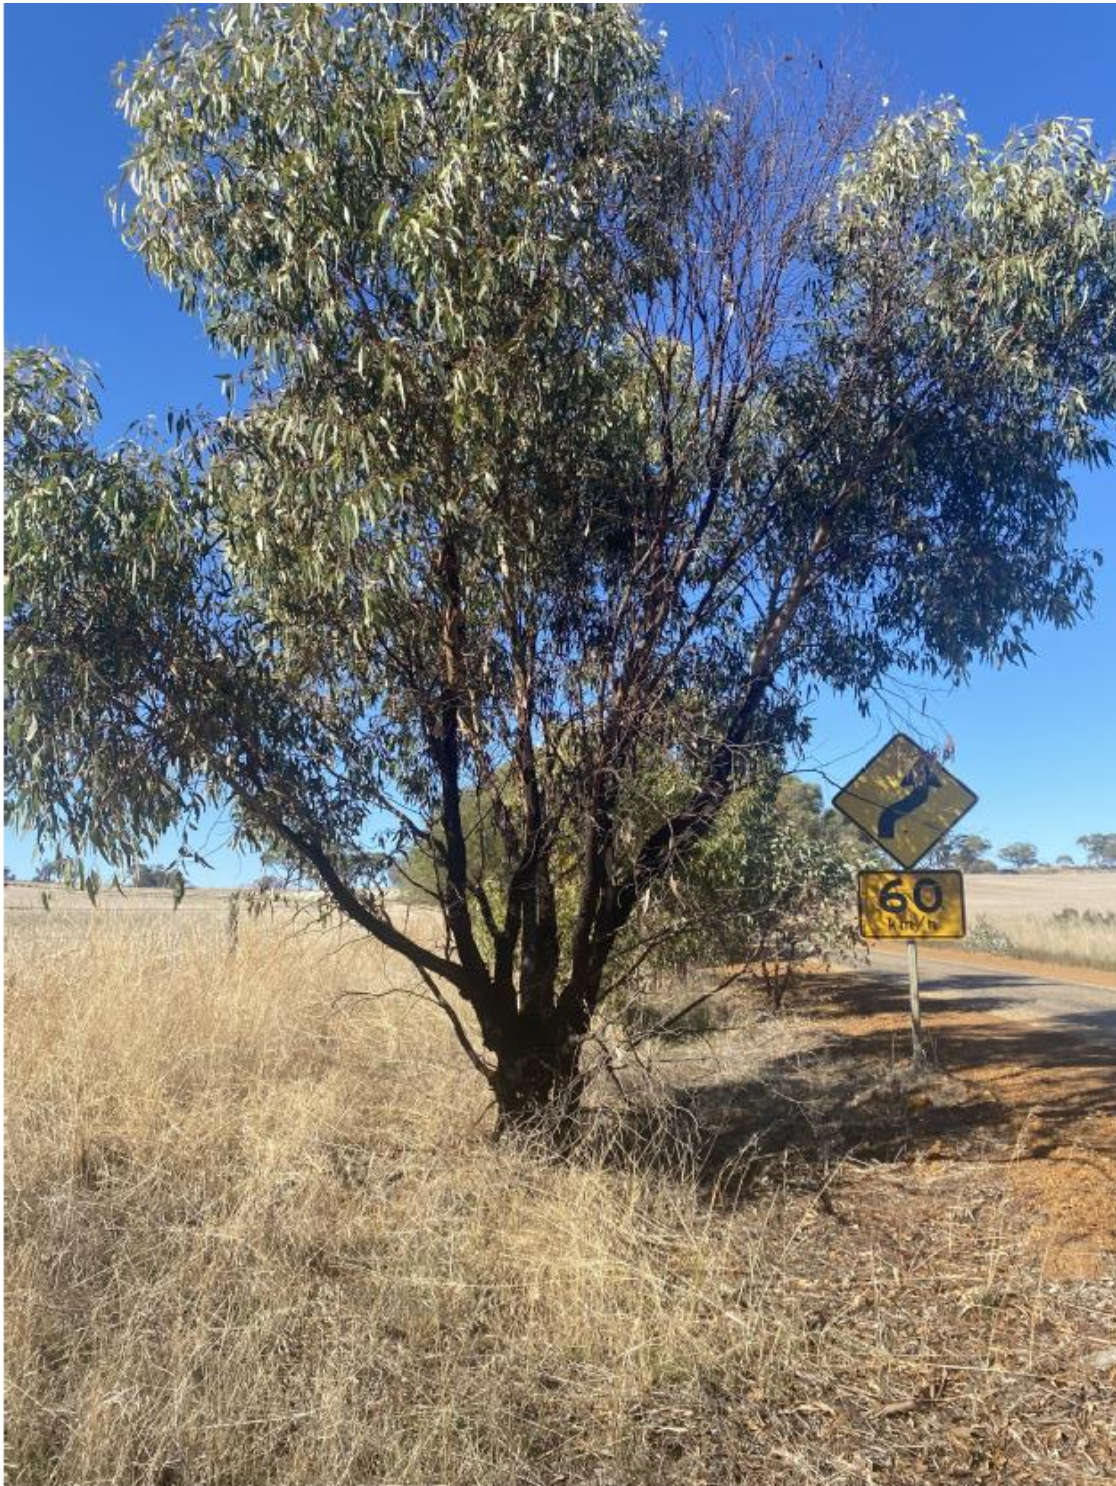
**ID 4 – Photo 5:** 1 York gum (5m).

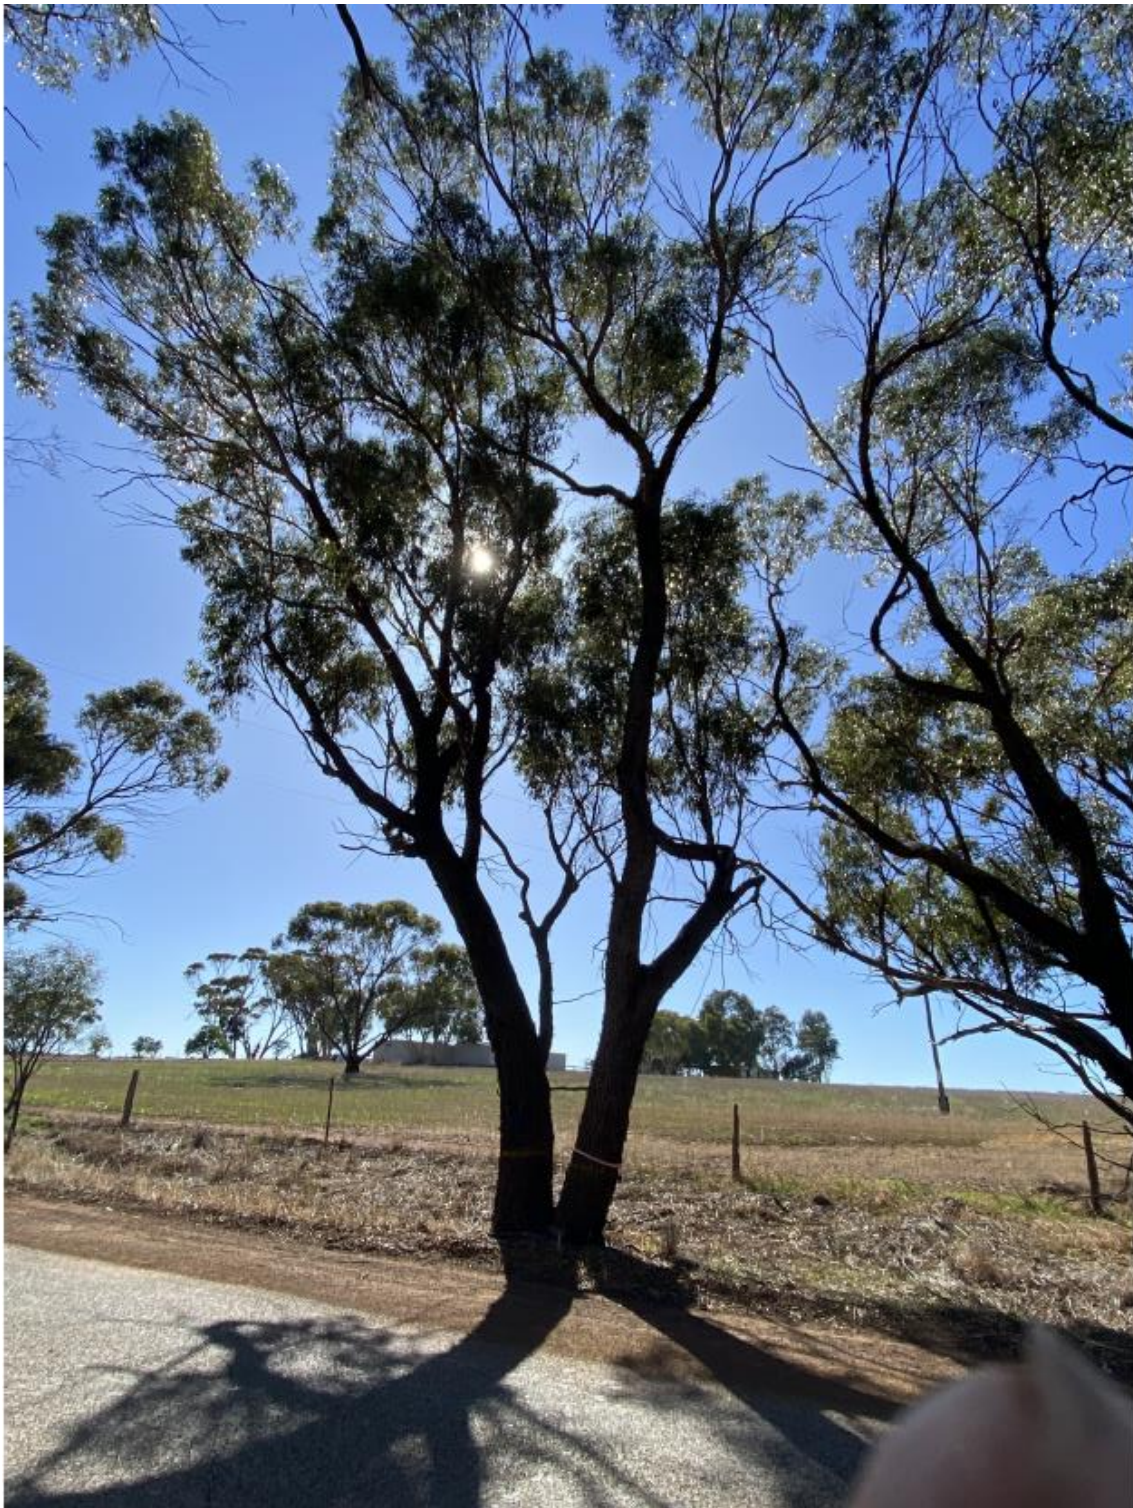
**ID 5 – Photo 7:** 1 York gum (15m), situated in shoulder area

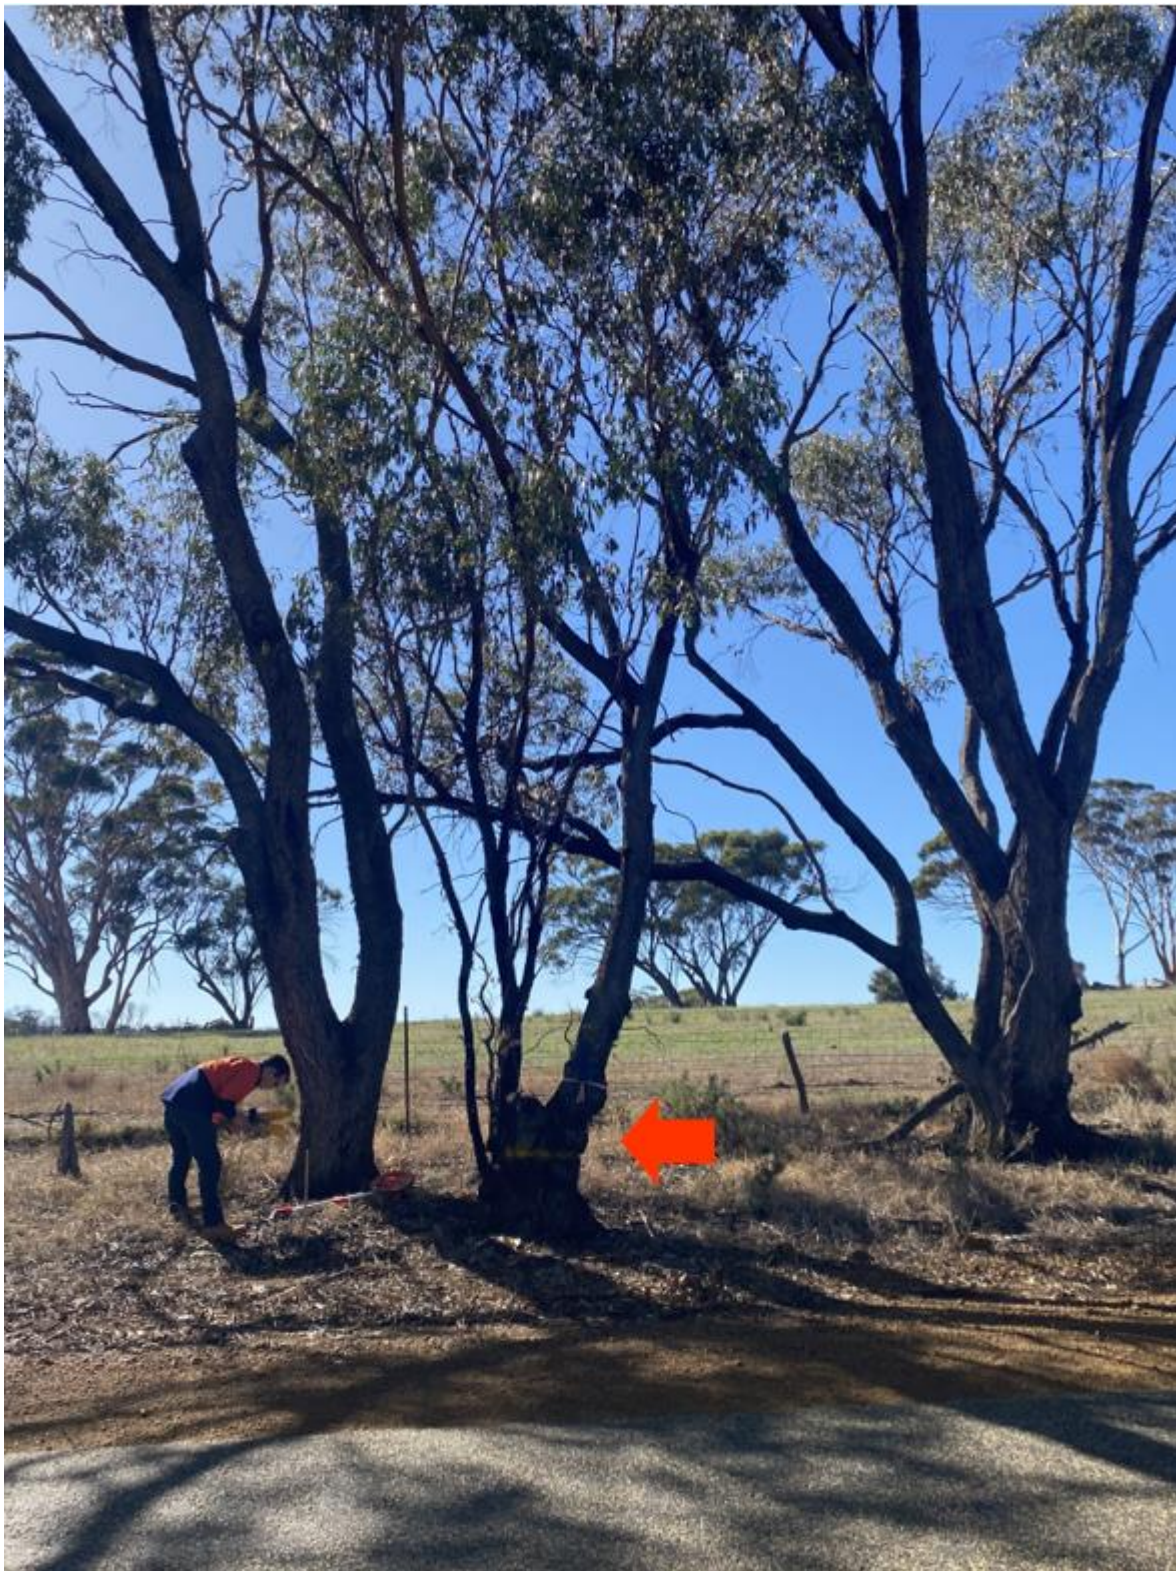
**ID 6 – Photo 8:** 1 York gum, unhealthy, front with poor historic pruning, situated in shoulder area

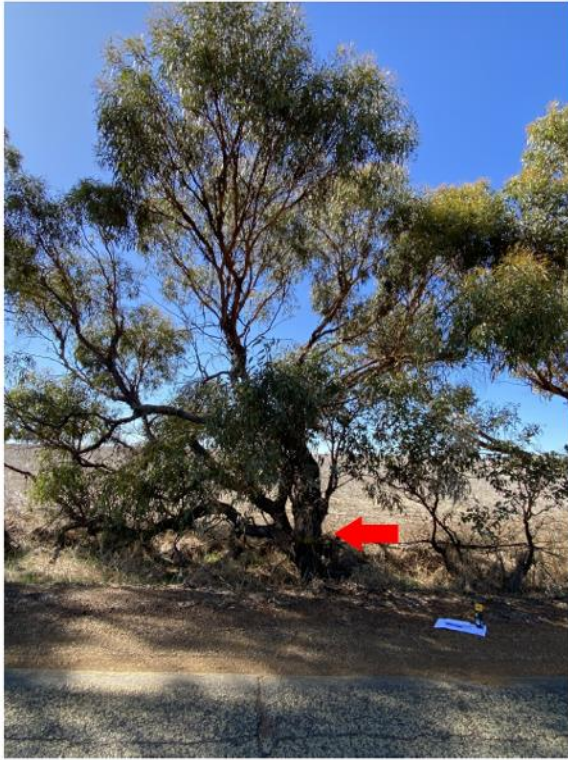
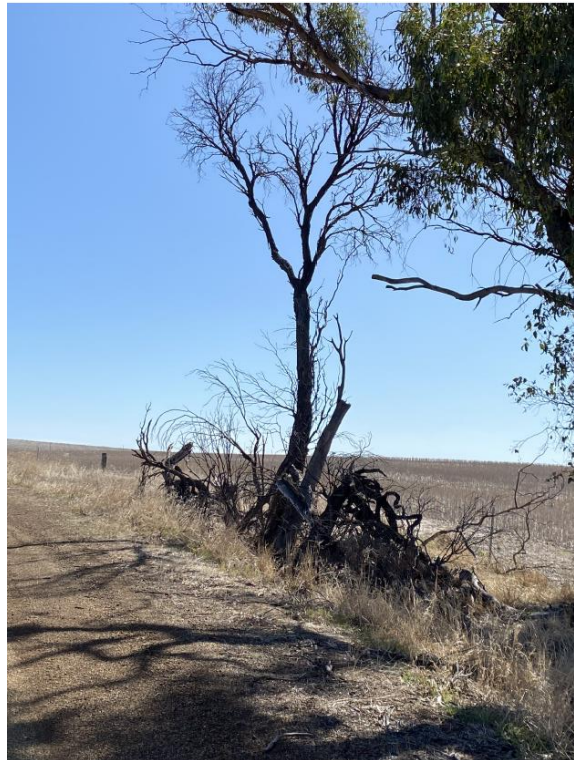
ID7 – Photo 16, 17: 1 York gum (7 m), near corner, safety concern + 1 dead tree

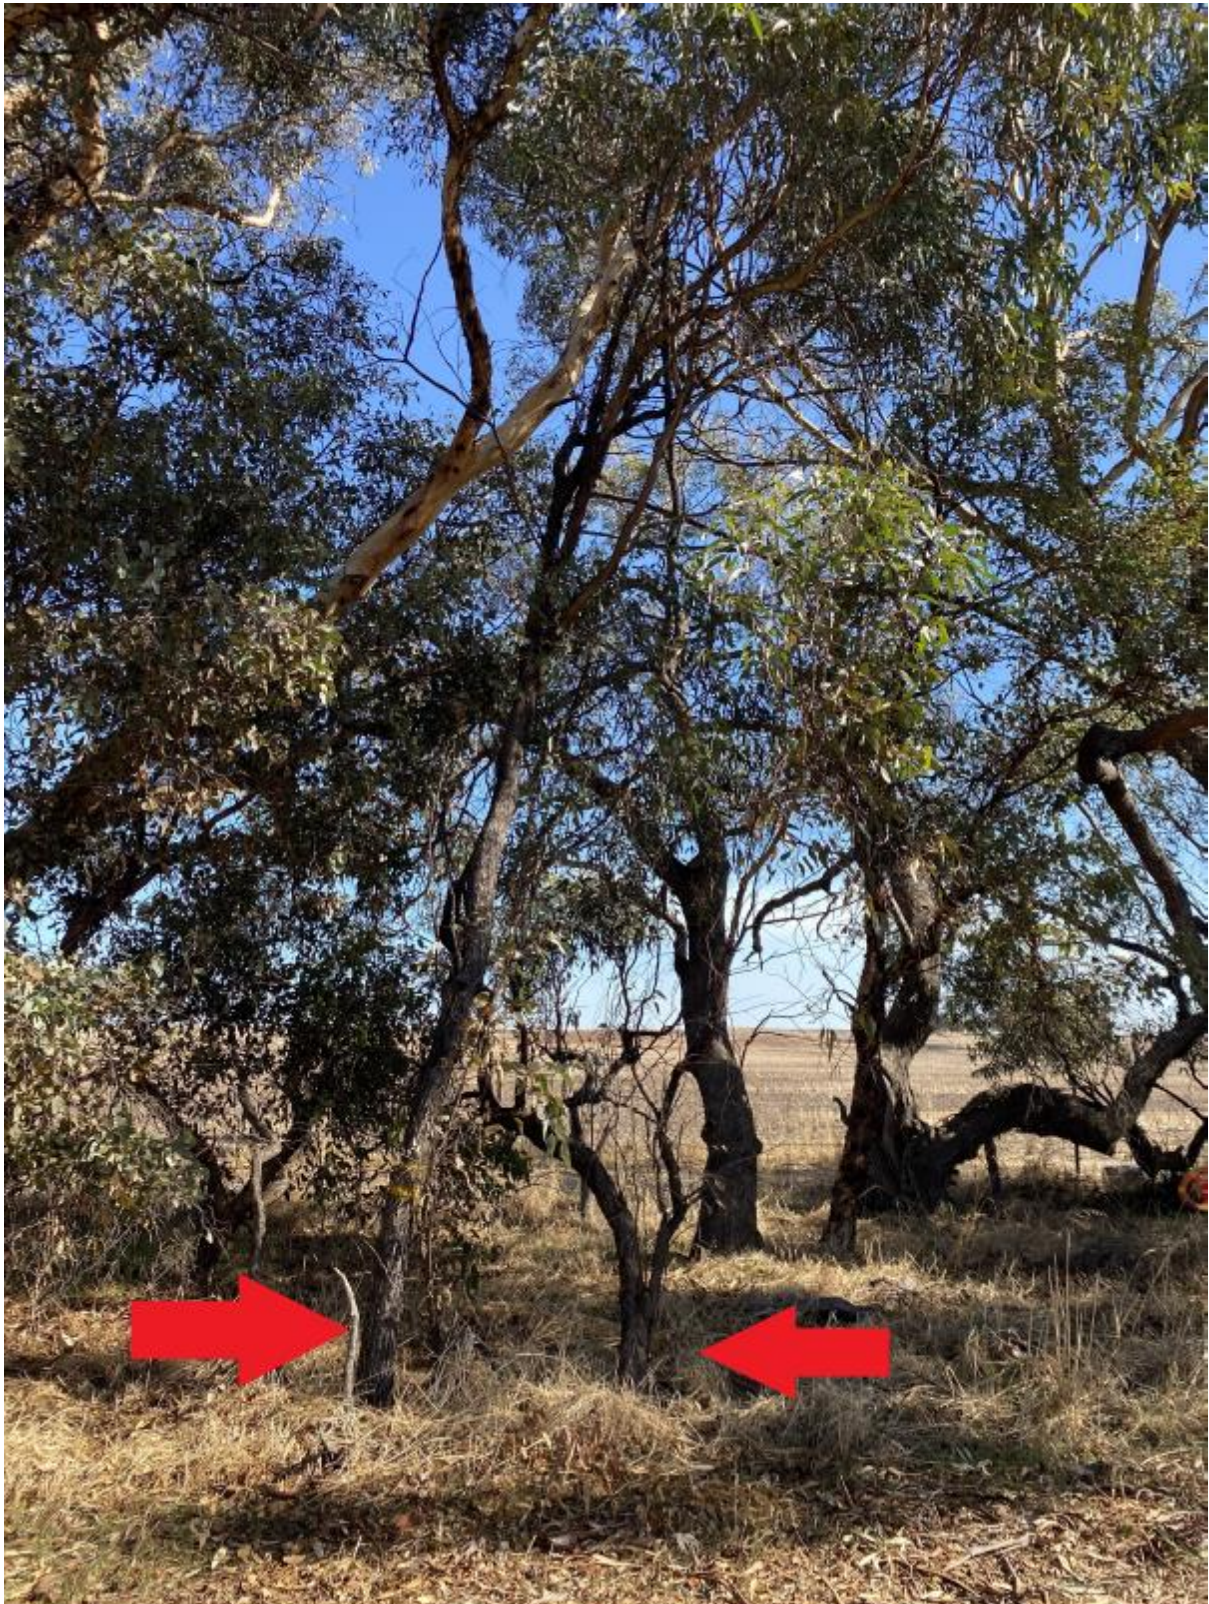
**ID 8 – Photo 29:** 1 York gum + 1 immature York gum

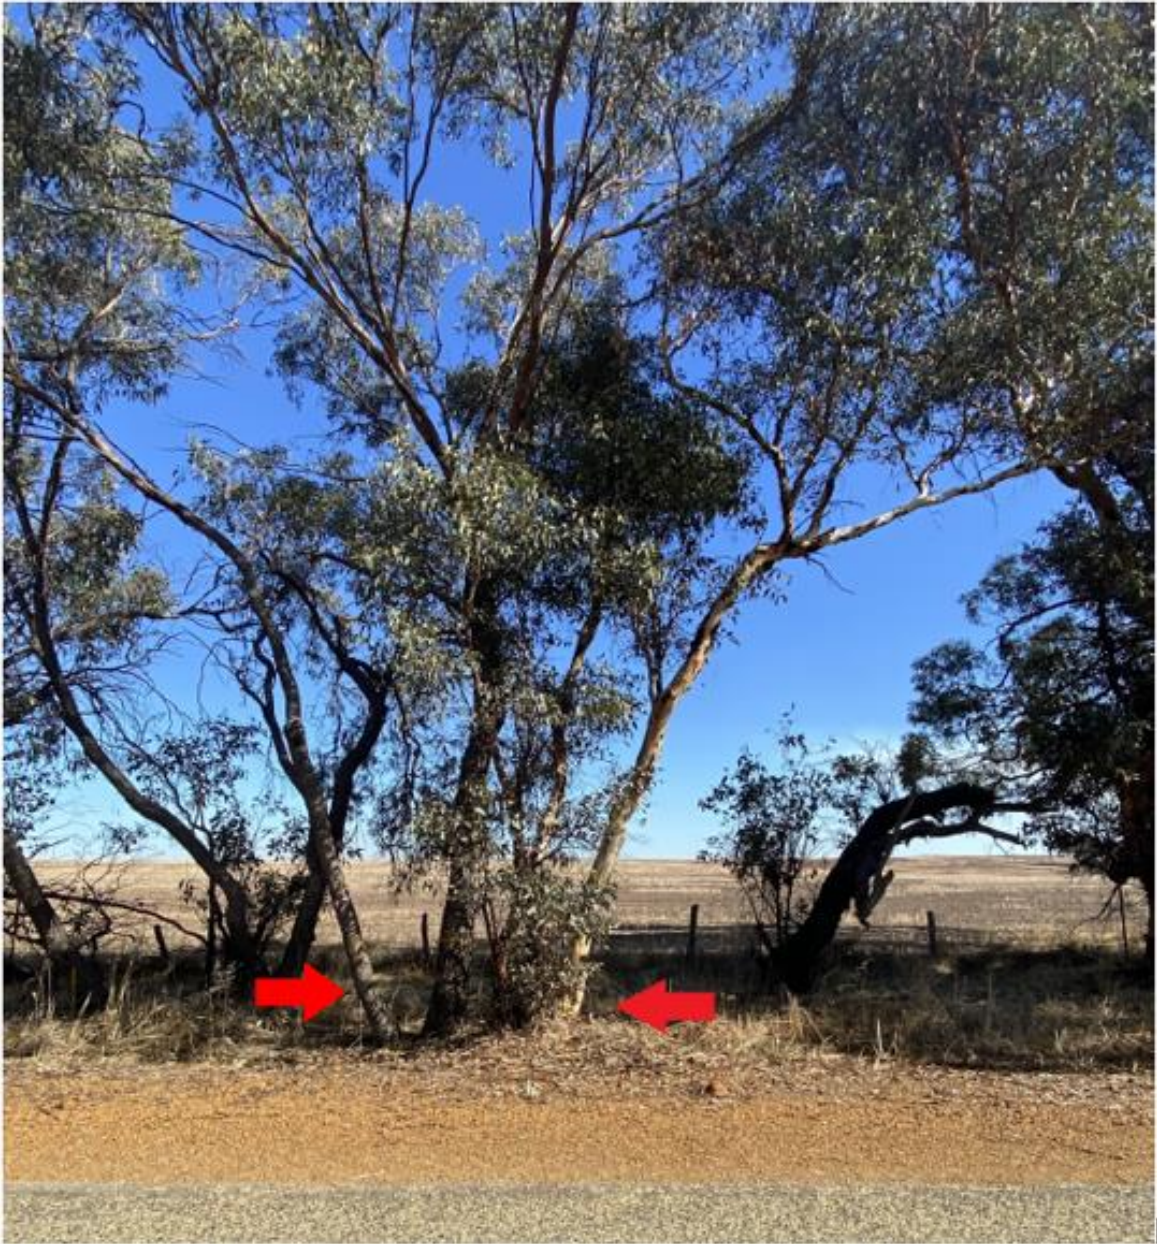
ID 9 – Photo 28: 2 York gum + 1 Wandoo (7m)

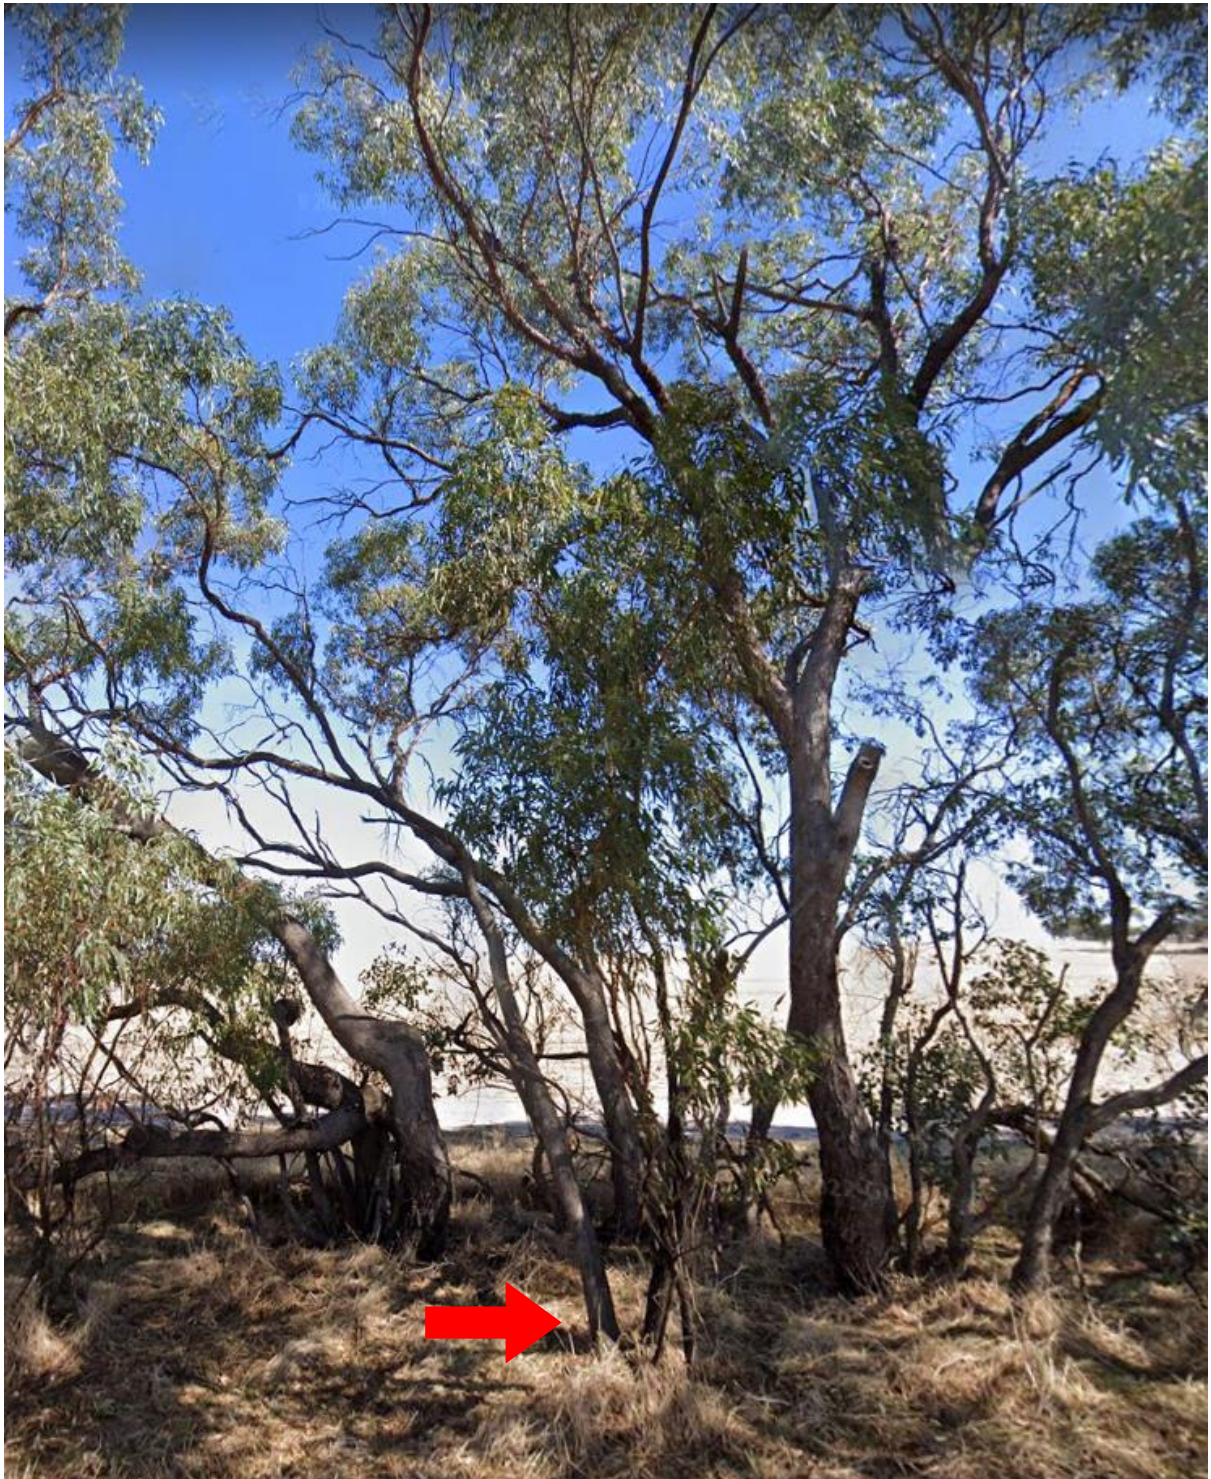
ID 10 – Photo 30: 3 York gum

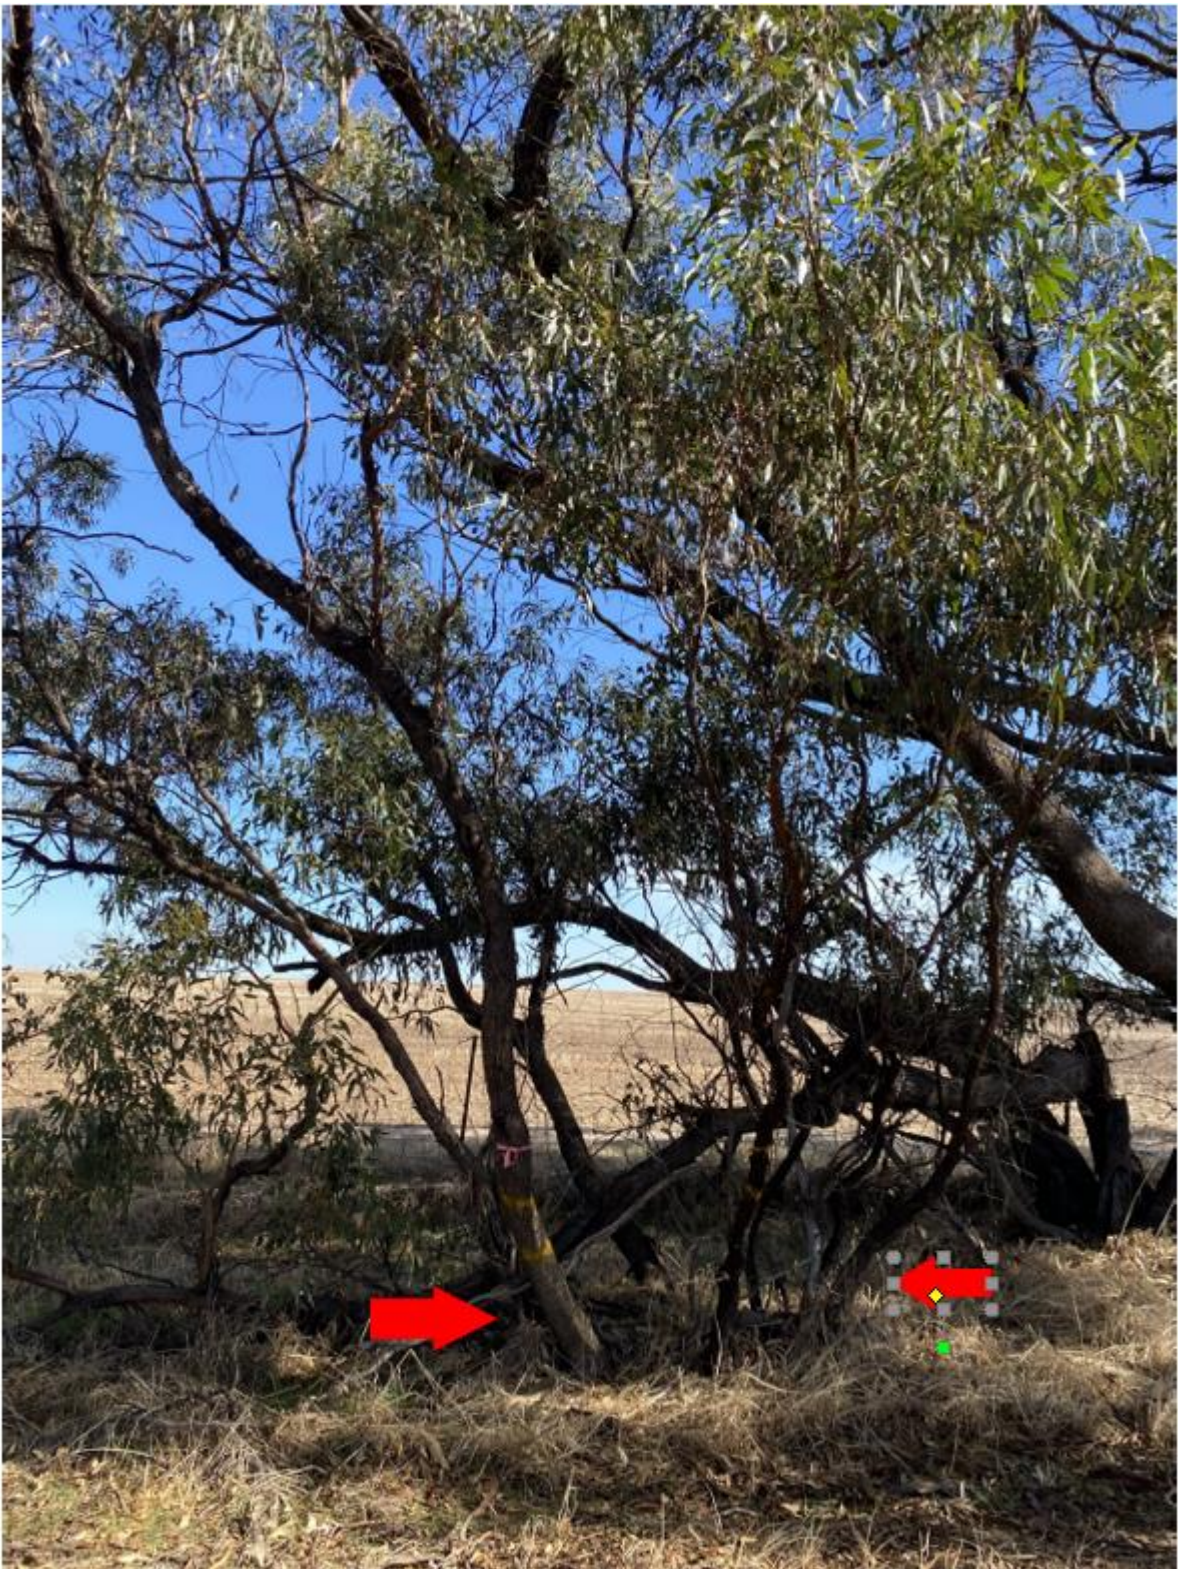
**ID 11 – Photo 31:** 1 York gum (<6m high) + 1 York gum with multiple stems to the right

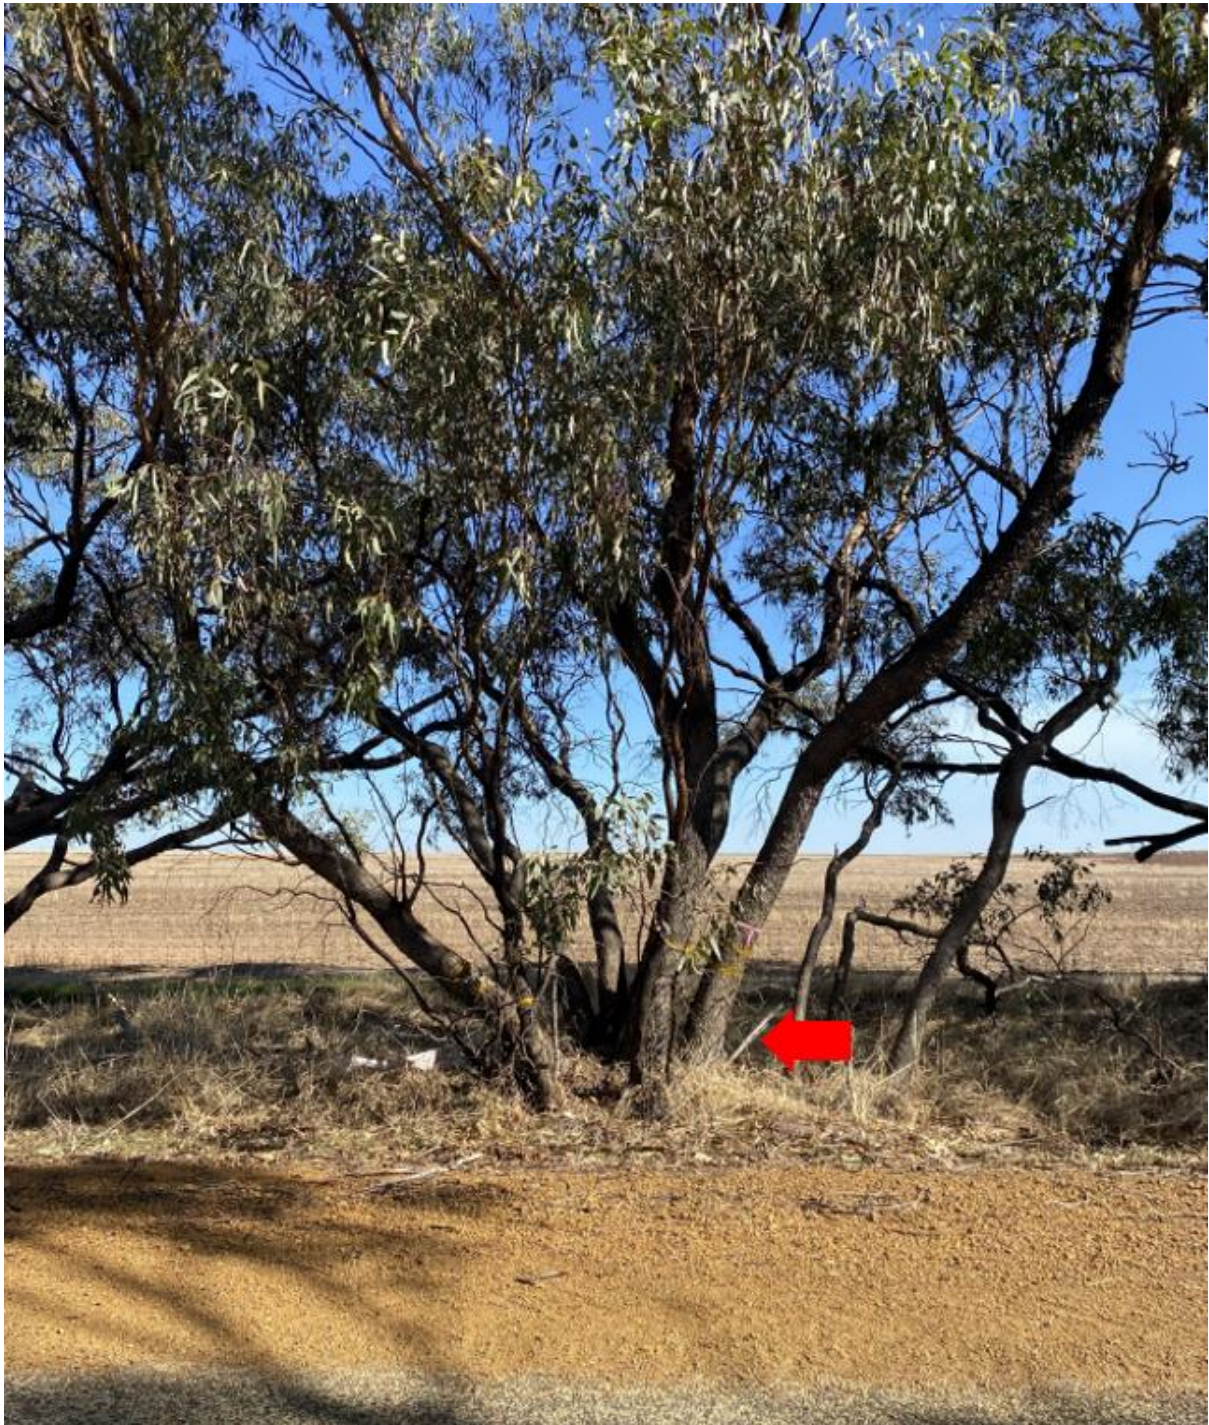
**ID 12 – Photo 32:** 1 York gum (7 m), with 6 stems, situated in the central area of proposed drain.

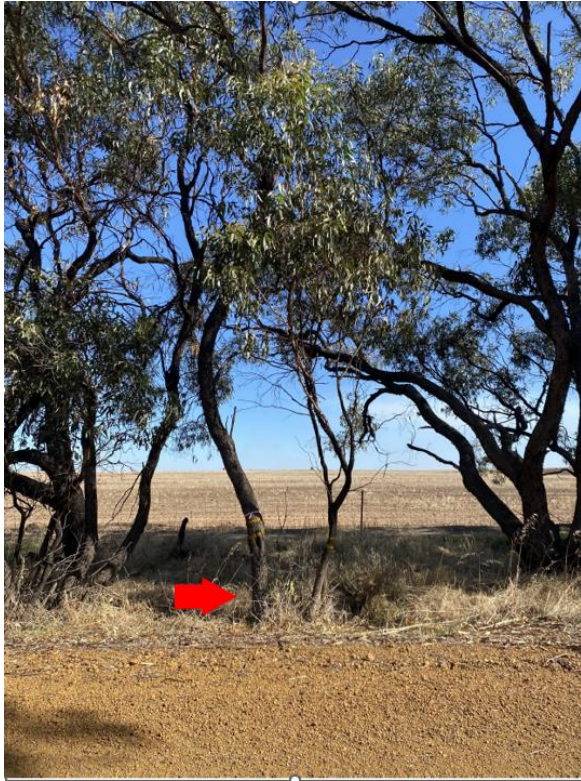
**ID 13 – Photo 33:** 1 York gum (7m high) + 1 immature York gum to the right

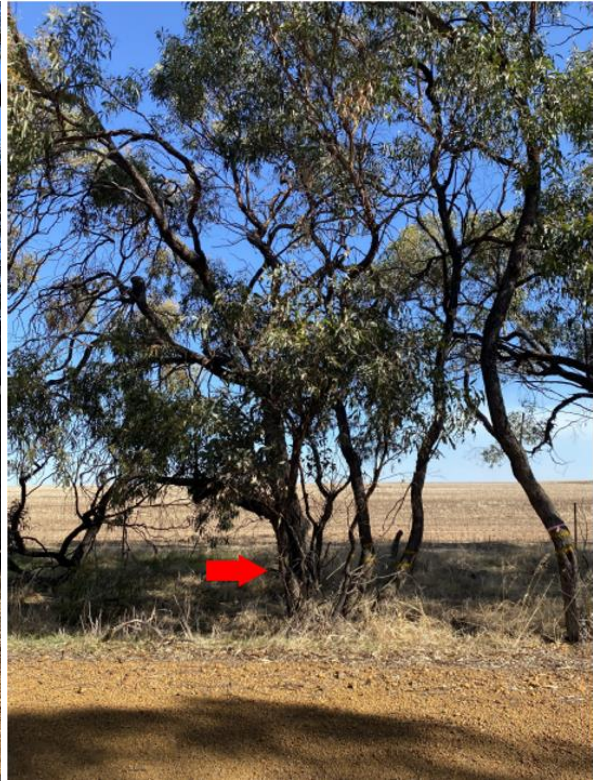
**Photo 34:** 1 York gum (5m high), multi stems due to epicormic growth and poor pruning previously

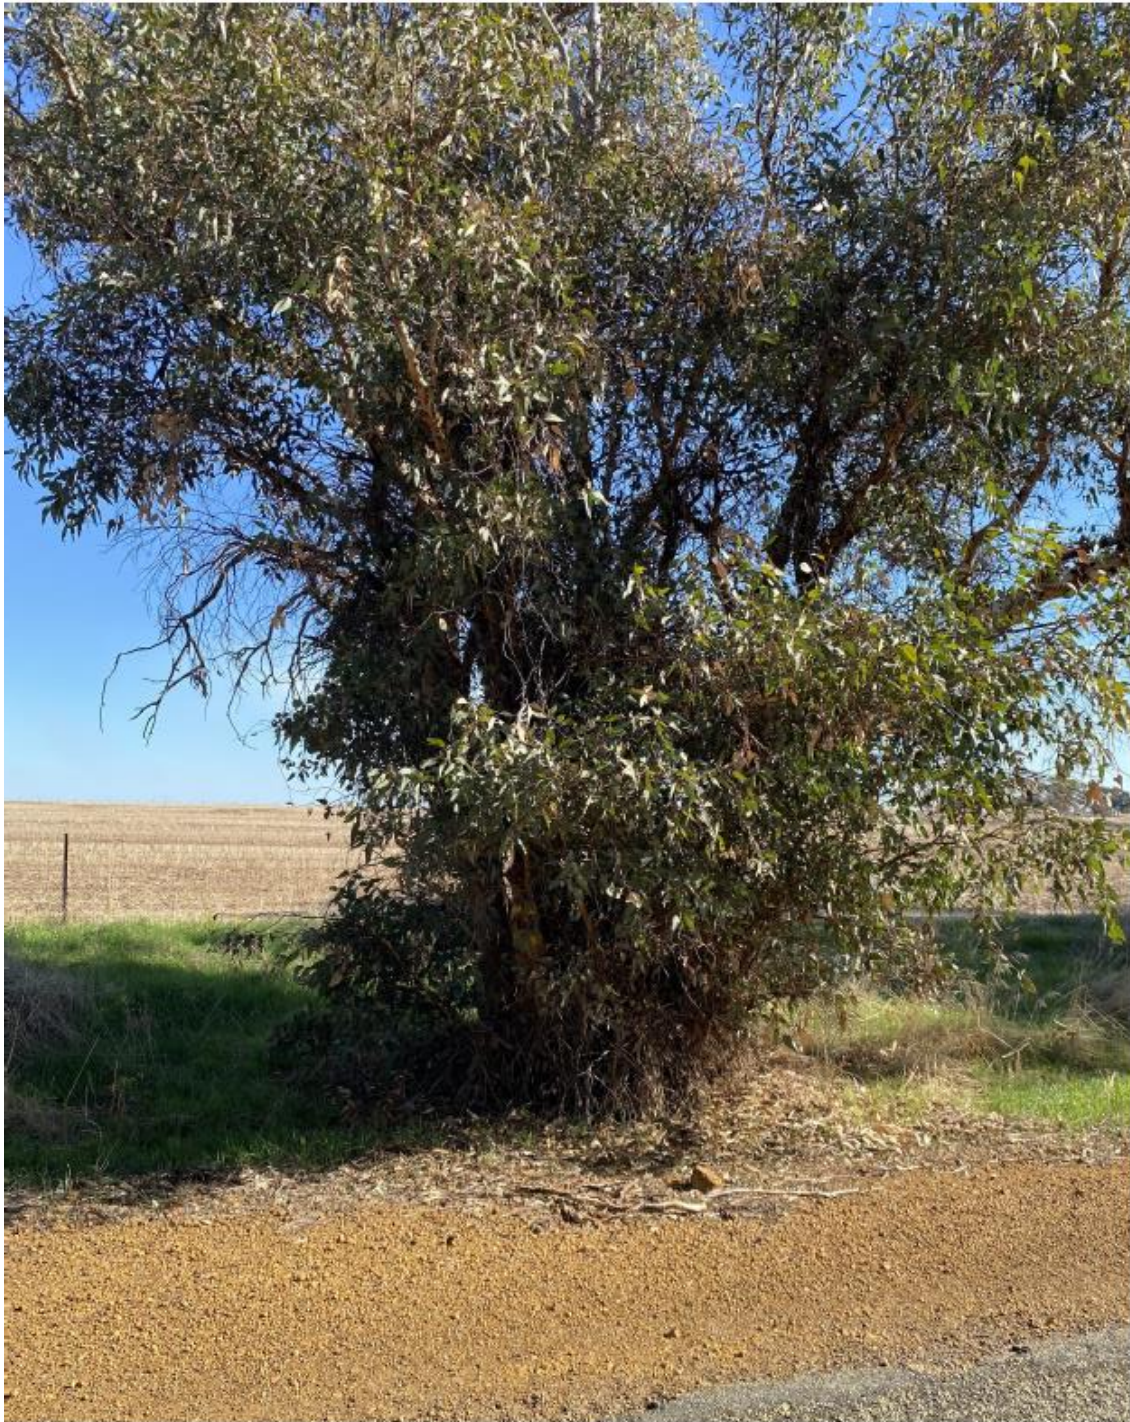
**ID 14 – Photo 35: 1 Wandoo (5m high)**
