## PHOTOS OF TREES PROPOSED TO CLEAR (CPS 9937/1)

**Total: 31 trees** (indicated by red arrows), **including:** 10 Acacia trees.

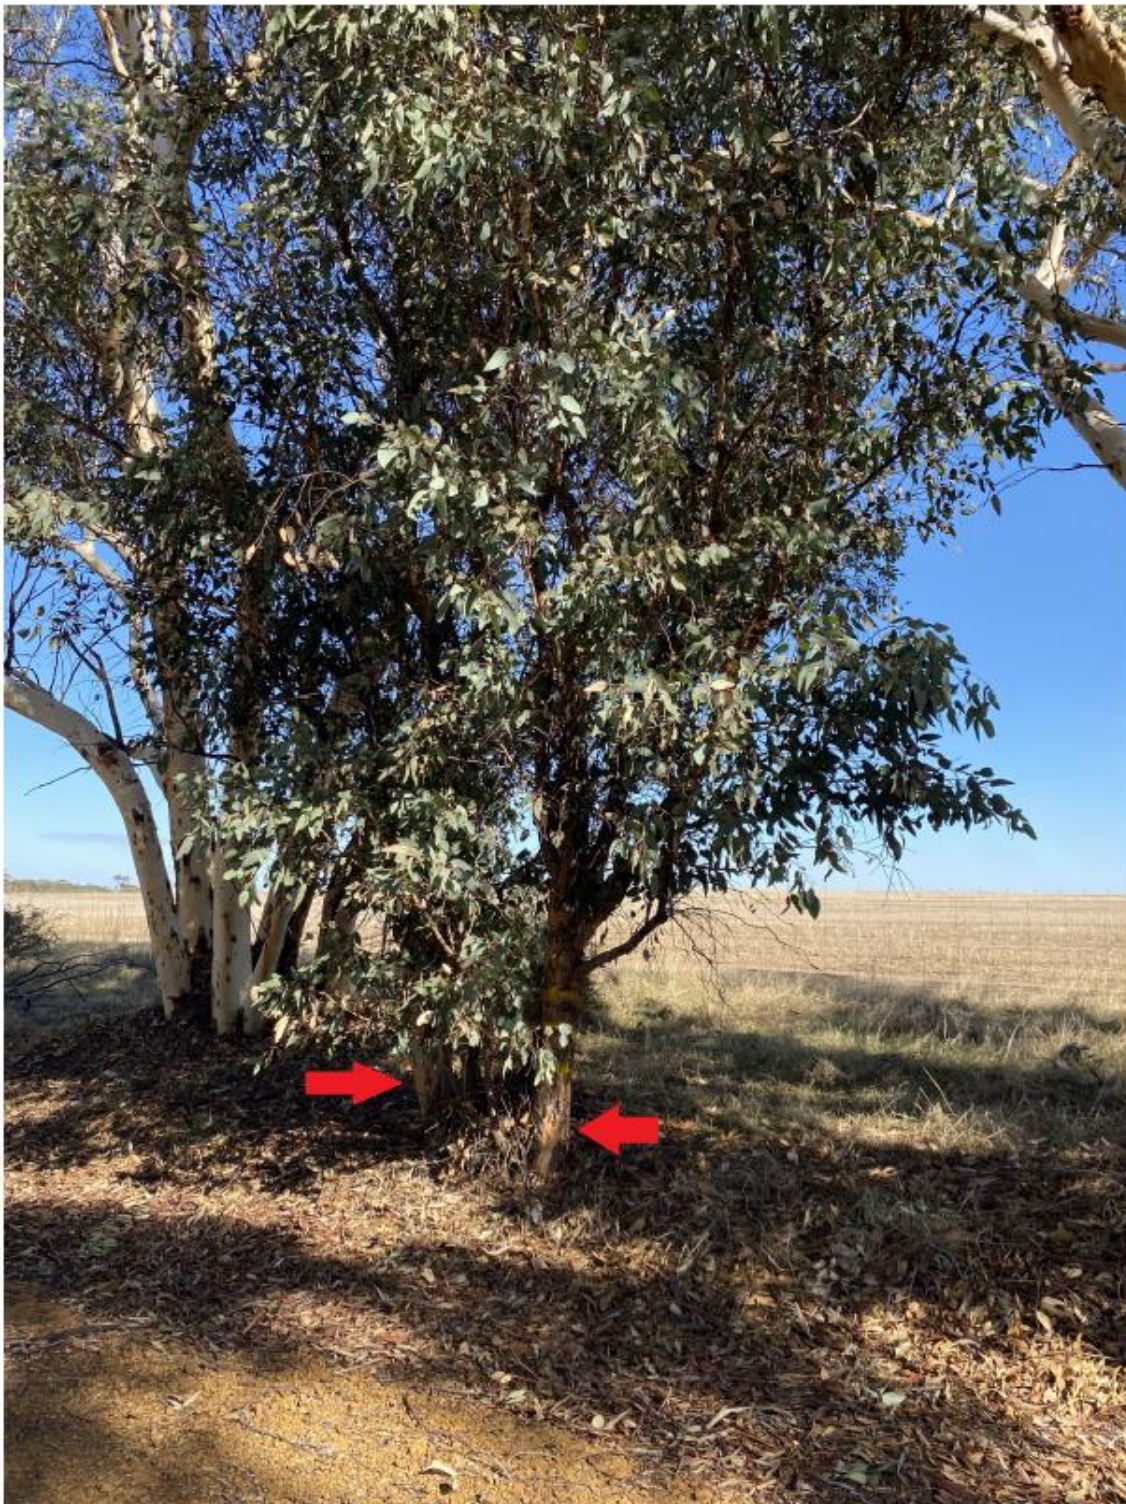
**ID 15 – Photo 36:** 1 Wandoo + 1 York gum (6m), situated in the central area of proposed drain

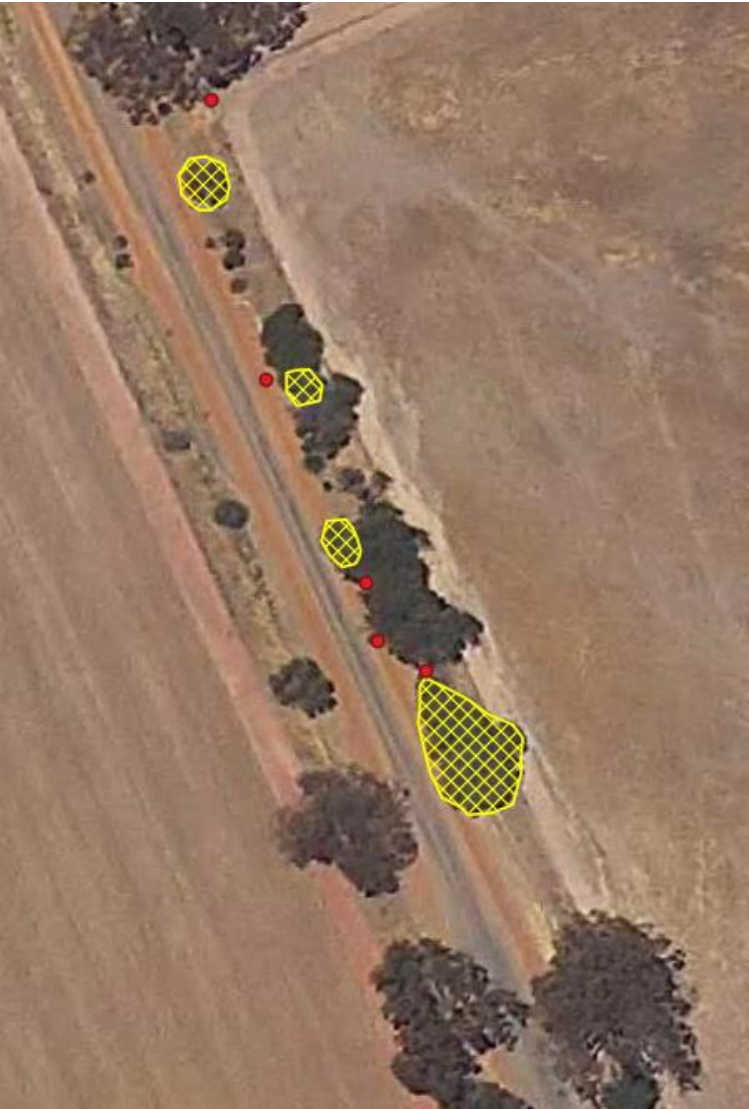
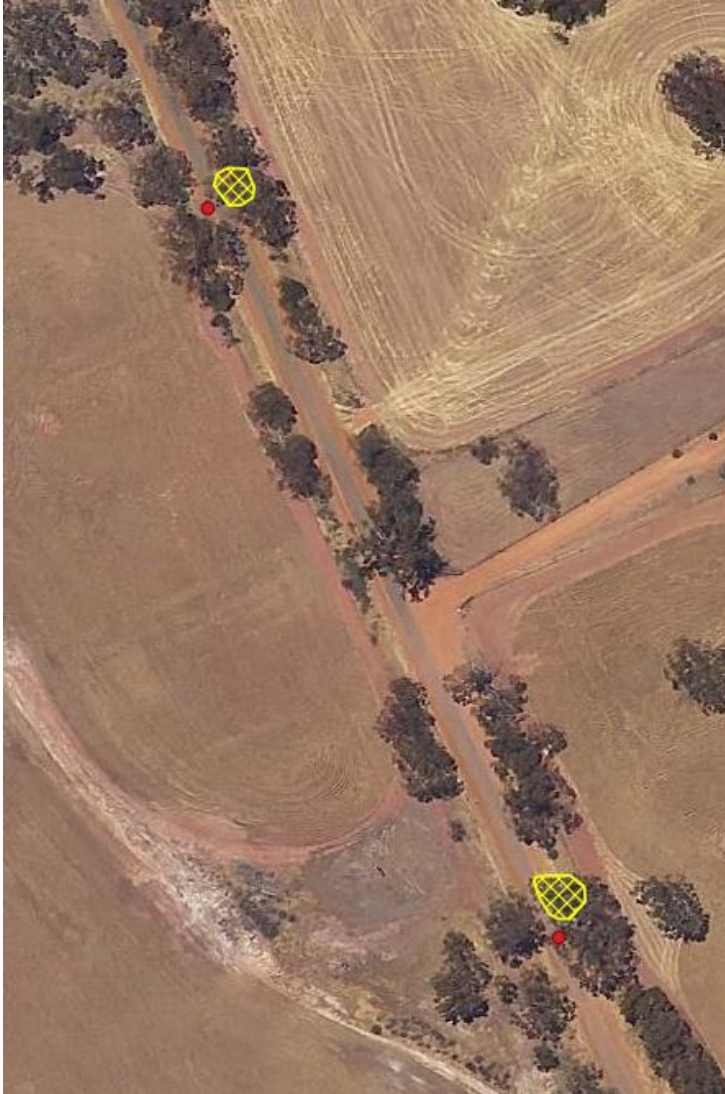
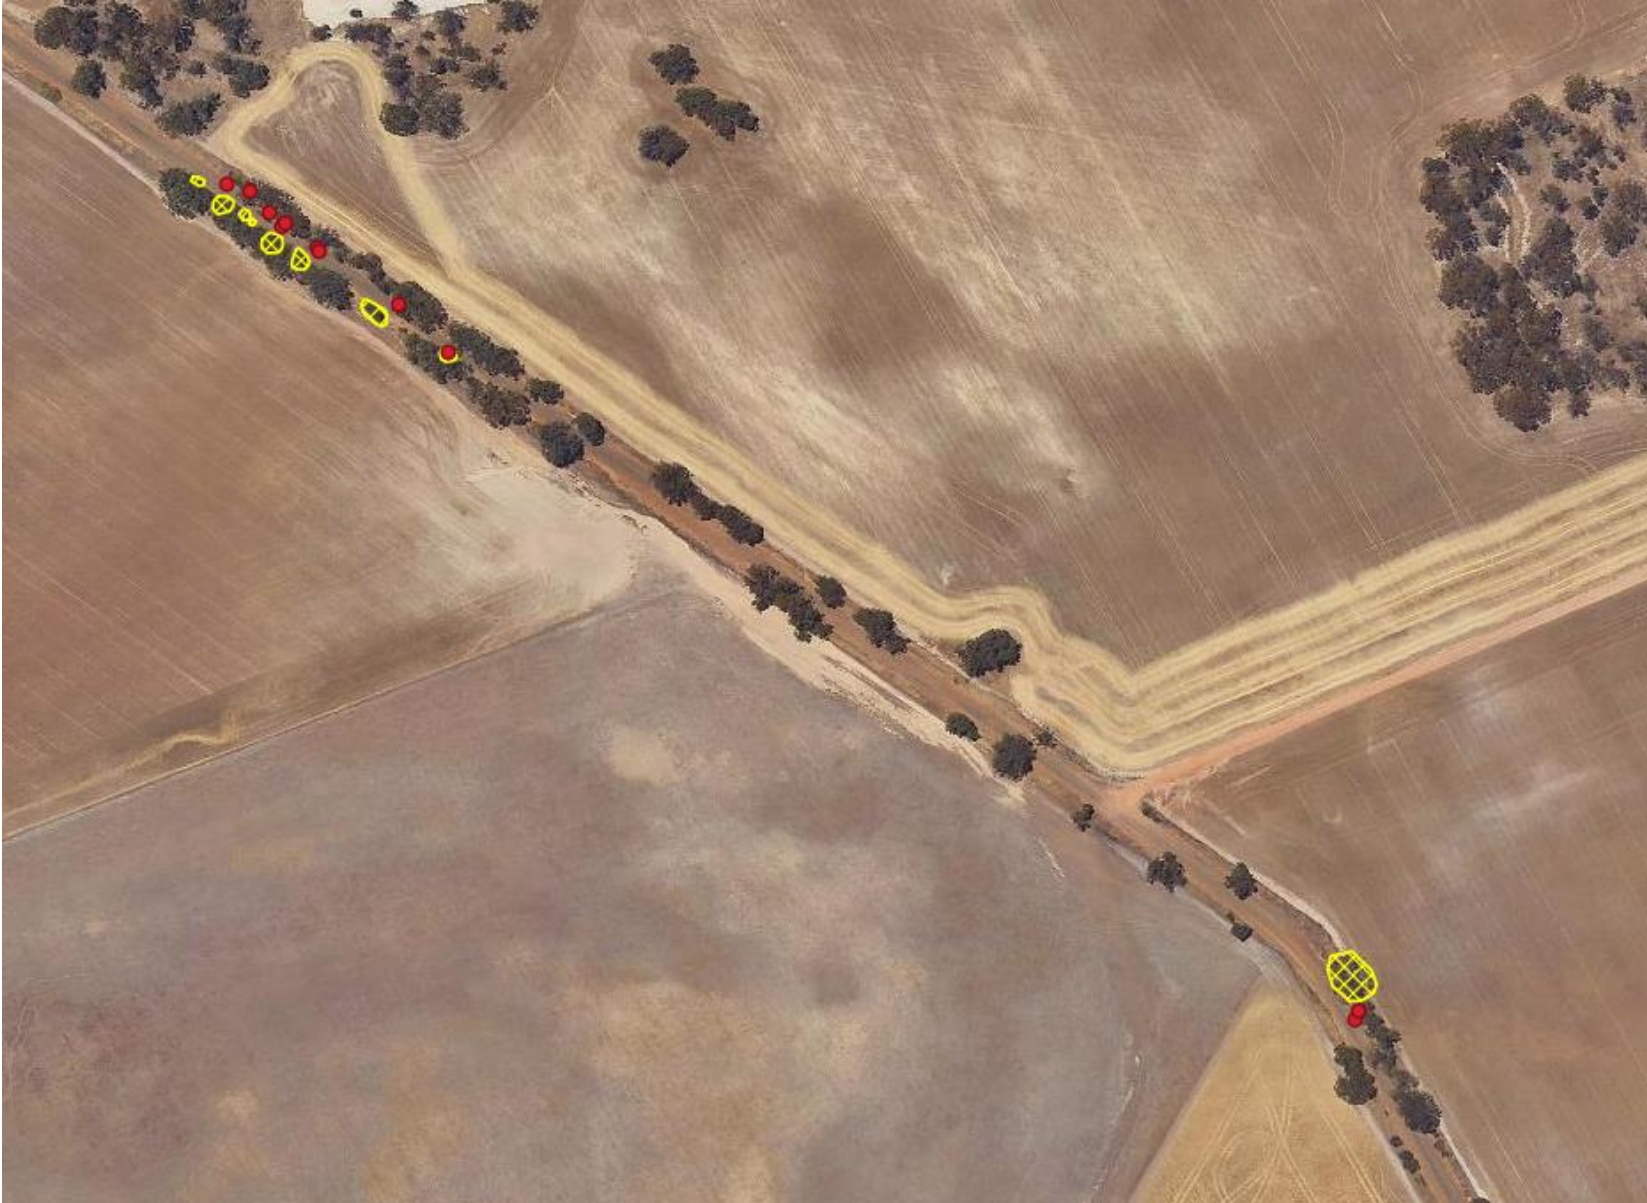
Inconsistency between GPS coordinates and the real locations of the trees.
