Natural Area Holdings Pty Ltd
Whadjuk Country
57 Boulder Road
Malaga WA 6090

15 December 2022

RE: BALDIVIS ROAD TO FURIOSO GREEN, ROAD UPGRADE

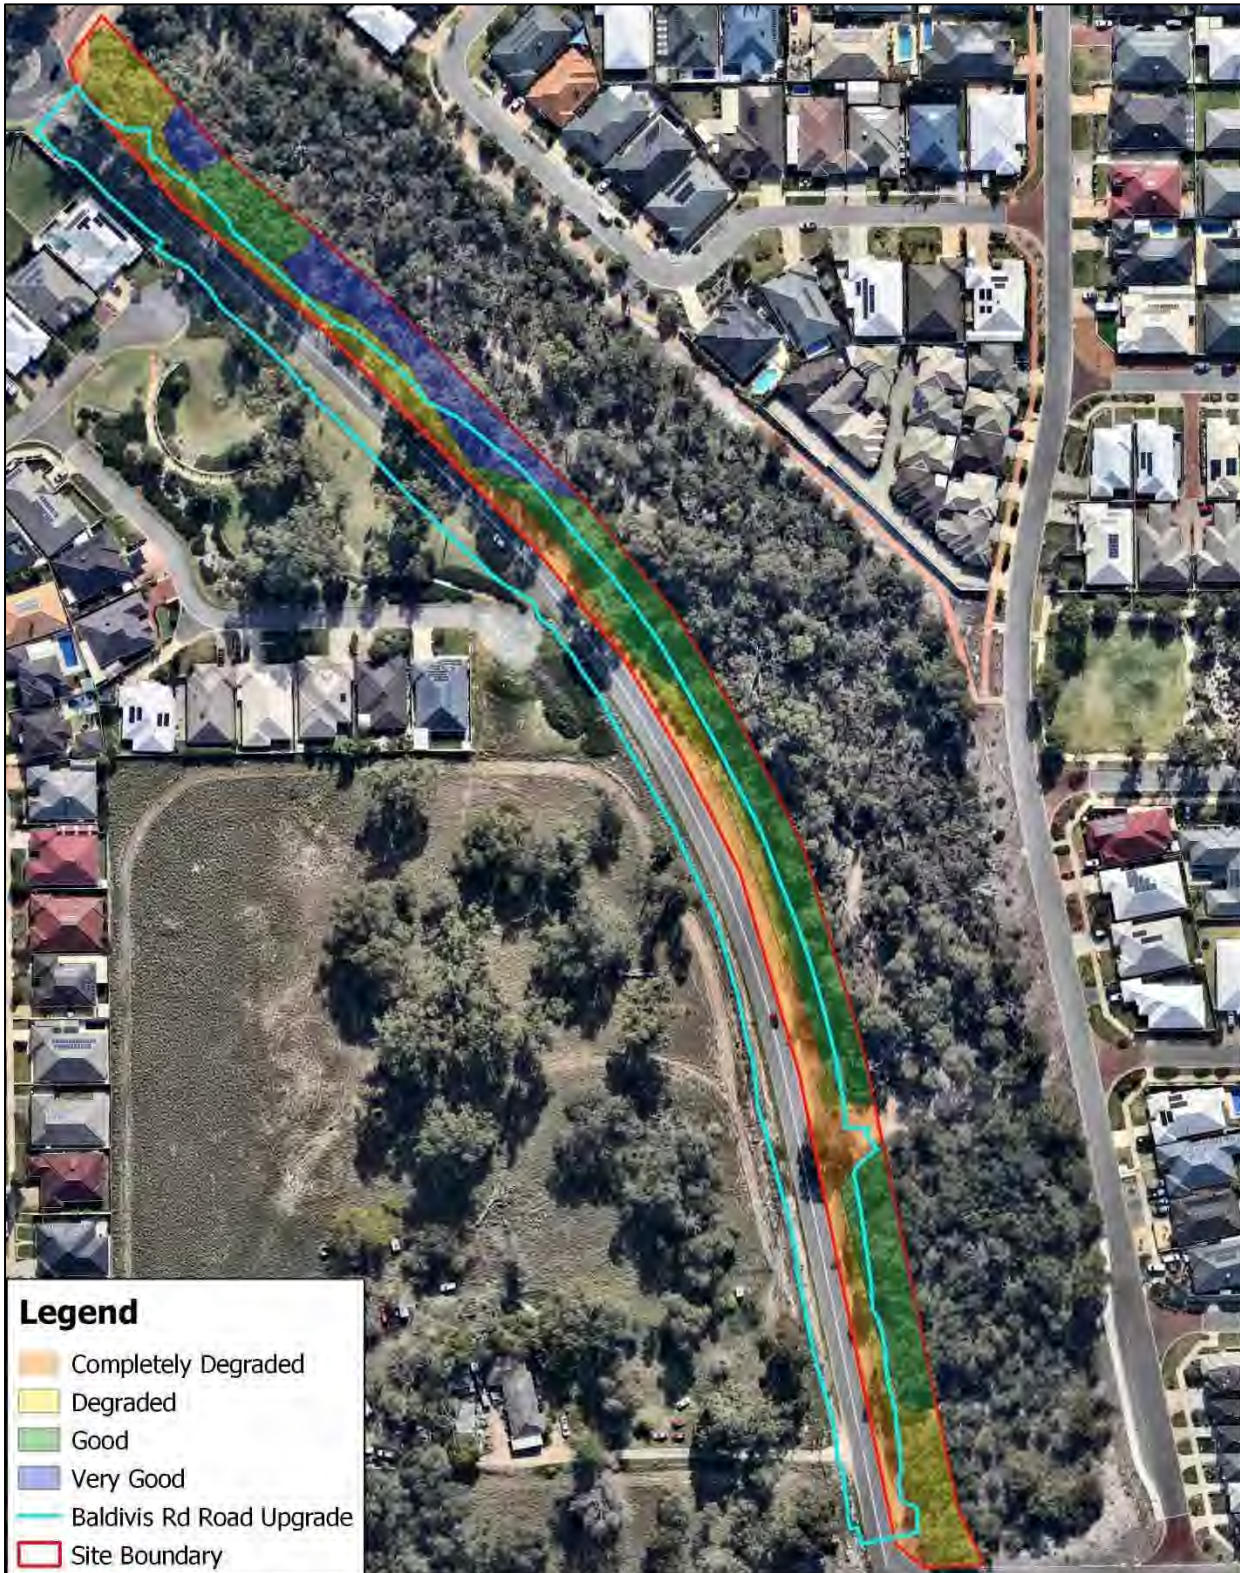
Figure 2:
Vegetation Condition
Baldvis Road

Vegetation condition for the proposed construction footprint is detailed in Table 1 and shown in Figure 2. The majority of the proposed construction footprint is in Completely Degraded condition with many areas lacking native vegetation and consisting of the existing road batter. Areas in better condition, Good and Very Good, contain numerous native species with a reduced weed presence.

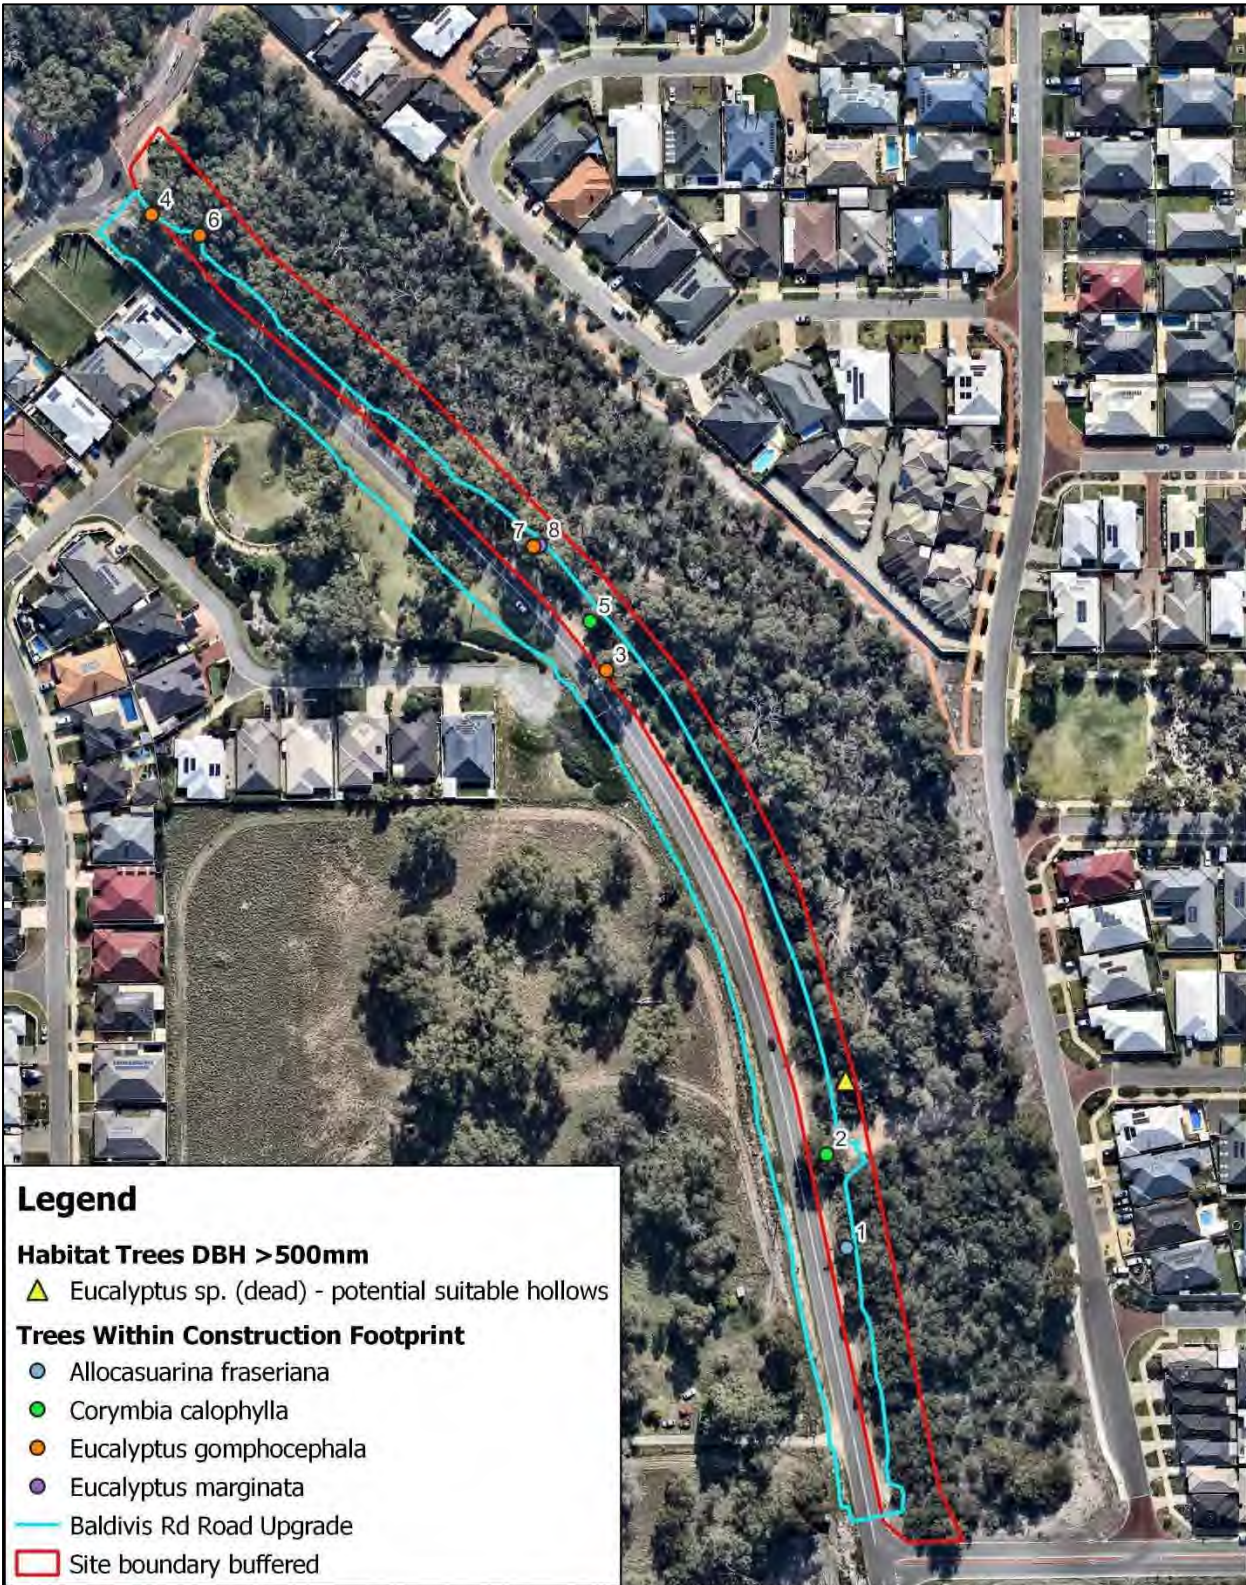
Figure 3:

Along with the initial flora and vegetation assessment, a Black Cockatoo assessment was undertaken recording potential habitat trees with a diameter at breast height (DBH) of ≥ 500 mm. One potential habitat tree containing hollows which may be suitable for use by Black Cockatoos was observed during the initial survey. This tree, a dead Eucalypt, occurs outside of the revised construction footprint (Figure 3). Within the revised construction footprint, the City of Rockingham has identified four trees which will be impacted by construction activities, trees number one to four in Table 2. A further four trees (numbered five to eight) are also present within the proposed construction footprint. Locations of these habitat trees are shown in Figure 3.

SRZ has been provided for each tree within the proposed construction footprint in Table 2. It is noted that some trees recorded in the September survey (Natural Area, 2022) are in close proximity to the construction footprint boundary and that any root disturbance activities should take into account the root zone viability of these trees. For all tree locations refer to *Detailed Flora and Vegetation Survey, Baldivis Road* (Natural Area, 2022).

The one potential habitat tree containing hollows which may be suitable for use by Black Cockatoos, which occurs outside of the proposed construction footprint, is recommended to be protected during construction activities and to ensure that works do not occur within the SRZ of the tree.

In relation to the habitat trees present within the construction footprint, it is recommended that, where possible, the project boundary be altered to minimise the impacts to the habitat trees and retain as many trees as possible within the site. Habitat trees which occur outside of the construction footprint will need to be ensured that activities do not impact on the SRZ and TPZ of these trees.
