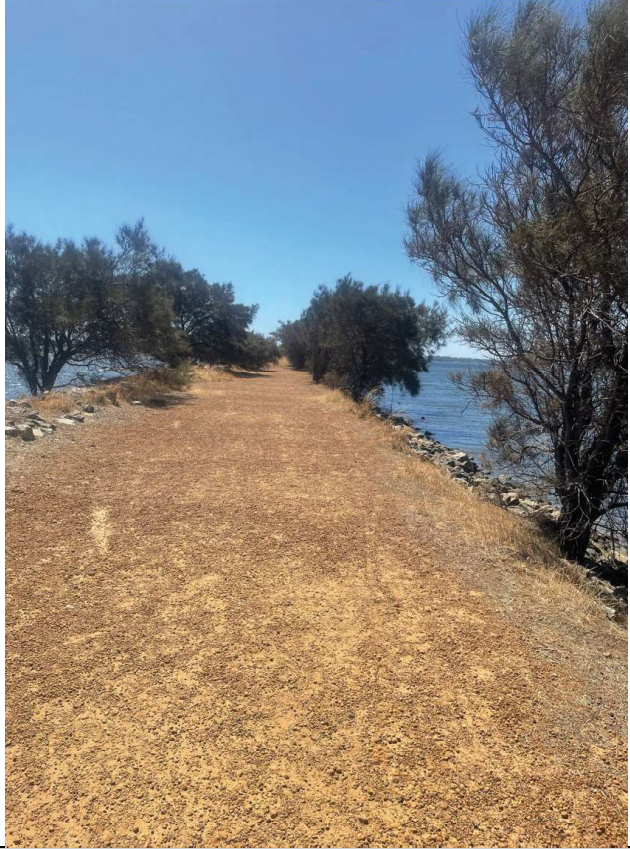
IMG 5173

<b>Species</b>	<b>Location</b>	<b>Impacts</b>
<i>Casuarina obesa</i>	Scattered mature trees growing through the rock batters (photo 5173), with several saplings either in the rock batters or on the edge of the gravel surface	Prune mature trees as required to allow machine access Mark the location of saplings to avoid machine and/or rock placement damage Take care when placing rocks near trees to prevent trunk damage
<i>Scaevola crassifolia</i> & <i>Olearia axillaris</i>	Scattered plants growing on the gravel surface (photo 5191)	Removal of these plants to facilitate works is acceptable. They would be self-colonized and are likely with time to return
<i>Juncus kraussii</i> & <i>Salicornia quinqueflora</i>	A small area of these plants at the toe of the northern rock batter was noted (photo 5174)	Most likely to be outside of the work zone but if impacted by rock placement not considered a problem as root zone will not be impacted and they will regrow around rocks

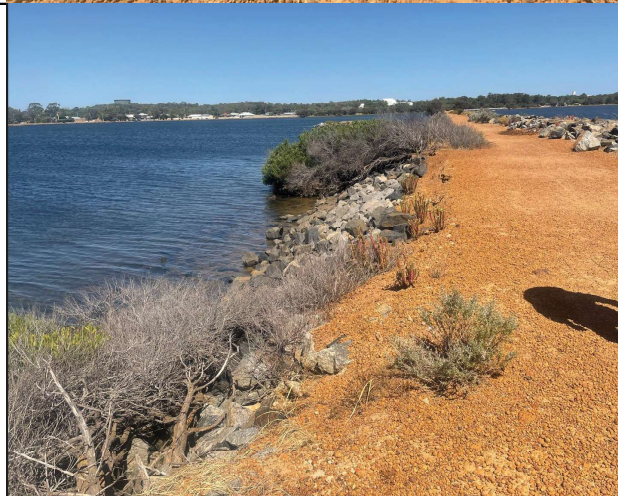
IMG 5189

are not disturbed some level of above ground damage can occur as the sedges will resprout.
<i>Acacia cyclops</i>	Towards the end of the jetty large plants of this species have established on the northern rock batter (photo 5189)	Generally these are outside of work zone. The pruning back of dead material may be required to allow for bund repairs.
