ARBORIST REPORT

DUNSBOROUGH TREE SERVICES PTY LTD

Address: 12 Elmore Road, Quindalup 6281

11 x *Agonis flexuosa* (Peppermint tree)

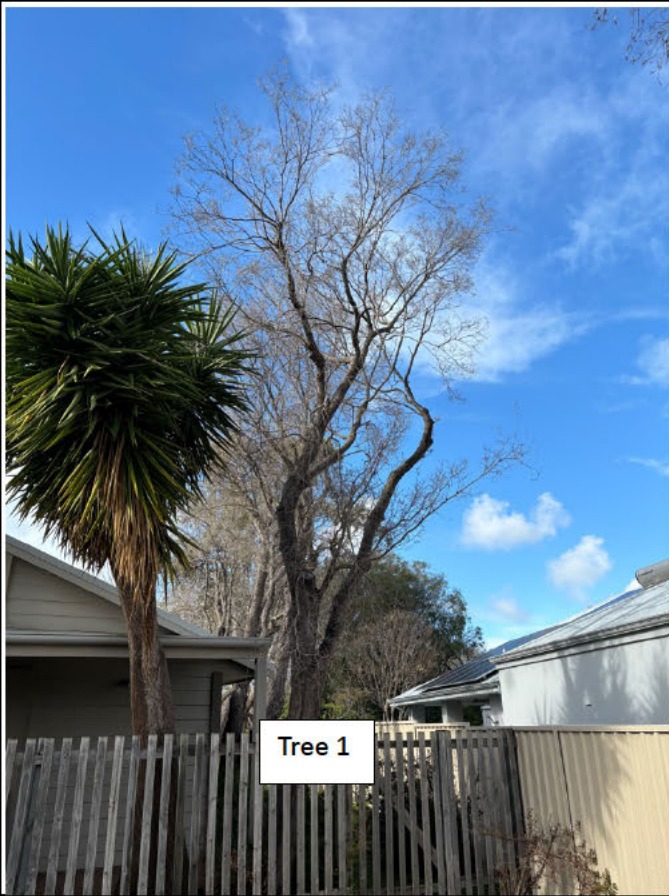
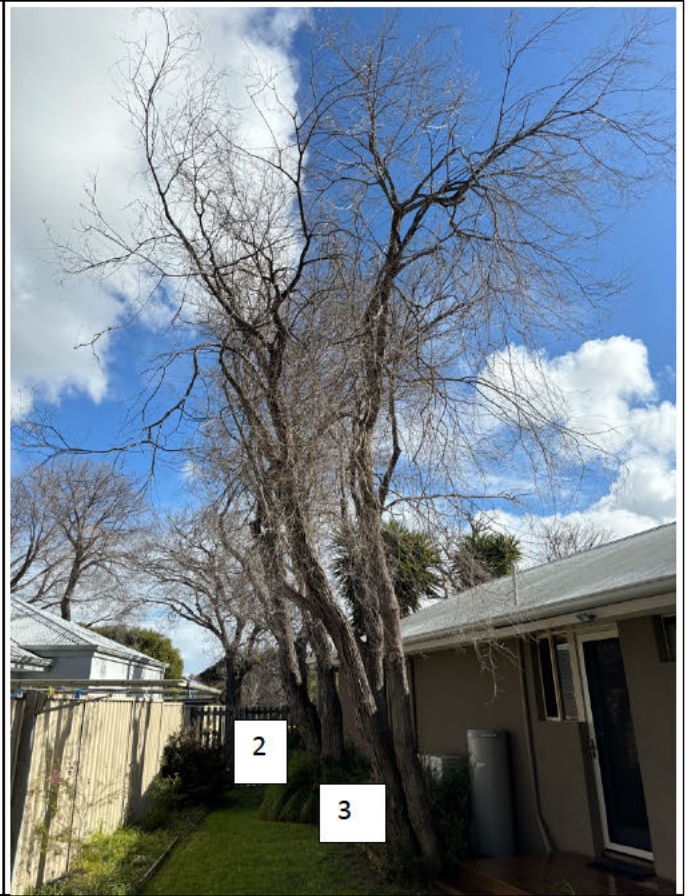
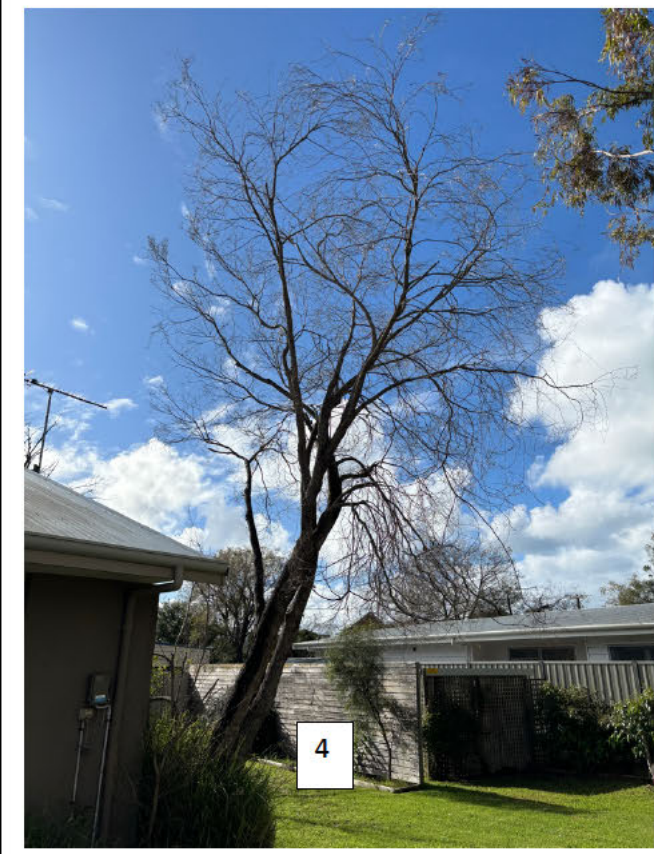
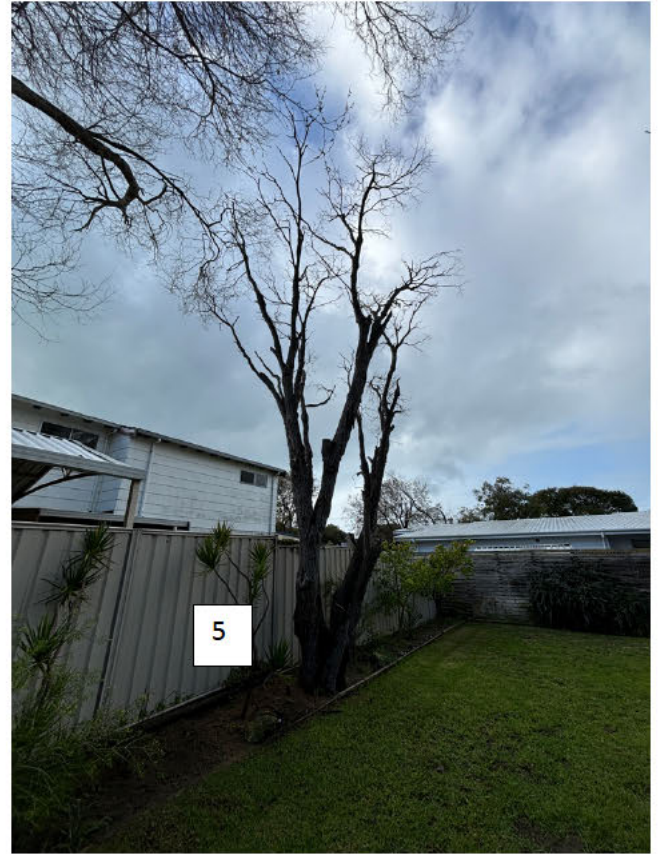
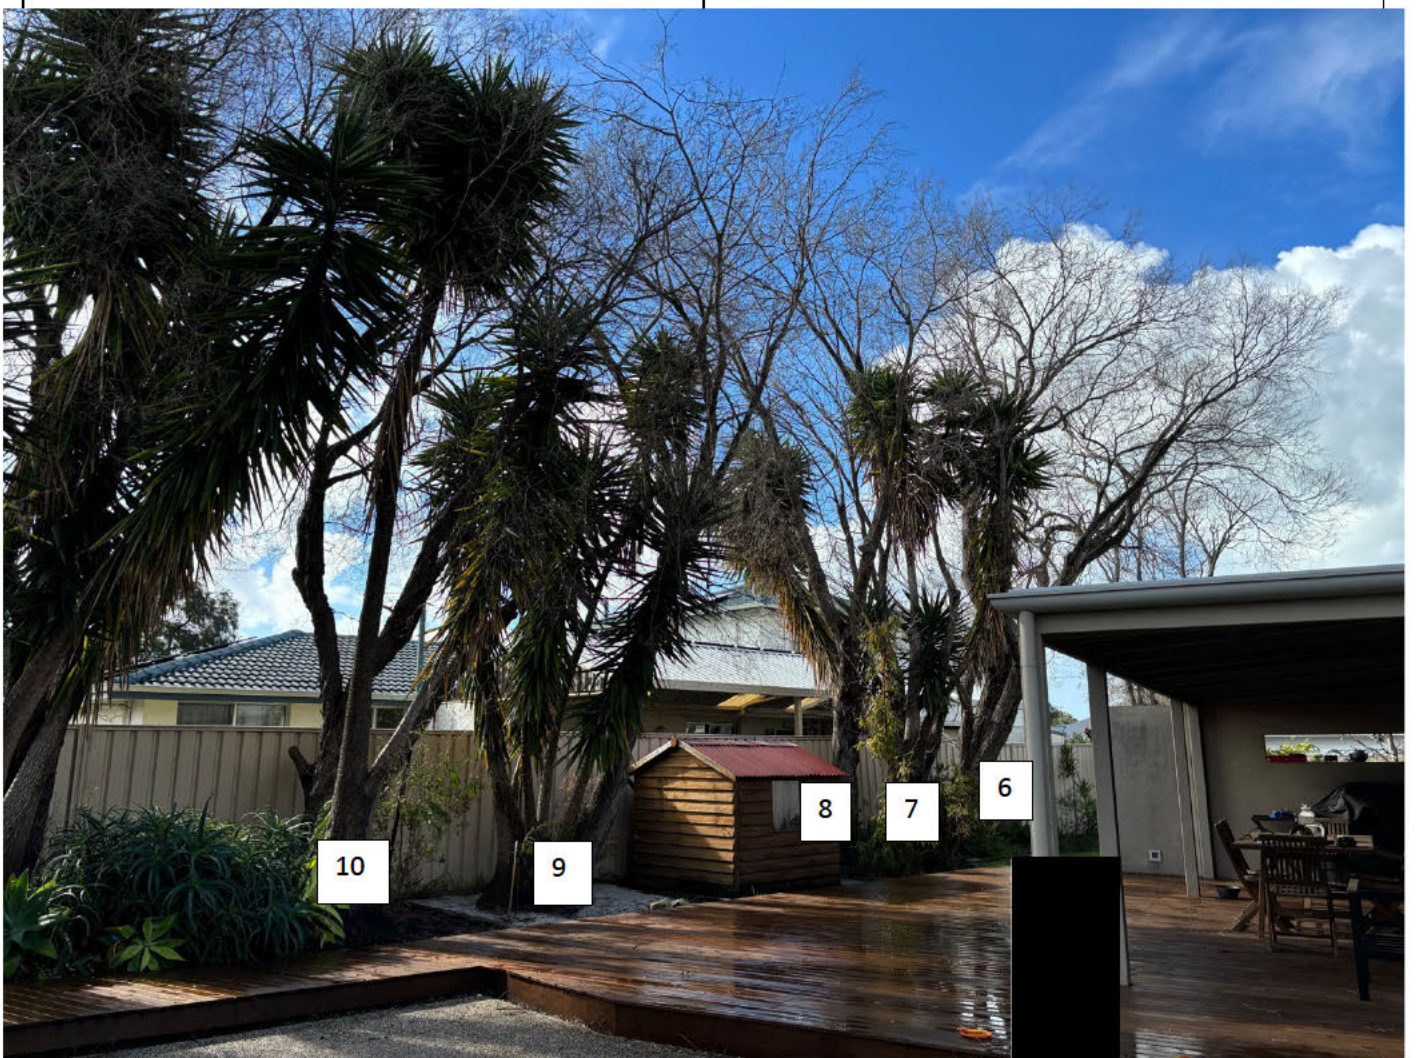
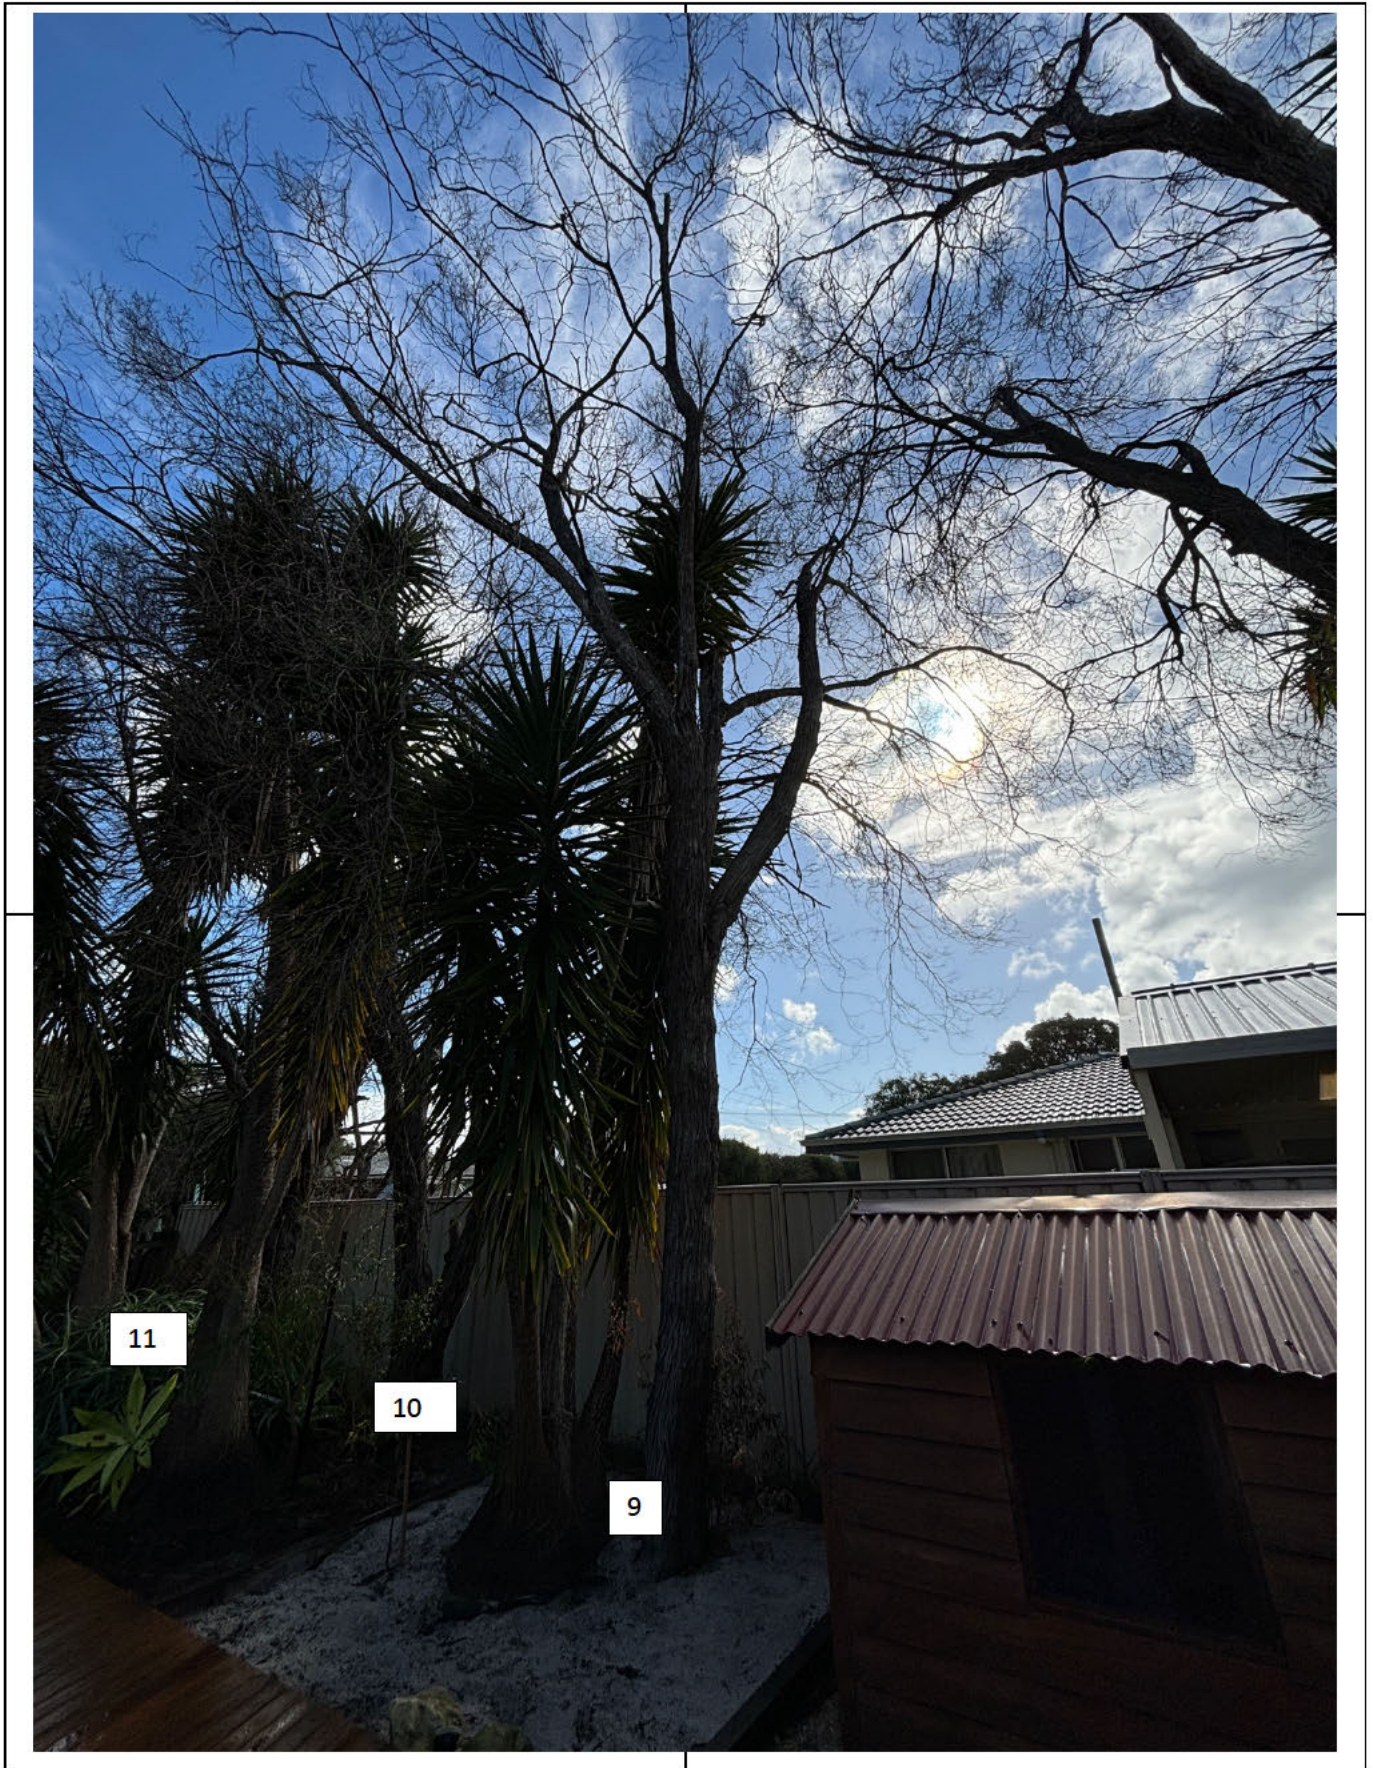
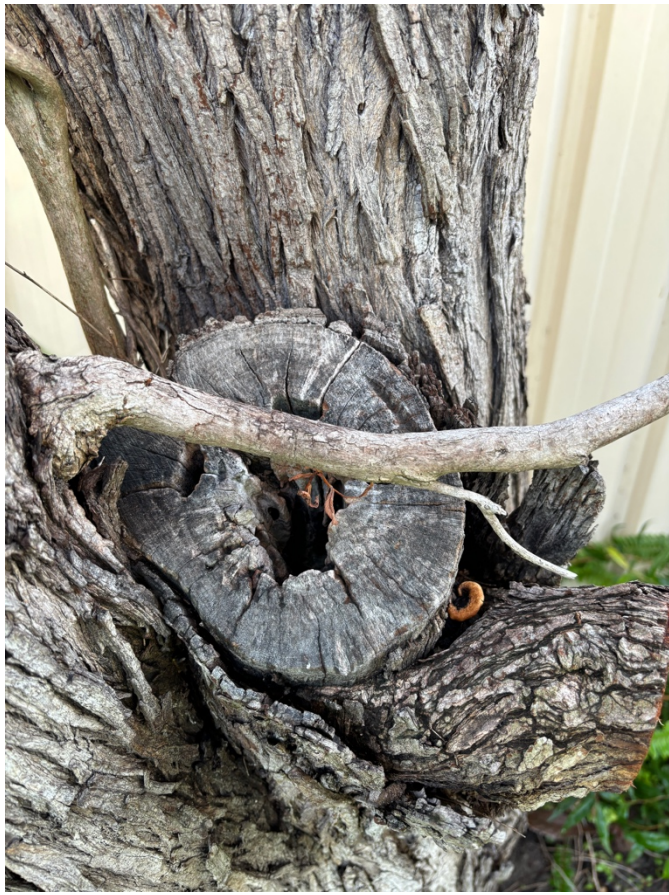
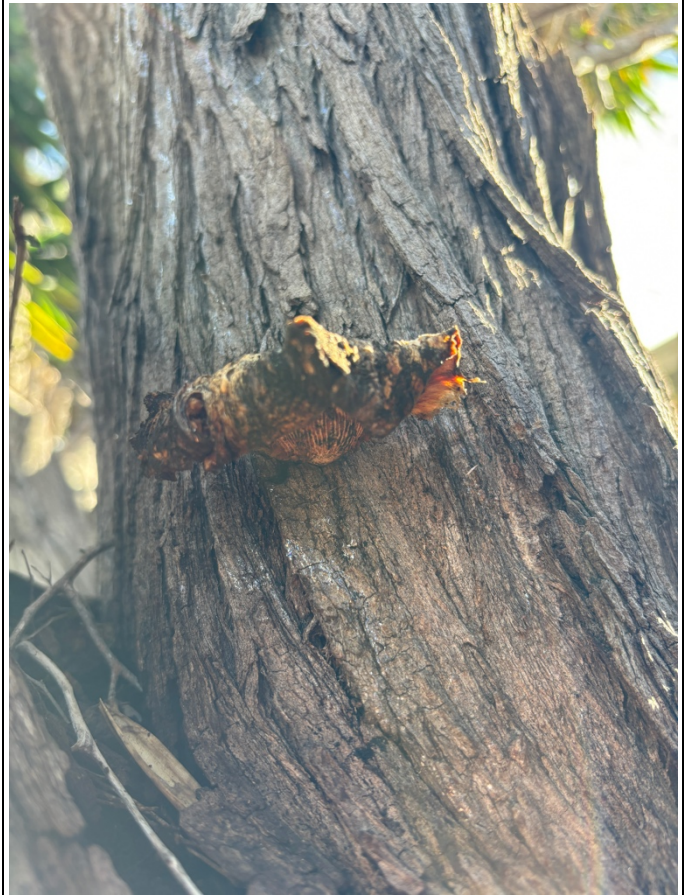
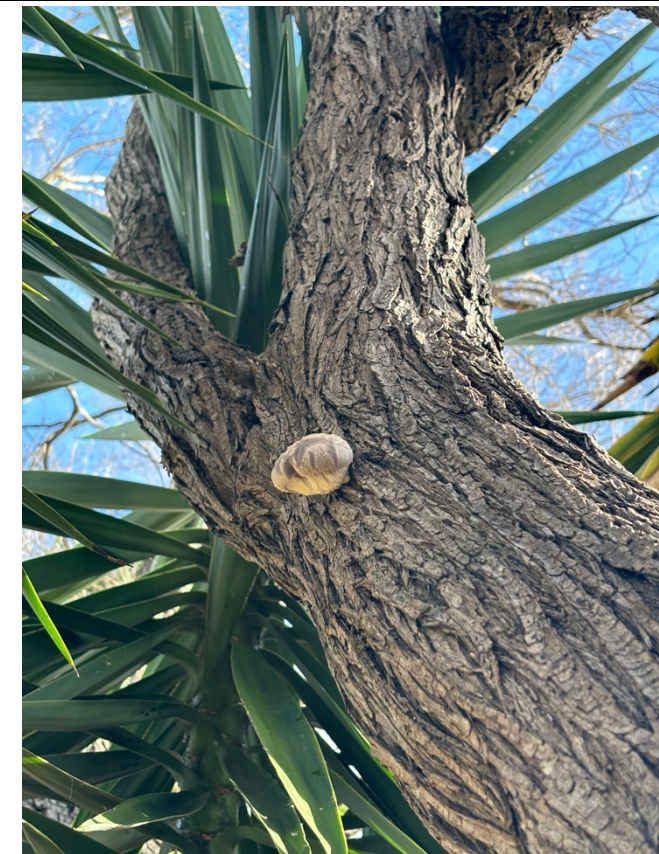
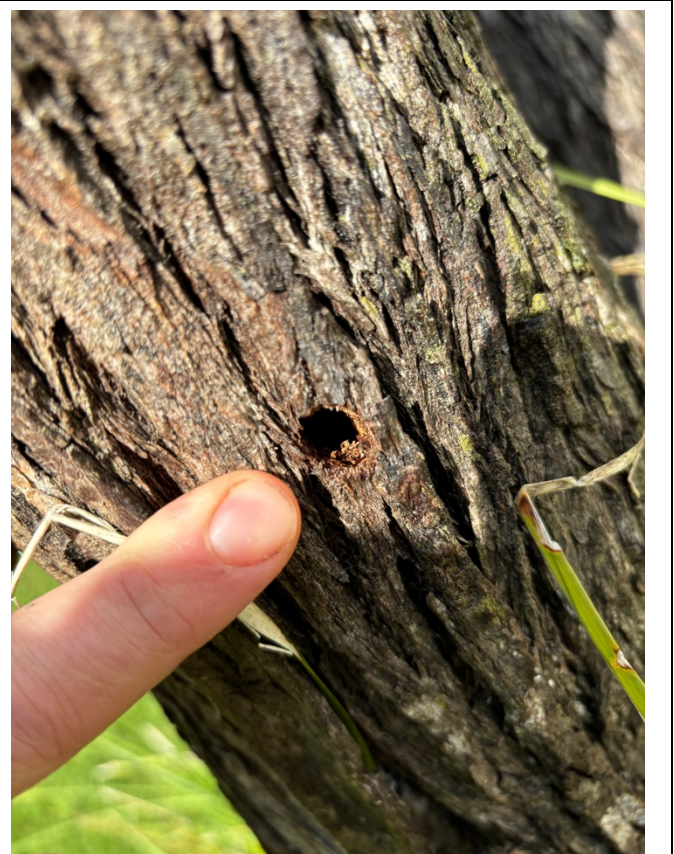
The health of all the subject trees listed on this property is very poor. They are all showing nearly full canopy die back, only some with minimal green shoots still present.

Most are showing fruiting bodies (fungus infections), decay, pest entry holes and very poor structure.

Pests present include boring beetles and insects, ants and possums.

All trees have a high possibility of failure due to their lack of live wood. All trees have the potential to cause harm to life and/or damage to property if left the way they are.

I would recommend pruning subject trees 2,3 & 6, removing all deadwood down to live wood to give them a chance to reform. It is predicted that the other trees (1,4,5,7,8,9,10,11) will not have live wood to cut back to due to there being little, to none, live foliage or active nodes.

If a tree is found to have no live wood to prune back to then I would recommend removal of that tree all together. This will allow the owners to plant new trees in their place.
