## **Application for referral to clear native vegetation - Infrastructure Areas Vegetation Assessment February 2025**

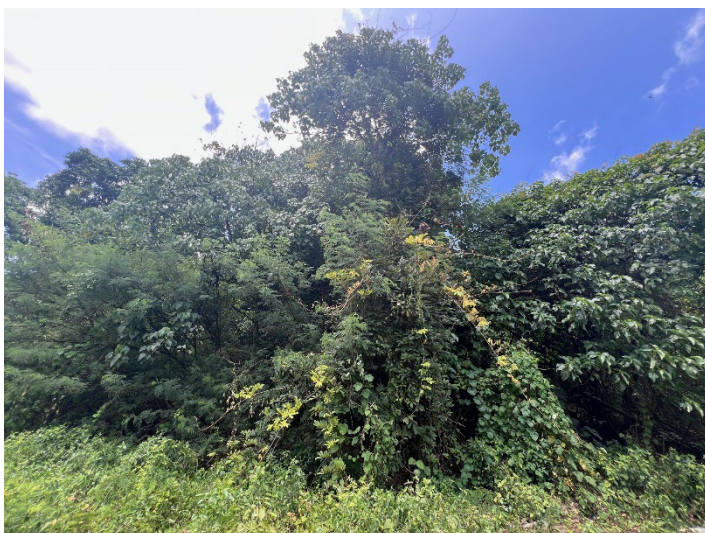
<b>Waypoint Reference</b>	1
<b>Site</b>	LB4/ROM
<b>Tenement</b>	GCI 70/1
<b>GPS Coordinates</b>	N 8845116.0471, E 572652.7407
<b>Photo Direction</b>	280° W
<b>Native Vegetation</b>	<i>Macaranga tanarius</i> <i>Pipturus argenteus</i>
<b>Weed Species</b>	<i>Leucaena leucocephala</i> Other weed species
<b>Vegetation Rating (1=Pristine, 7=Cleared)</b>	5, 6, 7
<b>ESA</b>	Outside, exemptions apply
<b>Notes</b>	Mature trees present, good regeneration. The boundary is ~5-8m into forest from a cleared area, as a buffer zone.

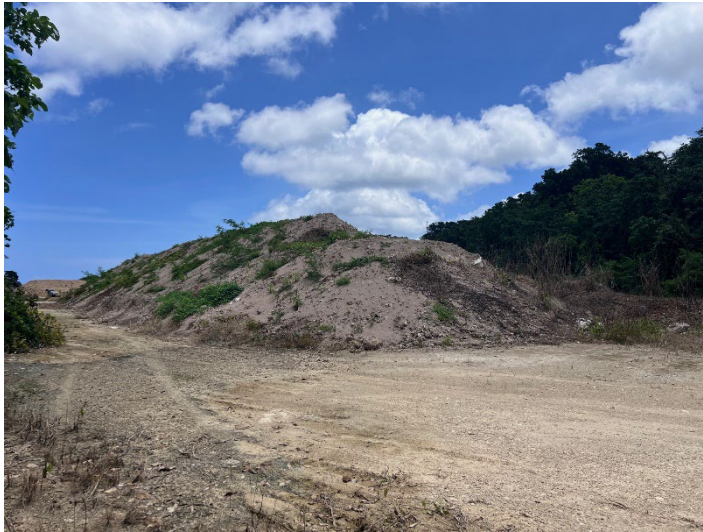
<b>Waypoint Reference</b>	1
<b>Site</b>	LB4/ROM
<b>Tenement</b>	GCI 70/1
<b>GPS Coordinates</b>	N 8845116.0471, E 572652.7407
<b>Photo Direction</b>	75° NE
<b>Native Vegetation</b>	-
<b>Weed Species</b>	<i>Leucaena leucocephala</i> <i>Muntingia calabura</i> Other weed species
<b>Vegetation Rating (1=Pristine, 7=Cleared)</b>	7
<b>ESA</b>	Outside, exemptions apply
<b>Notes</b>	Disturbed, used as a laydown area. Stockpile of product hauled from mining field.

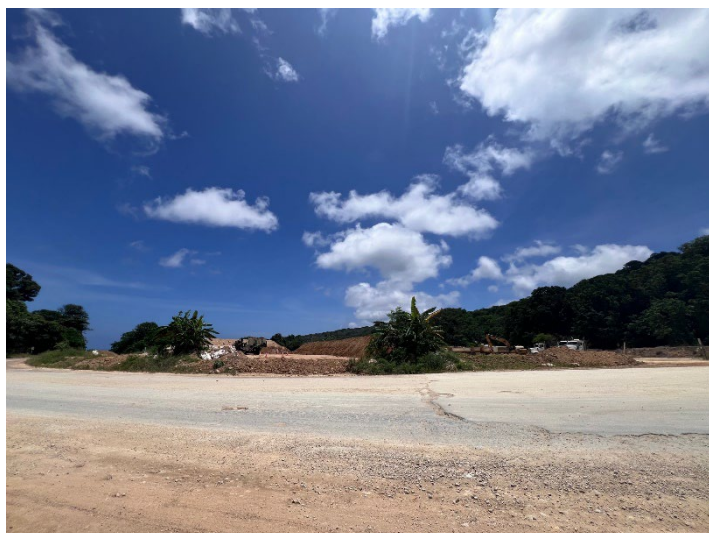
<b>Waypoint Reference</b>	2
<b>Site</b>	LB4
<b>Tenement</b>	GCI 70/1
<b>GPS Coordinates</b>	N 8845213.0198, E 572705.9151
<b>Photo Direction</b>	28° NE
<b>Native Vegetation</b>	-
<b>Weed Species</b>	<i>Leucaena leucocephala</i> <i>Musa acuminata</i> Other weed species
<b>Vegetation Rating (1=Pristine, 7=Cleared)</b>	7
<b>ESA</b>	Outside, exemptions apply
<b>Notes</b>	Road - laydown area. Stockpile of product hauled from mining field.

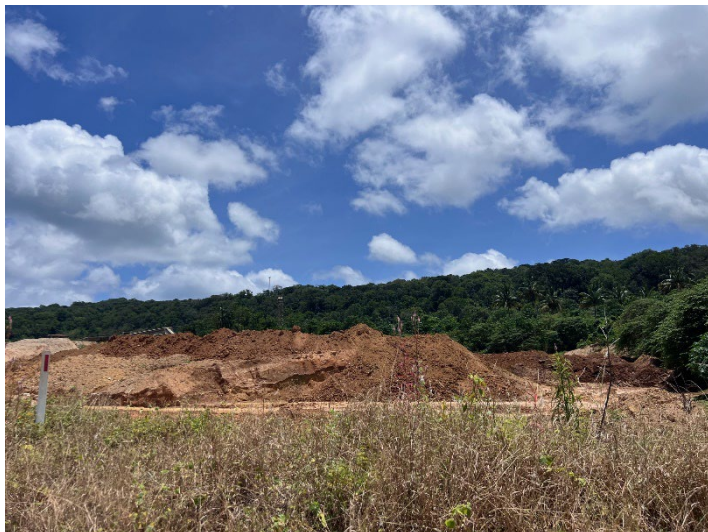
<b>Waypoint Reference</b>	4
<b>Site</b>	ROM
<b>Tenement</b>	MCI 70/1A
<b>GPS Coordinates</b>	N 8845492.0729, E 572720.7307
<b>Photo Direction</b>	68° E
<b>Native Vegetation</b>	-
<b>Weed Species</b>	<i>Muntingia calabura</i> Other weed species
<b>Vegetation Rating (1=Pristine, 7=Cleared)</b>	7
<b>ESA</b>	Inside, exemptions do not apply
<b>Notes</b>	Track / Laydown area. Stockpile of product hauled from mining field. Weed species on windrow.

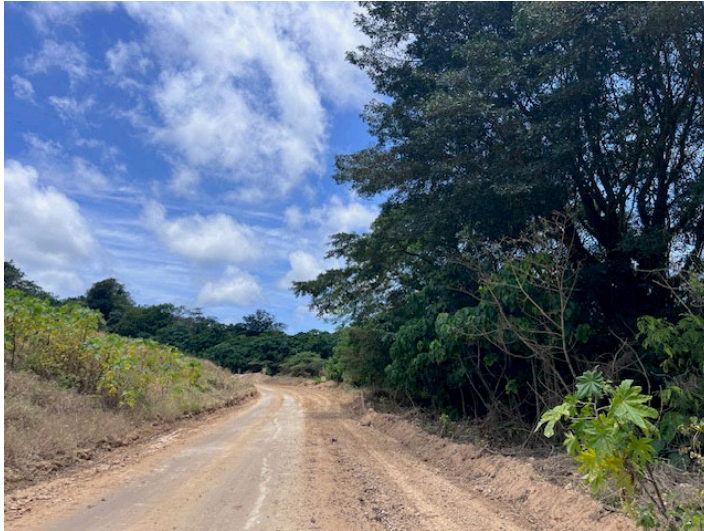
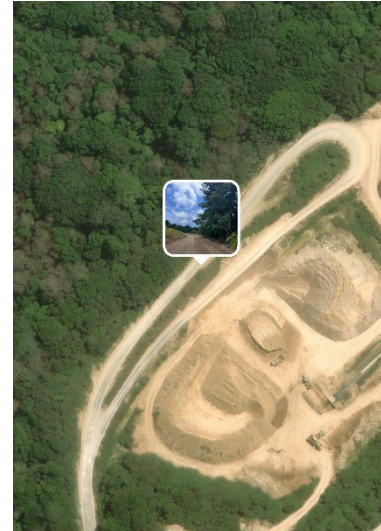
<b>Waypoint Reference</b>	5
<b>Site</b>	ROM
<b>Tenement</b>	GCI 70/2
<b>GPS Coordinates</b>	N 8845599.7664, E 572779.5155
<b>Photo Direction</b>	220° SW
<b>Native Vegetation</b>	<i>Macaranga tanarius</i> <i>Ficus macrocarpa</i>
<b>Weed Species</b>	<i>Leucaena leucocephala</i> <i>Ricinus communis</i> Other weed species
<b>Vegetation Rating (1=Pristine, 7=Cleared)</b>	6, 7
<b>ESA</b>	Inside, exemptions do not apply
<b>Notes</b>	Road exiting Tip-head. Vegetation along track, overhanging Ficus limbs.

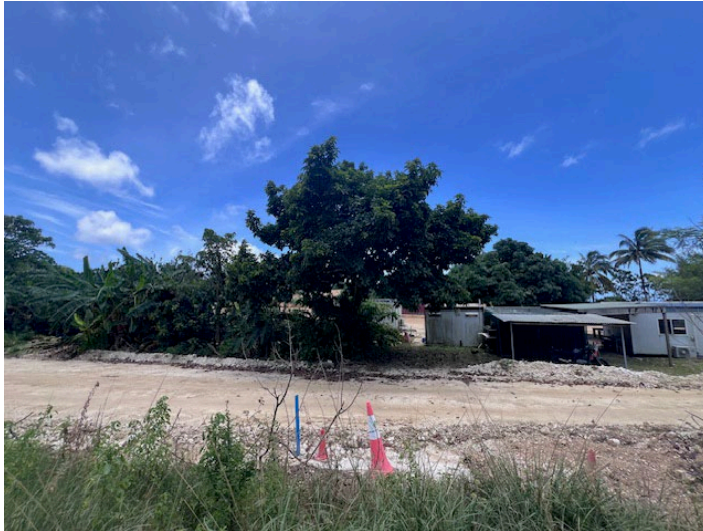
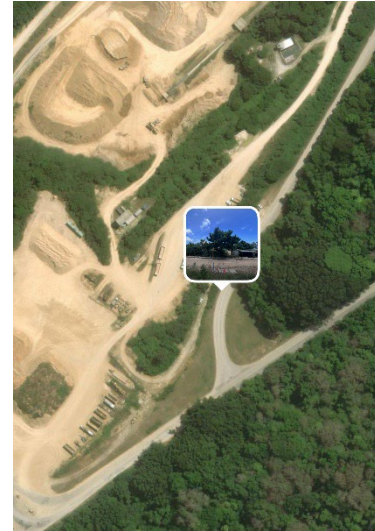
<b>Waypoint Reference</b>	6
<b>Site</b>	LB4 Office/Makan Hut
<b>Tenement</b>	MCI 70/1A
<b>GPS Coordinates</b>	N 8845356.1608, E 572889.5502
<b>Photo Direction</b>	302° NW
<b>Native Vegetation</b>	<i>Macaranga tanarius</i>
<b>Weed Species</b>	<i>Persea americana</i> <i>Leucaena leucocephala</i> <i>Musa acuminata</i> <i>Mangifera indica</i> <i>Carica papaya</i> <i>Cocos nucifera</i> <i>Artocarpus heterophyllus</i> <i>Pandanus amaryllifolius</i> Other weed species
<b>Vegetation Rating (1=Pristine, 7=Cleared)</b>	6, 7
<b>ESA</b>	Outside, exemptions apply
<b>Notes</b>	From Murray Road looking towards LB4 Makan Hut. Vegetation consists of mainly fruit trees.

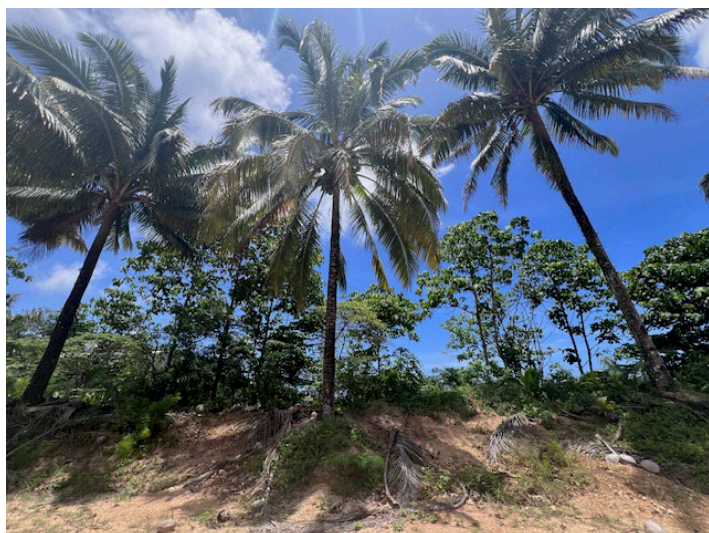
<b>Waypoint Reference</b>	7
<b>Site</b>	LB4
<b>Tenement</b>	MCI 70/1A
<b>GPS Coordinates</b>	N 8845420.4471, E 572866.5946
<b>Photo Direction</b>	277° W
<b>Native Vegetation</b>	<i>Macaranga tanarius</i>
<b>Weed Species</b>	<i>Cocos nucifera</i> <i>Muntingia calabura</i> Other weed species
<b>Vegetation Rating (1=Pristine, 7=Cleared)</b>	6, 7
<b>ESA</b>	Outside, exemptions apply
<b>Notes</b>	Laydown / Road Train Parking.

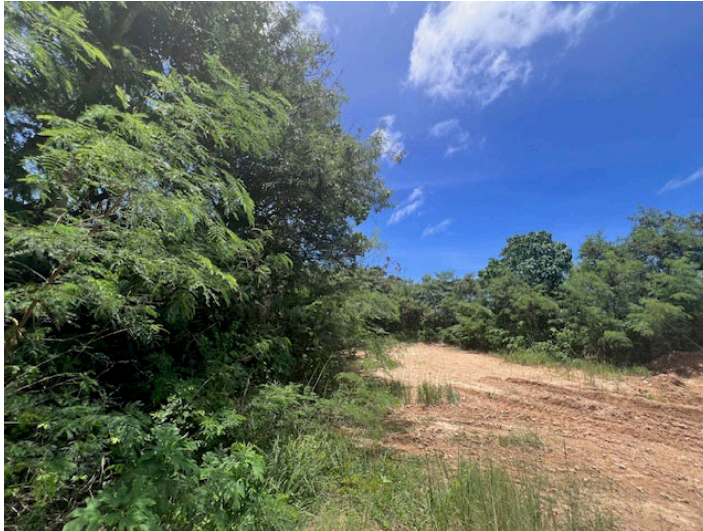
<b>Waypoint Reference</b>	8
<b>Site</b>	Track from LB4 to ROM
<b>Tenement</b>	MCI 70/1A
<b>GPS Coordinates</b>	N 8845427.3278, E 572803.2346
<b>Photo Direction</b>	304° NW
<b>Native Vegetation</b>	<i>Macaranga tanarius</i> <i>Asplenium nidus</i> <i>Schefflera elliptica</i> <i>Tristiropsis acutangula</i> <i>Dysoxylum gaudichaudianum</i>
<b>Weed Species</b>	<i>Leucaena leucocephala</i> <i>Carica papaya</i> <i>Muntingia calabura</i> Other weed species
<b>Vegetation Rating (1=Pristine, 7=Cleared)</b>	5, 6, 7
<b>ESA</b>	Outside, exemptions apply
<b>Notes</b>	Disturbed - vegetation growth dominated by weed species.

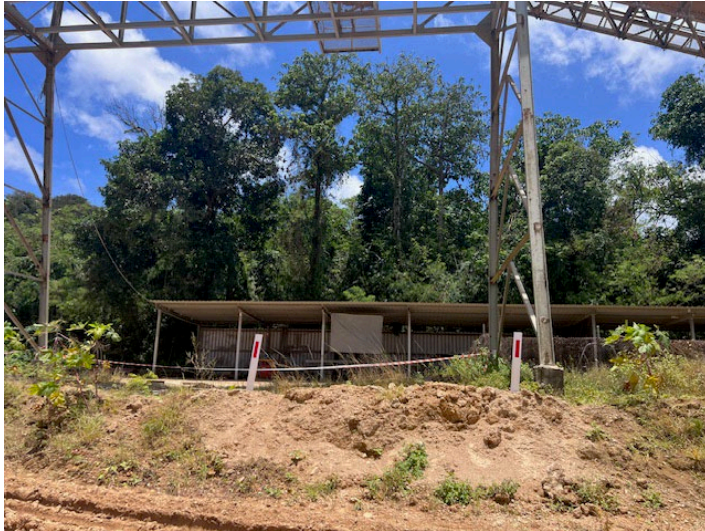
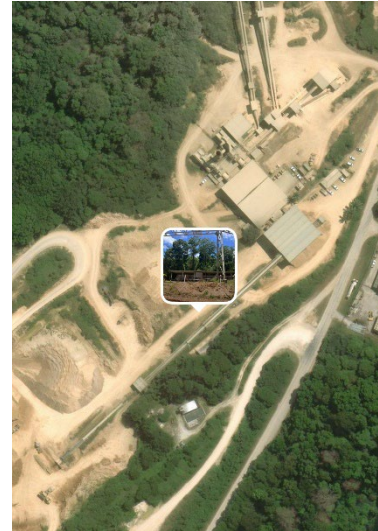
<b>Waypoint Reference</b>	9
<b>Site</b>	ROM
<b>Tenement</b>	MCI 70/1A
<b>GPS Coordinates</b>	N 8845623.2698, E 572960.2676
<b>Photo Direction</b>	117° SE
<b>Native Vegetation</b>	<i>Macaranga tanarius</i> <i>Arenga listeri</i> <i>Dysoxylum gaudichaudianum</i> <i>Maclura cochinchinensis</i>
<b>Weed Species</b>	<i>Leucaena leucocephala</i> <i>Mangifera indica</i> <i>Carica papaya</i> Other weed species
<b>Vegetation Rating (1=Pristine, 7=Cleared)</b>	5, 6, 7
<b>ESA</b>	Outside, exemptions apply
<b>Notes</b>	Disturbed. Looking towards Bio Shed.

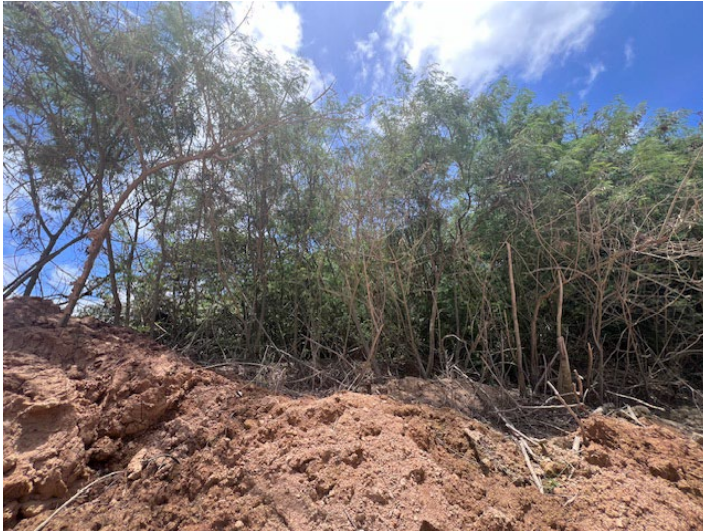
<b>Waypoint Reference</b>	10
<b>Site</b>	Dryers
<b>Tenement</b>	MCI 70/1A
<b>GPS Coordinates</b>	N 8845711.7506, E 572948.4177
<b>Photo Direction</b>	292° NW
<b>Native Vegetation</b>	<i>Maclura cochinchinensis</i>
<b>Weed Species</b>	<i>Leucaena leucocephala</i> <i>Muntingia calabura</i> Other weed species
<b>Vegetation Rating (1=Pristine, 7=Cleared)</b>	6, 7
<b>ESA</b>	Inside, exemptions do not apply
<b>Notes</b>	Disturbed - weed dominated. Between reject stockpile and Baghouse.

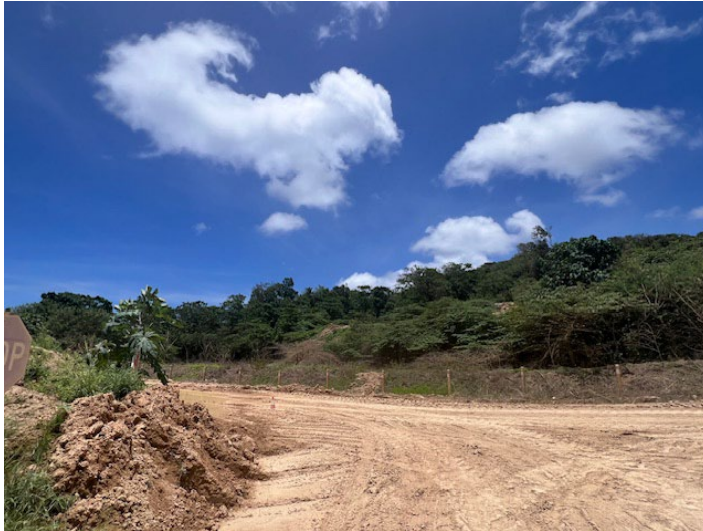
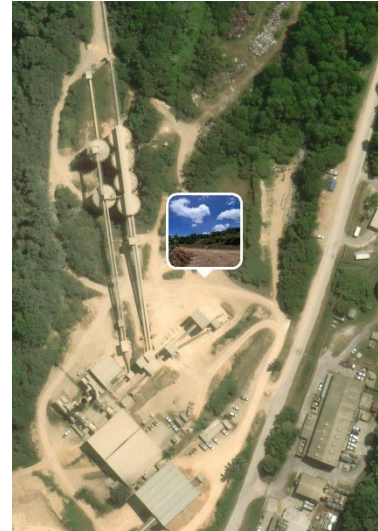
<b>Waypoint Reference</b>	11
<b>Site</b>	Dryers
<b>Tenement</b>	MCI 70/1A
<b>GPS Coordinates</b>	N 8845820.6598, E 573054.5999
<b>Photo Direction</b>	32° NE
<b>Native Vegetation</b>	<i>Macaranga tanarius</i>
<b>Weed Species</b>	<i>Muntingia calabura</i> <i>Leucaena leucocephala</i> <i>Ricinus communis</i> Other weed species
<b>Vegetation Rating (1=Pristine, 7=Cleared)</b>	6, 7
<b>ESA</b>	Outside, exemptions apply
<b>Notes</b>	Operational processing area. Outside Crusher House.

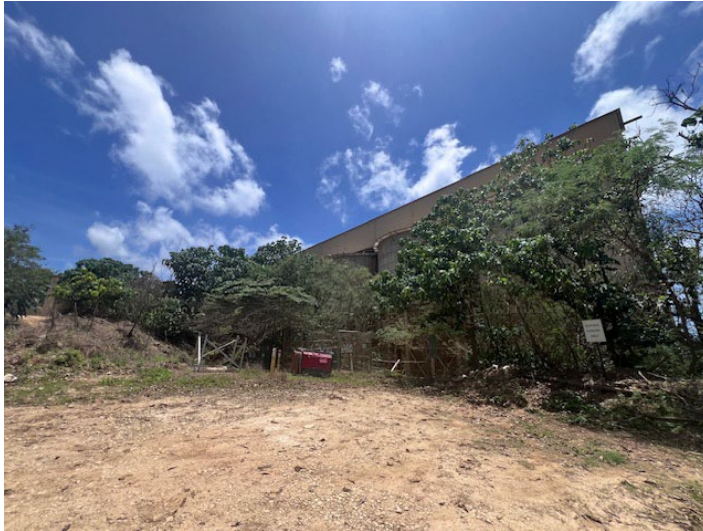
<b>Waypoint Reference</b>	12
<b>Site</b>	Cross Country
<b>Tenement</b>	MCI 70/1A
<b>GPS Coordinates</b>	N 8845922.1007, E 573036.8601
<b>Photo Direction</b>	240° SW
<b>Native Vegetation</b>	<i>Macaranga tanarius</i>
<b>Weed Species</b>	<i>Muntingia calabura</i> <i>Leucaena leucocephala</i> <i>Mangifera indica</i> <i>Cocos nucifera</i> Other weed species
<b>Vegetation Rating (1=Pristine, 7=Cleared)</b>	6, 7
<b>ESA</b>	Outside, exemptions apply
<b>Notes</b>	Operational area. Top of Cross Country Control Room, entrance of Scrap Yard.

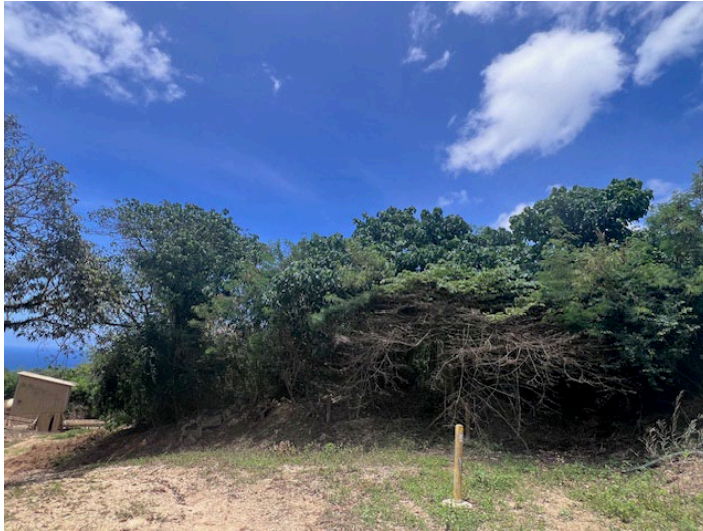
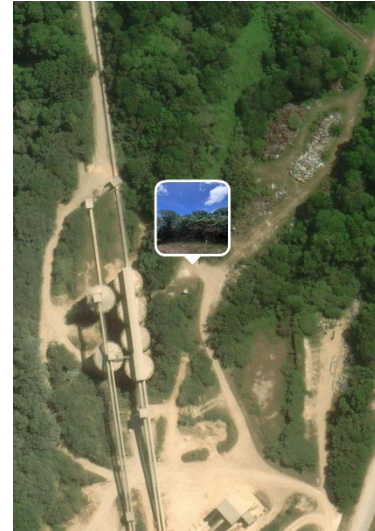
<b>Waypoint Reference</b>	12
<b>Site</b>	Cross Country
<b>Tenement</b>	MCI 70/1A
<b>GPS Coordinates</b>	N 8845922.1007, E 573036.8601
<b>Photo Direction</b>	25° N
<b>Native Vegetation</b>	<i>Macaranga tanarius</i> <i>Maclura cochinchinensis</i>
<b>Weed Species</b>	<i>Leucaena leucocephala</i> <i>Musa acuminata</i> <i>Carica papaya</i> Other weed species
<b>Vegetation Rating (1=Pristine, 7=Cleared)</b>	6, 7
<b>ESA</b>	Outside, exemptions apply
<b>Notes</b>	Operational area. Top of Cross Country Control Room, entrance of Scrap Yard.

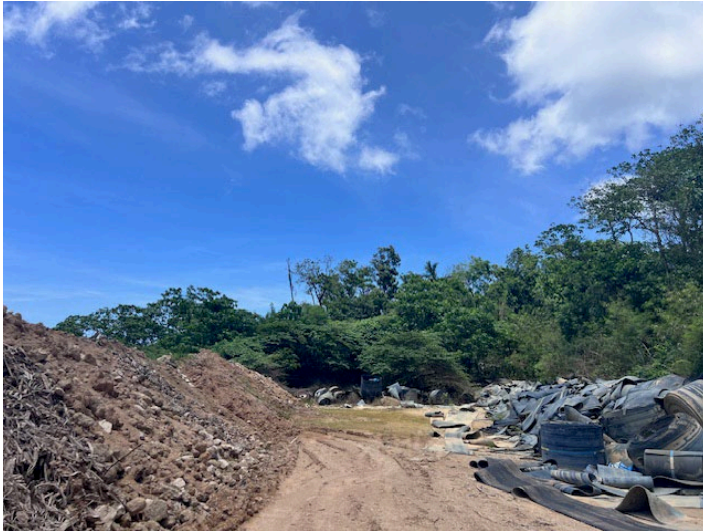
<b>Waypoint Reference</b>	13
<b>Site</b>	Conveyor Belt Storage Area
<b>Tenement</b>	MCI 70/1A
<b>GPS Coordinates</b>	N 8845846.2036, E 573106.9650
<b>Photo Direction</b>	355° N
<b>Native Vegetation</b>	<i>Macaranga tanarius</i> <i>Schefflera elliptica</i> <i>Arenga listeri</i> <i>Maclura cochinchinensis</i> <i>Dysoxylum gaudichaudianum</i> <i>Tristiropsis acutangula</i>
<b>Weed Species</b>	<i>Leucaena leucocephala</i> <i>Muntingia calabura</i> Other weed species
<b>Vegetation Rating (1=Pristine, 7=Cleared)</b>	5, 6, 7
<b>ESA</b>	Outside, exemptions apply
<b>Notes</b>	Laydown. Area for storage of used conveyor belts.

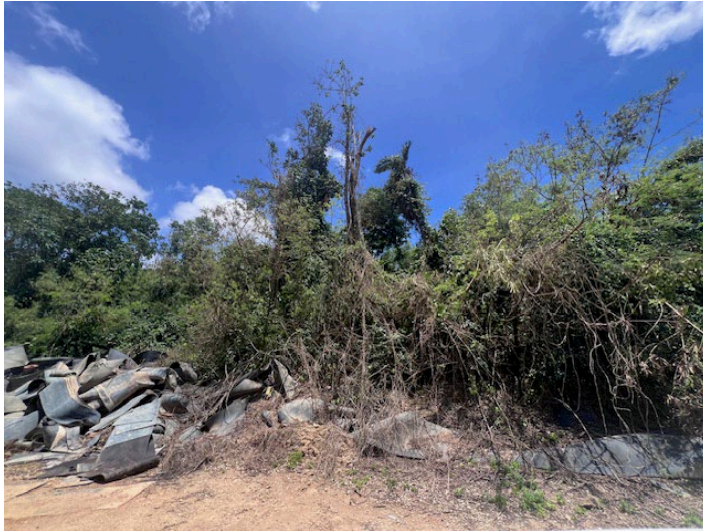
<b>Waypoint Reference</b>	13
<b>Site</b>	Conveyor Belt Storage Area
<b>Tenement</b>	MCI 70/1A
<b>GPS Coordinates</b>	N 8845846.2036, E 573106.9650
<b>Photo Direction</b>	77° E
<b>Native Vegetation</b>	Schefflera elliptica Macaranga tanarius Tristiropsis acutangula Arenga listeri Dysoxylum gaudichaudianum Maclura cochinchinensis
<b>Weed Species</b>	<i>Leucaena leucocephala</i> Other weed species
<b>Vegetation Rating (1=Pristine, 7=Cleared)</b>	5, 6, 7
<b>ESA</b>	Outside, exemptions apply
<b>Notes</b>	Laydown. Area for storage of used conveyor belts.

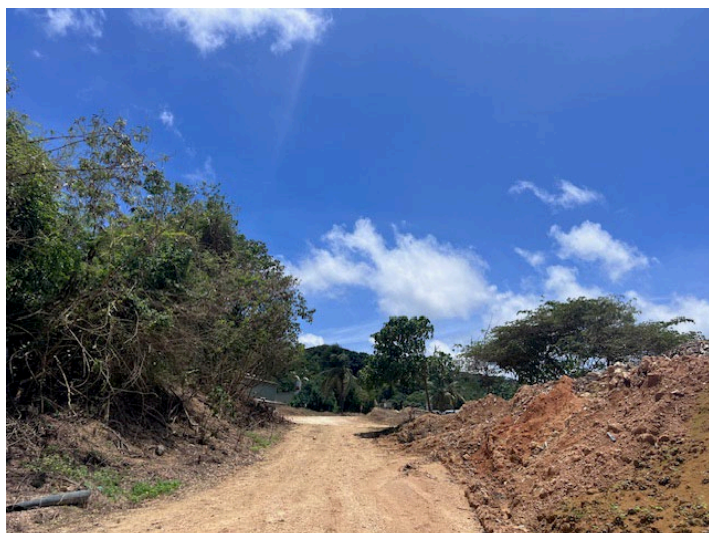
<b>Waypoint Reference</b>	13
<b>Site</b>	Conveyor Belt Storage Area
<b>Tenement</b>	MCI 70/1A
<b>GPS Coordinates</b>	N 8845846.2036, E 573106.9650
<b>Photo Direction</b>	163° S
<b>Native Vegetation</b>	<i>Macaranga tanarius</i>
<b>Weed Species</b>	<i>Leucaena leucocephala</i> <i>Cocos nucifera</i> <i>Muntingia calabura</i> Other weed species
<b>Vegetation Rating (1=Pristine, 7=Cleared)</b>	6, 7
<b>ESA</b>	Outside, exemptions apply
<b>Notes</b>	Laydown. Area for storage of used conveyor belts.

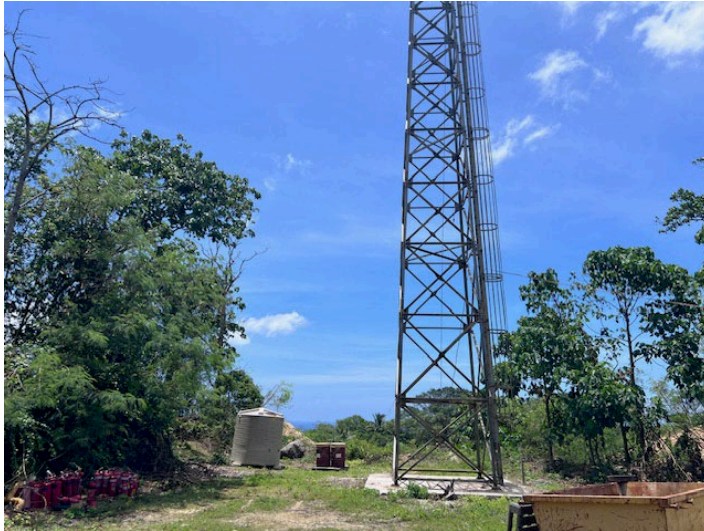
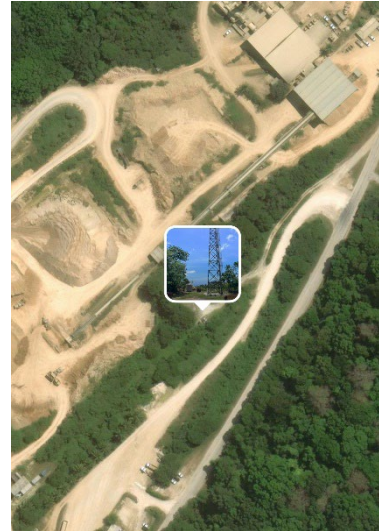
<b>Waypoint Reference</b>	14
<b>Site</b>	Incinerator
<b>Tenement</b>	MCI 70/1A
<b>GPS Coordinates</b>	N 8845534.0592, E 572949.0246
<b>Photo Direction</b>	311° NW
<b>Native Vegetation</b>	Macaranga tanarius Maclura cochinchinensis Schefflera elliptica Barringtonia racemosa Dysoxylum gaudichaudianum
<b>Weed Species</b>	<i>Cocos nucifera</i> <i>Leucaena leucocephala</i> <i>Muntingia calabura</i> Other weed species
<b>Vegetation Rating (1=Pristine, 7=Cleared)</b>	6, 7
<b>ESA</b>	Outside, exemptions apply
<b>Notes</b>	Operational area. Area for incineration of hydrocarbon waste.

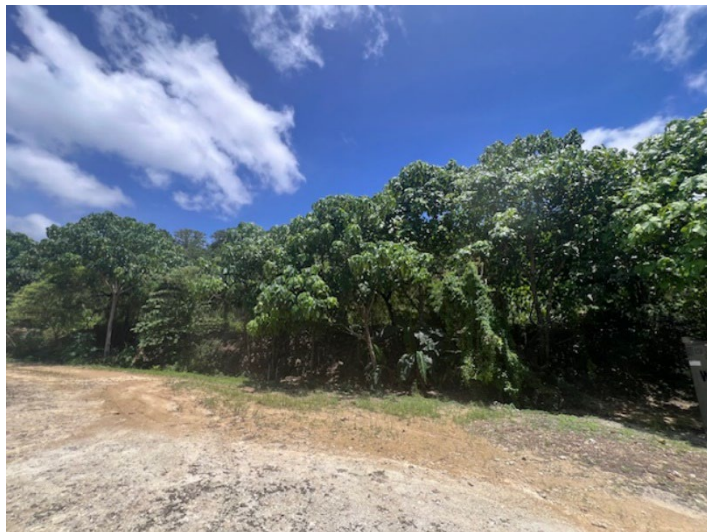
<b>Waypoint Reference</b>	14
<b>Site</b>	Incinerator
<b>Tenement</b>	MCI 70/1A
<b>GPS Coordinates</b>	N 8845534.0592, E 572949.0246
<b>Photo Direction</b>	108° E
<b>Native Vegetation</b>	<i>Macaranga tanarius</i>
<b>Weed Species</b>	<i>Musa acuminata</i> <i>Muntingia calabura</i> <i>Leucaena leucocephala</i> Other weed species
<b>Vegetation Rating (1=Pristine, 7=Cleared)</b>	6, 7
<b>ESA</b>	Outside, exemptions apply
<b>Notes</b>	Operational area. Area for incineration of hydrocarbon waste.

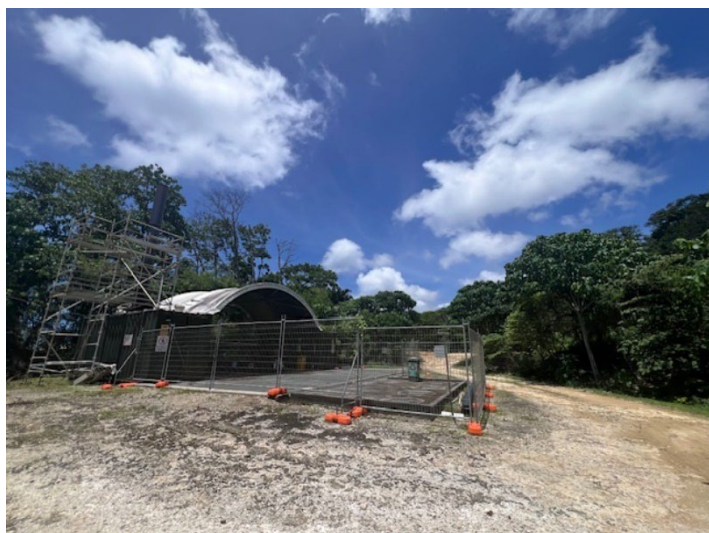
<b>Waypoint Reference</b>	14
<b>Site</b>	Incinerator
<b>Tenement</b>	MCI 70/1A
<b>GPS Coordinates</b>	N 8845534.0592, E 572949.0246
<b>Photo Direction</b>	63° NE
<b>Native Vegetation</b>	<i>Macaranga tanarius</i> <i>Arenga listeri</i>
<b>Weed Species</b>	<i>Leucaena leucocephala</i> Other weed species
<b>Vegetation Rating (1=Pristine, 7=Cleared)</b>	7
<b>ESA</b>	Outside, exemptions apply
<b>Notes</b>	Operational area. Area for incineration of hydrocarbon waste.

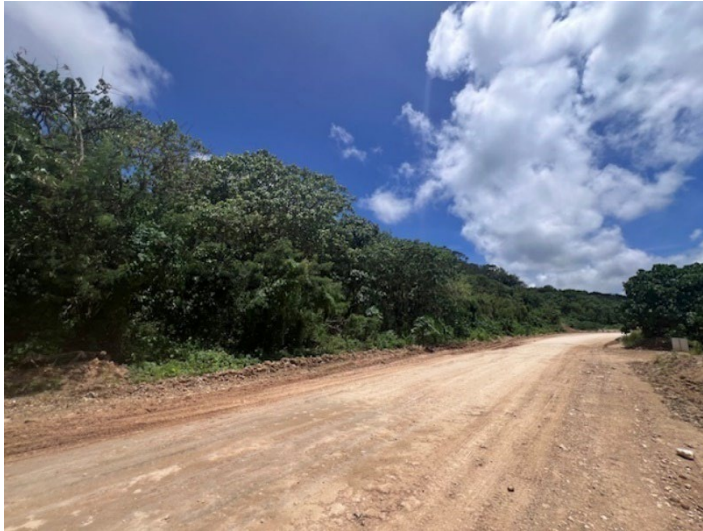
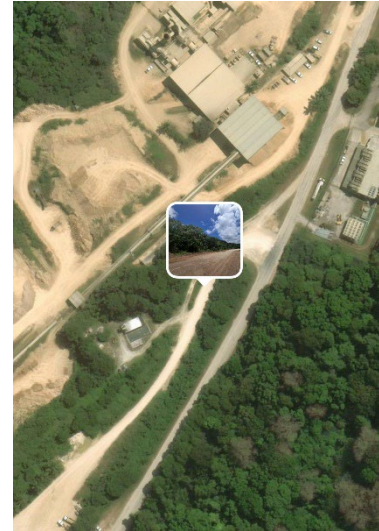
<b>Waypoint Reference</b>	15
<b>Site</b>	Entrance to Incinerator
<b>Tenement</b>	MCI 70/1A
<b>GPS Coordinates</b>	N 8845581.4934, E 573001.9951
<b>Photo Direction</b>	167° S
<b>Native Vegetation</b>	<i>Macaranga tanarius</i> <i>Arenga listeri</i> <i>Dysoxylum gaudichaudianum</i> <i>Schefflera elliptica</i>
<b>Weed Species</b>	<i>Leucaena leucocephala</i> <i>Carica papaya</i> <i>Ricinus communis</i> Other weed species
<b>Vegetation Rating (1=Pristine, 7=Cleared)</b>	5, 6, 7
<b>ESA</b>	Outside, exemptions apply
<b>Notes</b>	Vegetation along road. Vegetation buffer along Murray Road.

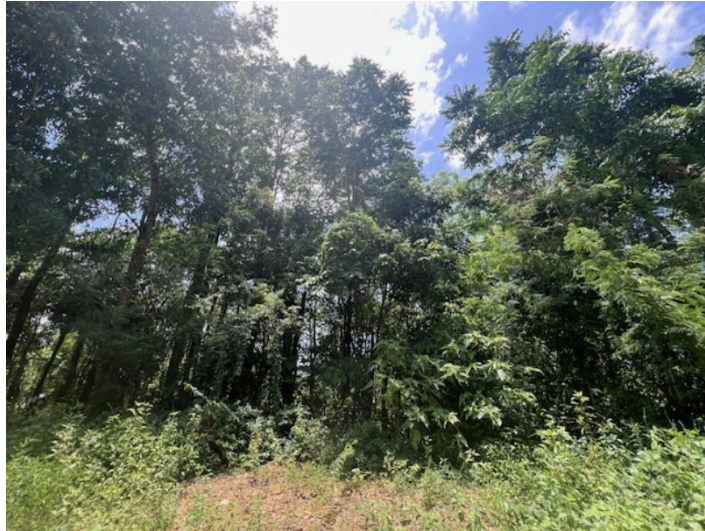
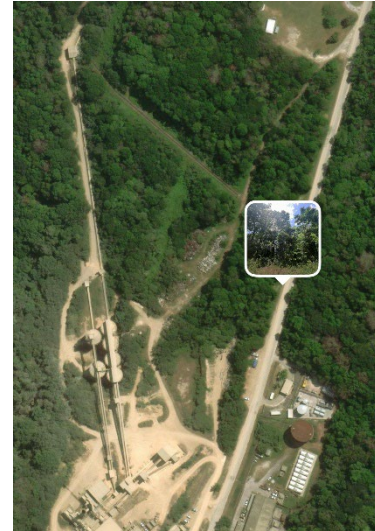
<b>Waypoint Reference</b>	16
<b>Site</b>	Murray Road
<b>Tenement</b>	MCI 70/1A
<b>GPS Coordinates</b>	N 8845956.3537, E 573150.1536
<b>Photo Direction</b>	286° W
<b>Native Vegetation</b>	<i>Dysoxylum gaudichaudianum</i> <i>Macaranga tanarius</i> <i>Claoxylon indicum</i> <i>Maclura cochinchinensis</i> <i>Tristiropsis acutangula</i> <i>Arenga listeri</i> <i>Asplenium nidus</i> <i>Leea angulata</i>
<b>Weed Species</b>	<i>Leucaena leucocephala</i> Other weed species
<b>Vegetation Rating (1=Pristine, 7=Cleared)</b>	4, 5 – good condition internally, degraded on the fringes
<b>ESA</b>	Outside, exemptions apply
<b>Notes</b>	Healthy vegetation growth. ~40m of vegetation between Murray Road and Scrap Yard.

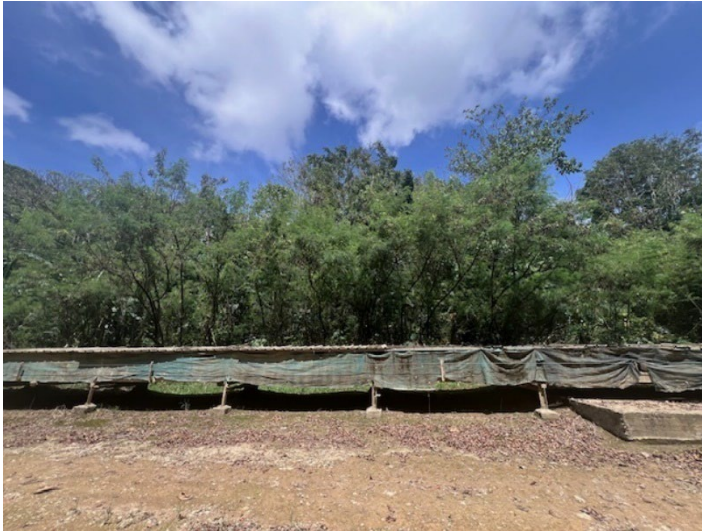
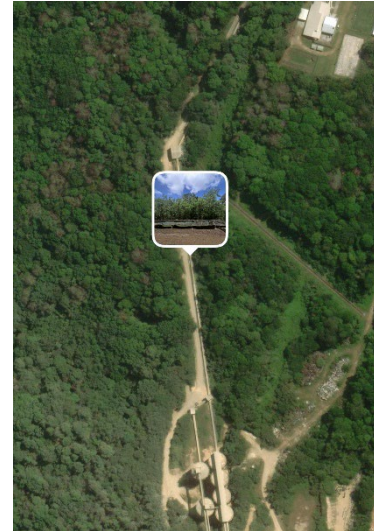
<b>Waypoint Reference</b>	17
<b>Site</b>	Cross Country Conveyors
<b>Tenement</b>	MCI 70/1A
<b>GPS Coordinates</b>	N 8846085.2137, E 572974.4892
<b>Photo Direction</b>	37° NE
<b>Native Vegetation</b>	<i>Macaranga tanarius</i> <i>Dysoxylum gaudichaudianum</i> <i>Leea angulata</i> <i>Arenga listeri</i> <i>Melochia umbellata</i> <i>Maclura cochinchinensis</i>
<b>Weed Species</b>	<i>Leucaena leucocephala</i> <i>Musa acuminata</i> <i>Muntingia calabura</i> Other weed species
<b>Vegetation Rating (1=Pristine, 7=Cleared)</b>	6, 7
<b>ESA</b>	Inside, exemptions do not apply
<b>Notes</b>	Along PS10 Conveyor. Operational area – Vegetation along track and overhanging limbs.

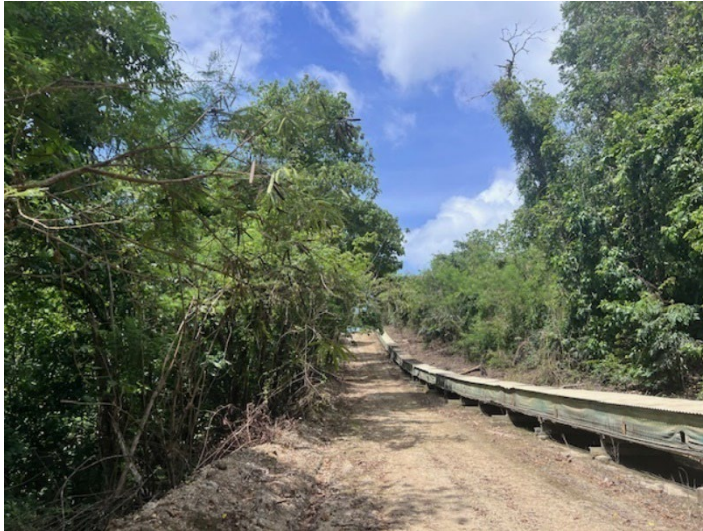
<b>Waypoint Reference</b>	18
<b>Site</b>	Cross Country Conveyors
<b>Tenement</b>	MCI 70/1A
<b>GPS Coordinates</b>	N 8846271.9901, E 573021.1856
<b>Photo Direction</b>	21° N
<b>Native Vegetation</b>	<i>Inocarpus fagifer</i> <i>Terminalia catappa</i> <i>Maclura cochinchinensis</i> <i>Macaranga tanarius</i> <i>Tristiropsis acutangula</i> <i>Gyrocarpus americanus</i> <i>Ficus microcarpa</i> <i>Barringtonia racemosa</i>
<b>Weed Species</b>	<i>Leucaena leucocephala</i> Other weed species
<b>Vegetation Rating (1=Pristine, 7=Cleared)</b>	5, 7
<b>ESA</b>	Inside, exemptions do not apply
<b>Notes</b>	Along C1 Conveyor (bottom of hill). Operational area – Vegetation along track and overhanging limbs.

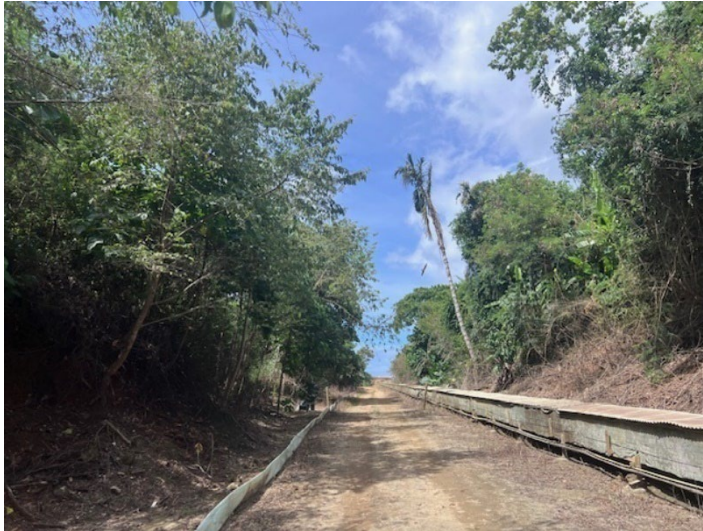
<b>Waypoint Reference</b>	19
<b>Site</b>	Cross Country Conveyors
<b>Tenement</b>	MCI 70/1A
<b>GPS Coordinates</b>	N 8846389.6308, E 573074.1861
<b>Photo Direction</b>	34° NE
<b>Native Vegetation</b>	<i>Arenga listeri</i> <i>Macaranga tanarius</i> <i>Celtis timorensis</i> <i>Maclura cochinchinensis</i>
<b>Weed Species</b>	<i>Leucaena leucocephala</i> <i>Muntigia calabura</i> <i>Musa acuminata</i> Other weed species
<b>Vegetation Rating (1=Pristine, 7=Cleared)</b>	6, 7
<b>ESA</b>	Outside, exemptions apply
<b>Notes</b>	Along C1 Conveyor. Operational area – Vegetation along track and overhanging limbs.

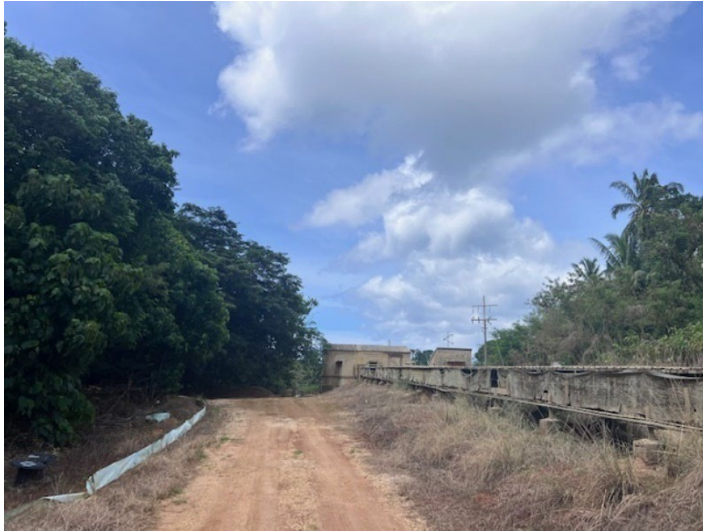
<b>Waypoint Reference</b>	20
<b>Site</b>	Cross Country Conveyors
<b>Tenement</b>	MCI 70/1A
<b>GPS Coordinates</b>	N 8846556.7703, E 573150.3926
<b>Photo Direction</b>	52° NE
<b>Native Vegetation</b>	<i>Macaranga tanarius</i> <i>Ficus microcarpa</i> <i>Maclura cochinchinensis</i>
<b>Weed Species</b>	<i>Leucaena leucocephala</i> <i>Cocos nucifera</i> Other weed species
<b>Vegetation Rating (1=Pristine, 7=Cleared)</b>	7
<b>ESA</b>	Outside, exemptions apply
<b>Notes</b>	Along C1 Conveyor, before C1/C2 Transfer Station. Operational area – Vegetation along track and overhanging limbs.

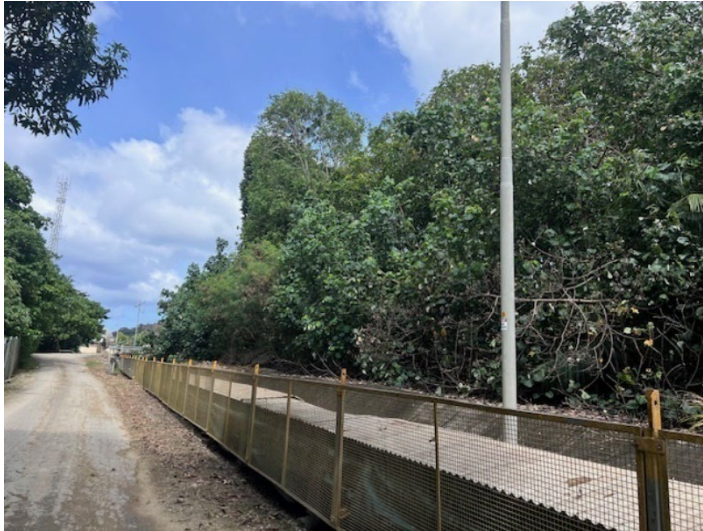
<b>Waypoint Reference</b>	21
<b>Site</b>	Cross Country Conveyors
<b>Tenement</b>	MCI 70/1A
<b>GPS Coordinates</b>	N 8846661.3341, E 573273.2019
<b>Photo Direction</b>	55° NE
<b>Native Vegetation</b>	<i>Hibiscus tiliaceus</i>
<b>Weed Species</b>	<i>Leucaena leucocephala</i> <i>Cocos nucifera</i> <i>Mangifera indica</i> Other weed species
<b>Vegetation Rating (1=Pristine, 7=Cleared)</b>	6, 7
<b>ESA</b>	Outside, exemptions apply
<b>Notes</b>	Along C2 Conveyor, outside Park's Nursery. Operational area - overhanging limbs.

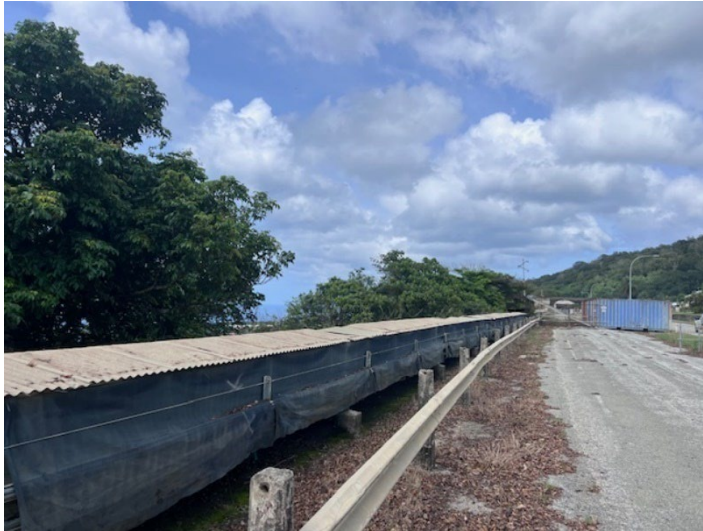
<b>Waypoint Reference</b>	22
<b>Site</b>	Cross Country Conveyors
<b>Tenement</b>	MCI 70/1A
<b>GPS Coordinates</b>	N 8846798.7950, E 573529.2853
<b>Photo Direction</b>	34° NE
<b>Native Vegetation</b>	<i>Tristiropsis acutangula</i> <i>Macaranga tanarius</i>
<b>Weed Species</b>	<i>Delonix regia</i> Other weed species
<b>Vegetation Rating (1=Pristine, 7=Cleared)</b>	6, 7
<b>ESA</b>	Outside, exemptions apply
<b>Notes</b>	Along C2 Conveyor, on Murray Road. Operational area – Vegetation on edge of cliff and overhanging limbs.

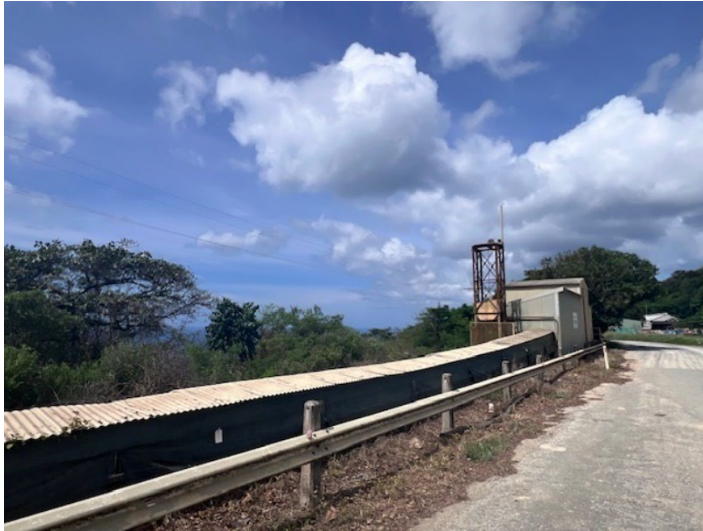
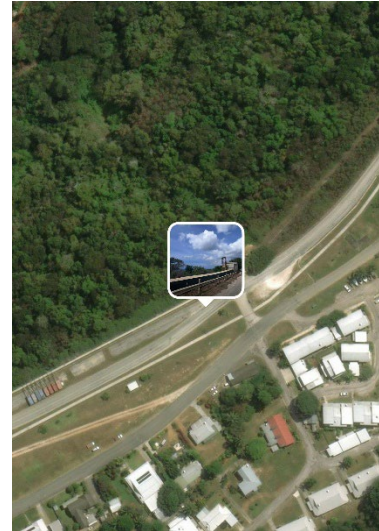
<b>Waypoint Reference</b>	23
<b>Site</b>	Cross Country Conveyors
<b>Tenement</b>	MCI 70/1A
<b>GPS Coordinates</b>	N 8846882.3698, E 573693.4289
<b>Photo Direction</b>	34° NE
<b>Native Vegetation</b>	<i>Dysoxylum gaudichaudianum</i> <i>Terminalia catappa</i> <i>Hibiscus tiliaceus</i>
<b>Weed Species</b>	<i>Leucaena leucocephala</i> <i>Delonix regia</i> <i>Spathodea campanulata</i> Other weed species
<b>Vegetation Rating (1=Pristine, 7=Cleared)</b>	6, 7
<b>ESA</b>	Outside, exemptions apply
<b>Notes</b>	Along C2, before C2/C3 Transfer Station, on Murray Road. Operational area - Vegetation on edge of cliff and overhanging limbs.

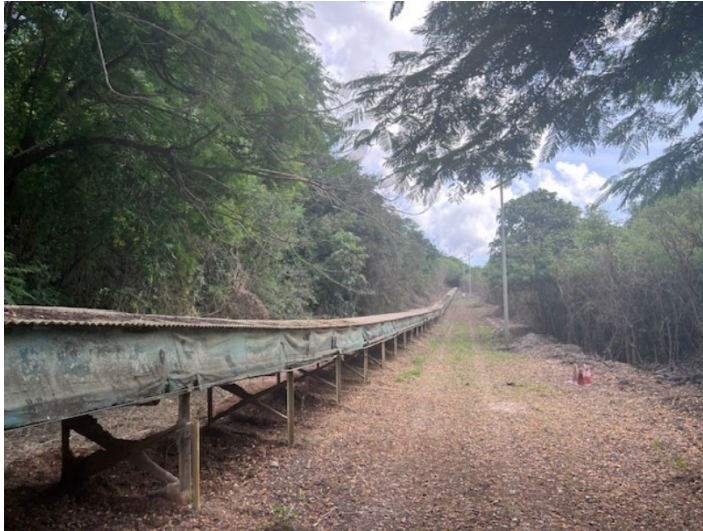
<b>Waypoint Reference</b>	24
<b>Site</b>	Cross Country Conveyors
<b>Tenement</b>	MCI 70/1A
<b>GPS Coordinates</b>	N 8847136.1654, E 573939.4795
<b>Photo Direction</b>	208° SW
<b>Native Vegetation</b>	<i>Macaranga tanarius</i> <i>Maclura cochinchinensis</i> <i>Ficus microcarpa</i> <i>Dysoxylum gaudichaudianum</i>
<b>Weed Species</b>	<i>Leucaena leucocephala</i> <i>Delonix regia</i> Other weed species
<b>Vegetation Rating (1=Pristine, 7=Cleared)</b>	6, 7
<b>ESA</b>	Outside, exemptions apply
<b>Notes</b>	Along C3 Conveyors. Operational area – overhanging limbs.

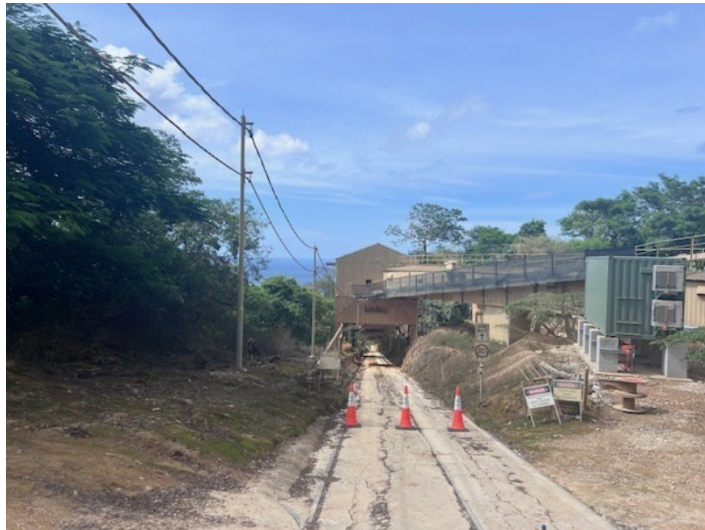
<b>Waypoint Reference</b>	25
<b>Site</b>	Downhill
<b>Tenement</b>	MCI 70/1A
<b>GPS Coordinates</b>	N 8847279.3830, E 573970.7220
<b>Photo Direction</b>	20° NE
<b>Native Vegetation</b>	<i>Macaranga tanarius</i>
<b>Weed Species</b>	<i>Muntingia calabura</i> <i>Leucaena leucocephala</i> <i>Delonix regia</i> Other weed species
<b>Vegetation Rating (1=Pristine, 7=Cleared)</b>	6, 7
<b>ESA</b>	Inside, exemptions do not apply
<b>Notes</b>	Incline. Operational area – vegetation along incline and overhanging limbs.

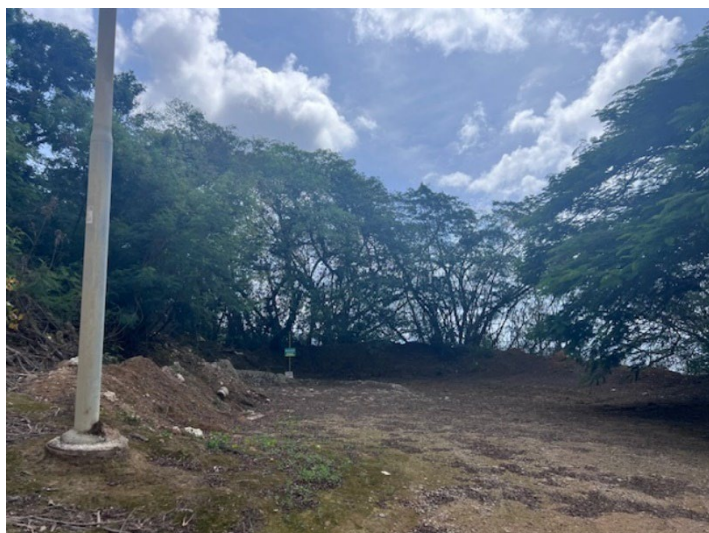
<b>Waypoint Reference</b>	25
<b>Site</b>	Downhill
<b>Tenement</b>	MCI 70/1A
<b>GPS Coordinates</b>	N 8847279.3830, E 573970.7220
<b>Photo Direction</b>	274° W
<b>Native Vegetation</b>	<i>Macaranga tanarius</i> <i>Dysoxylum gaudichaudianum</i>
<b>Weed Species</b>	<i>Delonix regia</i> <i>Muntingia calabura</i> <i>Leucaena leucocephala</i> Other weed species
<b>Vegetation Rating (1=Pristine, 7=Cleared)</b>	7
<b>ESA</b>	Inside, exemptions do not apply
<b>Notes</b>	Parking area outside of lease. Operational area - Parking Area, overhanging limbs.

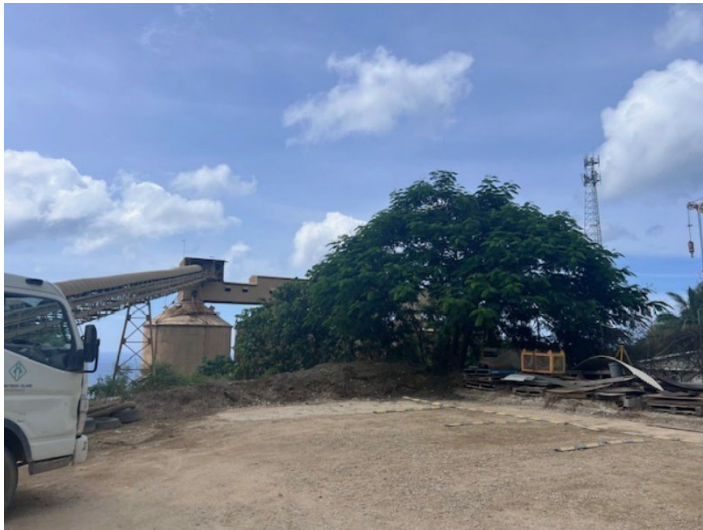
<b>Waypoint Reference</b>	26
<b>Site</b>	Structural Workshop car park
<b>Tenement</b>	MCI 70/1A
<b>GPS Coordinates</b>	N 8847213.3725, E 574029.2889
<b>Photo Direction</b>	5° N
<b>Native Vegetation</b>	<i>Macaranga tanarius</i>
<b>Weed Species</b>	<i>Delonix regia</i> <i>Muntingia calabura</i> <i>Cocos nucifera</i> <i>Leucaena leucocephala</i> Other weed species
<b>Vegetation Rating (1=Pristine, 7=Cleared)</b>	6, 7
<b>ESA</b>	Outside, exemptions apply
<b>Notes</b>	Operational area.

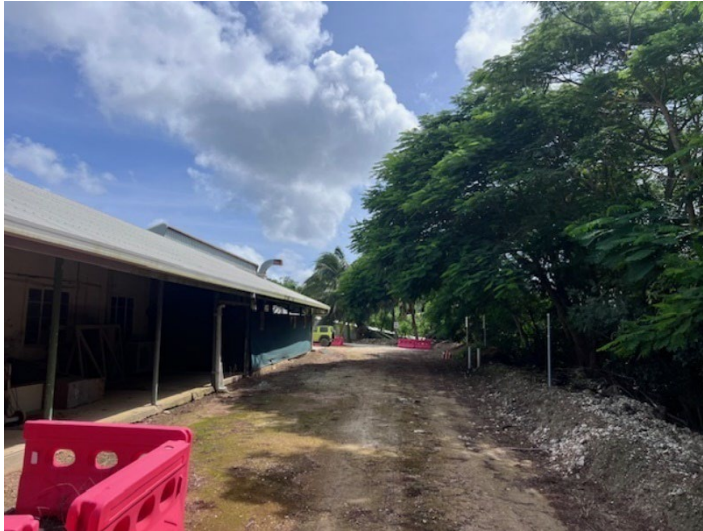
<b>Waypoint Reference</b>	27
<b>Site</b>	Laboratory
<b>Tenement</b>	MCI 70/1A
<b>GPS Coordinates</b>	N 8847306.2640, E 574095.2675
<b>Photo Direction</b>	220° SW
<b>Native Vegetation</b>	<i>Arenga listeri</i> <i>Dysoxylum gaudichaudianum</i> <i>Ficus microcarpa</i>
<b>Weed Species</b>	<i>Delonix regia</i> <i>Leucaena leucocephala</i> <i>Cocos nucifera</i> <i>Muntingia calabura</i> Other weed species
<b>Vegetation Rating (1=Pristine, 7=Cleared)</b>	7
<b>ESA</b>	Outside, exemptions apply
<b>Notes</b>	Operational area – limbs overhanging lease boundary.

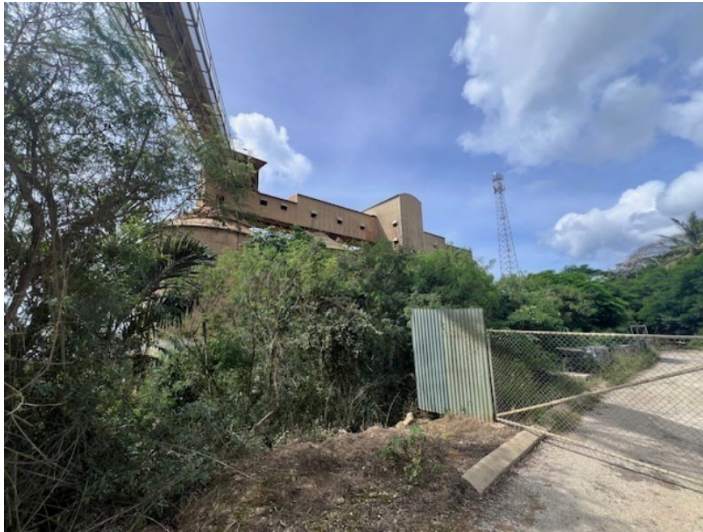
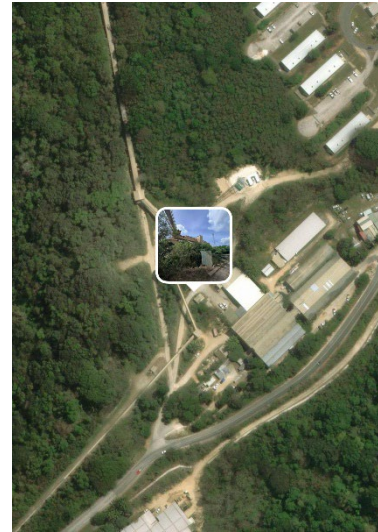
<b>Waypoint Reference</b>	28
<b>Site</b>	CIEM Workshop
<b>Tenement</b>	MCI 70/1A
<b>GPS Coordinates</b>	N 8847239.2940, E 574004.0209
<b>Photo Direction</b>	0° N
<b>Native Vegetation</b>	<i>Maclura cochinchinensis</i> <i>Arenga listeri</i>
<b>Weed Species</b>	<i>Spathodea campanulata</i> <i>Leucaena leucocephala</i> <i>Ricinus communis</i> <i>Muntingia calabura</i> <i>Delonix regia</i> Other weed species
<b>Vegetation Rating (1=Pristine, 7=Cleared)</b>	6, 7
<b>ESA</b>	Outside, exemptions apply
<b>Notes</b>	Operational area - weed dominated.

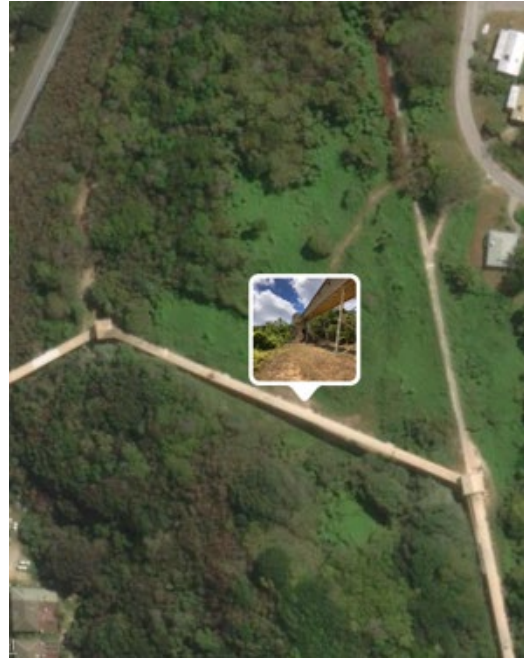
<b>Waypoint Reference</b>	30
<b>Site</b>	Downhill - D11
<b>Tenement</b>	MCI 70/1A
<b>GPS Coordinates</b>	N 8847639.0677, E 573850.9666
<b>Photo Direction</b>	110° E
<b>Native Vegetation</b>	<i>Maclura cochinchinensis</i> <i>Schefflera elliptica</i> <i>Ficus microcarpa</i>
<b>Weed Species</b>	<i>Leucaena leucocephala</i> <i>Antigonon leptopus</i> <i>Manihot esculenta</i> <i>Carica papaya</i> Other weed species
<b>Vegetation Rating (1=Pristine, 7=Cleared)</b>	6, 7
<b>ESA</b>	Inside, exemptions do not apply
<b>Notes</b>	Operational area - largely cleared or weeds with overhanging native limbs.

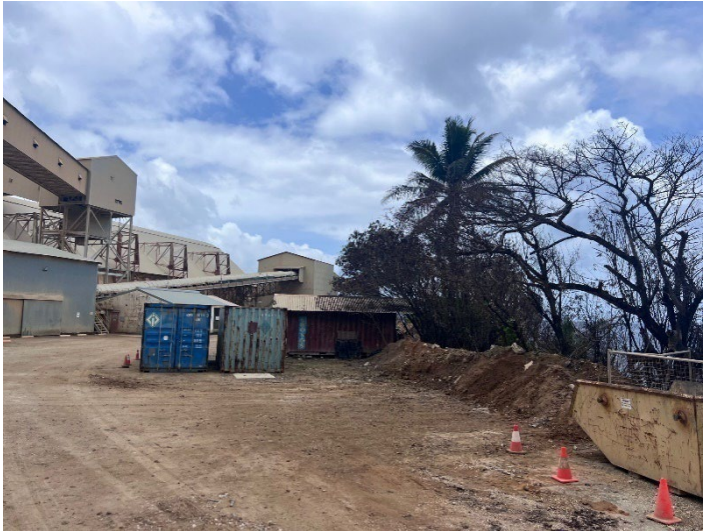
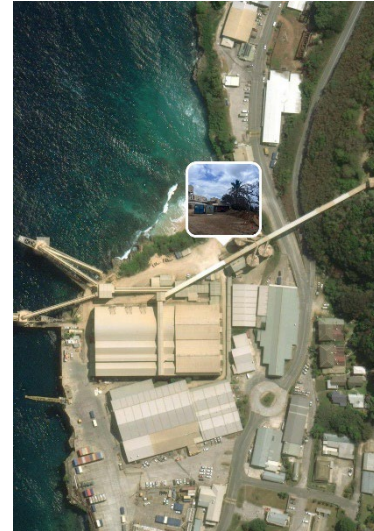
<b>Waypoint Reference</b>	32
<b>Site</b>	Shiploading
<b>Tenement</b>	MCI 70/1A
<b>GPS Coordinates</b>	N 8847624.0924, E 573615.9671
<b>Photo Direction</b>	240° WSW
<b>Native Vegetation</b>	<i>Scaevola taccada</i>
<b>Weed Species</b>	<i>Leucaena leucocephala</i> <i>Cocos nucifera</i> <i>Delonix regia</i> Other weed species
<b>Vegetation Rating (1=Pristine, 7=Cleared)</b>	7
<b>ESA</b>	Outside, exemptions apply
<b>Notes</b>	Entrance to Shiploading. Operational area - Vegetation is in poor condition from salt burn and outside of lease.

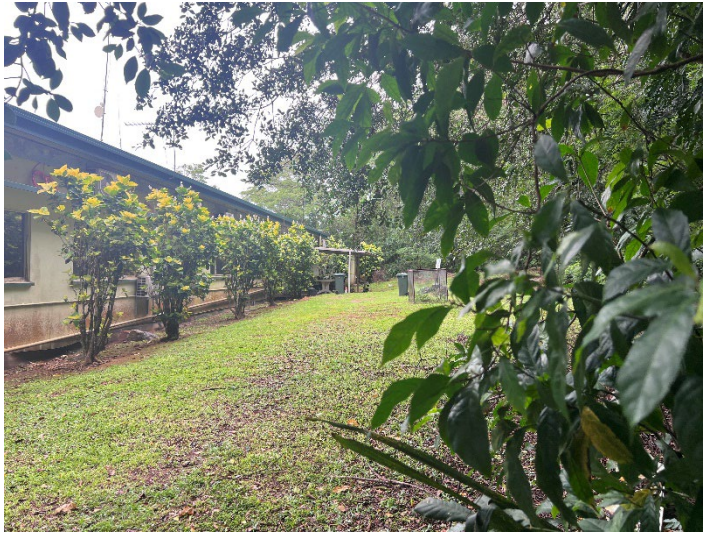
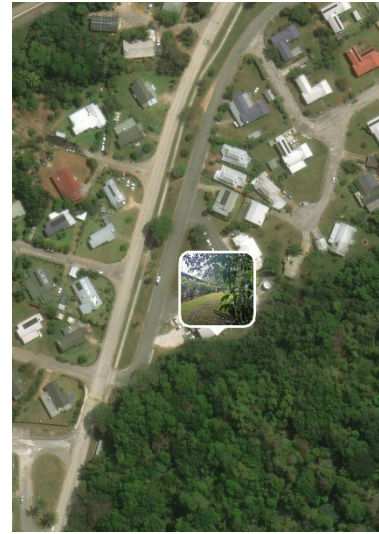
<b>Waypoint Reference</b>	33
<b>Site</b>	CIP Main Office
<b>Tenement</b>	MCI 70/1A
<b>GPS Coordinates</b>	N 8846446.2113, E 573371.5731
<b>Photo Direction</b>	65° NE
<b>Native Vegetation</b>	<i>Ficus macrocarpa</i> <i>Arenga listeri</i> <i>Tristiropsis acutangula</i> <i>Asplenium nidus</i> <i>Inocaropus fagifer</i> <i>Carmona retusa</i>
<b>Weed Species</b>	<i>Leucaena leucocephala</i> Other weed species
<b>Vegetation Rating (1=Pristine, 7=Cleared)</b>	5, 7
<b>ESA</b>	Outside, exemptions apply
<b>Notes</b>	Healthy vegetation growth, boundary ~2m from grassed area.
