## **Application for referral to clear native vegetation - Infrastructure Areas Vegetation Assessment February 2025**

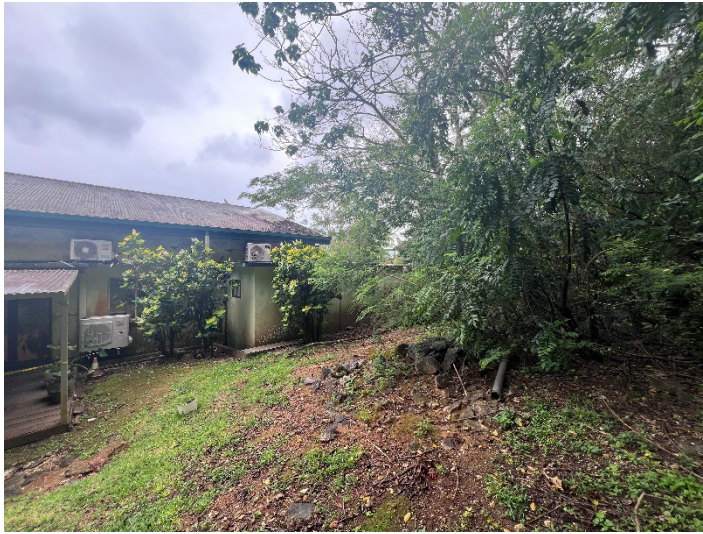
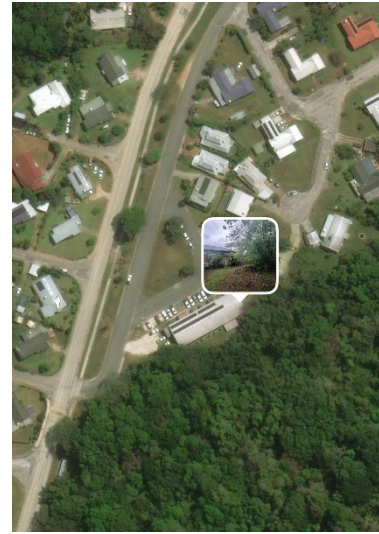
<b>Waypoint Reference</b>	34
<b>Site</b>	CIP Main Office
<b>Tenement</b>	MCI 70/1A
<b>GPS Coordinates</b>	N 8846462.6747, E 573401.1515
<b>Photo Direction</b>	20° N
<b>Native Vegetation</b>	<i>Carmona retusa</i> <i>Schefflera elliptica</i> <i>Leea angulata</i> <i>Barringtonia racemosa</i> <i>Arenga listeri</i> <i>Ficus microcarpa</i> <i>Dysoxylum gaudichaudianum</i> <i>Inocarpus fagifer</i> <i>Macaranga tanarius</i>
<b>Weed Species</b>	<i>Murraya koenigii</i> Other weed species
<b>Vegetation Rating (1=Pristine, 7=Cleared)</b>	5, 7
<b>ESA</b>	Outside, exemptions apply
<b>Notes</b>	Garden area with overhanging limbs of native vegetation.

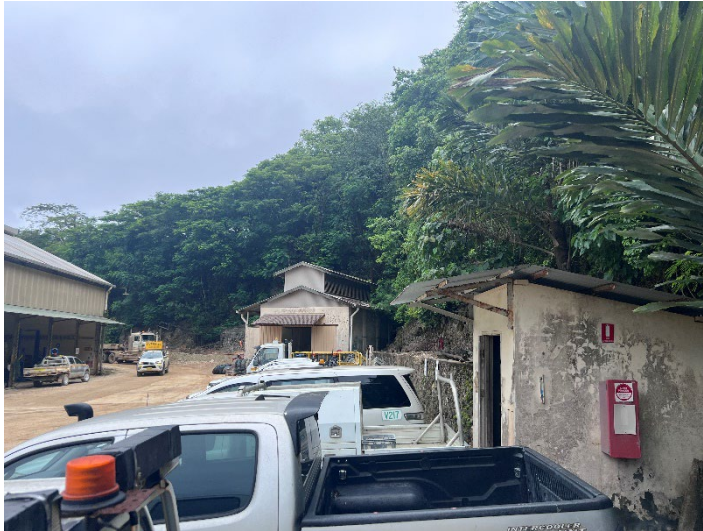
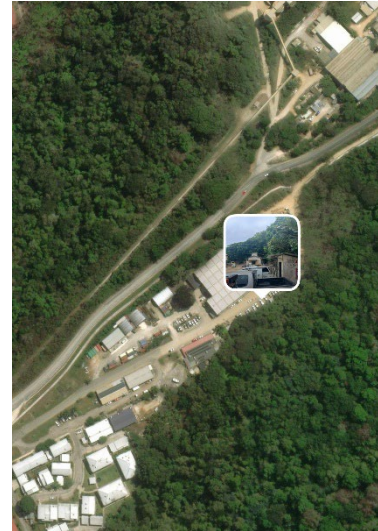
<b>Waypoint Reference</b>	35
<b>Site</b>	Workshop Carpark
<b>Tenement</b>	MCI 70/1A
<b>GPS Coordinates</b>	N 8847000.4809, E 573980.7210
<b>Photo Direction</b>	50° NE
<b>Native Vegetation</b>	<i>Ficus microcarpa</i> <i>Macaranga tanarius</i> <i>Arenga listeri</i> <i>Terminalia catappa</i>
<b>Weed Species</b>	<i>Delonix regia</i> <i>Leucaena leucocephala</i> Other weed species
<b>Vegetation Rating (1=Pristine, 7=Cleared)</b>	3, 7
<b>ESA</b>	Outside, exemptions apply
<b>Notes</b>	Cliff-side vegetation and overhanging limbs.

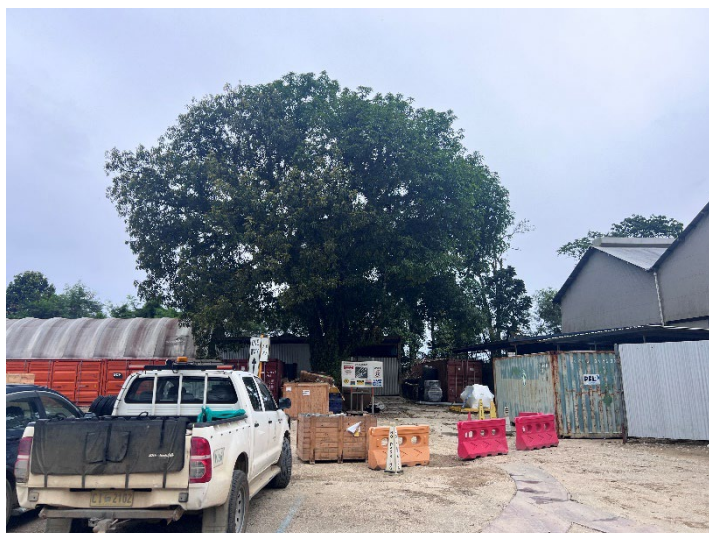
<b>Waypoint Reference</b>	36
<b>Site</b>	Warehouse
<b>Tenement</b>	MCI 70/1A
<b>GPS Coordinates</b>	N 8846981.6921, E 573927.1450
<b>Photo Direction</b>	331° NW
<b>Native Vegetation</b>	-
<b>Weed Species</b>	<i>Mangifera indica</i> <i>Leucaena leucocephala</i> Other weed species
<b>Vegetation Rating (1=Pristine, 7=Cleared)</b>	7
<b>ESA</b>	Outside, exemptions apply
<b>Notes</b>	Weeds surrounding single <i>Mangifera indica</i> . Vegetation along the fence is outside of boundary.

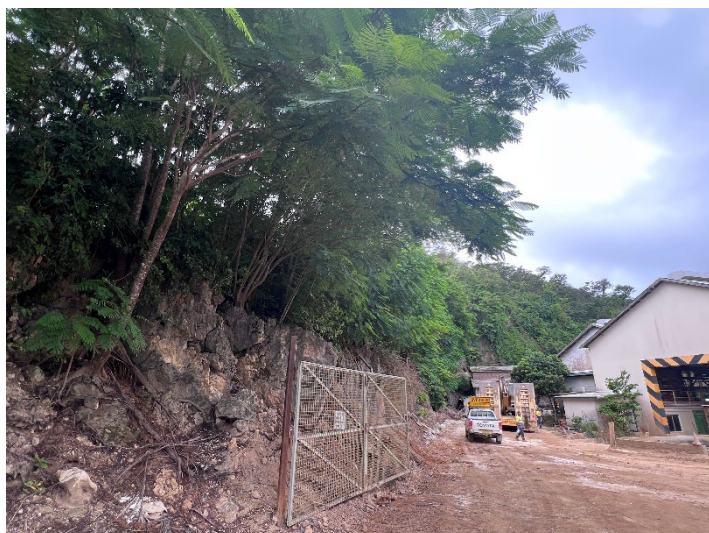
<b>Waypoint Reference</b>	37
<b>Site</b>	MPM Back Gate
<b>Tenement</b>	MCI 70/1A
<b>GPS Coordinates</b>	N 8847097.2100, E 574005.0768
<b>Photo Direction</b>	125° SE
<b>Native Vegetation</b>	<i>Ficus microcarpa</i>
<b>Weed Species</b>	<i>Delonix regia</i> <i>Leucaena leucocephala</i> Other weed species
<b>Vegetation Rating (1=Pristine, 7=Cleared)</b>	6, 7
<b>ESA</b>	Outside, exemptions apply
<b>Notes</b>	Cliff-side vegetation, weed dominated.

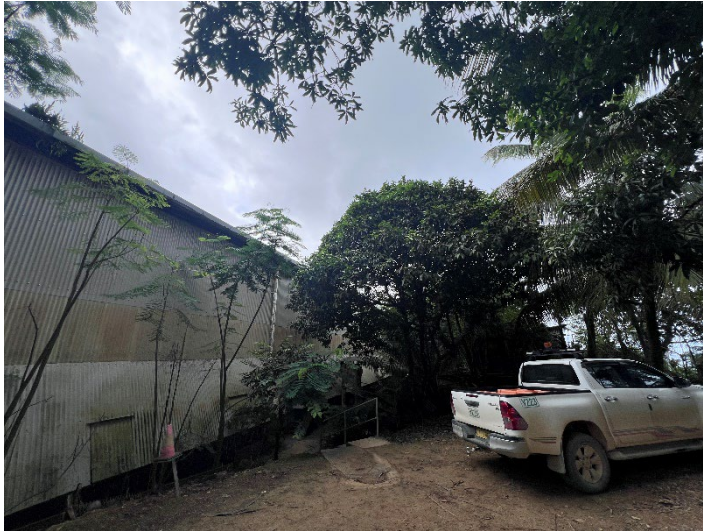
<b>Waypoint Reference</b>	38
<b>Site</b>	Behind Electrical Workshop
<b>Tenement</b>	MCI 70/1A
<b>GPS Coordinates</b>	N 8847065.9627, E 573960.8625
<b>Photo Direction</b>	217° SW
<b>Native Vegetation</b>	<i>Ficus microcarpa</i> <i>Nephrolepis biserrata</i>
<b>Weed Species</b>	<i>Mangifera indica</i> <i>Cocos nucifera</i> <i>Delonix regia</i> <i>Pandanus amaryllifolius</i> <i>Psidium guajava</i> Other weed species
<b>Vegetation Rating (1=Pristine, 7=Cleared)</b>	6, 7
<b>ESA</b>	Outside, exemptions apply
<b>Notes</b>

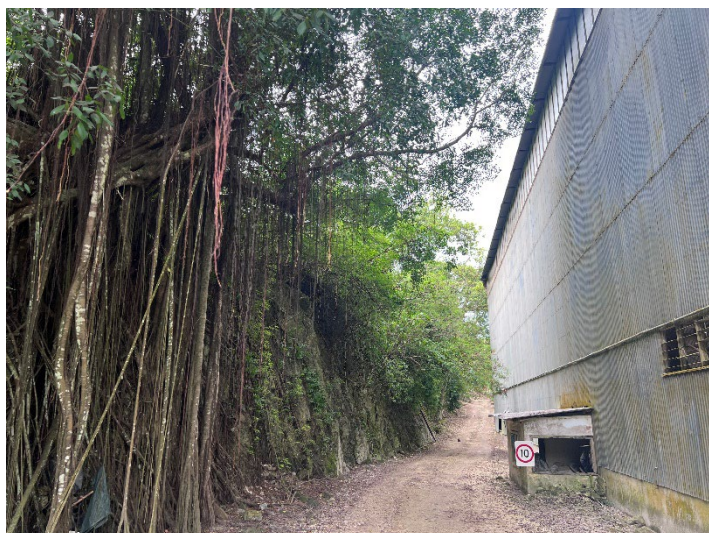
<b>Waypoint Reference</b>	39
<b>Site</b>	Behind the Old Wet Bin/ Structural Workshop
<b>Tenement</b>	MCI 70/1A
<b>GPS Coordinates</b>	N 8847216.1956, E 574104.7099
<b>Photo Direction</b>	207° SW
<b>Native Vegetation</b>	<i>Ficus microcarpa</i> <i>Microsorium scolopendria</i> <i>Guettarda speciosa</i> <i>Schefflera elliptica</i> <i>Nephrolepis biserrata</i> <i>Macaranga tanarius</i>
<b>Weed Species</b>	<i>Leucaena leucocephala</i> Other weed species
<b>Vegetation Rating (1=Pristine, 7=Cleared)</b>	7
<b>ESA</b>	Outside, exemptions apply
<b>Notes</b>	Limbs overhanging lease boundary.

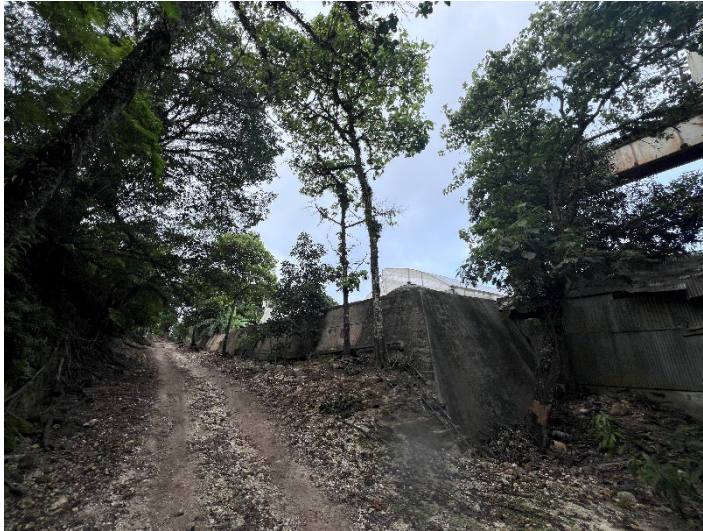
<b>Waypoint Reference</b>	40
<b>Site</b>	Behind the Old Wet Bin/ Structural Workshop
<b>Tenement</b>	MCI 70/1A
<b>GPS Coordinates</b>	N 8847183.1137, E 574067.8285
<b>Photo Direction</b>	272° W
<b>Native Vegetation</b>	<i>Macaranga tanarius</i> <i>Microsorium scolopendria</i> <i>Maclura cochinchinensis</i> <i>Ficus microcarpa</i> <i>Barringtonia racemosa</i>
<b>Weed Species</b>	<i>Mangifera indica</i> <i>Carica papaya</i> Other weed species
<b>Vegetation Rating (1=Pristine, 7=Cleared)</b>	7
<b>ESA</b>	Outside, exemptions apply
<b>Notes</b>	Overhanging limbs and individual trees only.

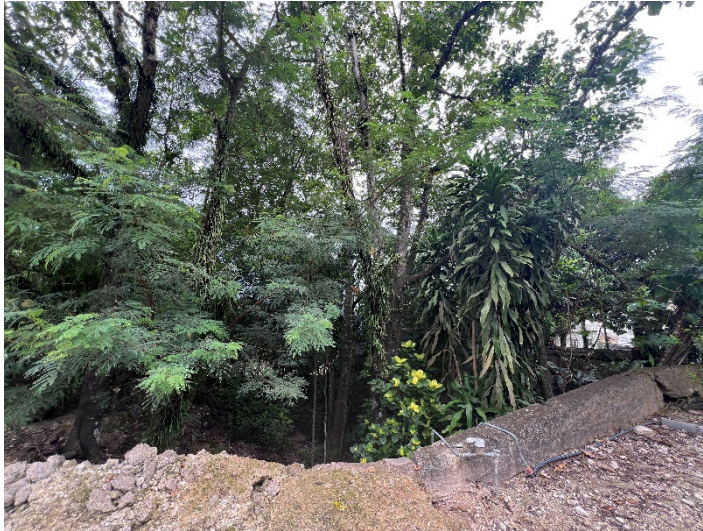
<b>Waypoint Reference</b>	41
<b>Site</b>	Entrance to Green Space
<b>Tenement</b>	MCI 70/1A
<b>GPS Coordinates</b>	N 8847142.0913, E 574011.6224
<b>Photo Direction</b>	351° N
<b>Native Vegetation</b>	<i>Terminalia catappa</i> <i>Macaranga tanarius</i> <i>Asplenium nidus</i> <i>Maclura cochinchinensis</i> <i>Planchonella nitida</i> <i>Barringtonia racemosa</i> <i>Dysoxylum gaudichaudianum</i>
<b>Weed Species</b>	<i>Leucaena leucocephala</i> <i>Dracaena fragrans</i> <i>Musa acuminata</i> Other weed species
<b>Vegetation Rating (1=Pristine, 7=Cleared)</b>	5
<b>ESA</b>	Outside, exemptions apply
<b>Notes</b>

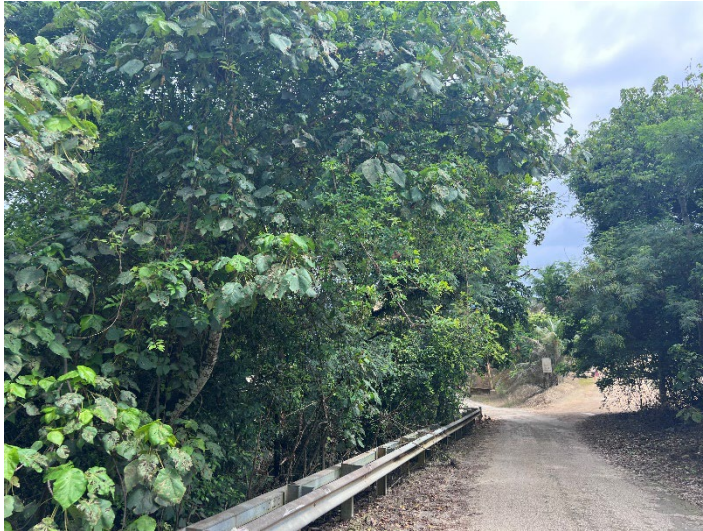
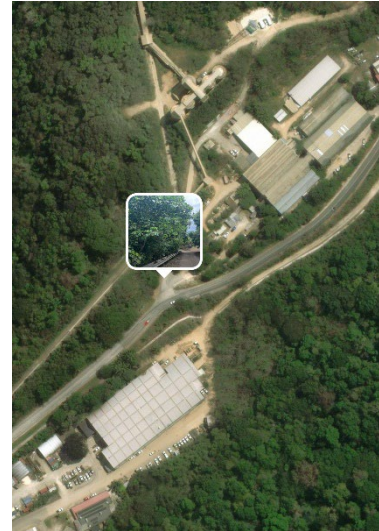
<b>Waypoint Reference</b>	42
<b>Site</b>	Entrance to Downhill from Murray Road
<b>Tenement</b>	MCI 70/1A
<b>GPS Coordinates</b>	N 8847153.5353, E 573983.7439
<b>Photo Direction</b>	357° N
<b>Native Vegetation</b>	<i>Macaranga tanarius</i> <i>Maclura cochinchinensis</i> <i>Terminalia catappa</i> <i>Schefflera elliptica</i> <i>Dysoxylum gaudichaudianum</i>
<b>Weed Species</b>	<i>Carica papaya</i> <i>Leucaena leucocephala</i> <i>Delonix regia</i> Other weed species
<b>Vegetation Rating (1=Pristine, 7=Cleared)</b>	5, 7
<b>ESA</b>	Outside, exemptions apply
<b>Notes</b>	Overhanging limbs.
