28 November 2024

## RE: 279 Riverside Drive, Furnissdale – Vegetation Assessment

Following is our vegetation assessment report for 279 (Lot 119) Riverside Drive, Furnissdale.

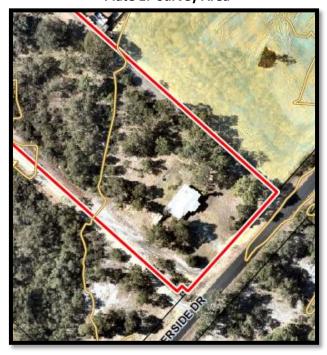
Plate 1: Survey Area

The south-east end of the lot contains some trees, shrubs, cleared lawn areas and a residential dwelling. PGV Environmental was commissioned by Providence Lifestyle (Dawesville) Trust to undertake an assessment of the vegetation on the site with regards to a potential clearing permit application. The area requiring survey is about 0.6ha in size and is located between the 2m AHD contour and Riverside Drive (Plate 1).

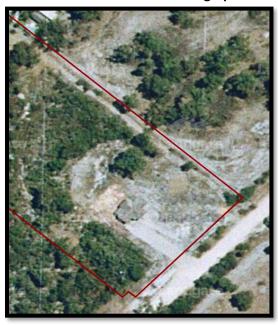
Plate 2:1989 Aerial Photograph

Assessment of historic aerial photograph available for the site shows that the site was mostly native vegetation until sometime between 1985 and 1989 when about half the site was cleared and a house was constructed (Plate 2). A wide firebreak was installed around the eastern perimeter of the site soon after the house was constructed and is clearly shown in the 2005 photograph (Plate 3).

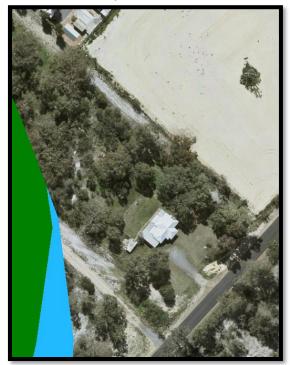
Plate 4: DBCA Geomorphic Wetlands, Swan Coastal Plain

The site is not mapped as being within a wetland (Plate 4). A Conservation Category Wetland (green area on Plate 4) is in close proximity to the site.

The survey area is not mapped as riparian vegetation/wetland on the Geomorphic Wetlands of the Swan Coastal Plain (Plate 4).

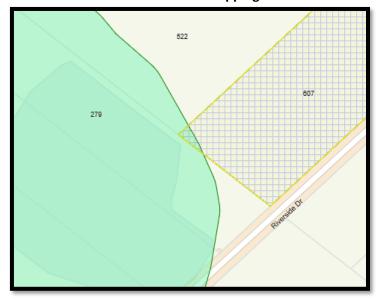
Plate 9: ESA Mapping

About half the site is mapped within an Environmentally Sensitive Area (ESA) (Plate 9). Therefore, the clearing of native vegetation in the ESA area will require a clearing permit.

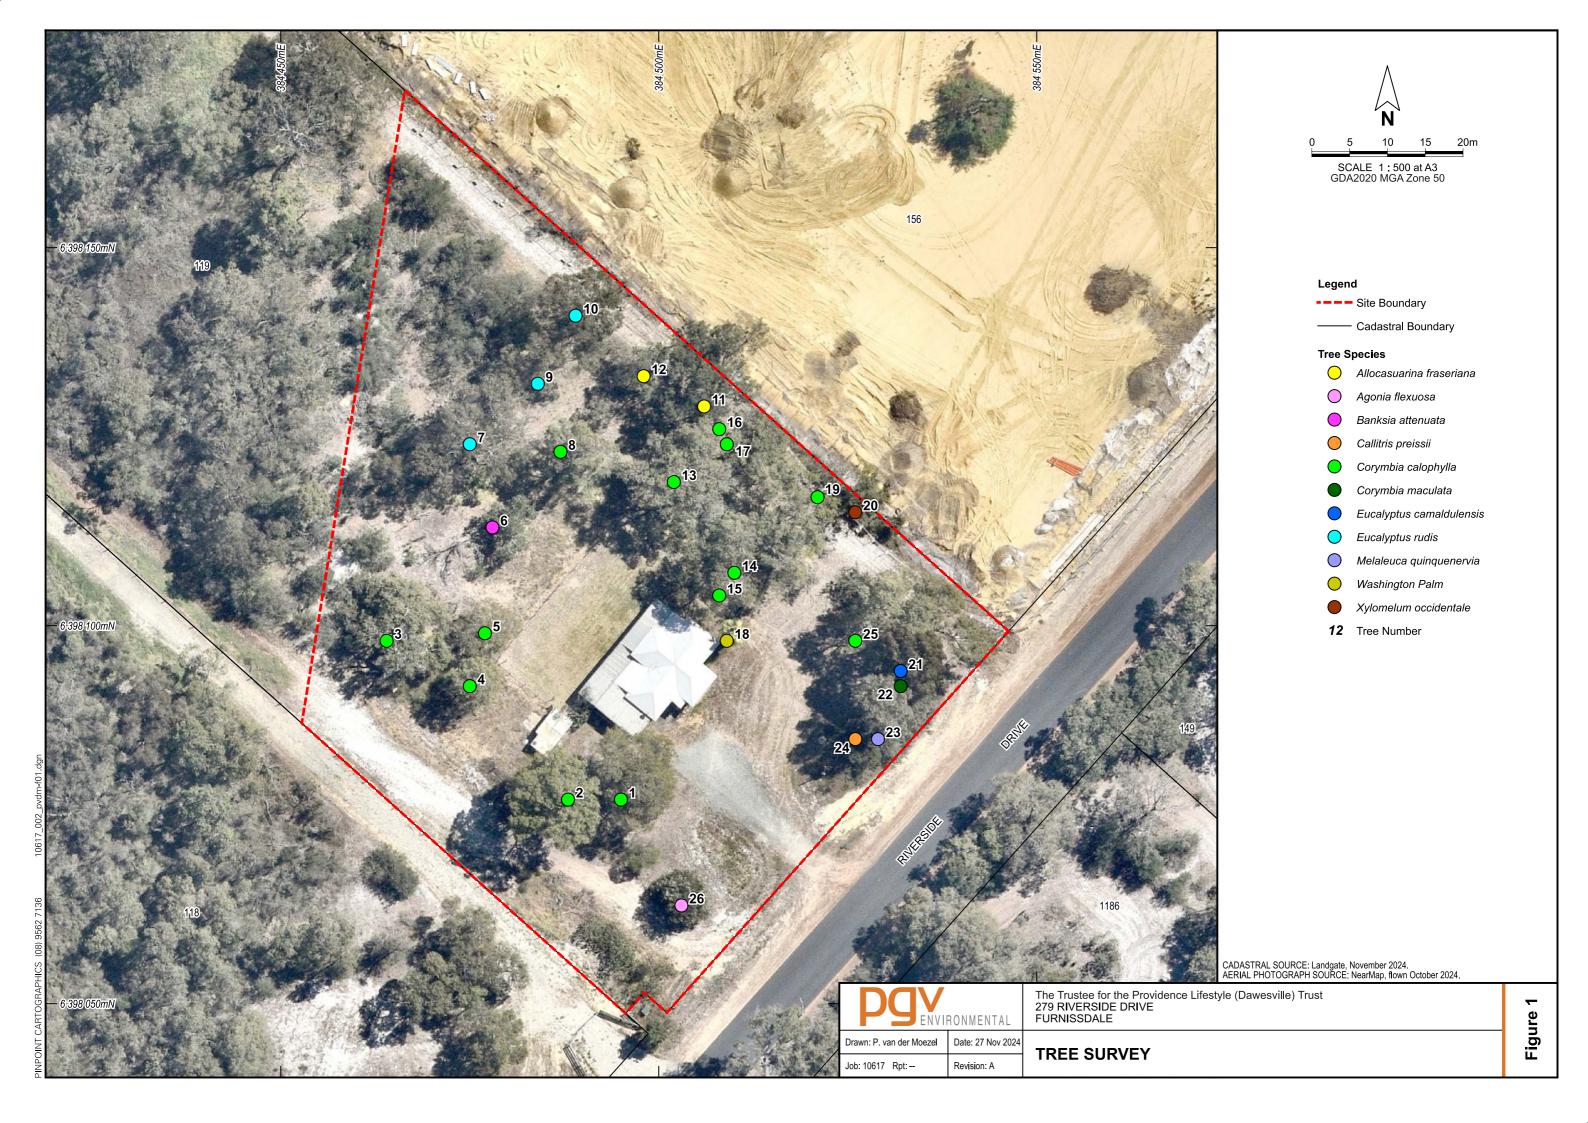
Attachment 1: Figure 1 Tree Locations

Twenty-six trees were recorded in the survey area (Attachments 1 and 3). The 26 trees included five locally native species and six non-local species. The five locally native species were:

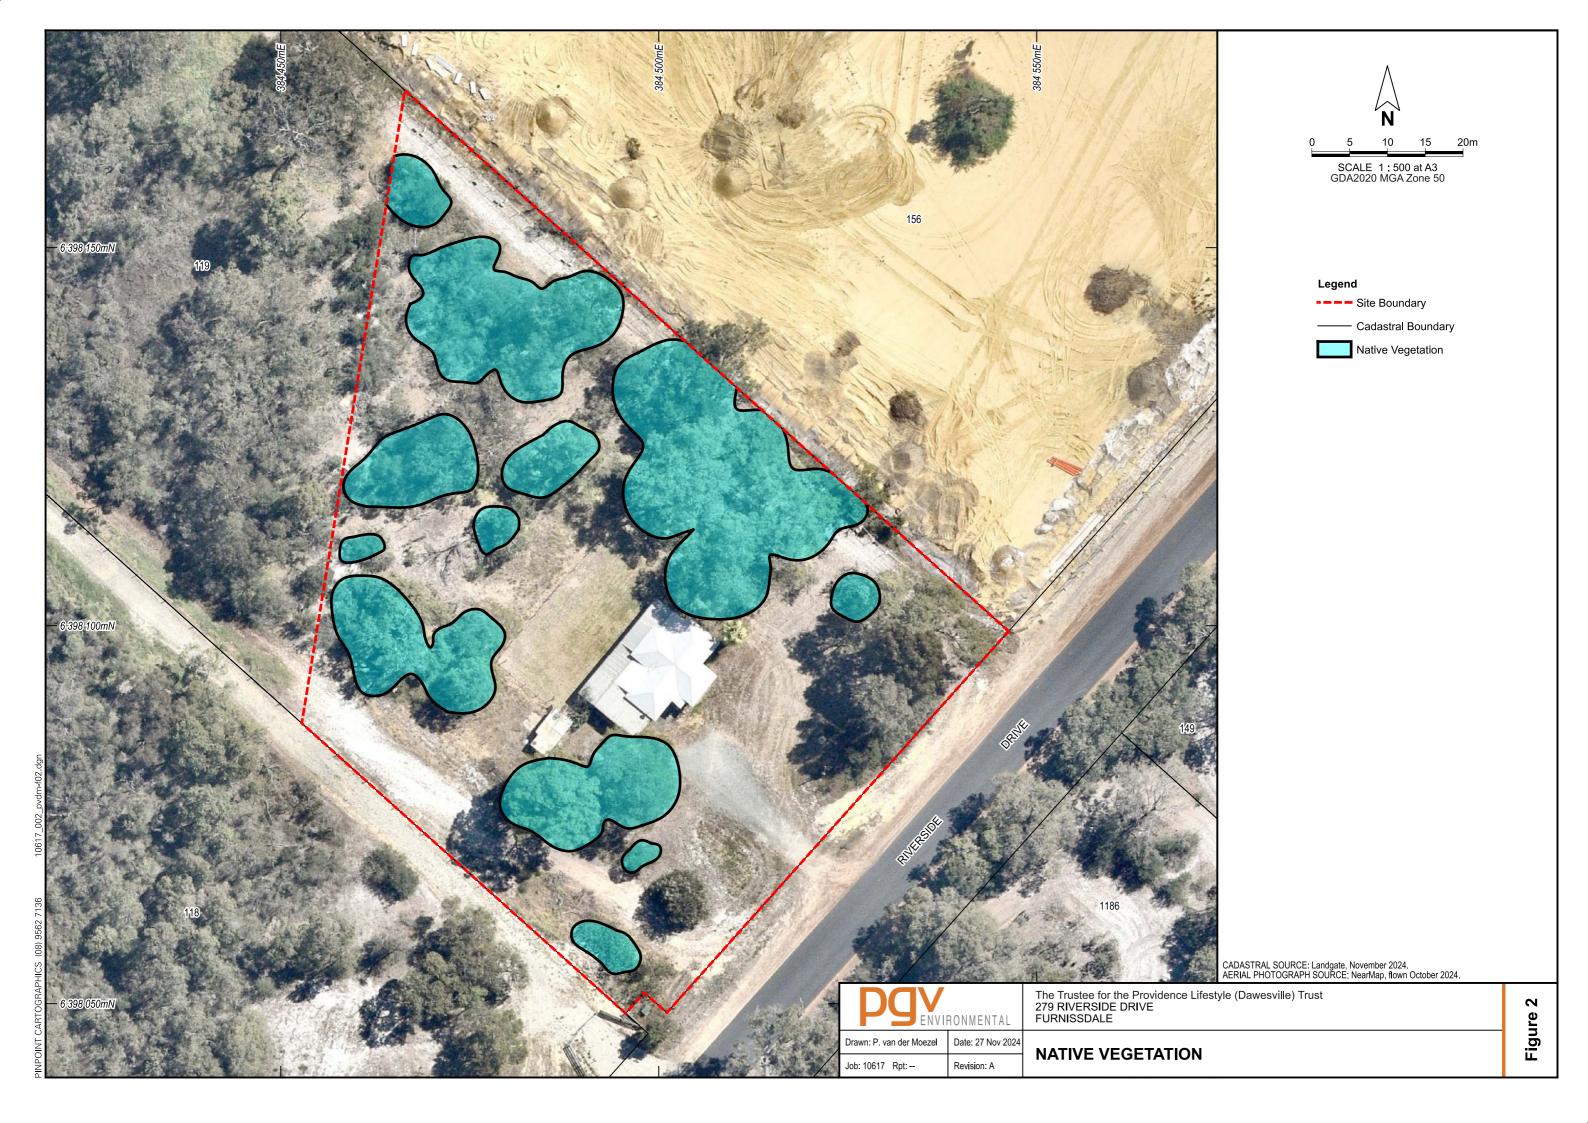
Attachment 2: Figure 2: Map of Native Vegetation

Figure 2 (Attachment 2) shows the location of native vegetation in the survey area. The amount of native vegetation (trees and shrubs) is 0.20ha
