# Clearing Referral

## Buller Road & Somers Road Reserve

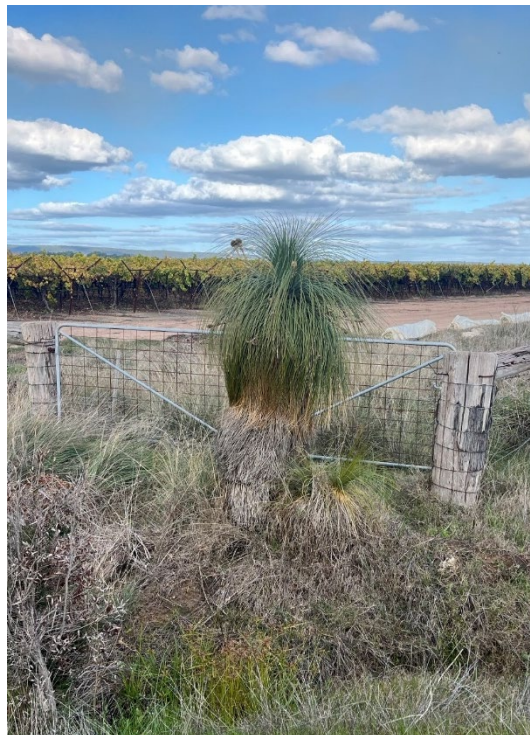
*Image: Kingias Australis on Buller Road*

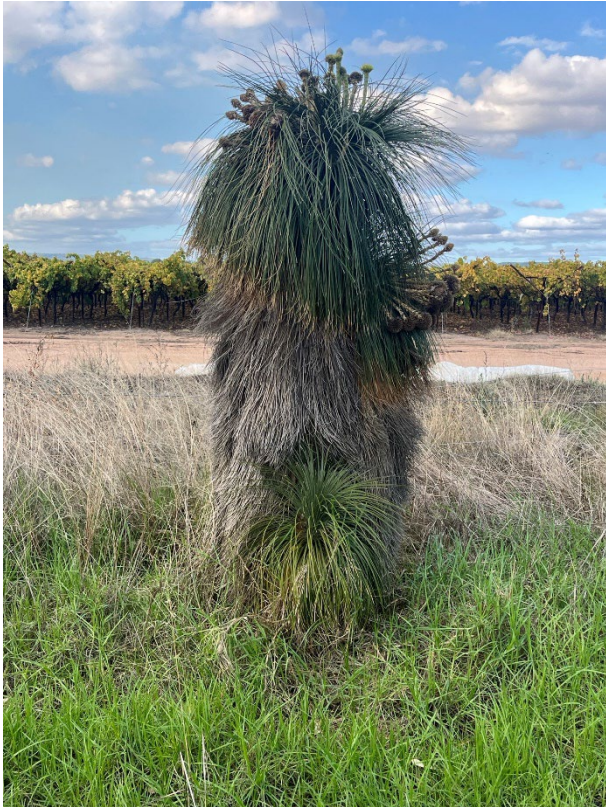
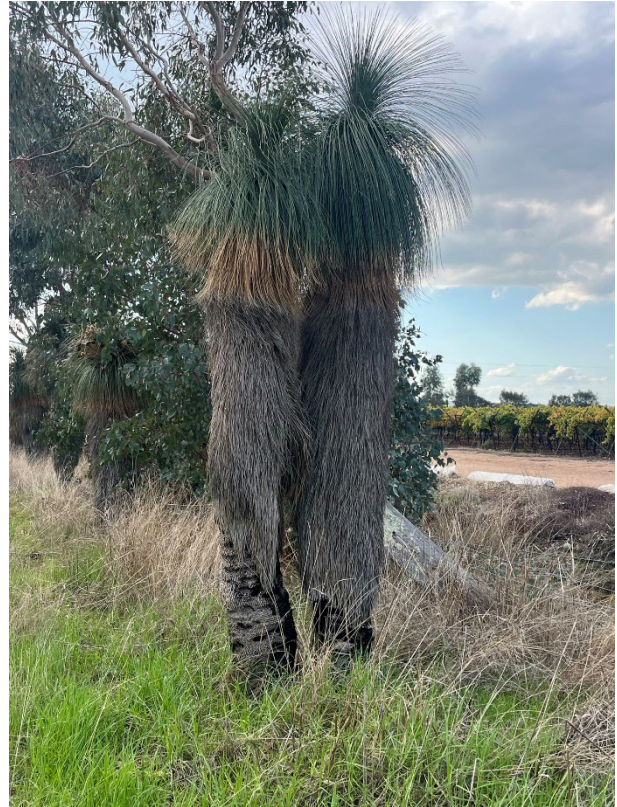
*Image: Kingias Australis on Somers Road*

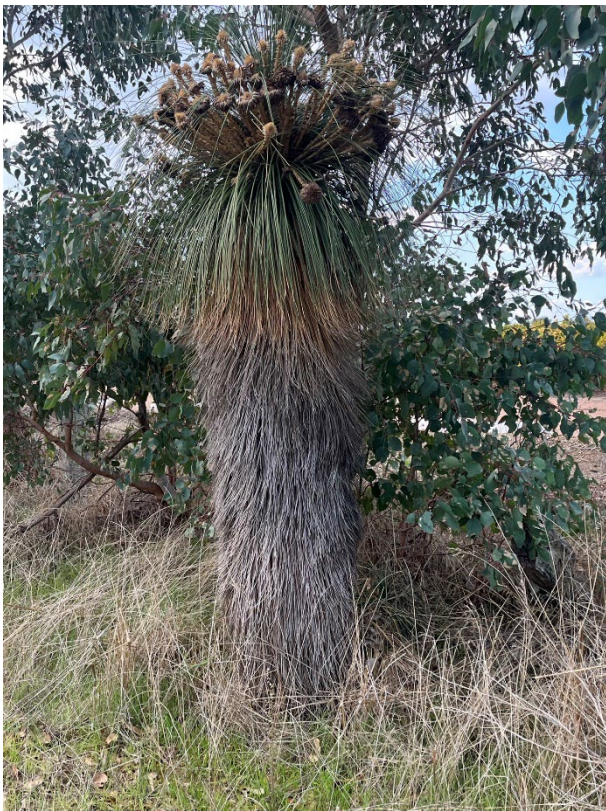
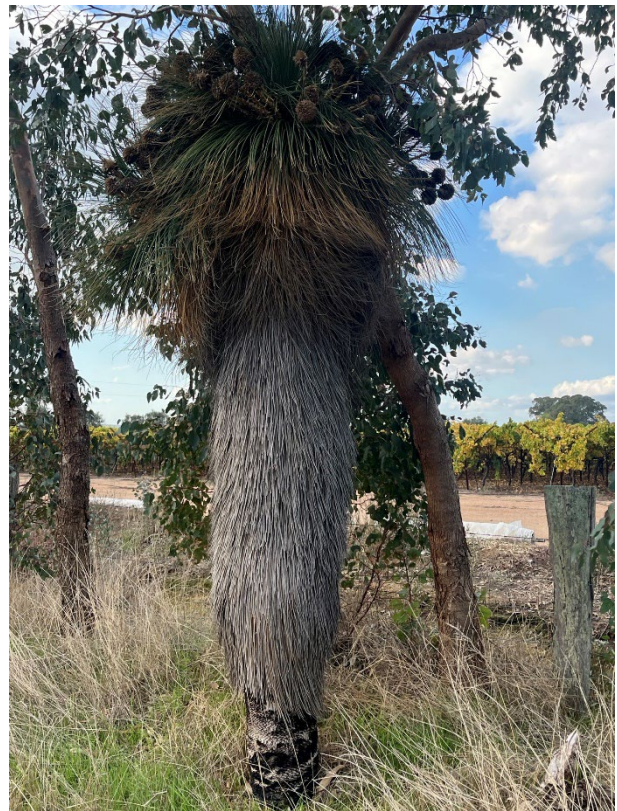
*Image: Kingias Australis on Somers Road*

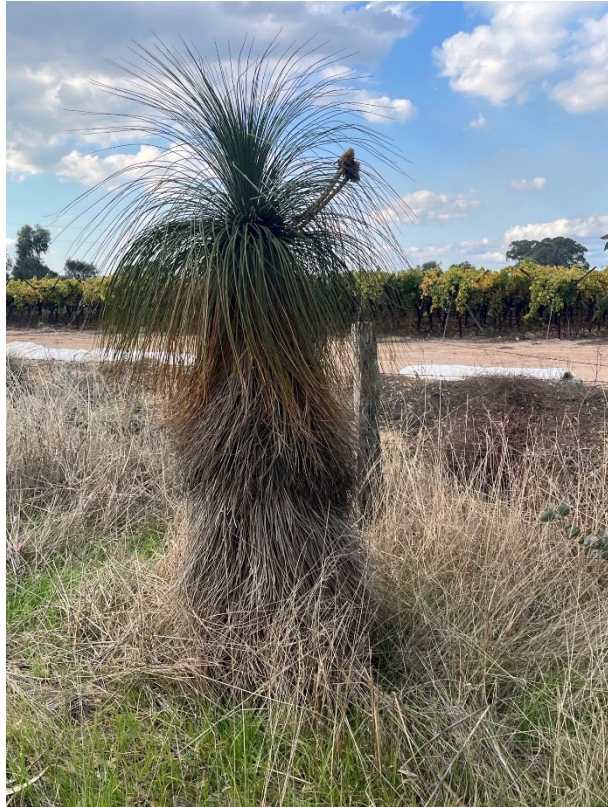
*Image: Kingia Australis on Buller Road*

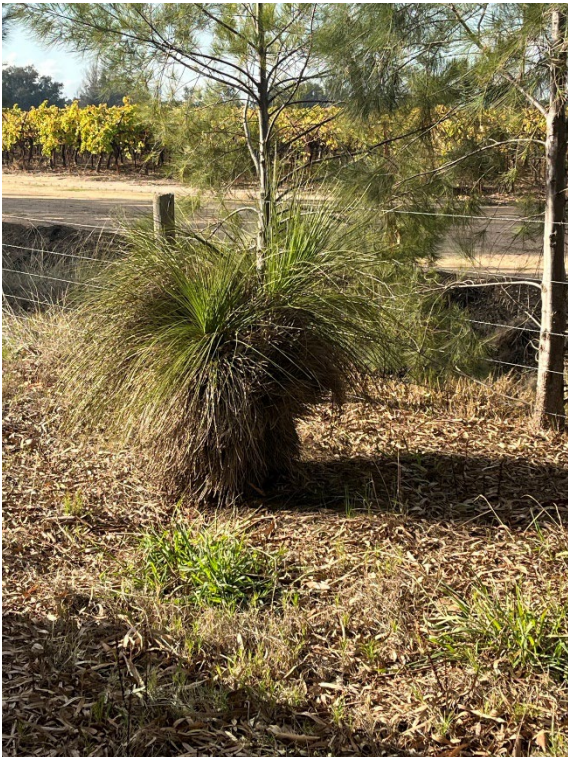
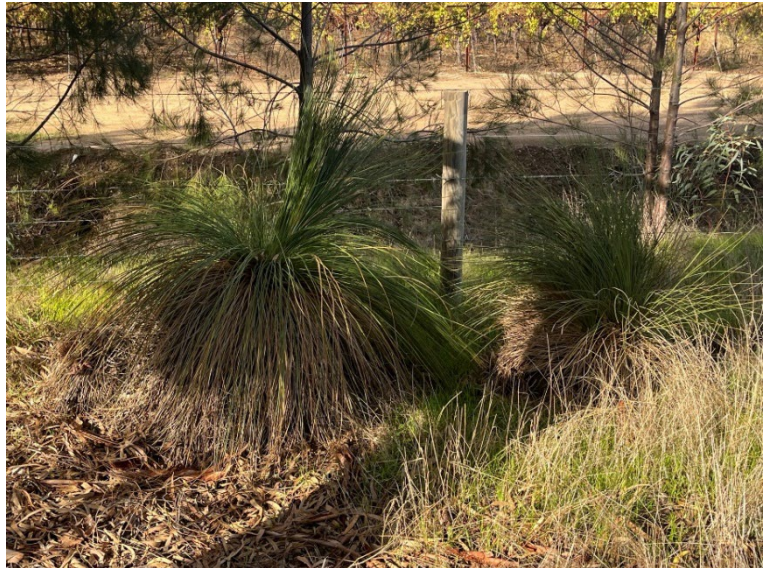
*Image: Xanthorrhoea Pressi on Somers Road*
