Arboricultural Survey – Elliot Road & Paltara Way, Wanneroo

Arboricultural Advice for the City of Wanneroo

Date inspected: 23rd March 2022

Project: Civil Works – Elliot Road & Paltara Way, Wanneroo

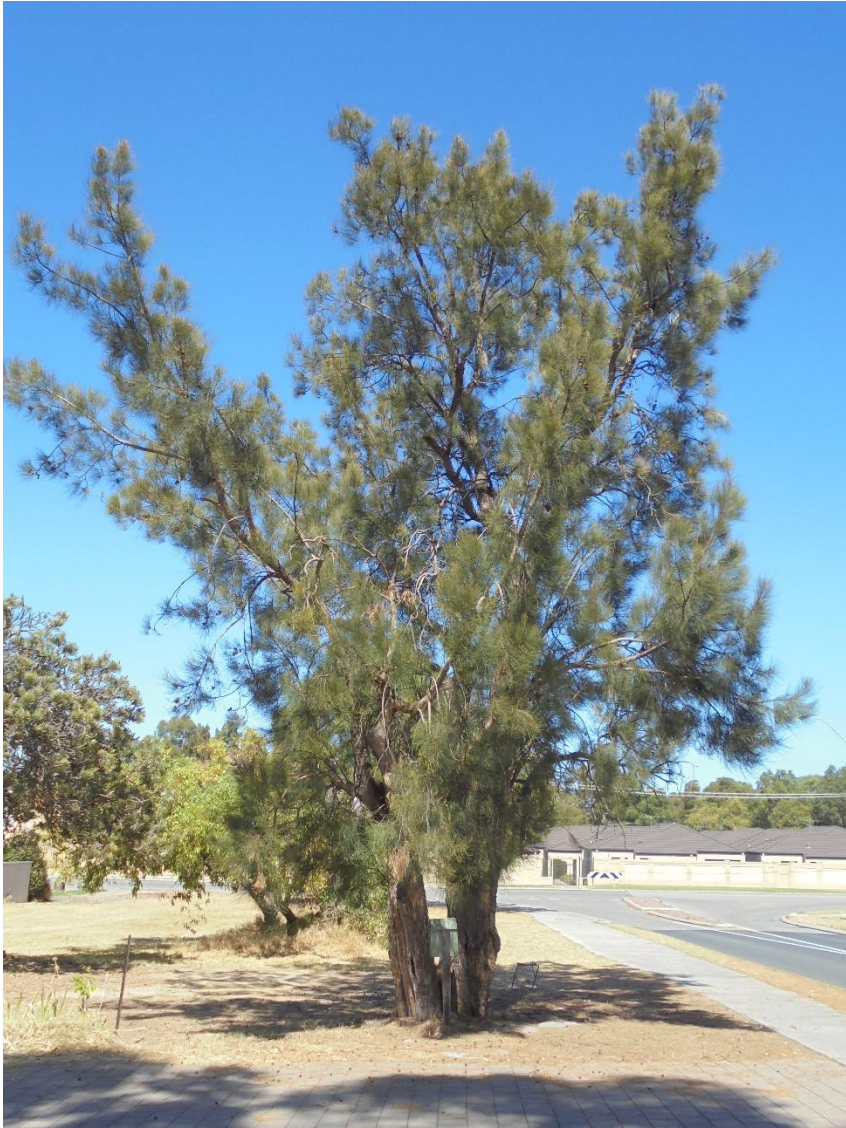
Tree 1

Tree no	Location	Species	Height (m)	Canopy Spread (m)	DBH (mm)	Health and structural condition	TPZ (m radius)	SRZ (m radius)	Comments & Recommendations
1	adjacent no. 83 Paltara Way	<i>Allocasuarina fraseriana</i>	11.6	10	900	Mature. Good health and fair structure. Displays a full canopy of healthy foliage and active extension growth and holds a small amount of minor dead wood. Fire damage and associated cavities evident at the base with prominent wound wood visible. Root plate firm. Surface roots not evident.	10.8	3.5	High retention value. 400mm depth of excavation required for road widening Excavation on western side only - recommended <u>minimum</u> clearance of 4m from the base of the tree
2	Cnr of Elliot Rd & Paltara Way	<i>Allocasuarina fraseriana</i>	8.6	8.5	720	Mature. Good health and fair structure. Displays a full canopy of healthy foliage and active extension growth supported by lower lateral limbs that have developed in response to the decline of the apical limb due to previous fire damage. No evidence of significant lower trunk or basal decay. No termite activity visible. Accumulated debris has raised level around the base. No surface roots visible. Low growth may require lifting.	8.6	3.1	Moderate retention value 400mm depth of excavation required for road widening (Paltara Way). Excavation on western side only - Recommended <u>minimum</u> clearance of 4m from the base of the tree. Excavation for Elliot Road appears outside of TPZ radius of this tree.

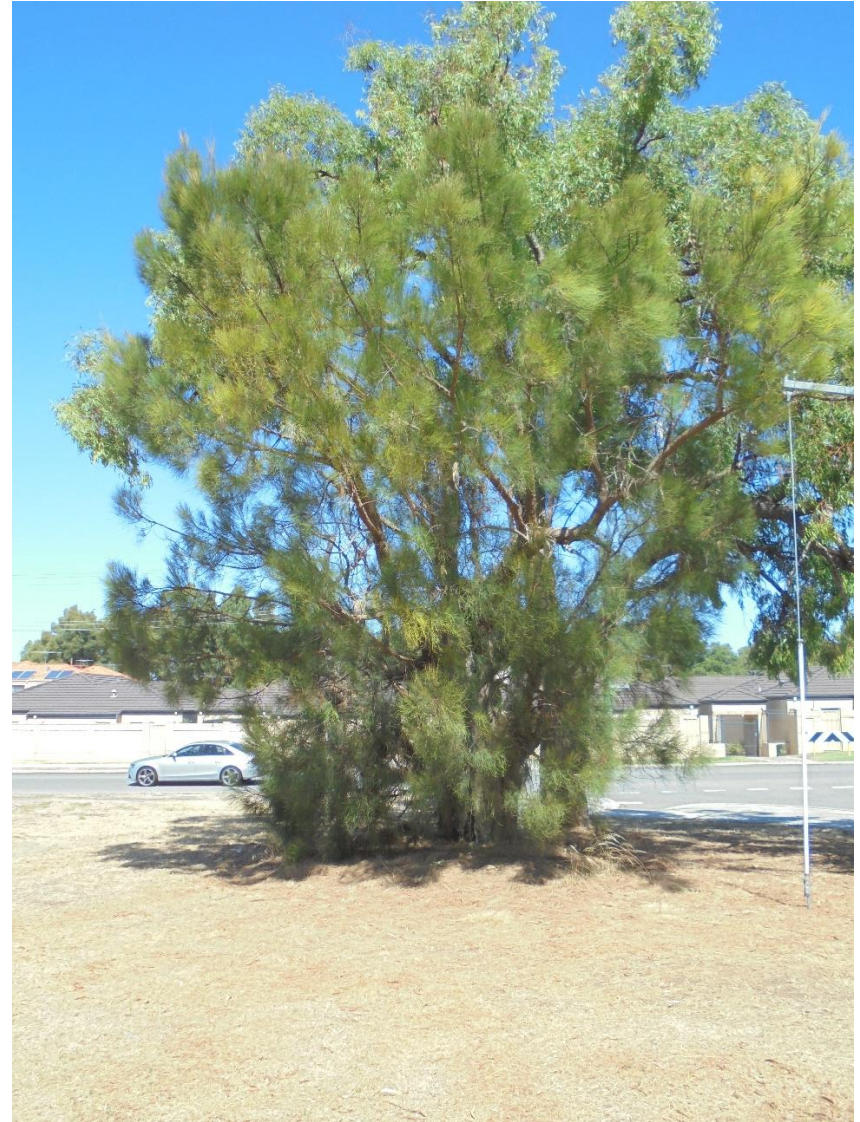
- The three *Allocasuarina fraseriana* (Western Sheoak) are remnants of the previous woodland of the locality and as a species are of a high retention value, however the structural form and condition of Tree 2 renders it to be of lesser retention value, while Tree 5 is located approximately 4.3m from the existing Elliot Rd roadway and is very unlikely able to be retained in a stable and viable condition. The retention Tree 1 (adjacent 83 Paltara Way) appears able to be achieved and protection and management of this tree through the course of the project is recommended.

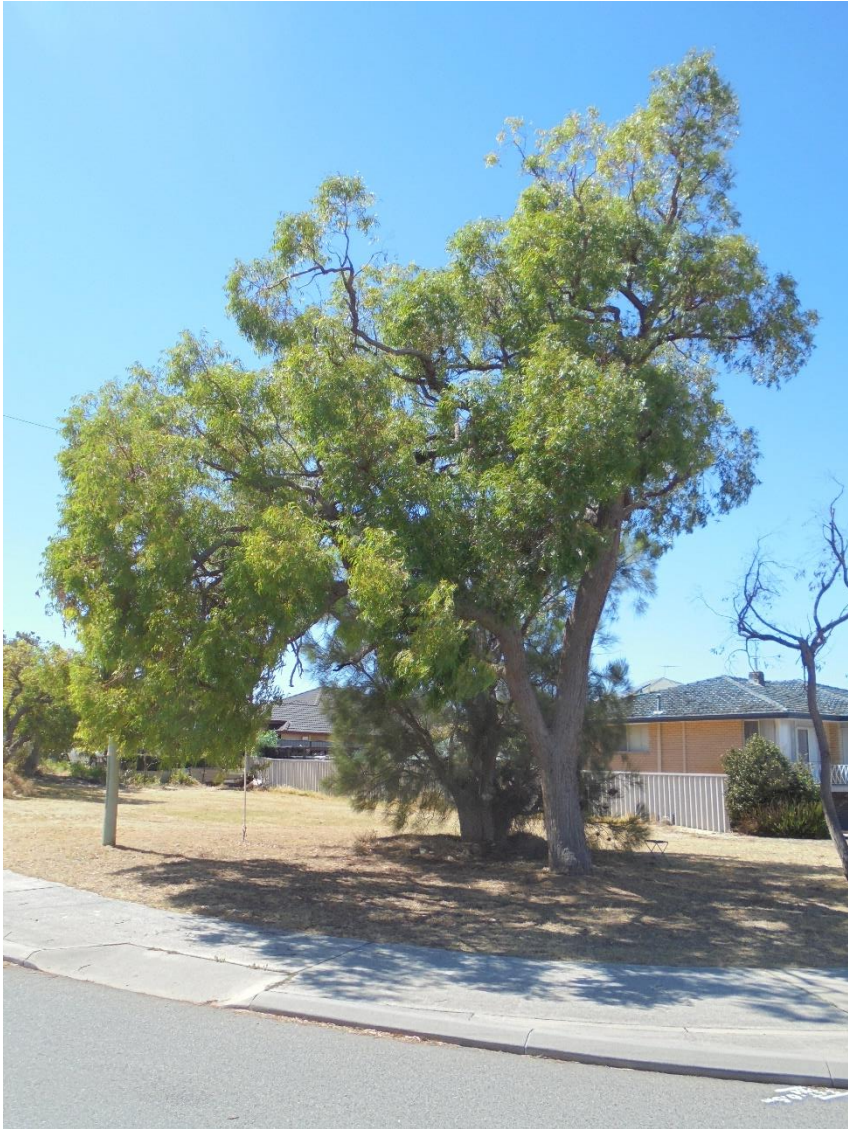
Tree 3

Tree no	Location	Species	Height (m)	Canopy Spread (m)	DBH (mm)	Health and structural condition	TPZ (m radius)	SRZ (m radius)	Comments & Recommendations
3	Cnr of Elliot Rd & Paltara Way	<i>Eucalyptus marginata</i>	14.7	13	620	Mature. Good health and structure. Full canopy of healthy foliage with some evidence of previous minor canopy dieback. Sporadic, predominantly minor deadwood. No evidence of fungal decay or termites. Root plate firm. Some lifting of the root crown within 1m of the base. No surface roots evident. Low growth may require lifting.	7.4	2.9	High retention value. 500mm depth of excavation assumed due to proximity to corner. Excavation on western and southern sides required - Recommended <u>minimum</u> clearance of 4m from the base of the tree western side. Recommended <u>minimum</u> clearance of 5m from the base of the tree southern side. Canopy lift likely to be required if tree is retained.

- The *Eucalyptus marginata* (Jarrah) – (Tree 3) is also a species endemic to the locality and this tree was found to be in good health and condition and should be retained if at all possible. It is therefore recommended that design and construction options that may mitigate the risk of root and canopy damage to this tree are fully considered prior to a decision to remove the tree being made.

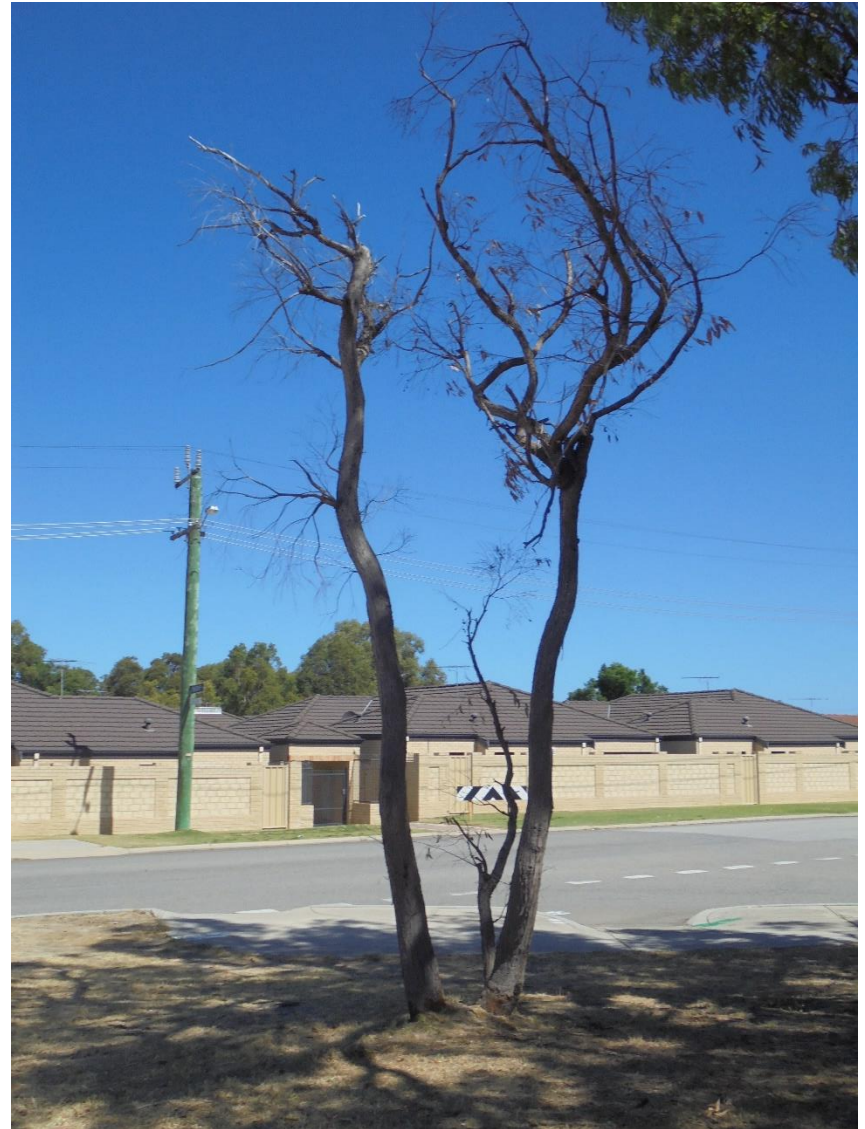
Tree 4

4	Cnr of Elliot Rd & Paltara Way	<i>Eucalyptus marginata</i>	6	na	300	Tree is dead	3.6	2.0	Removal recommended.
5	Opp. 68/70 Elliot Rd	<i>Allocasuarina fraseriana</i>	11.7	9	630	Mature. Good health and fair structure with a full canopy of healthy foliage and active extension growth evident. Upright form and previous limb failure the northern side over path evident. Lower southern limb supporting the crown forms an included fork. No evidence of fungal decay or termites. Root plate firm. No surface roots visible.	7.6	2.8	High retention value. 500mm depth of excavation required Recommended <u>minimum</u> clearance of 4.0m from the base of the tree southern side.

- Two of the seven trees inspected were identified as deceased *Eucalyptus marginata* (Jarrah), with the smaller tree (Tree 4) appearing to have died recently, and both were recommended to be removed.

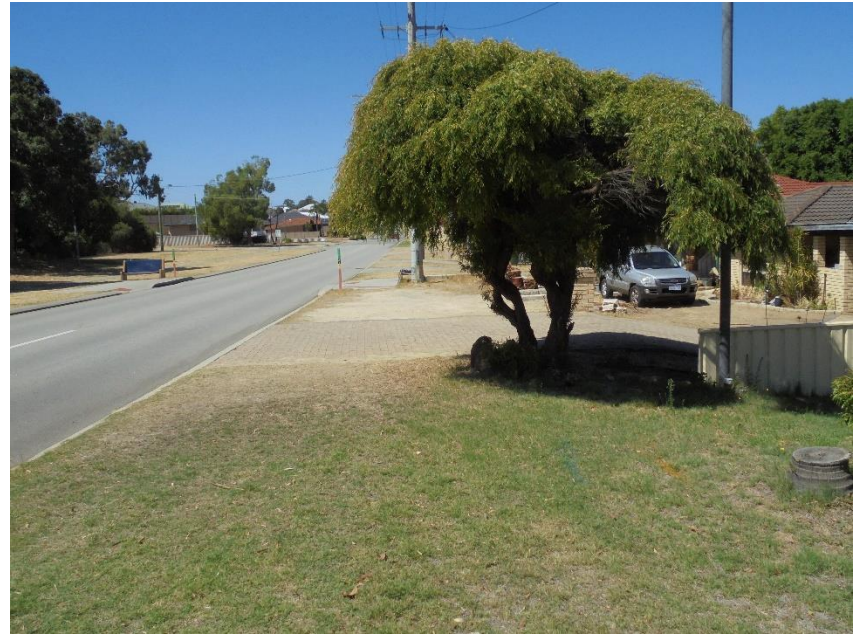
Tree 6

Tree no	Location	Species	Height (m)	Canopy Spread (m)	DBH (mm)	Health and structural condition	TPZ (m radius)	SRZ (m radius)	Comments & Recommendations
6	Adj. 70 Elliot Rd	<i>Agonis flexuosa nana</i>	3.7	5.2	340	Mature, dwarf form of the species. Good health and structure with a dense cover of healthy foliage supported by multiple leaders. Root plate firm.	3.4	2.0	Moderate retention value. 100mm depth of excavation for pedestrian path. Recommended <u>minimum</u> clearance of 1.5m from the base of the tree northern side.
7	Opp. 96 Greenfields Ct	<i>Eucalyptus marginata</i>	10.7	na	1070	Dead tree displays evidence of termite damage and black ants active within outer wood layers. Crown structure previously pruned to lower sections of scaffold limbs. Appears root firm at this time.	12.8	3.7	Removal recommended.
