Benthic Communities and Habitat Assessment

MWPA Tourist Jetty

CLIENT: Mid West Ports Authority

REPORT NUMBER: 21WAU-0074 / R210417

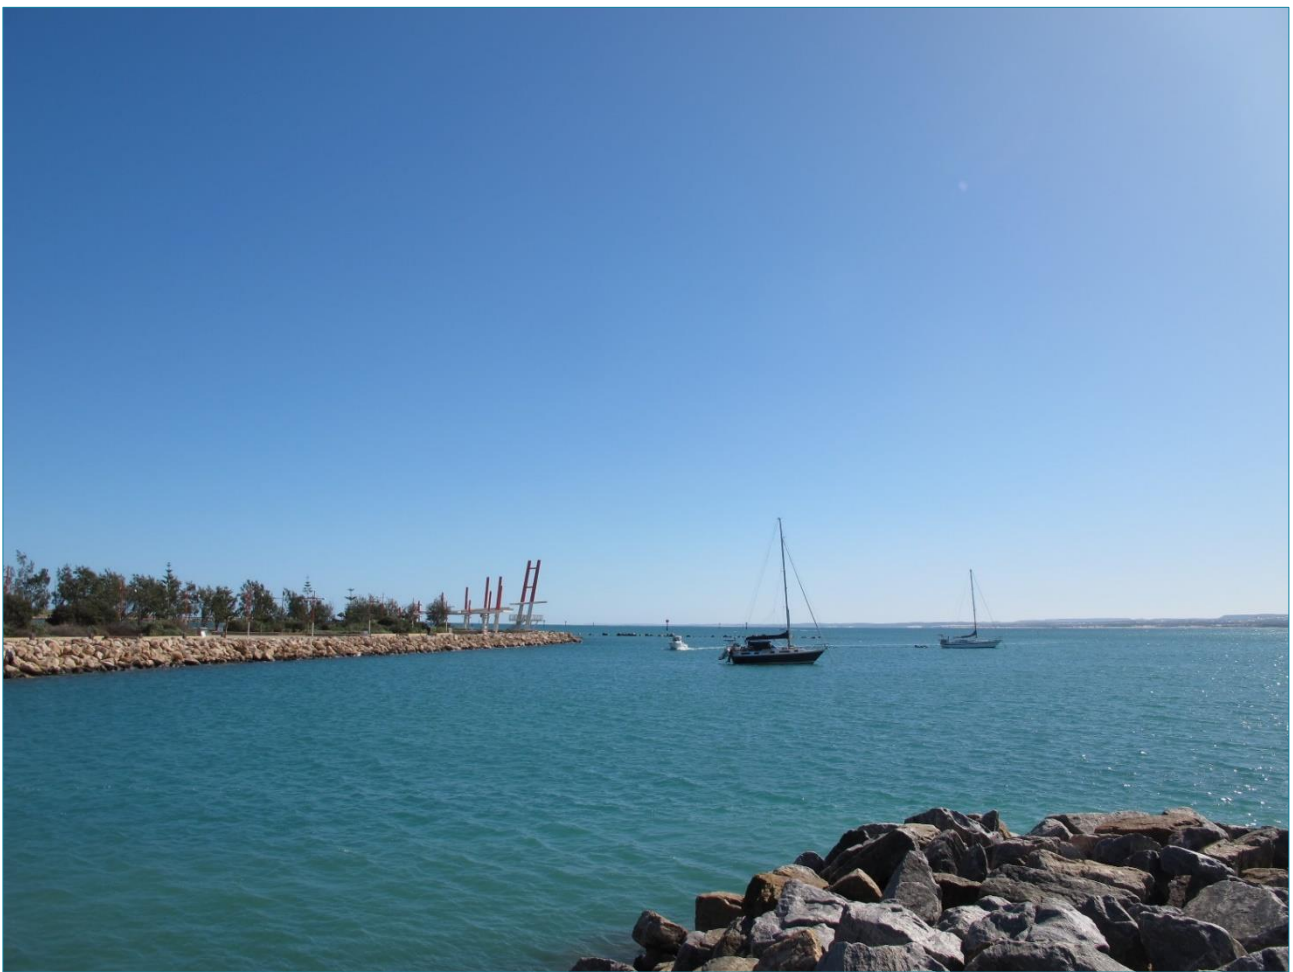
Figure 2: Project area location.

The Project area was approximately 17.8 Ha in size, with northern extent boundaries approximately 0.5 km from the southern shore (**Figure 1**). The area is subject to <1.2 m tidal range, which is diurnal in nature, therefore experiencing one high and low tide per day. The site is situated within the small embayment adjacent to the EBW in the Indian Ocean (**Figure 2**). The project area is bordered on the West by Geraldton Port and Fishing Boat Harbour. The survey methodology was designed to incorporate the recommendations contained within the Technical Guidance – Protection of Benthic Communities and Habitats (EPA, 2016).

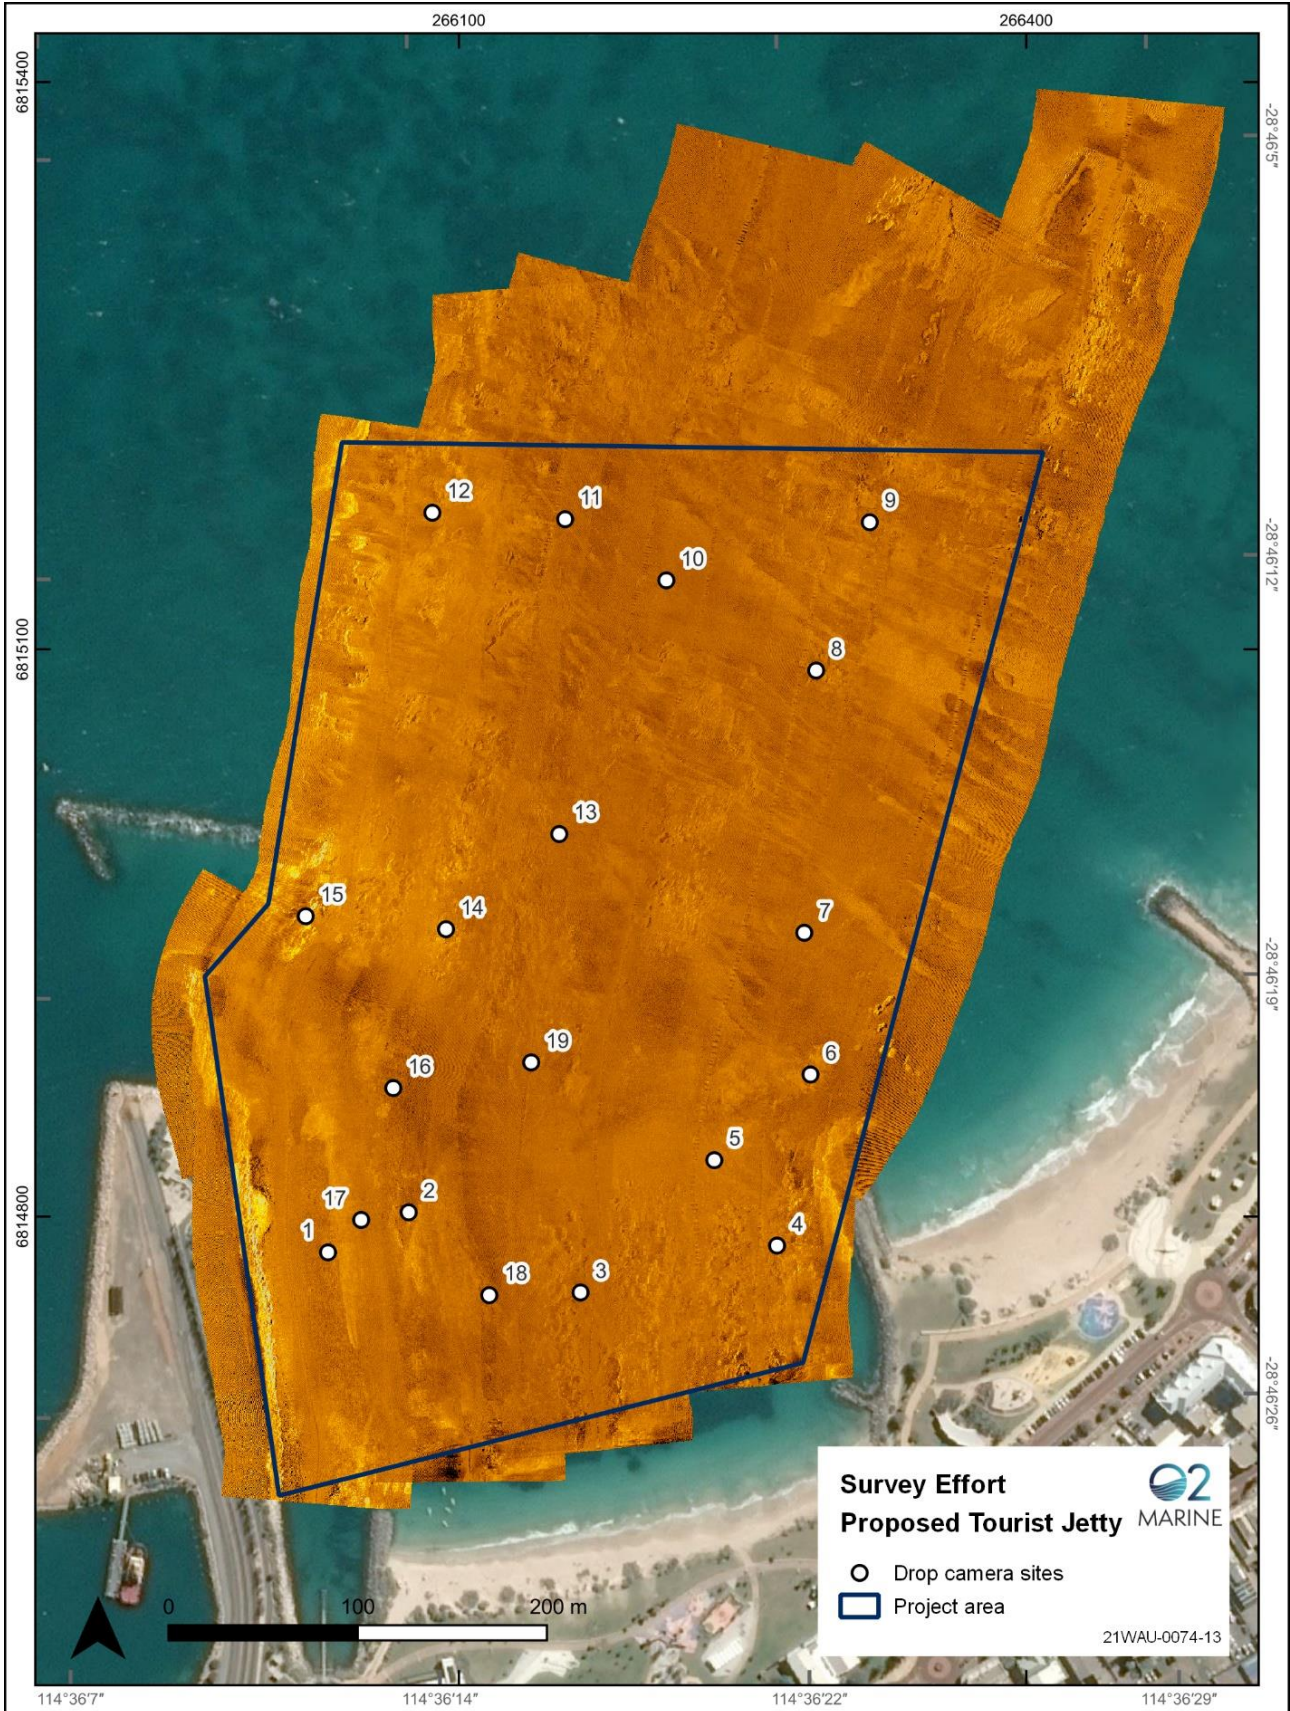
Figure 3: Benthic communities and habitat survey effort and project area.

The BCH project area and habitat survey effort is presented in **Figure 3**. Field survey activities were completed by qualified and experienced marine scientists using Side Scan Sonar (SSS) to determine the boundaries of seabed features and drop camera deployments using a Remotely Operated Vehicle (ROV) to provide ground

truth data. The survey was conducted over two separate field days, to provide time for sonar data processing and selection of targeted drop camera sites. A summary of the survey effort is presented in **Table 1**.

Overlapping, 100% coverage SSS data was collected over an area of approximately 17.8 Ha (**Figure 3**). Data could not be acquired in water less than approximately 0.5 m deep, resulting in minor survey gaps and some spatial distortion along the shoreline and along the beach to the south of the survey area. Overall, the data quality was excellent due to the relatively calm inshore conditions. Positional errors in the SSS mosaic are observed with a combined positional error of approximately +/- 5 m. Some interference in the SSS data was noticed possibly due to nearby vessels working sonar systems in the area.

Nineteen underwater video drops were completed in total at each location presented in **Figure 3**. As conditions were relatively good, adequate seabed imagery was obtained for each location surveyed. A summary of the BCH observed at each location is presented in **Table 3** and photo stills and a description presenting an example of each BCH type identified within the survey area in **Table 4**.

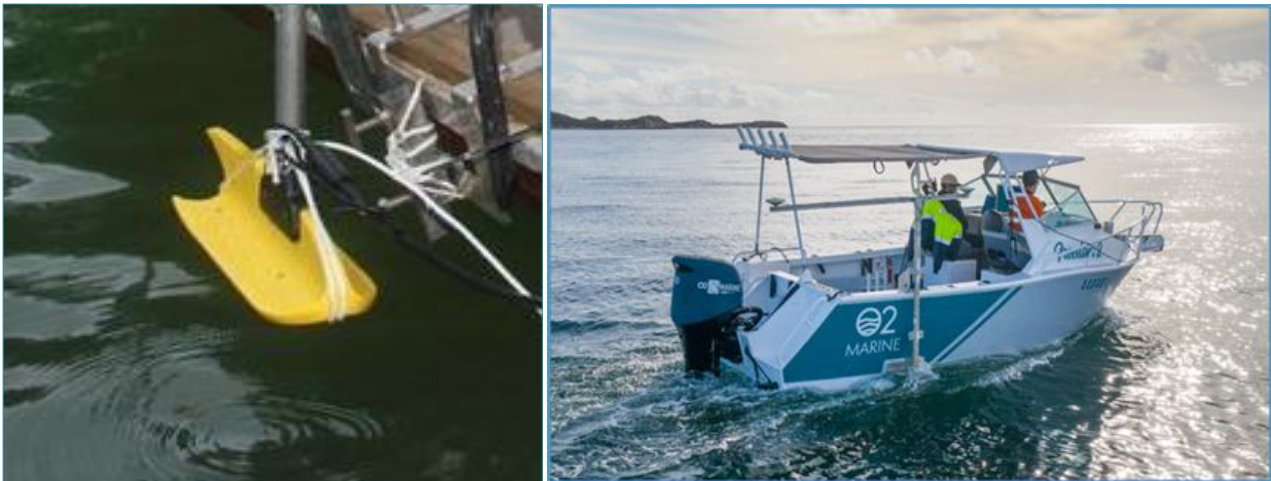
Figure 4: Example pole mounted Starfish Sidescan Sonar, Freedom II vessel undertaking survey.

The survey utilised a portable dual channel 450 kHz SSS system (Tritech Starfish 452F, **Figure 4**) that was operated via a topside control unit and proprietary acquisition software Scanline V2.1. Data was recorded as raw data files (.logdoc).

A standard Universal Serial Bus (USB) Global Positional System (GPS) antenna (<2 m accuracy) was used to provide geographic positioning of the system in real time. This was mounted on the roof of the survey vessel and offsets to the SSS measured to centimetric accuracy.

SSS data acquisition was conducted from the survey vessel using transects completed at a speed of approximately 3 knots and maintained at a height of between 1-5 m above the seabed. The SSS depth was varied live based on the data feed displayed on the topside control unit. Survey transects were designed to cover maximum coverage within the survey area to provide greater ability to accurately map the BCH. As excessive vessel movement can introduce noise in the SSS data, local conditions such as strong currents, adverse meteorological conditions and geomorphology were assessed at the beginning of each transect to minimise vessel movement and to collect the best quality data. In addition, local swell surge can generate noise through sediment suspension above the seafloor and through movement of detached wrack, both of which was noticed on SSS transects and visually observed at some locations of ROV video footage across both surveys. SSS recorded data using a swath width of ~ 50 m in shallow waters over an average depth of 9 m. Real-time observations of the side scan sonar were used to identify key seabed features

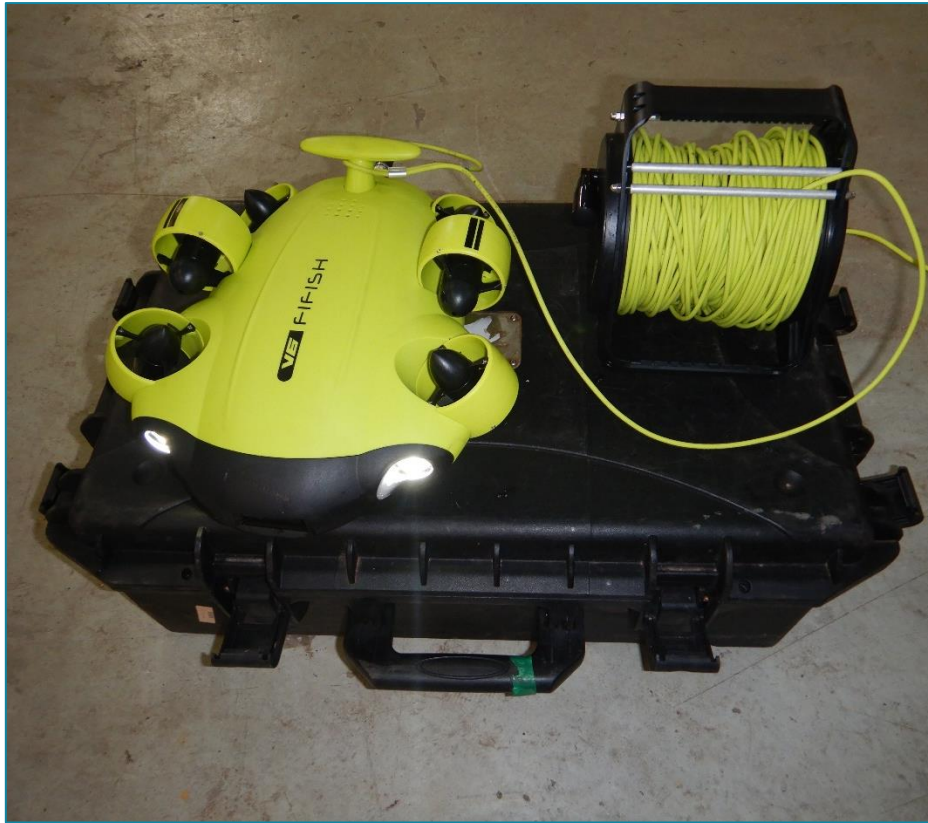
Figure 5: QYSEA Fifish HD ROV

Targeted ground-truth benthic videos were executed to assess areas of interest based on the combined bathymetric and SSS survey results. The QYSEA FiFish V6 Remotely Operated Video (ROV) (**Figure 5**) was deployed at each site to record high resolution video footage.

At each site, the ROV was positioned laterally (i.e. camera view directly down) approximately 2-3 m from the seafloor and a haphazard transect was recorded based upon the surge vector. Approximately 30-40 seconds of footage was analysed visually in the field via the topside control viewfinder, enabling approximately 20 m of seafloor imagery to be captured per transect

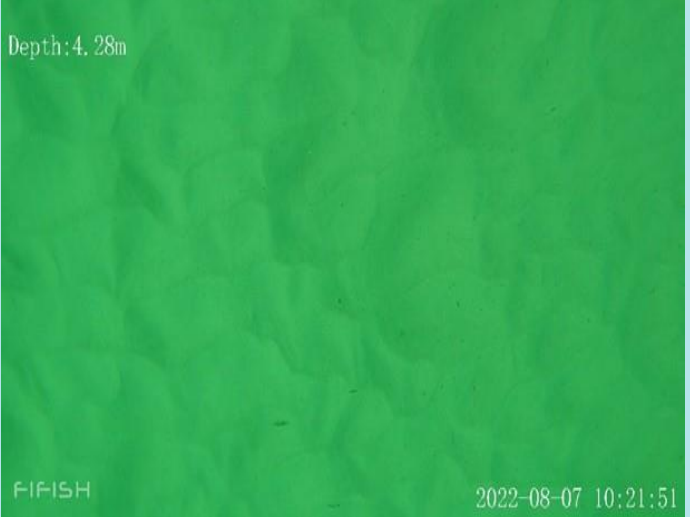
<p>Bare sand with ripples (Site DC9)</p>	<p>Relatively well compacted sediments comprising fine sands. No shell fragments. Sand ripples present.</p>

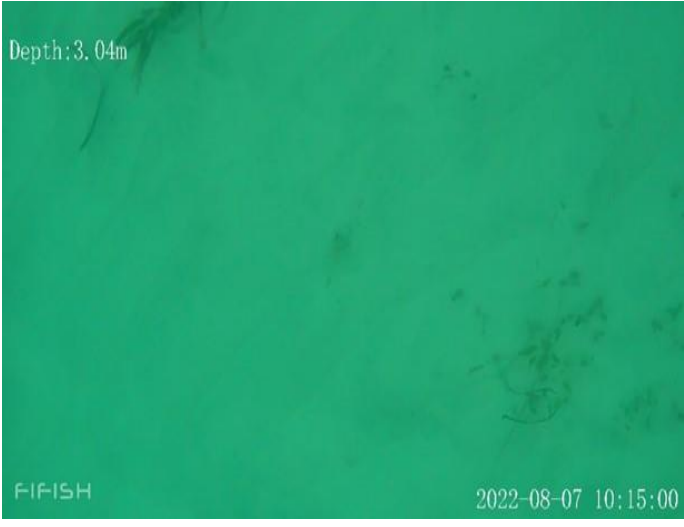
Benthic Community	Description	Example Image
<p>Flat sand with sparse seagrass (Site DC6)</p>	<p>Relatively well compacted sediments comprising fine sands with ripples present. Presence of <i>Halophila</i> spp. and <i>Posidonia sinuosa</i></p>

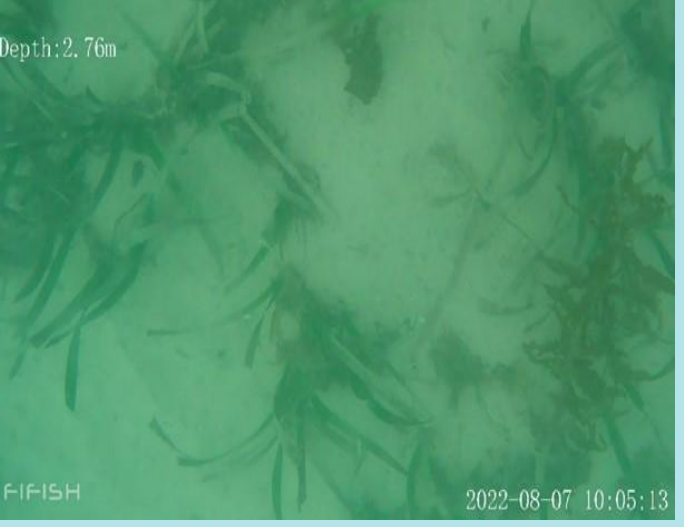
<p>Flat sand with low seagrass (Site DC6)</p>	<p>Relatively well compacted sediments comprising fine sands with ripples present. Presence of <i>Posidonia sinuosa</i></p>

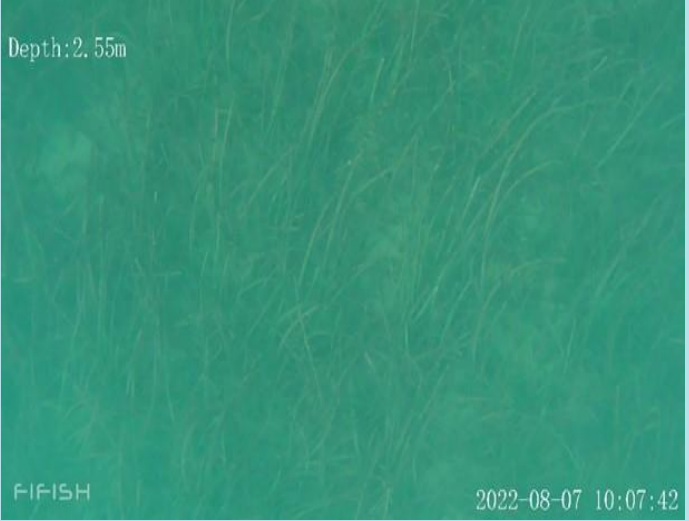
Benthic Community	Description	Example Image
Flat sand with high seagrass (Site DC3)	Relatively well compacted sediments comprising fine sands with ripples present. Presence of <i>Posidonia sinuosa</i>
