Benthic Communities and Habitat Cumulative Loss Assessment

MWPA Tourist Jetty

CLIENT: Mid West Ports Authority

REPORT NUMBER: 21WAU-0074 / R220003

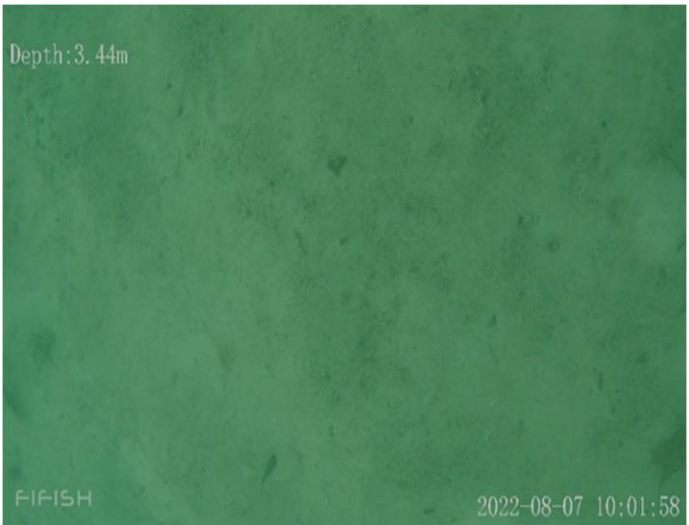
Benthic Community	Description	Example Image
Flat bare sand (Site DC1)	Compacted sediment comprising fine sands. No shell debris or algae/seagrass wrack present.

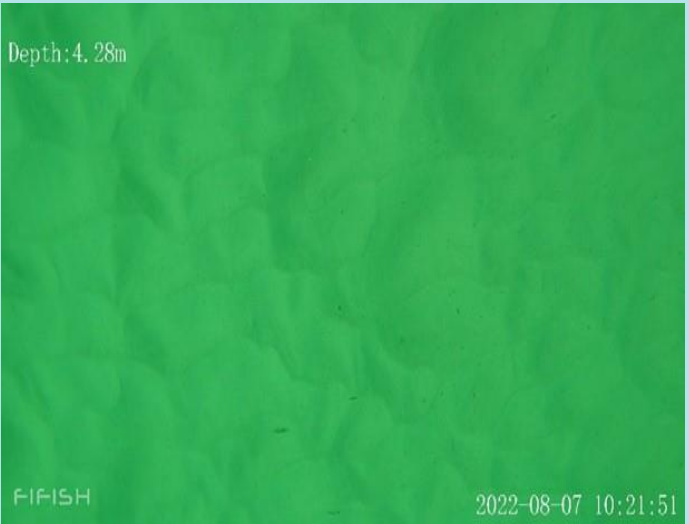
Bare sand with ripples (Site DC9)	Relatively well compacted sediments comprising fine sands. No shell fragments. Sand ripples present.

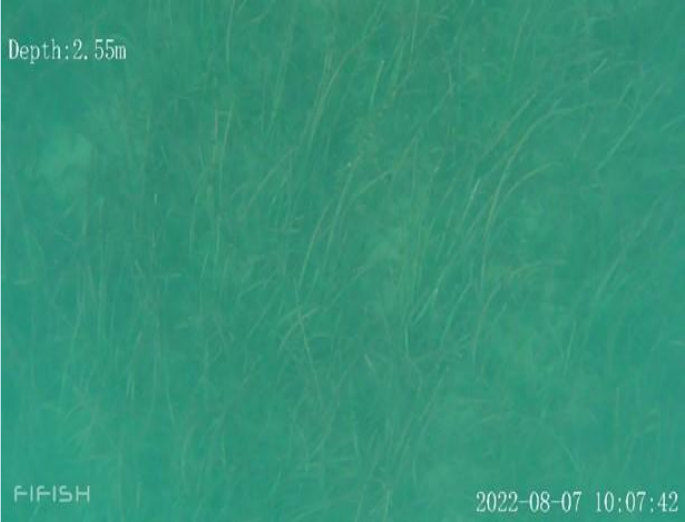
Benthic Community	Description	Example Image
Flat sand with high seagrass (Site DC3)	Relatively well compacted sediments comprising fine sands with ripples present. Presence of <i>Posidonia australis</i>
