CLEARING PERMIT

Purpose Permit number:	CPS 10011/1
Permit Holder:	Mid West Port Authority
Duration of Permit:	From 19 August 2023 to 19 August 2028

Clearing Permit Decision Report

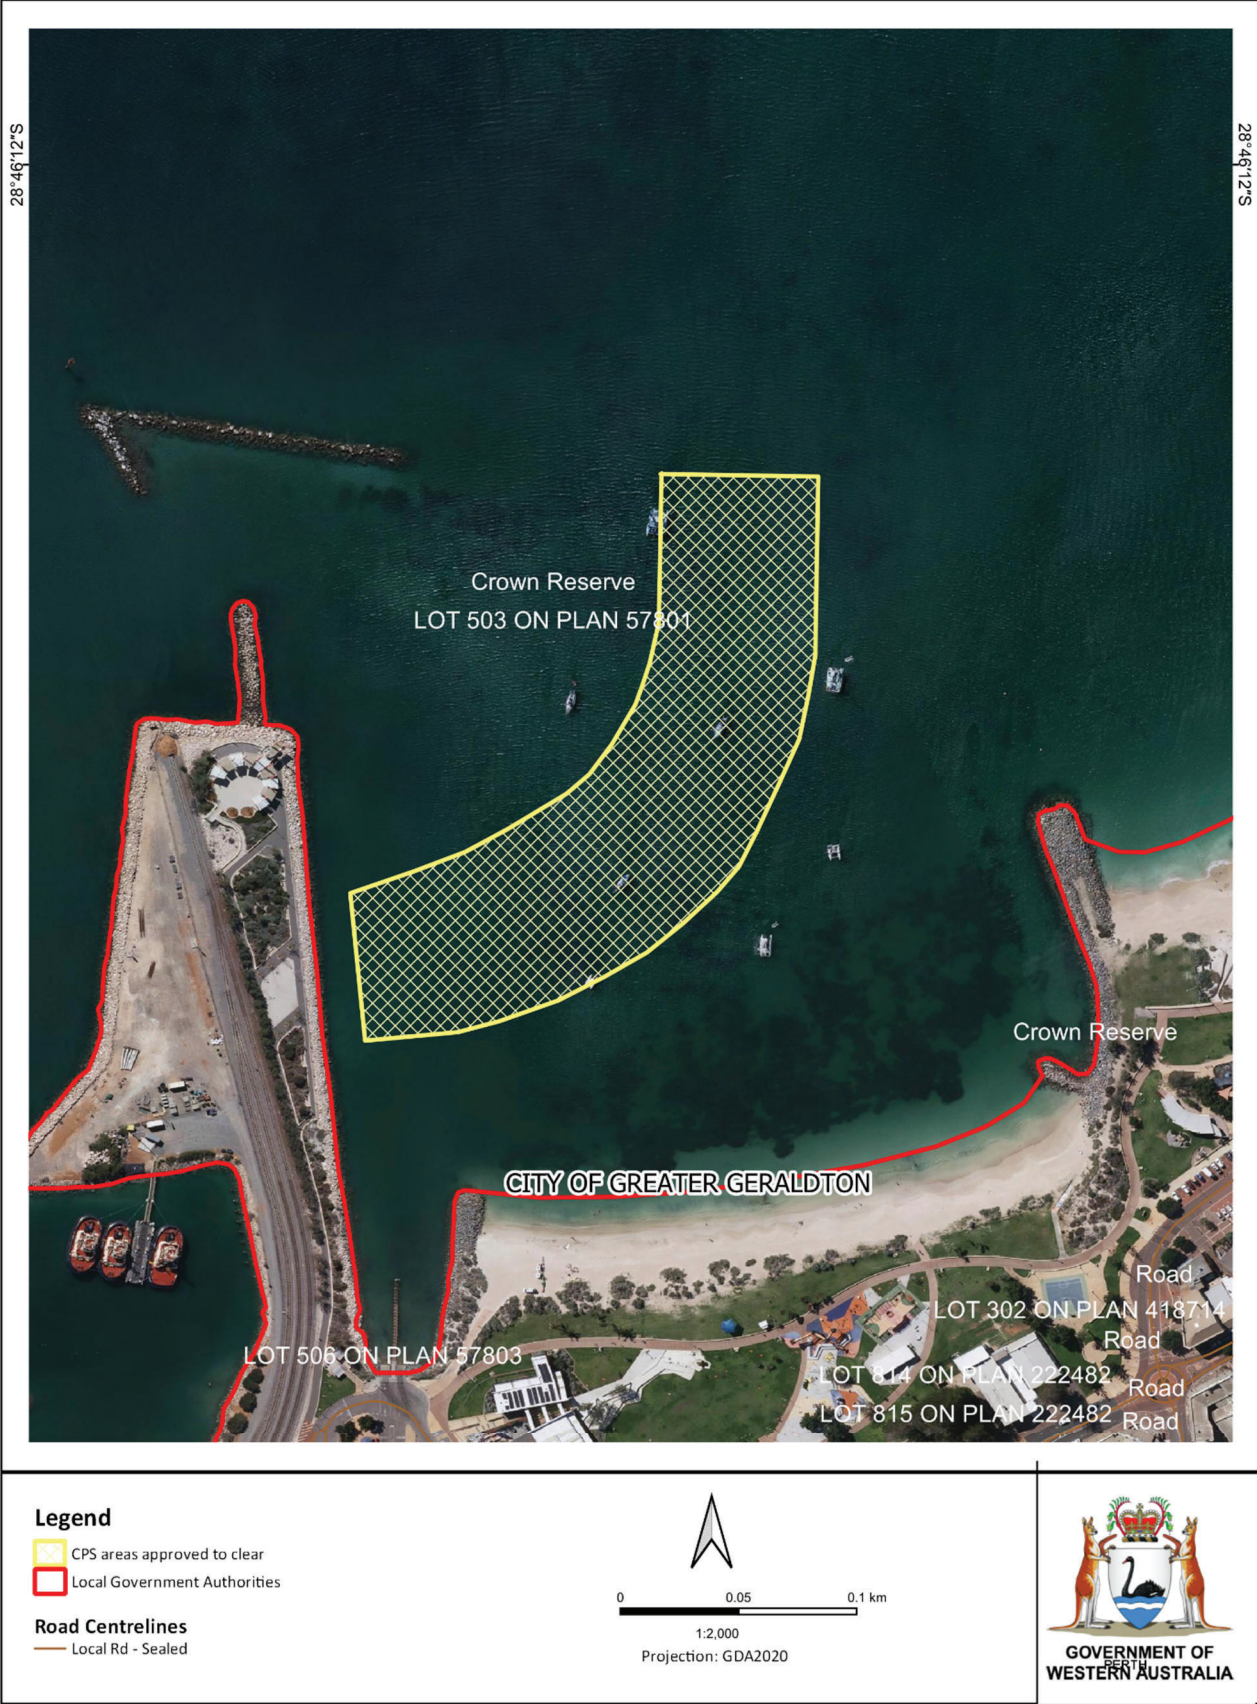
The boundary of the area authorised to be cleared is shown in the map below (Figure 1).

Figure 1: Map of the boundary of the area within which clearing may occur.

The permit holder must not clear more than 0.62 hectares of *native vegetation* within the area cross-hatched yellow in Figure 1 of Schedule 1.

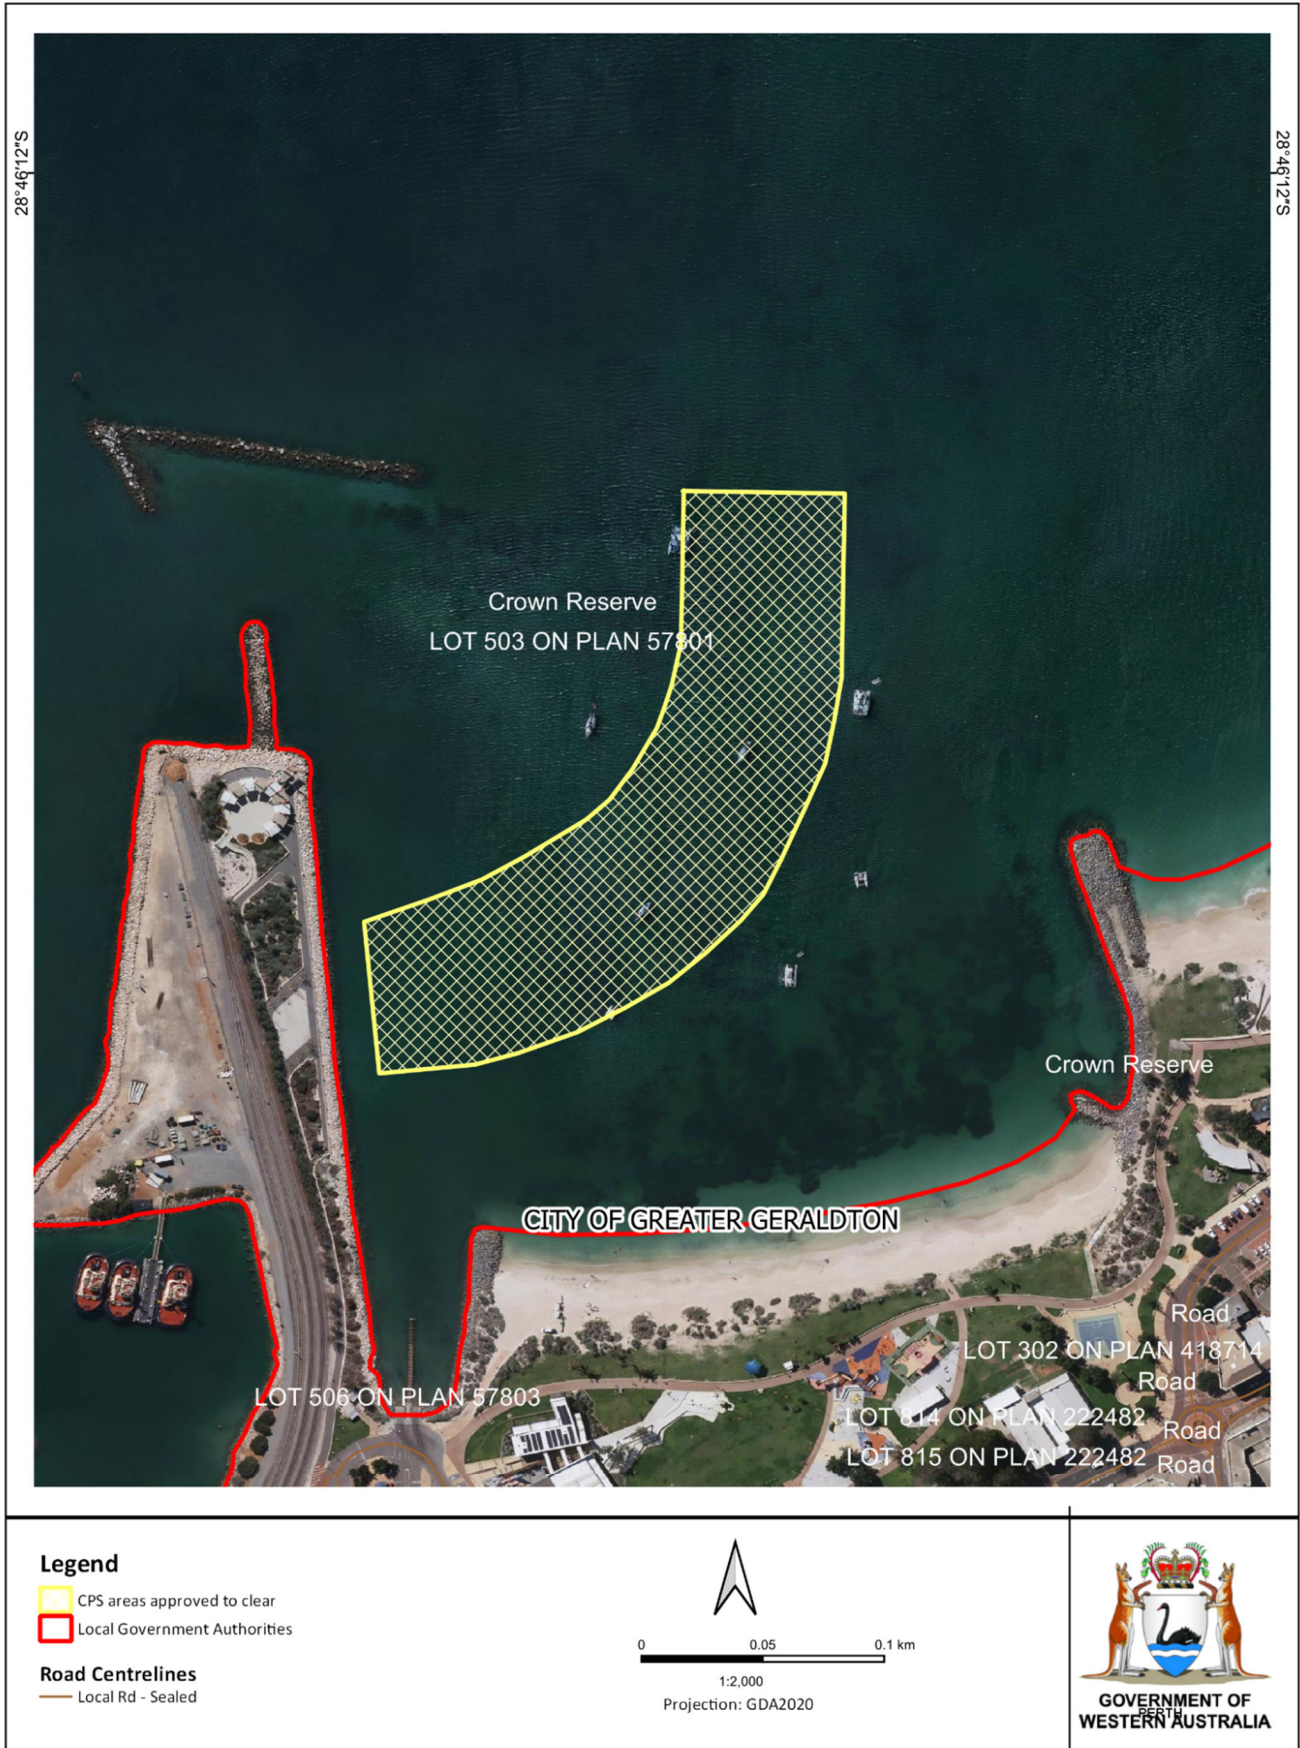
1.5. Site map

Figure 1. Map of the application area

The area cross-hatched yellow indicates the area authorised to be cleared under the granted clearing permit.

The vegetation proposed to be cleared is contained within a single contiguous area (see Figure 1, Section 1.5). The application is to clear 0.62 hectares of seagrass within a 2.39 hectare footprint.

Decision:	Granted
Decision date:	27 July 2023
Decision area:	0.62 hectares of native vegetation, as depicted in Section 1.5, below.

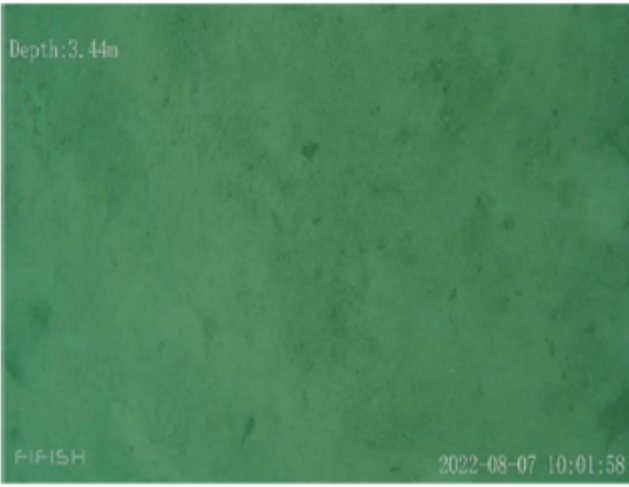
Benthic Community	Description	Example Image
<p>Flat bare sand (Site DC1)</p>	<p>Compacted sediment comprising fine sands. No shell debris or algae/seagrass wrack present.</p>

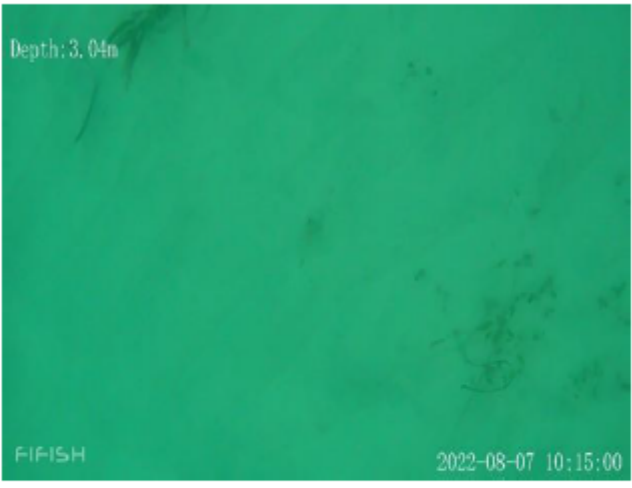
Benthic Community	Description	Example Image
Flat sand with sparse seagrass (Site DC6)	Relatively well compacted sediments comprising fine sands with ripples present. Presence of <i>Halophila ovalis</i> and <i>Posidonia australis</i>

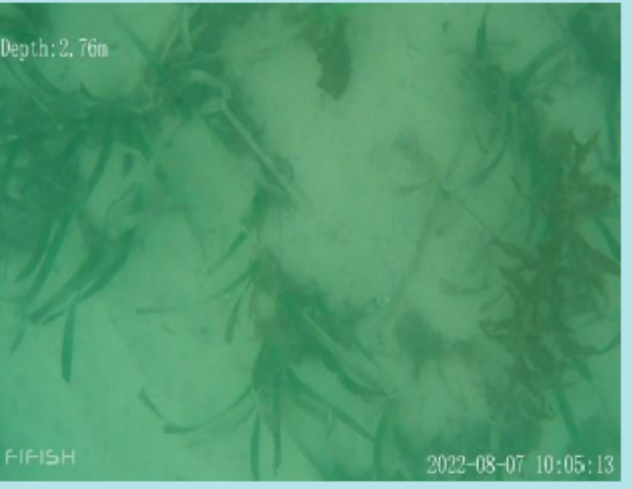
Flat sand with low seagrass (Site DC6)	Relatively well compacted sediments comprising fine sands with ripples present. Presence of <i>Posidonia australis</i>

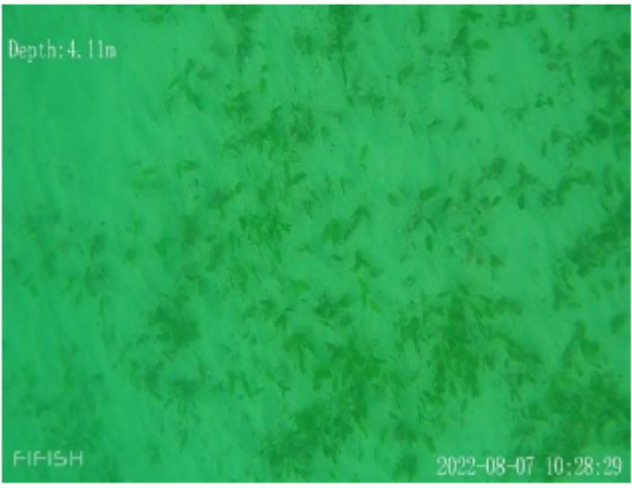
Flat sand with moderate seagrass (Site DC12)	Relatively well compacted sediments comprising fine sands with ripples present. Presence of <i>Halophila ovalis</i> .
