Attachment 1: Clearing assessment report, Glenarty Road reconstruction

File Reference: RDS/0200

Attachment 2: Tree Assessment- Glenarty Road

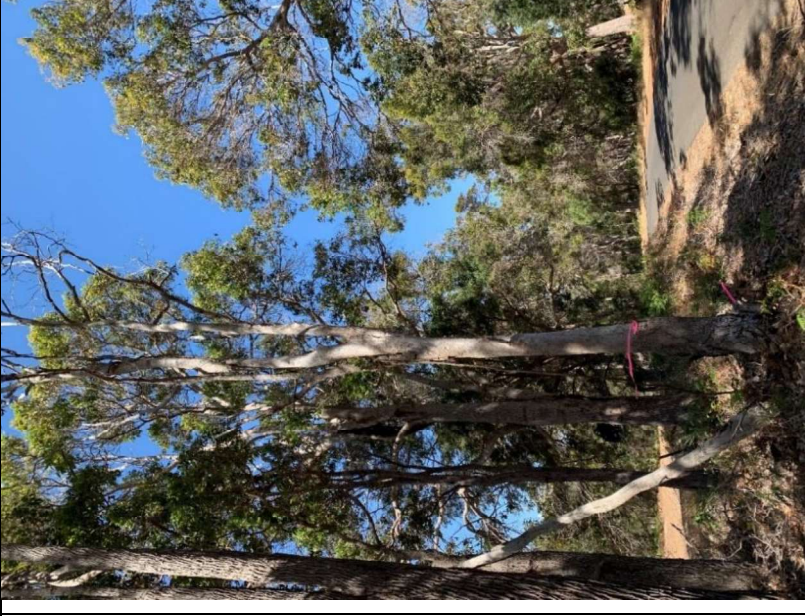
Tree ID	DBH cm	Species	GPS Coordinates- Lat/Long	Easting Northing	Hollows	Hollow size(s)	Description	Image
1	38	Marri- <i>Corymbia calophylla</i>	34 degrees, 14' 50" S, 115 degrees, 09' 37" E	330588 6208888	No	-	Dead tree- bark peeling off

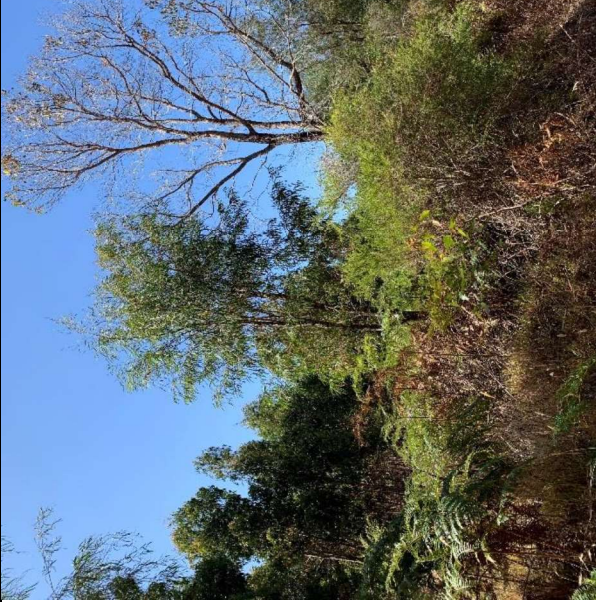
2	7	Peppermint- <i>Agonis flexuosa</i>	34 degrees, 14' 49"S, 115 degrees, 09' 45"E	330793 6208936	No	-	In foreground of photo. Approximately 4 metre high- small Peppermint

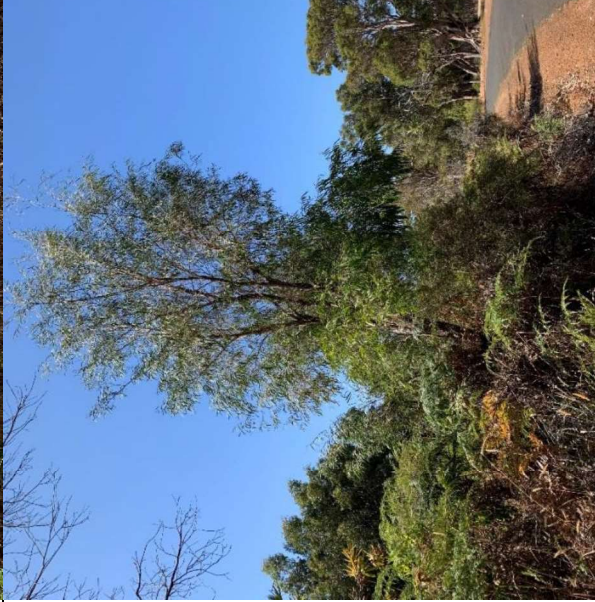
3	26	Marri- <i>Corymbia calophylla</i>	34 degrees, 14' 49"S, 115 degrees, 09' 45"E	330793 6208936	No	-	In background of photo. In poor health- partly dead

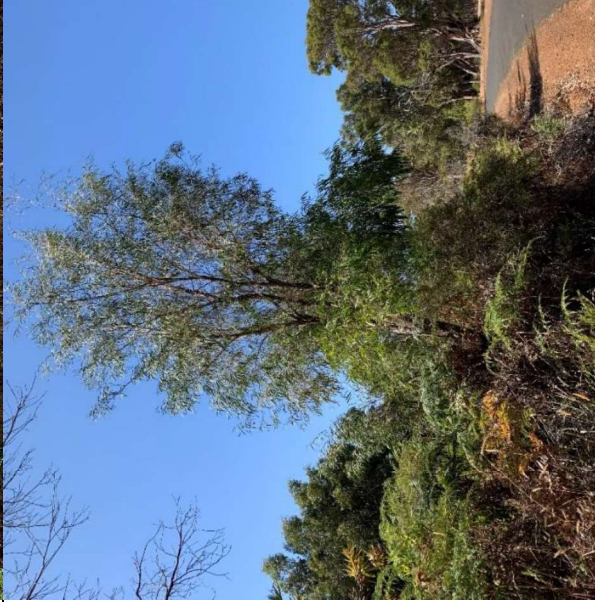
4	18	Peppermint- <i>Agonis flexuosa</i>	34 degrees, 14' 49"S, 115 degrees, 09' 45"E	330793 6208936	No	-	Approximately 6 metre high- small Peppermint

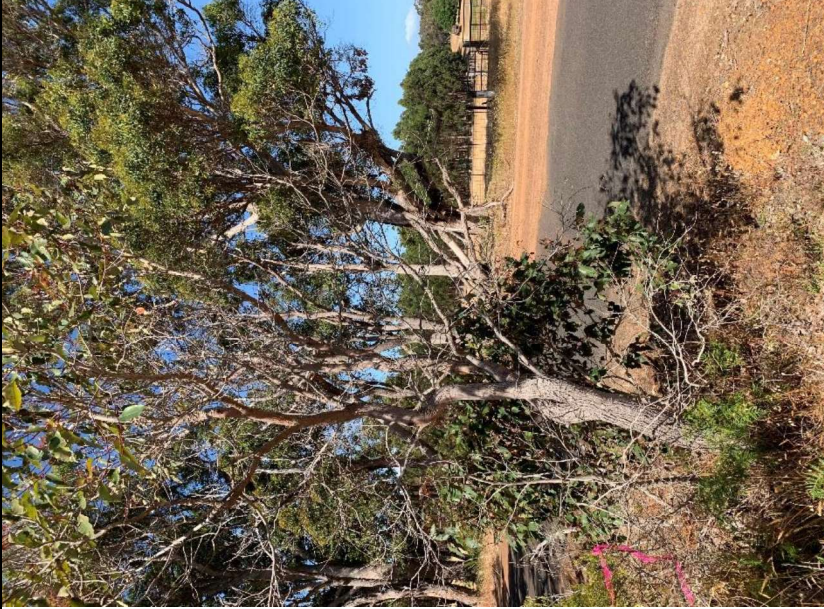
5	12	Marri- <i>Corymbia</i> <i>calophylla</i>	34 degrees, 14' 46" S, 115 degrees, 09' 47"E	330842 6209029	No	-	Small Marri tree- partly dead

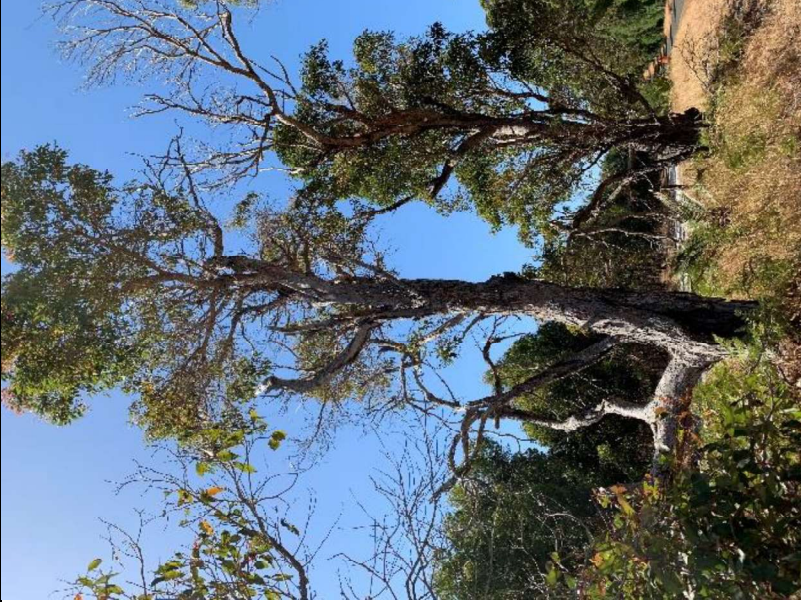
A total of eight trees, comprising 6 x Marri (*Corymbia calophylla*) and 2 x WA Peppermint (*Agonis flexuosa*) occur within the permit area and may be impacted during road works (see Attachment 2). The marri trees are in poor health, affected by canker, and either partly or completely dead. One of the marri trees (tree 6) is over 50cm DBH, however on inspection it

was not observed to contain branches large enough to support hollows suitable for black cockatoo nesting.

6	58	Marri- <i>Corymbia</i> <i>calophylla</i>	34 degrees, 14' 46" S, 115 degrees, 09' 47"E	330842 6209029	No	-	Impacted by Canker Trunk greater than 50cm DBH

- One marri tree over 50cm DBH may be impacted during clearing, however this tree is unlikely to provide nesting habitat for threatened fauna such as black cockatoo species or western ringtail possum, based on its poor condition, lack of suitable nesting hollows or dreys, and lack of visible evidence of feeding residue or scats. No other potential habitat trees will be impacted.

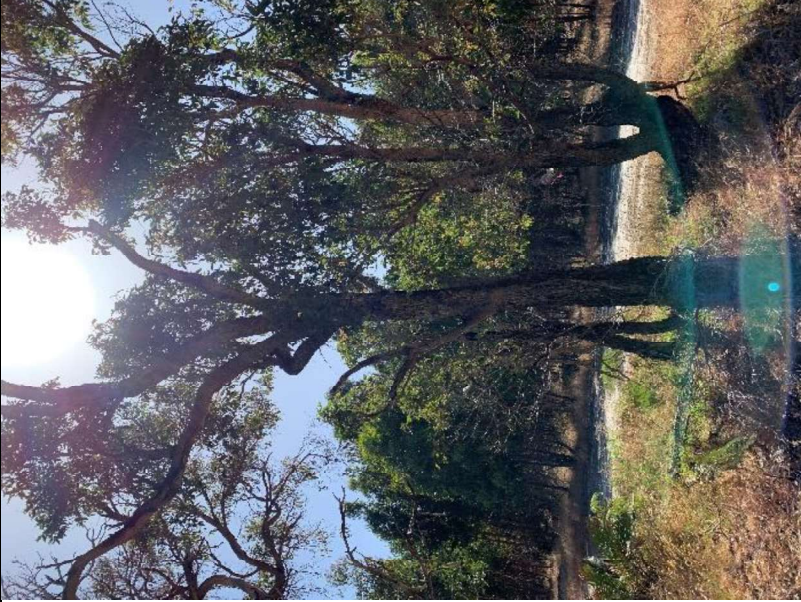
7	48	Marri- <i>Corymbia</i> <i>calophylla</i>	34 degrees, 14' 46" S, 115 degrees, 09' 47" E	330842 6209029	No	-	Marri in foreground. Impacted by Canker and termites

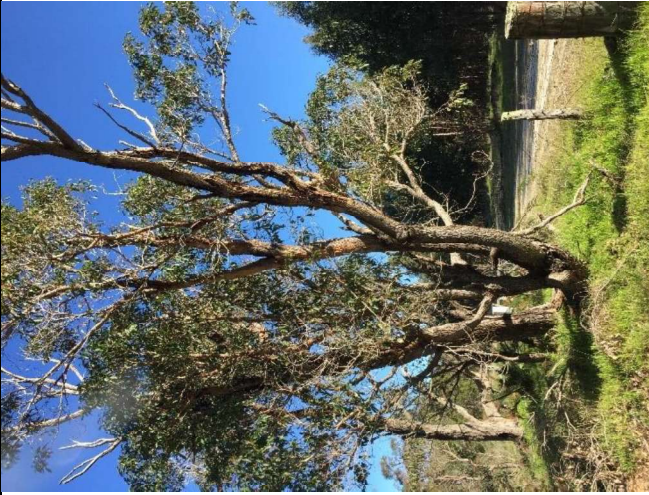
8	35	Marri- <i>Corymbia</i> <i>calophylla</i>	34 degrees, 14' 46" S, 115 degrees, 09' 47"E	330842 6209029	No	-	Tree in foreground- multi- stemmed. Impacted by canker.

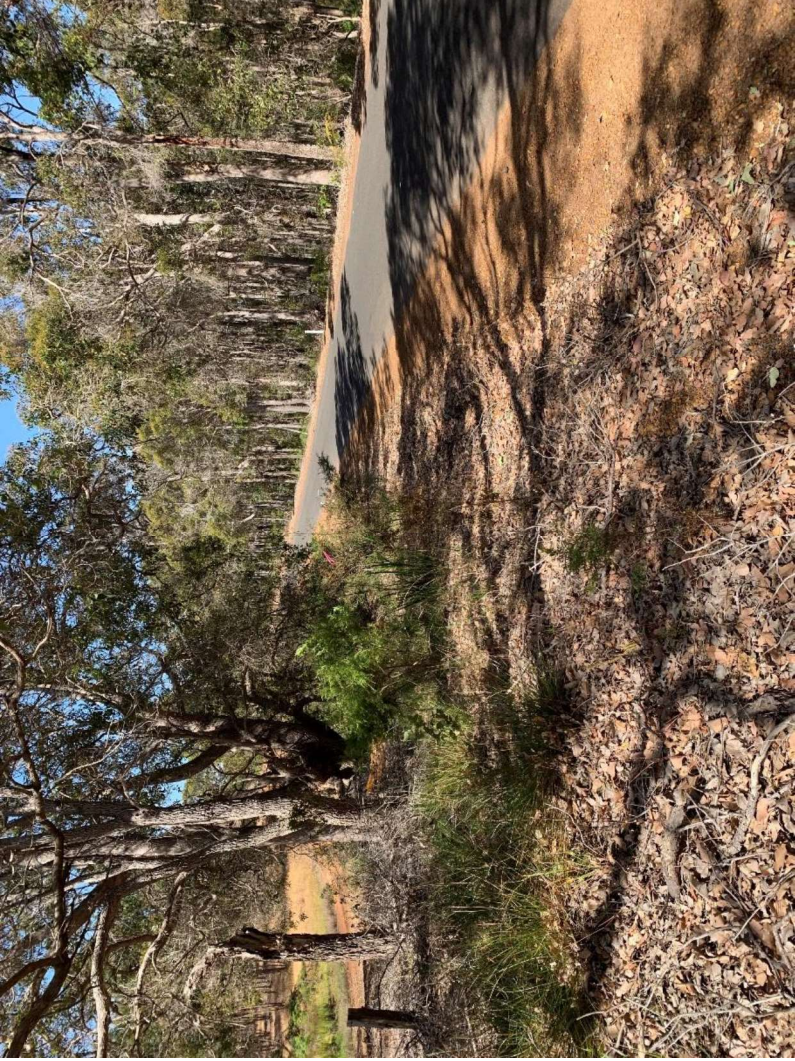
Figure 2: View looking east

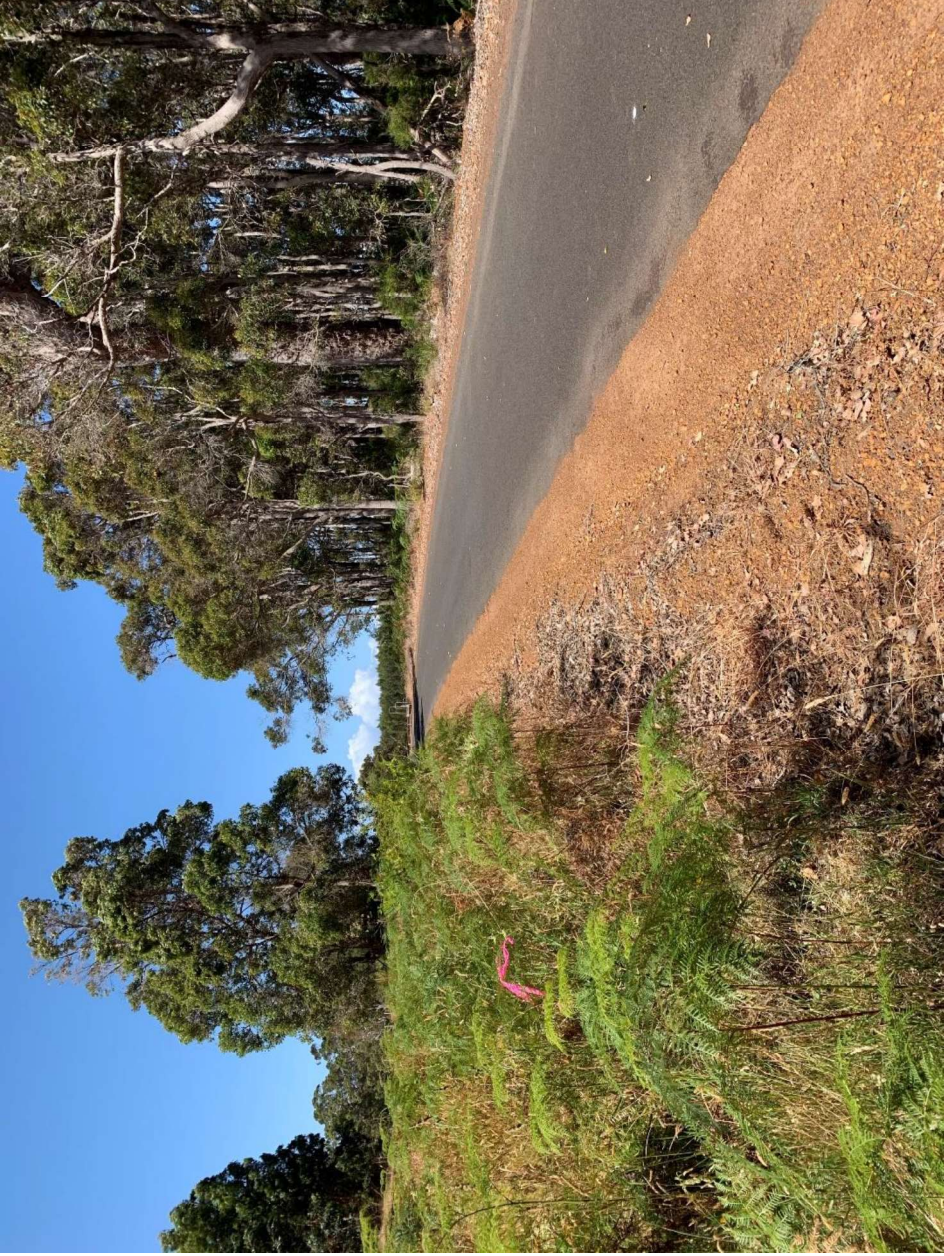
Figure 4: Bracken and introduced grass understorey

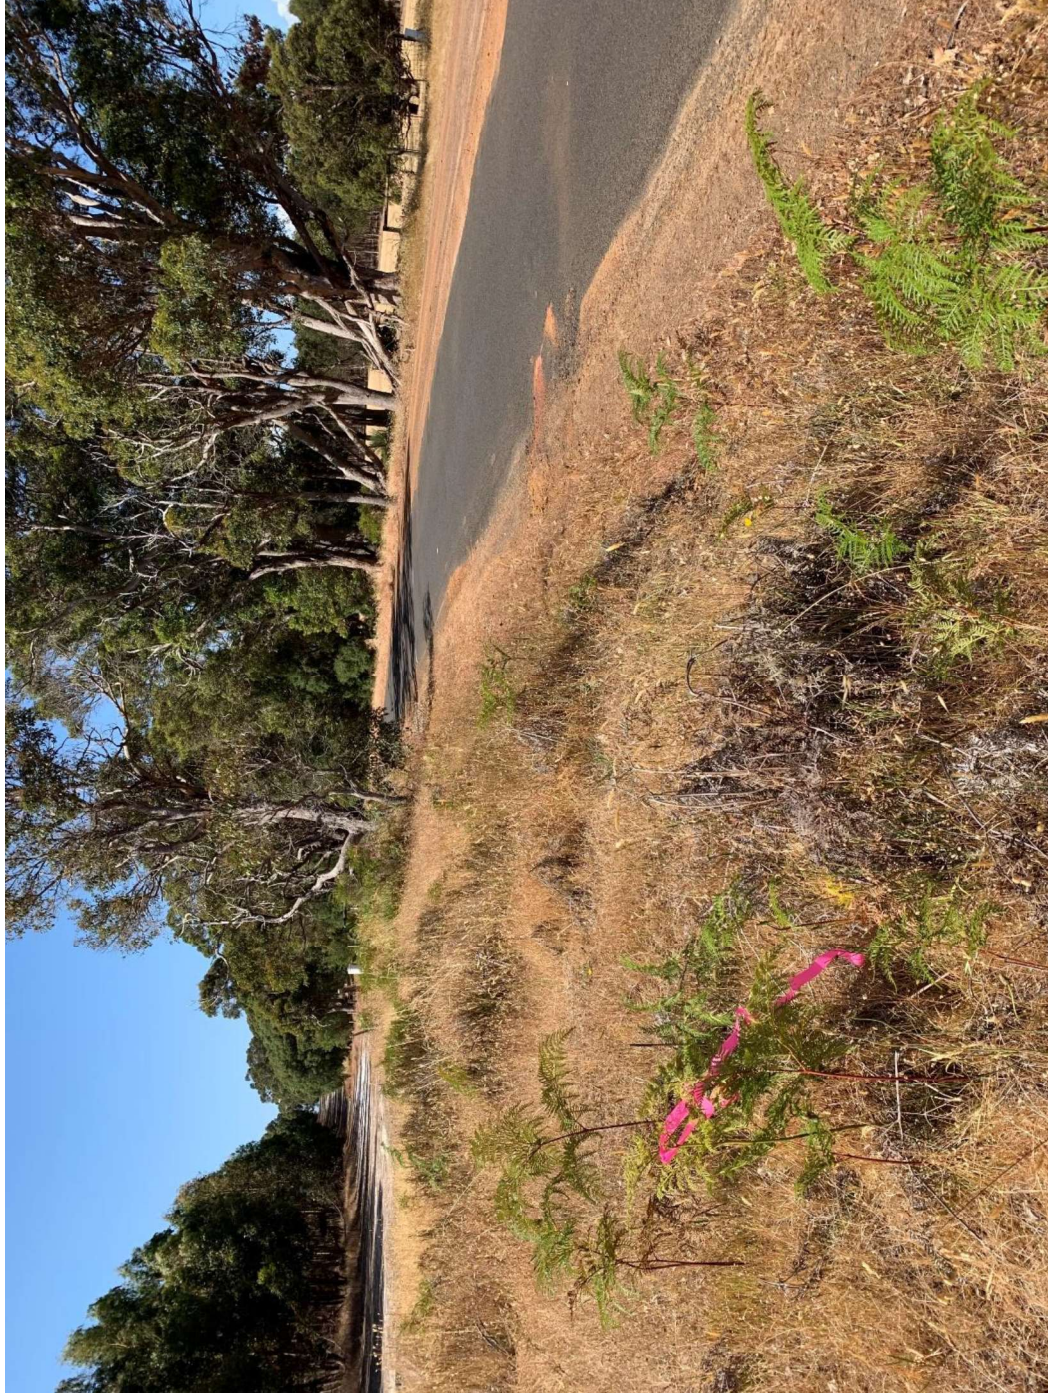
Figure 5: Trees 5-8 in the distance.
