RED DIRT METALS LIMITED

Mt Ida Lithium Project - Native Vegetation Clearing Permit Application: Supporting Document

220057-MIG-MTIDA-NVCP

March 2023

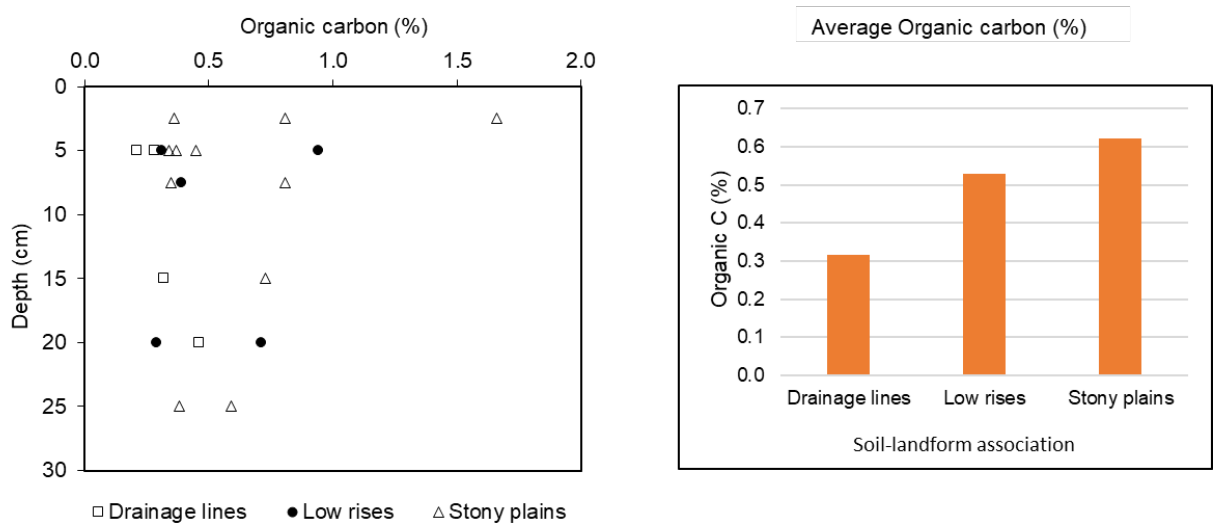
Figure 10 Individual Organic C concentration (%) of soils with depth and average Organic C of all depths for each soil-landform association

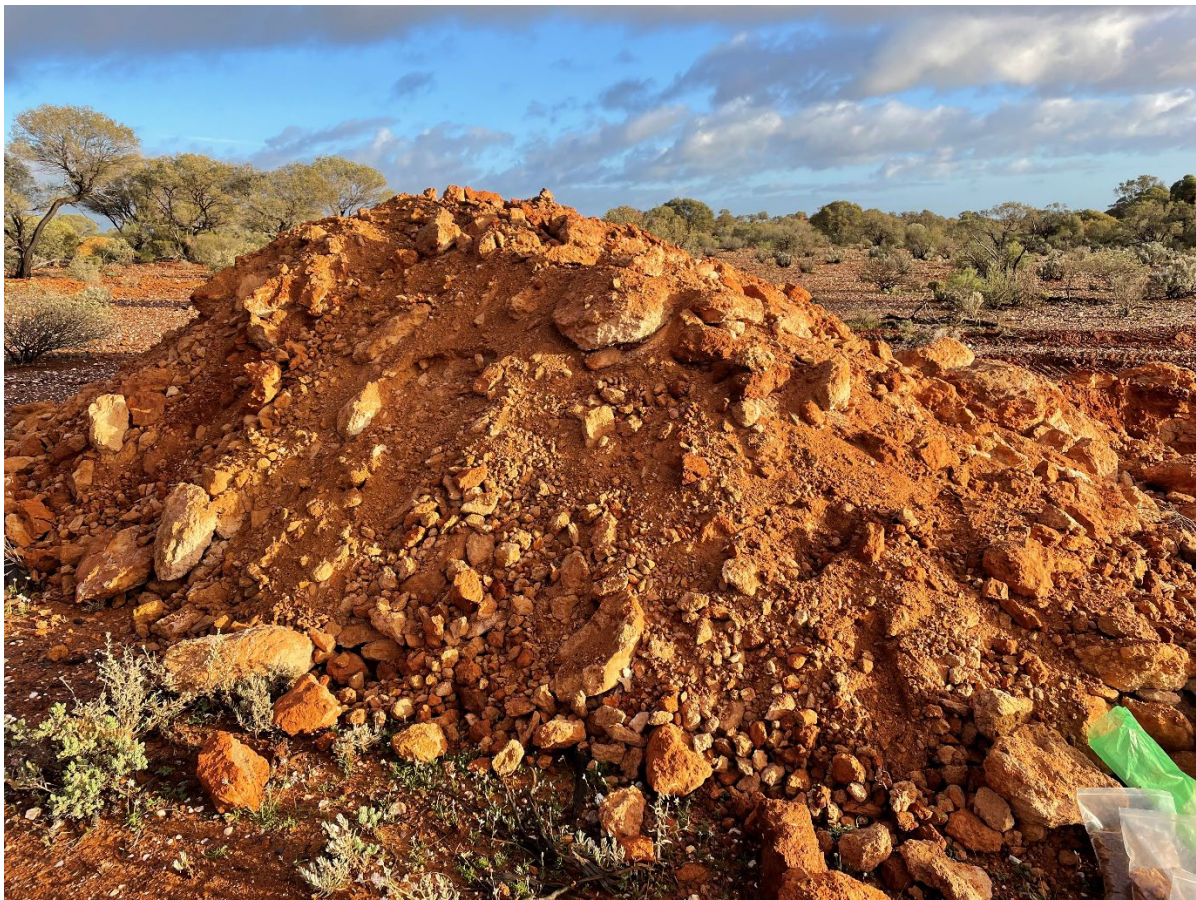
Plate 29 Hardpan / weathered amphibolite material excavated from a drill sump
