## Big Swamp wetland – supporting information and photographs

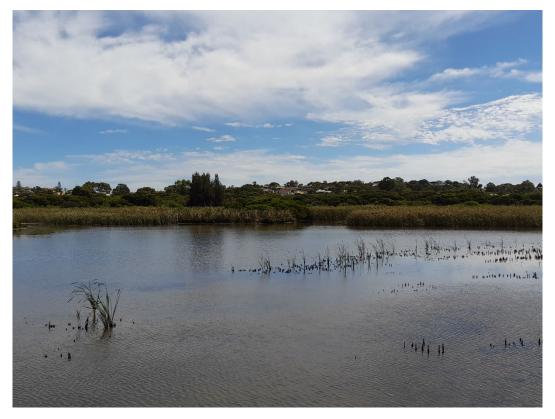
Plate 1: Photograph taken from the southern boardwalk at Big Swamp looking north

The Typha continues to reduce the wetlands capacity to function as a stormwater compensation basin by impeding the movement of water and crowding drainage outlets. An additional round of clearing of the Typha is proposed to help open strategic channels within Big Swamp to help the movement of water and improve water quality. It is proposed that up to 1 ha of Typha be removed from locations outlined in.
