## **Robe Mesa Project**

# **Native Vegetation Clearing Permit (NVCP) Application**

## **Supporting Document**

**June 2023**

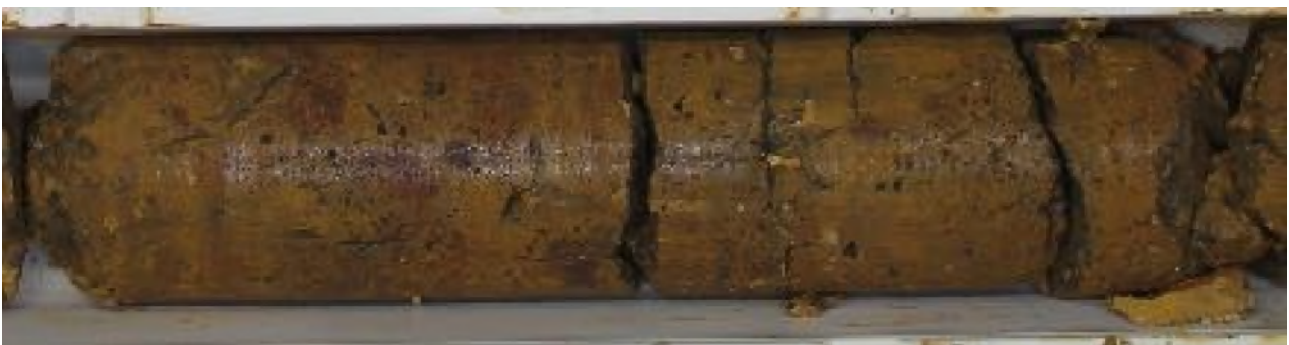
**Figure 3.30: Diamond core of CID-upper layer depicting vugs and fractures (CZR 2023)**

Robe Valley mesas are frequently vuggy, fractured and often contain small-scale caverns, which allow for percolation of water and nutrients from surface habitats, thereby representing suitable habitat for subterranean fauna (Biota 2006, 2011b, 2016a) (**Figure 3.30**).
