REPORT

Geotechnical Investigation

CBH Group Konnongorring Rail Loading Facility

1791739-070-R-Rev0

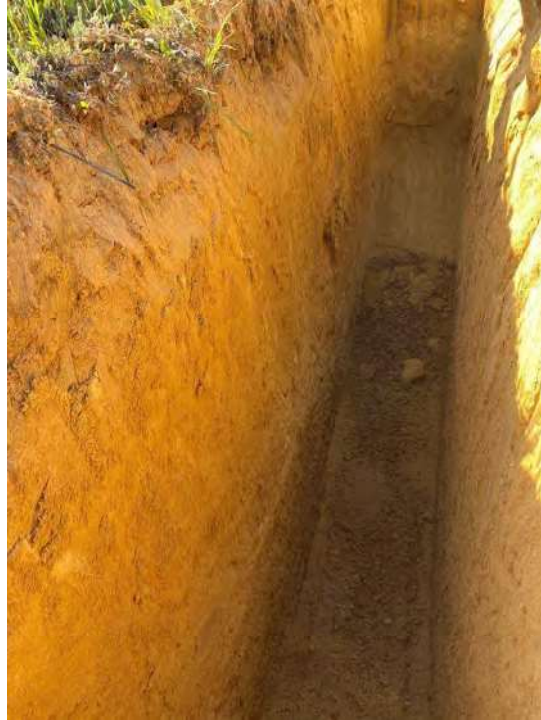
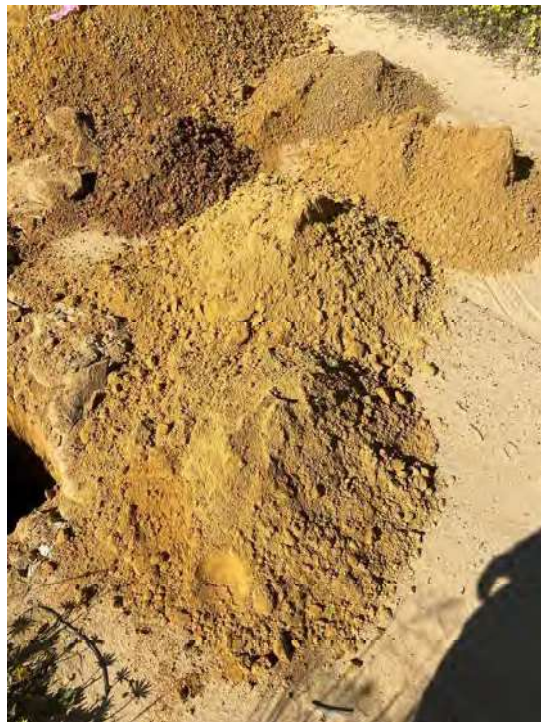
TP01 - 1

TP01 - 2

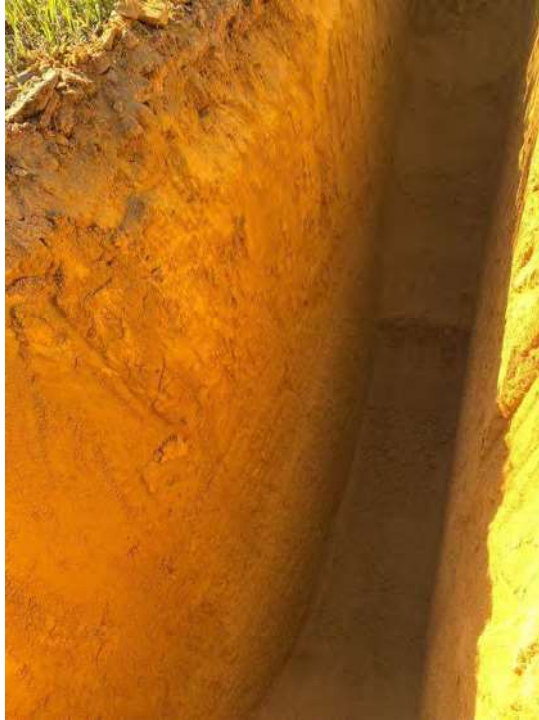
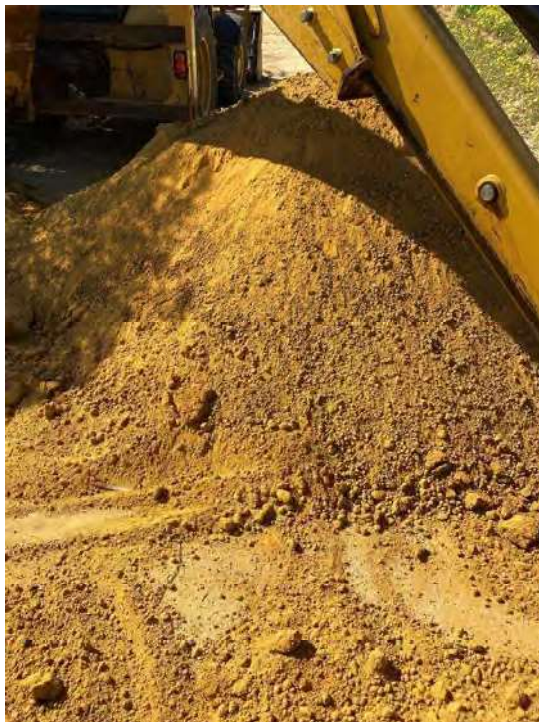
TP02 - 1

TP02 - 2

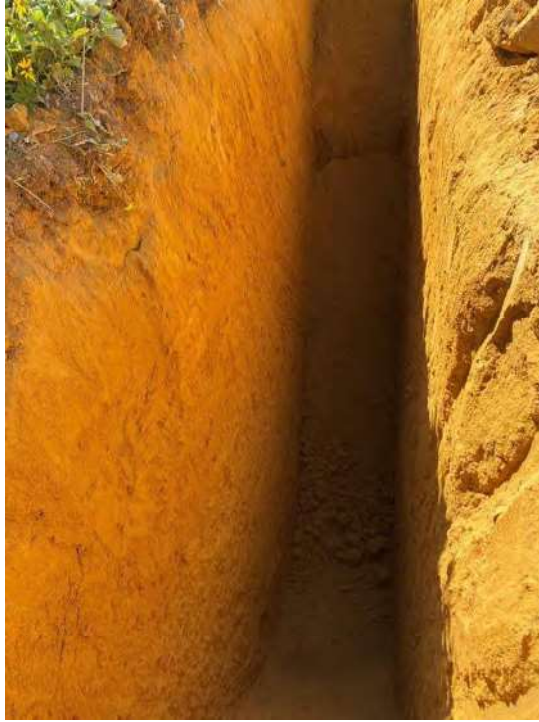
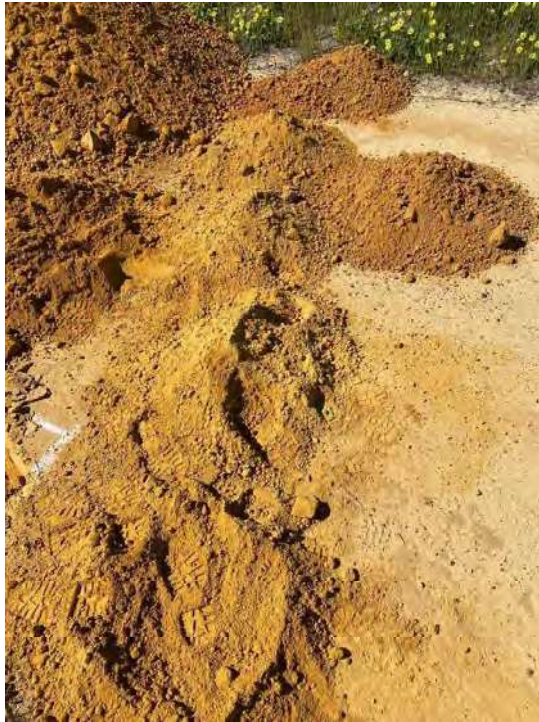
TP03 - 1

TP03 - 2

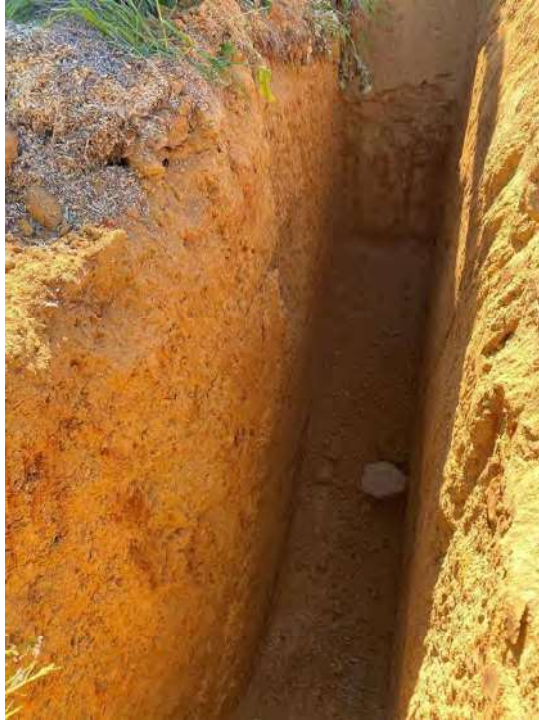
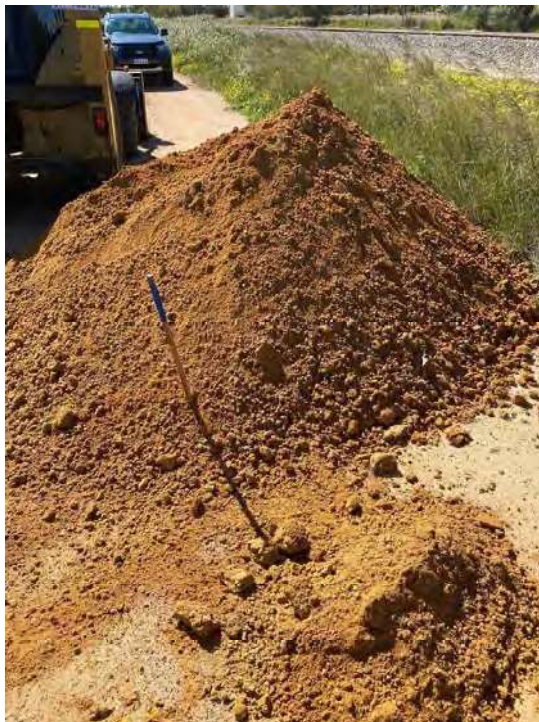
TP04 - 1

TP04 - 2

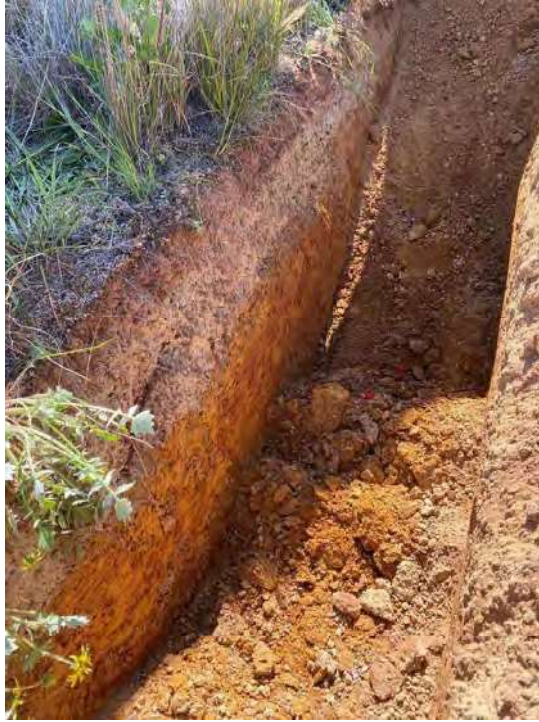
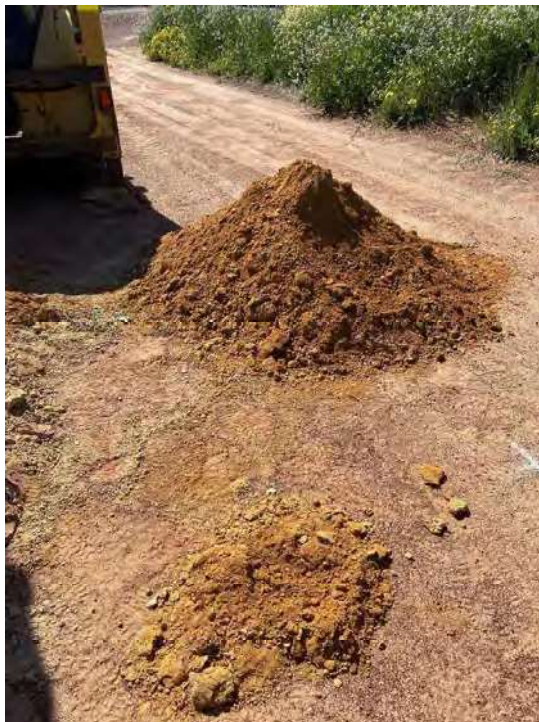
TP05 - 1

TP05 - 2

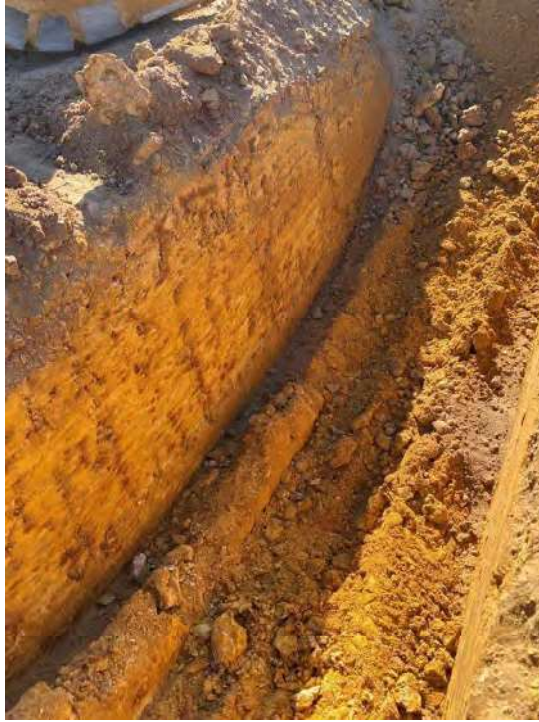
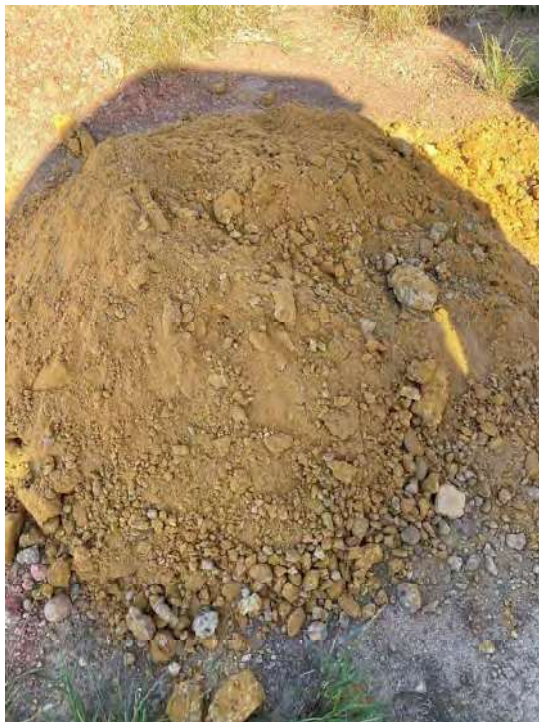
TP07 - 1

TP07 - 2

The alignment of the access roads and hardstand areas has not been finalised at this stage. For the access road design, we have utilised the subsurface conditions encountered within test pit TP07, TP09, BH01, BH02 and TP13 to develop the subgrade conditions. Based on the results of the test pits undertaken on the approaches to the ORBs the subsurface conditions generally comprise hard Sandy SILT/Sandy CLAY, dense Clayey SAND or Referruginised GRANITE. On the basis of the subsurface conditions encountered and in consideration of the provision of sealed pavements, which reduces the likelihood of soaked conditions occurring below pavements, the following subgrade design CBRs have been adopted for design:

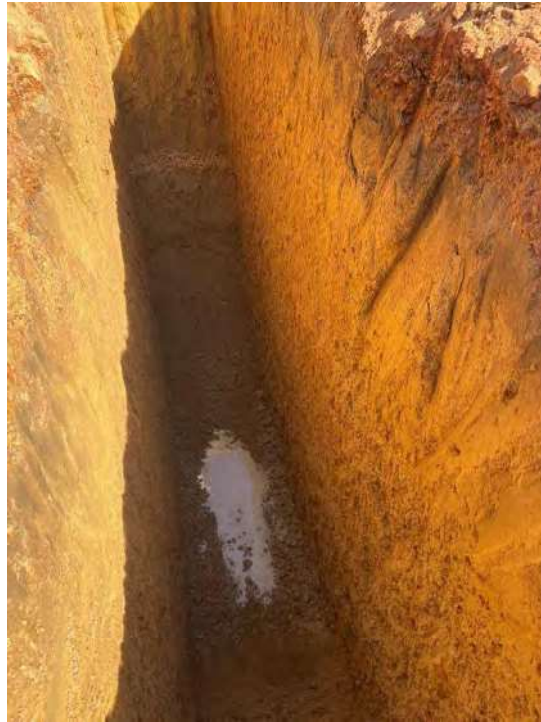
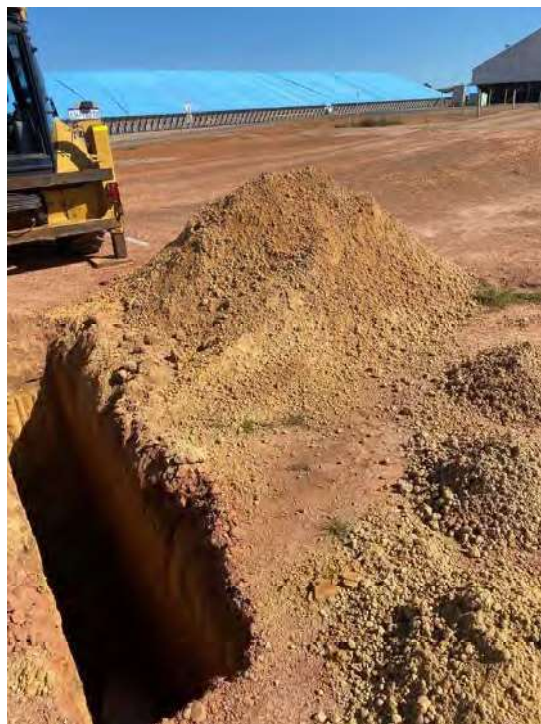
TP09 - 1

TP09 - 2

Based on Table 8, the in-situ subgrade conditions do not comply with all the Arc Infrastructure Specification requirements for Common Fill. The subgrade conditions at test pit locations TP05 and TP09 comply with the requirements for Subgrade. The gravelly subgrade conditions present over parts of the rail alignment are considered suitable to support the rail formation, provided suitable site preparation techniques are undertaken in accordance with the ARC Specifications.

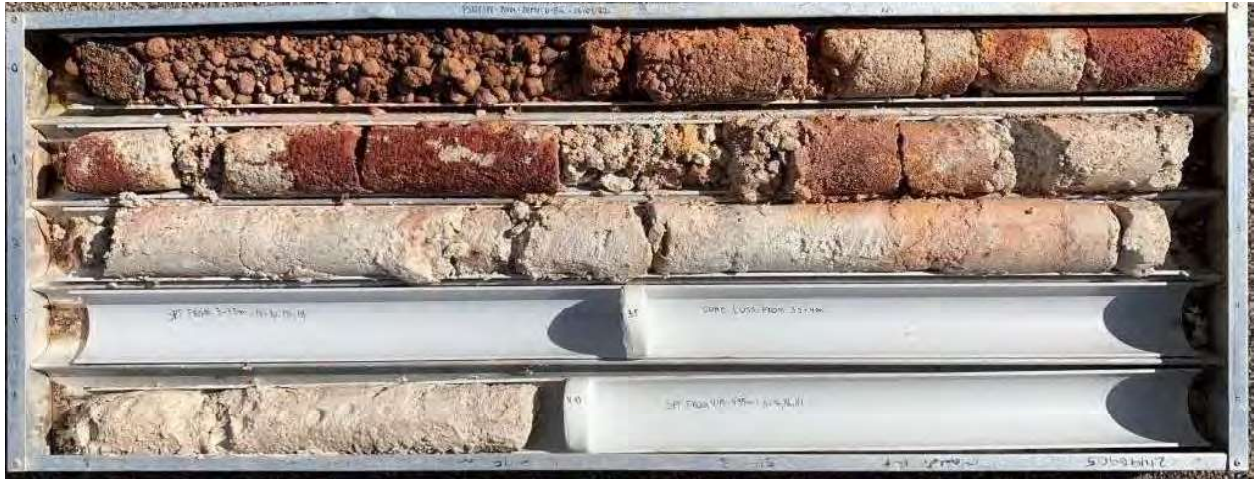
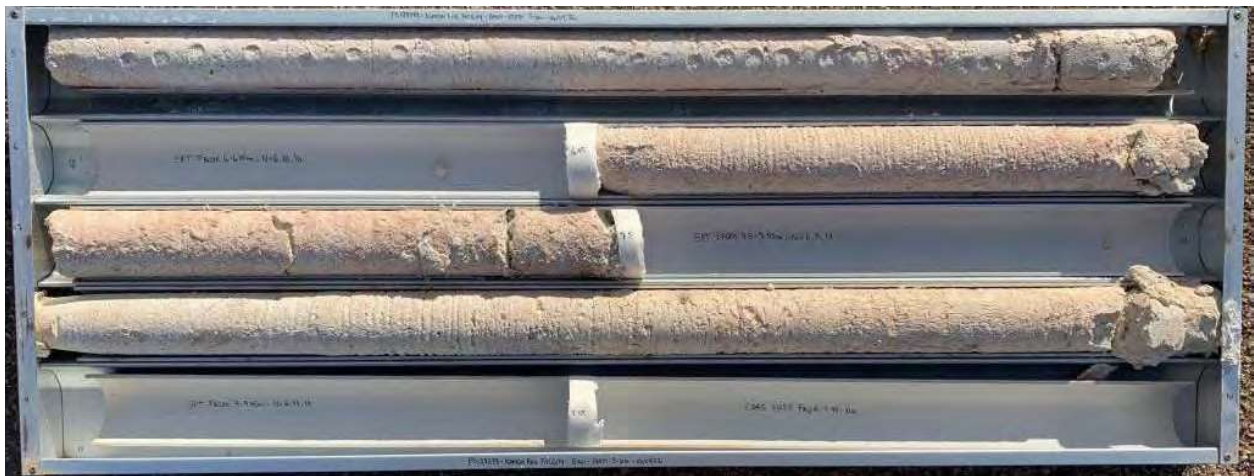
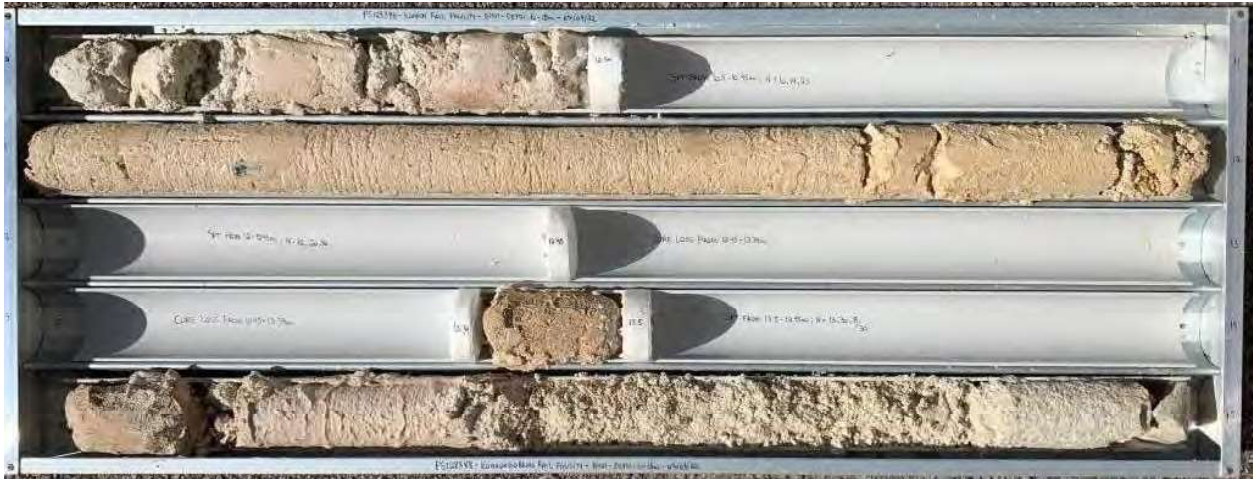
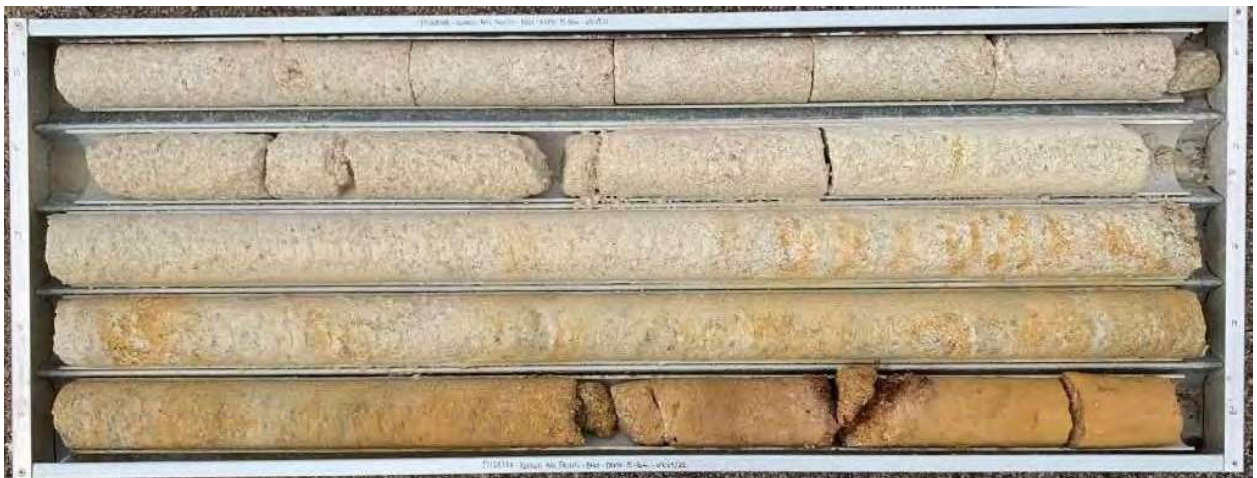
BH01 - 0.00 - 5.00 m

BH01 - 5.00 - 10.00 m

BH01 - 10.00 - 15.00 m

BH01 - 15.00 - 20.00 m

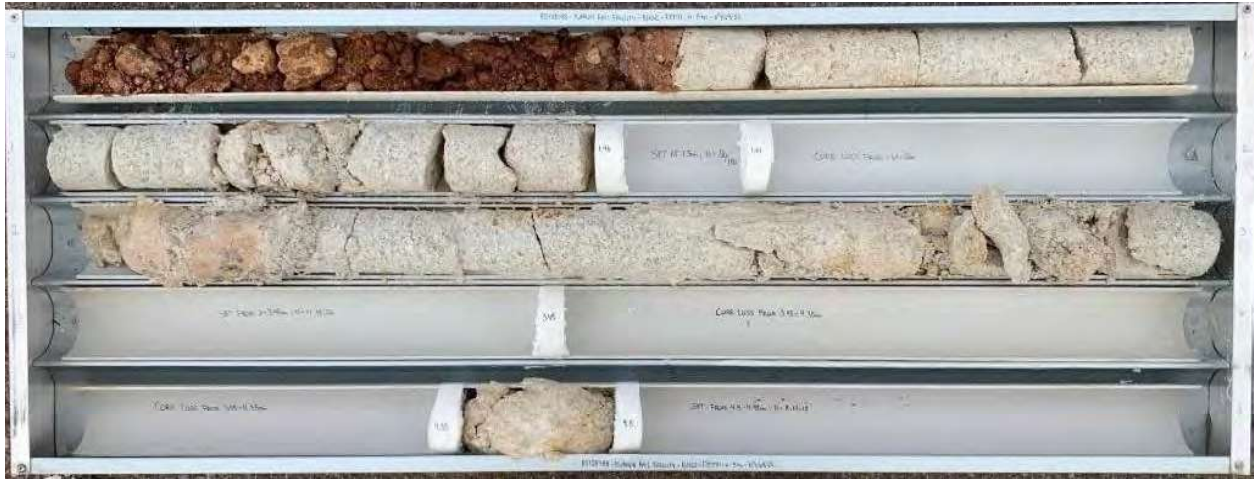
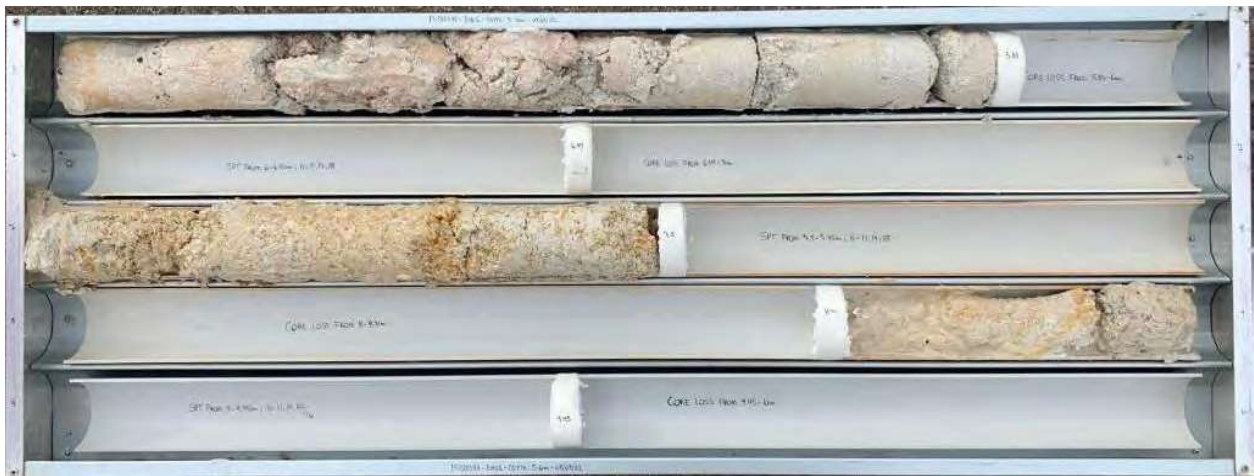
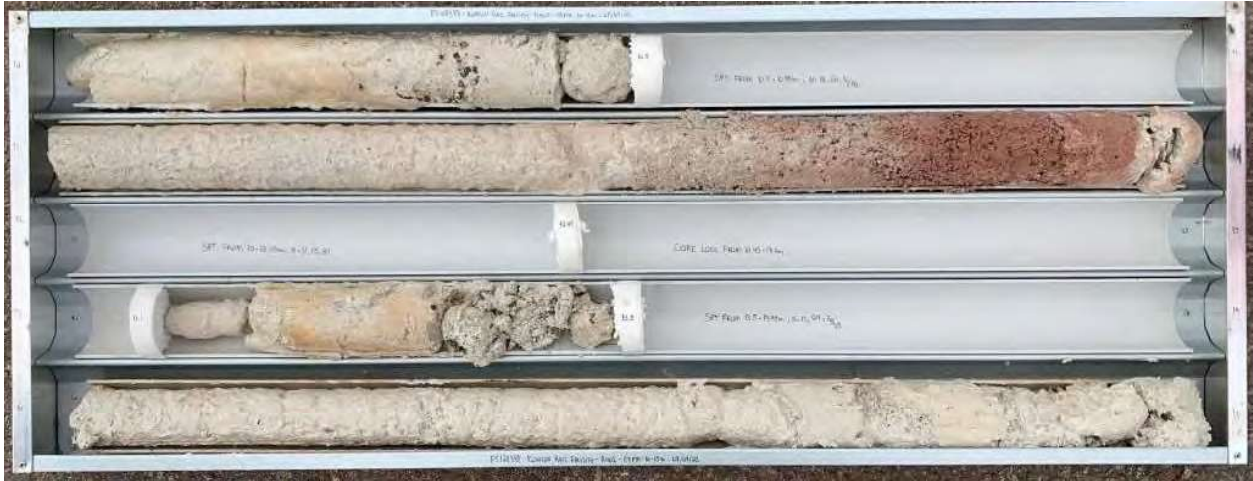
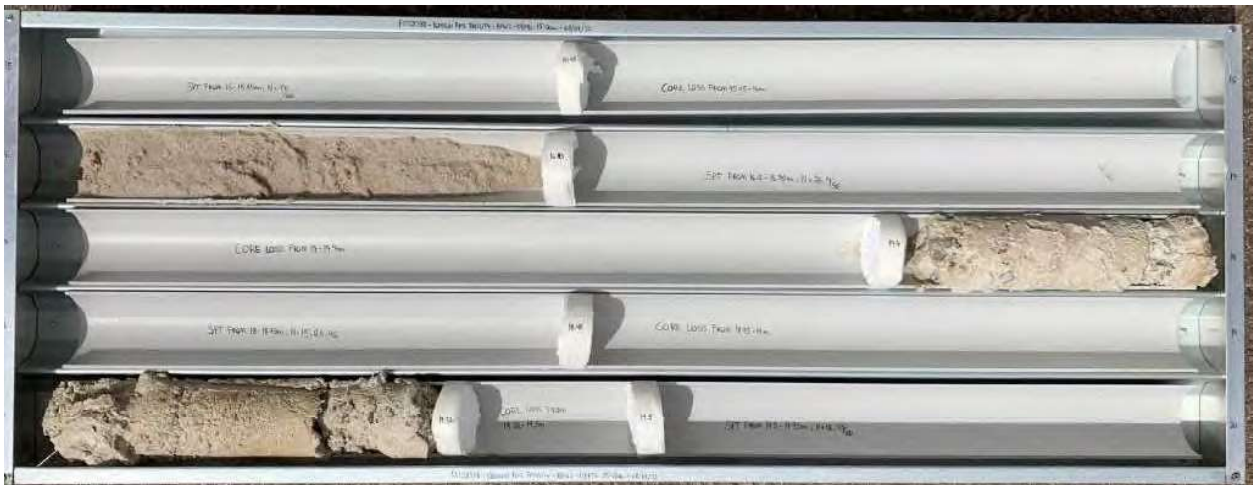
BH02 - 0.00 - 5.00 m

BH02 - 5.00 - 10.00 m

BH02 - 10.00 - 15.00 m

BH02 - 15.00 - 20.00 m

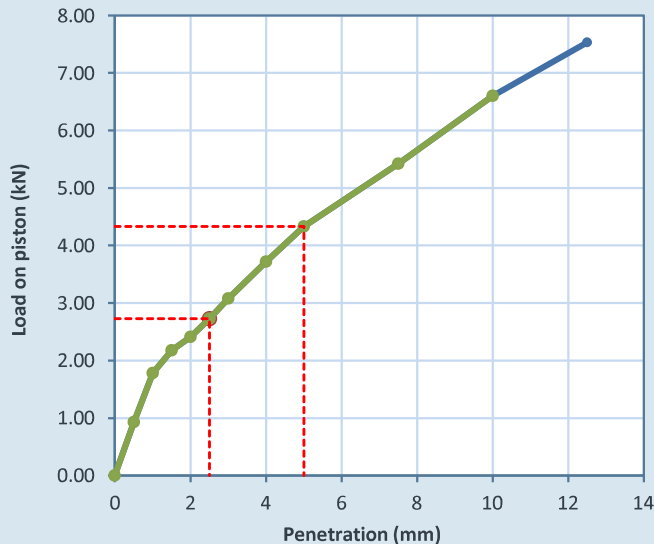
Penetration (mm):	0.0	0.5	1.0	1.5	2.0	2.5	3.0	4.0	5.0	7.5	10.0	12.5	Correction:
Load Original (kN)	0.00	0.93	1.78	2.18	2.41	2.73	3.08	3.72	4.33	5.42	6.60	7.53	
Load Corrected (kN)	0.00	0.93	1.78	2.18	2.41	2.73	3.08	3.72	4.33	5.42	6.60

Dry density t/m ³	before soaking:	1.94
	after soaking:	1.94
Density ratio	before soaking:	92.5%
	after soaking:	92.0%
Moisture ratio at compaction:		101.5%
Duration of soaking (days):		4
Surcharge applied (kg):		6.8
Moisture content top 30mm:		14.0%
Moisture content remainder:		11.6%
Swell after soaking:		NIL
Bearing ratio at 2.5mm penetration:		20.0%
Bearing ratio at 5.0mm penetration:		20.0%

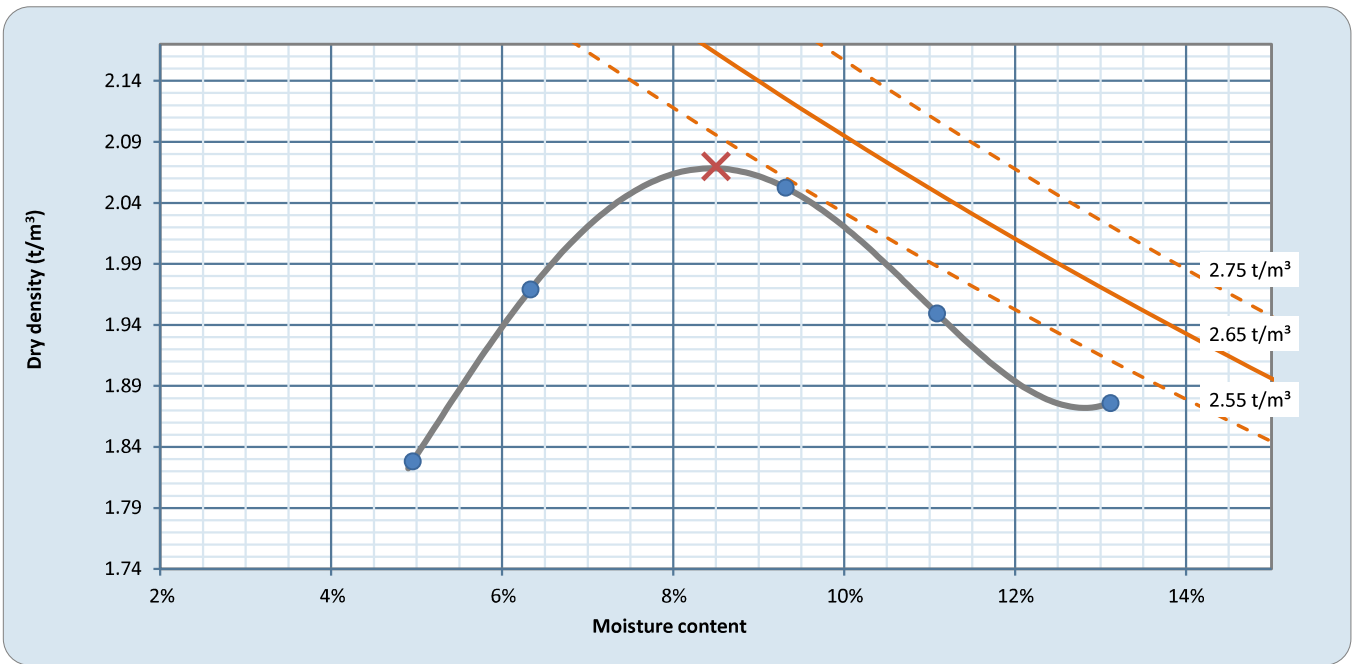
Point 1	Point 2	Point 3	Point 4	Point 5	Point 6	Oversize material - (by dry mass)	
Dry density (t/m ³):	1.83	1.97	2.05	1.95	1.88		No oversize correction required	+19 mm: 0%
Moisture content:	5.0%	6.3%	9.3%	11.1%	13.1%			+37.5 mm: 0%
<i>No oversize material present</i>

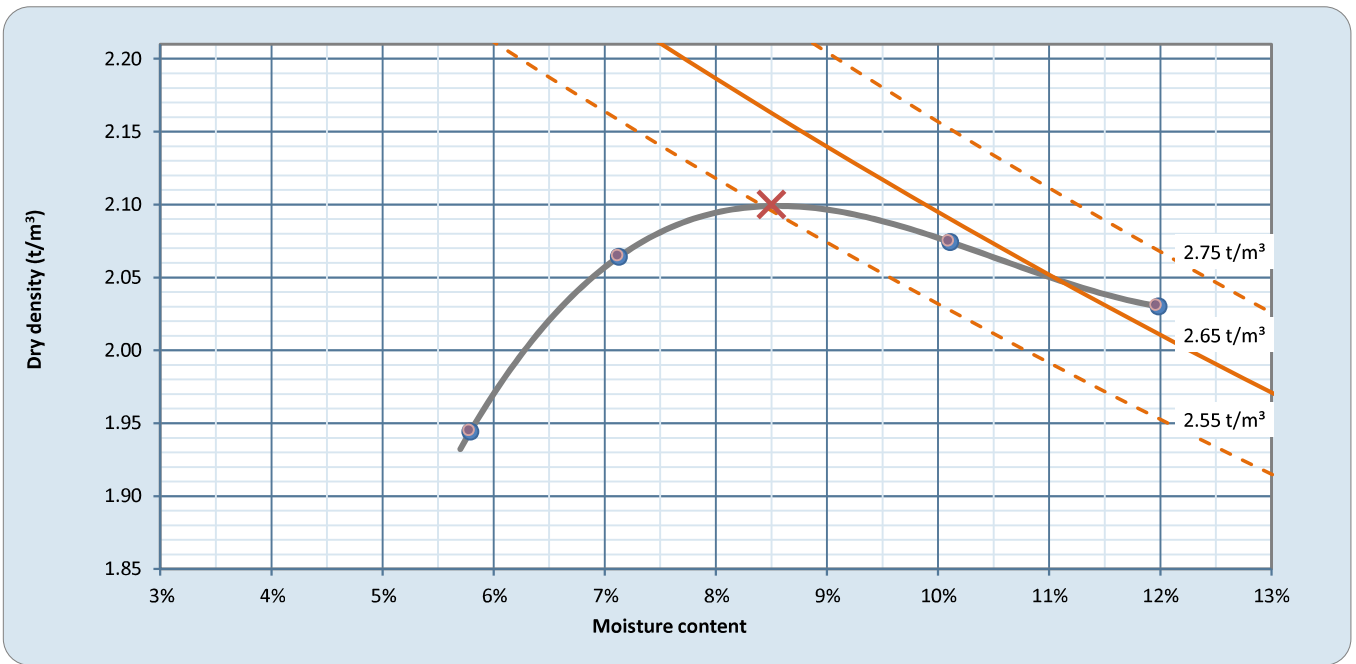
Point 1	Point 2	Point 3	Point 4	Point 5	Point 6	
Dry density (t/m ³):	1.94 1.95*	2.06 2.07*	2.07 2.08*	2.03 2.03*			Oversize material - (by dry mass) *Denotes value adjusted for oversize material +19 mm: 0% +37.5 mm: 0% Oversize material was discarded
Moisture content:	5.8% 5.8%*	7.1% 7.1%*	10.1% 10.1%*	12.0% 12.0%*
