Appendix 4. Site Images: Lot 27 Clements Place (dated 24 April 2023)

Appendix 6. Images: Comparison to nearby Banksia Woodland sites

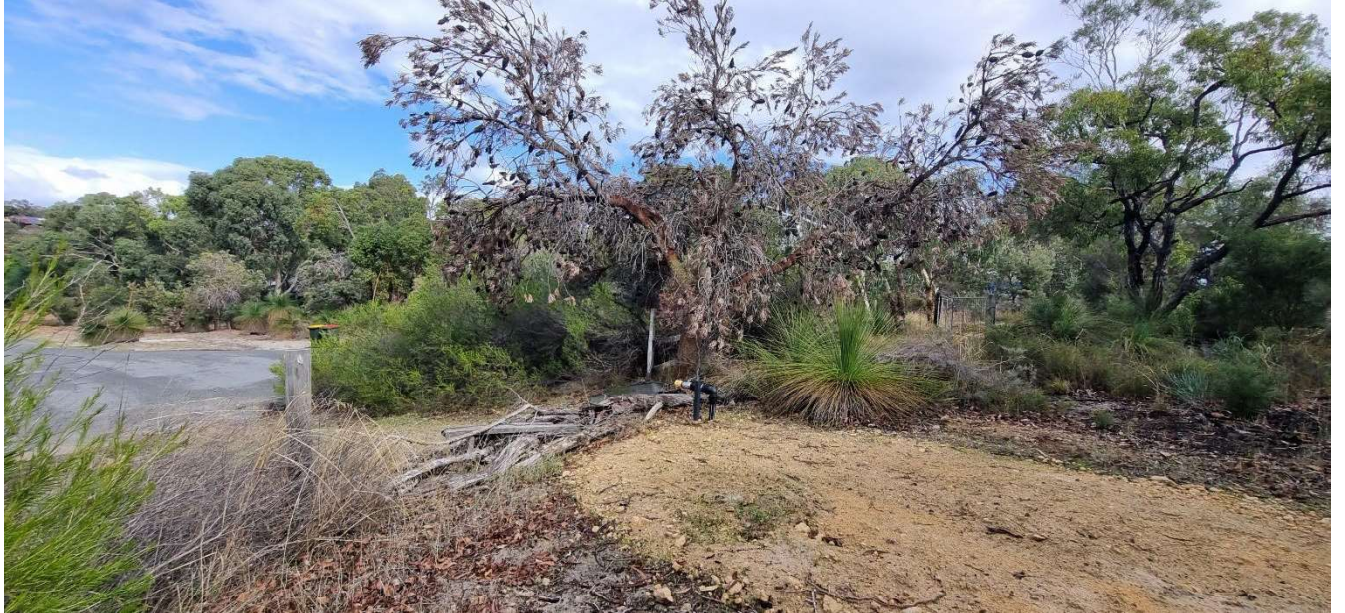
Image 1. Proposed entry point into Lot 27, from the cul-de-sac of Clements Place.

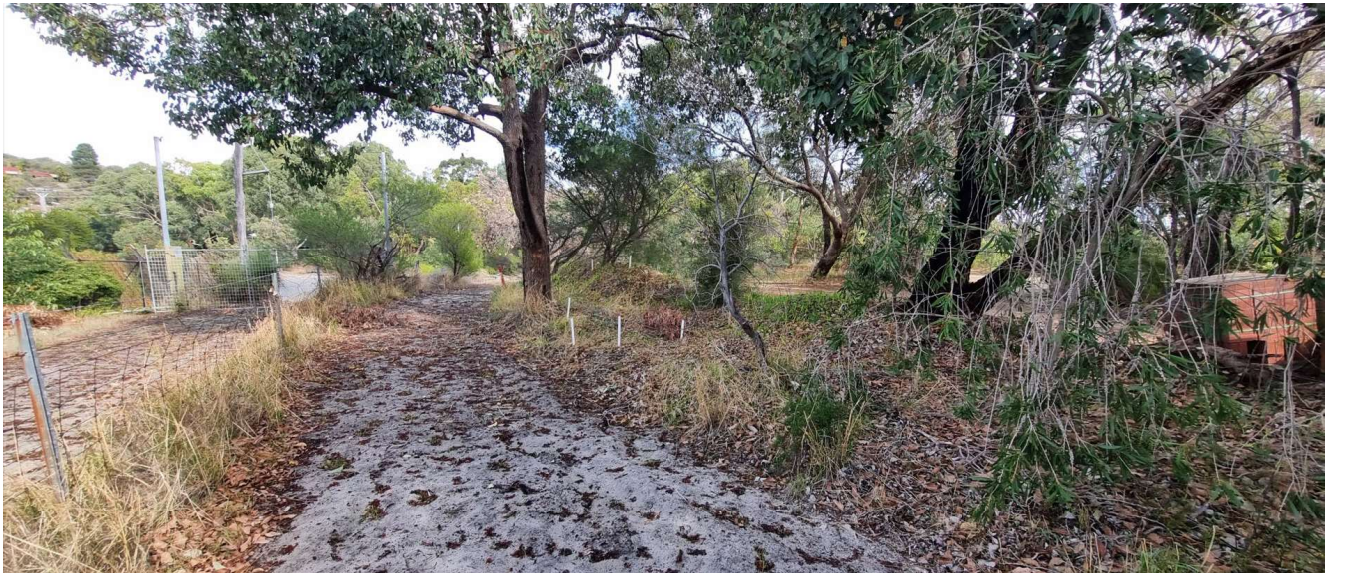
Image 2. Boundary of land acquisition area along the fence line. Lot 28 on the left side of the fence. This image partially shows the un-surveyed area on the far right of Lot 27.

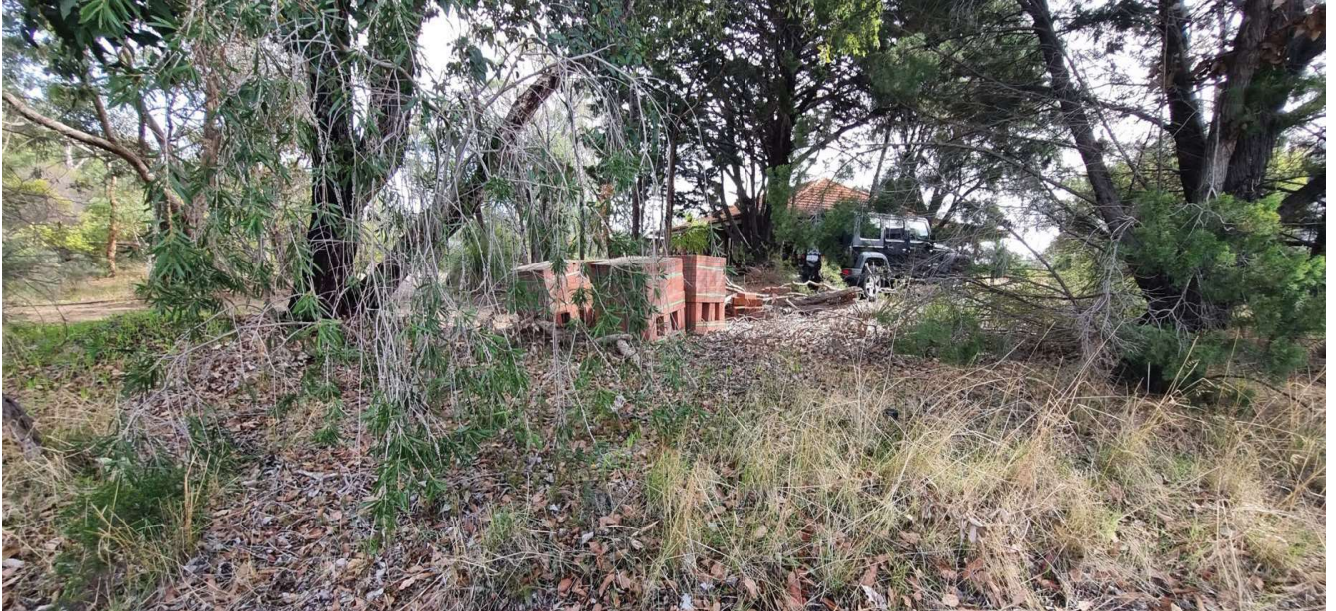
Image 3. View beyond the proposed access track and un-surveyed area of Lot 27.

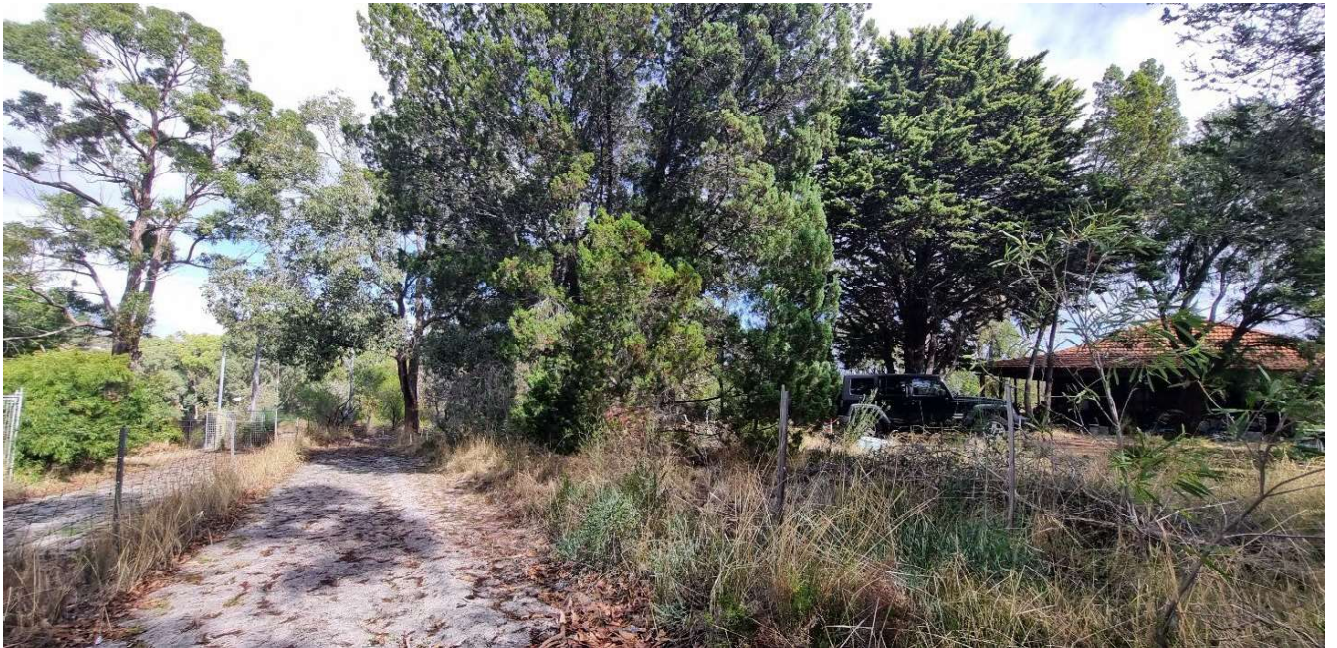
Image 4. Boundary of land acquisition area; Lot 28 on the left and Lot 27 house on the right. This part of the site represents an area of Degraded vegetation as per the Spring 2022 survey.

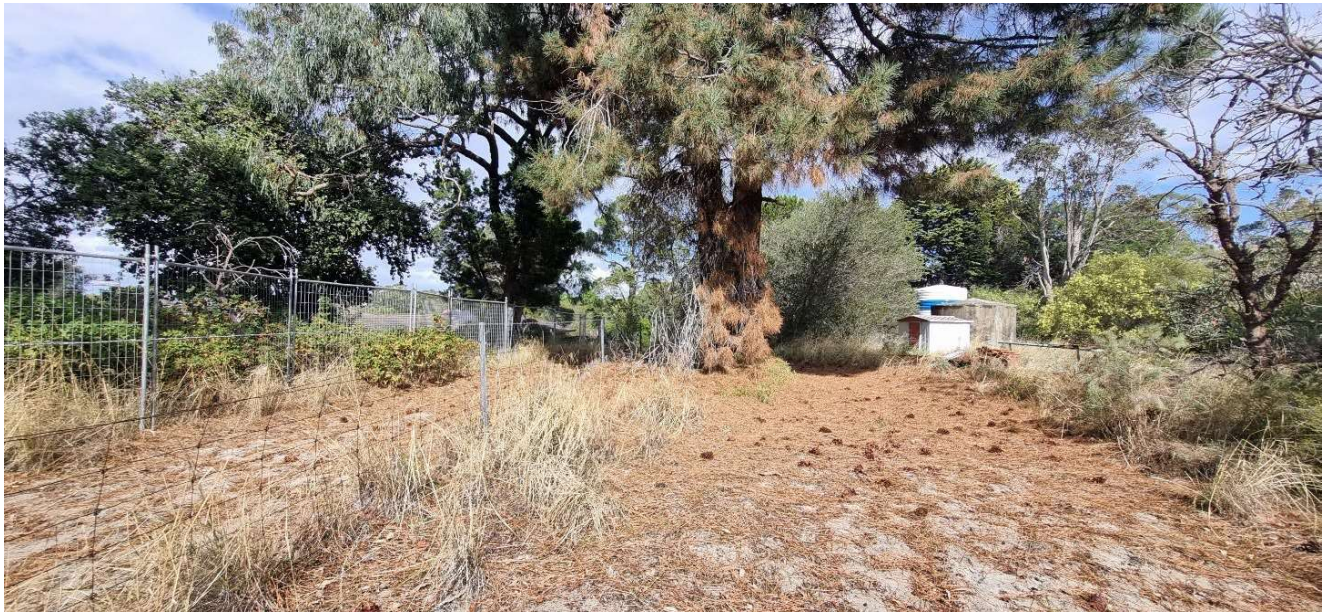
Image 5. Lot 28 on the left and Lot 27 shed on the right. This part of the site represents an area of Degraded vegetation as per the Spring 2022 survey.

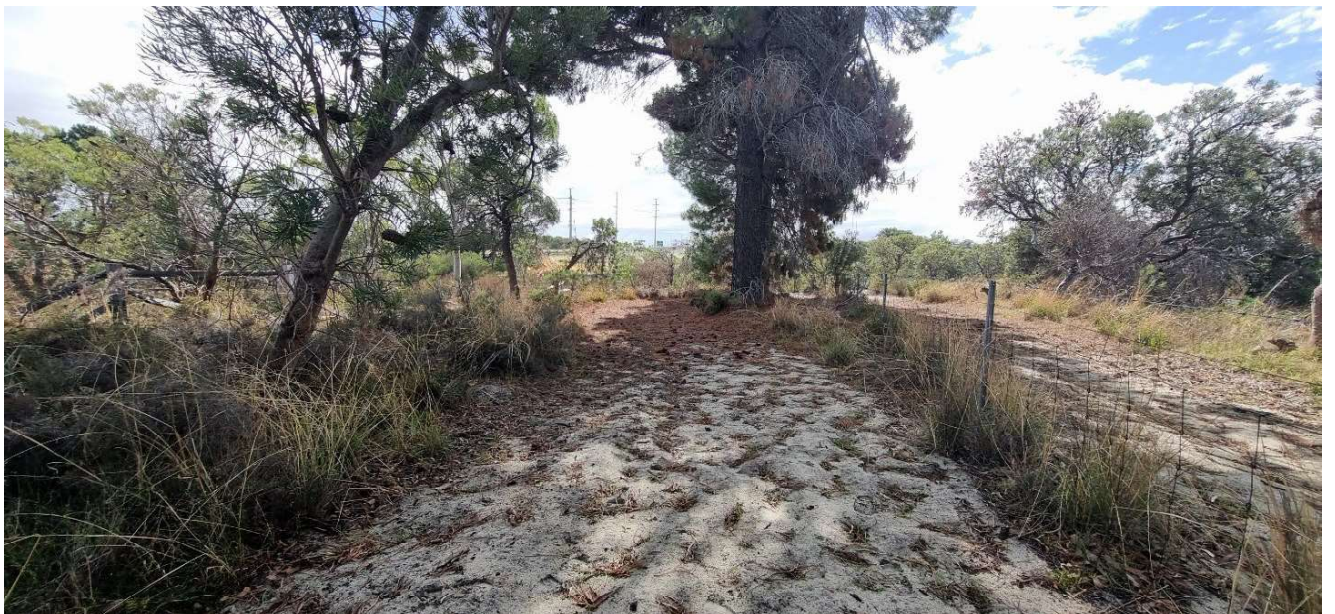
Image 6. Classed as Good vegetation on the left, as per the Spring 2022 survey. Lot 28 on the right.

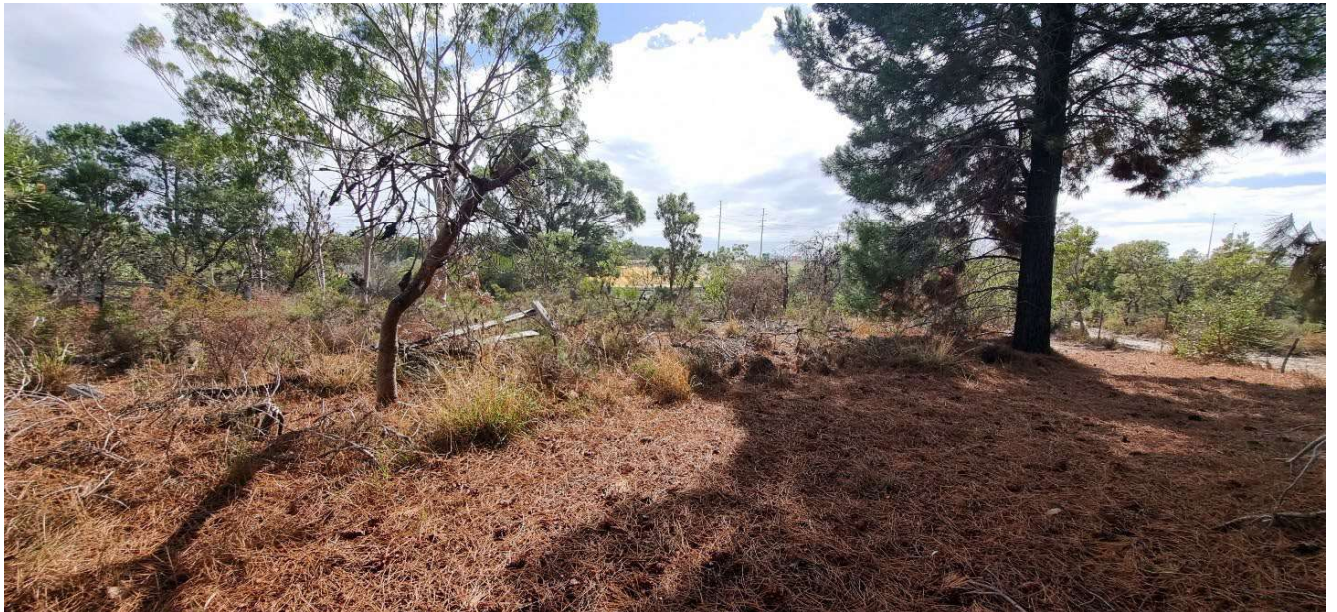
Image 7. Classed as Degraded vegetation on the left, as per the Spring 2022 survey. Lot 28 beyond the fence on the right.

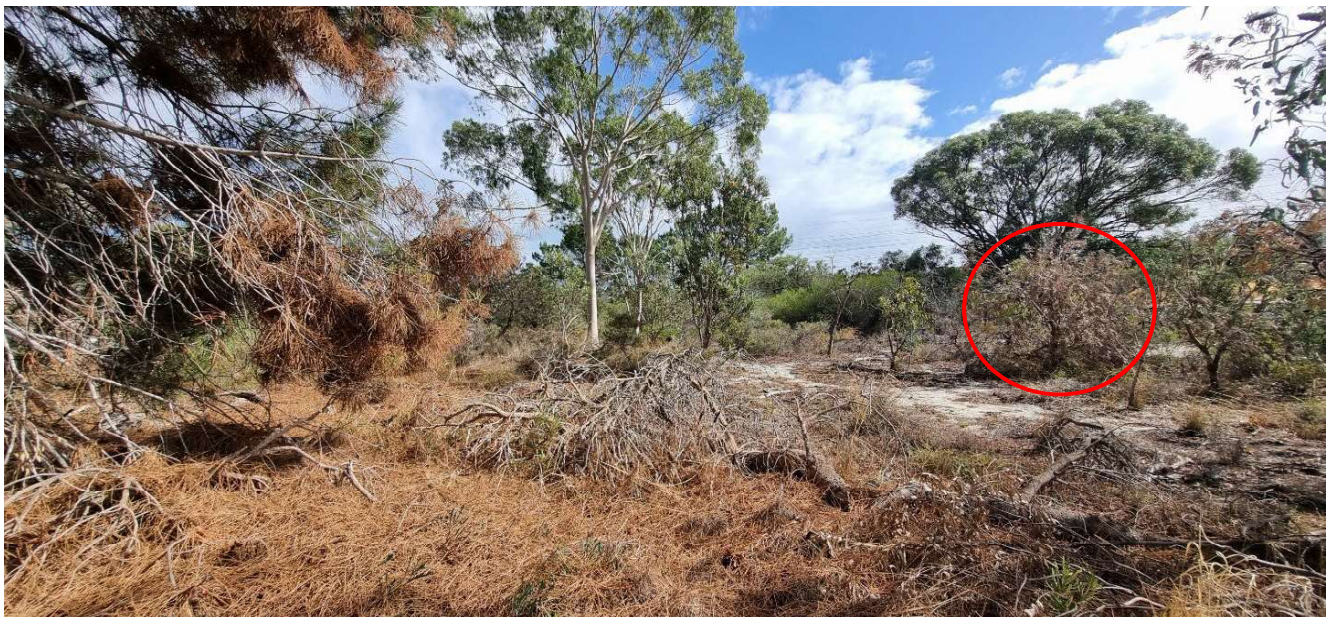
Image 8. Classed as Degraded vegetation on the left and becomes Good vegetation on the right. Suspect this is dieback infested, due to dead remnants of dead Banksias on the ground in the distance to the right (circled).

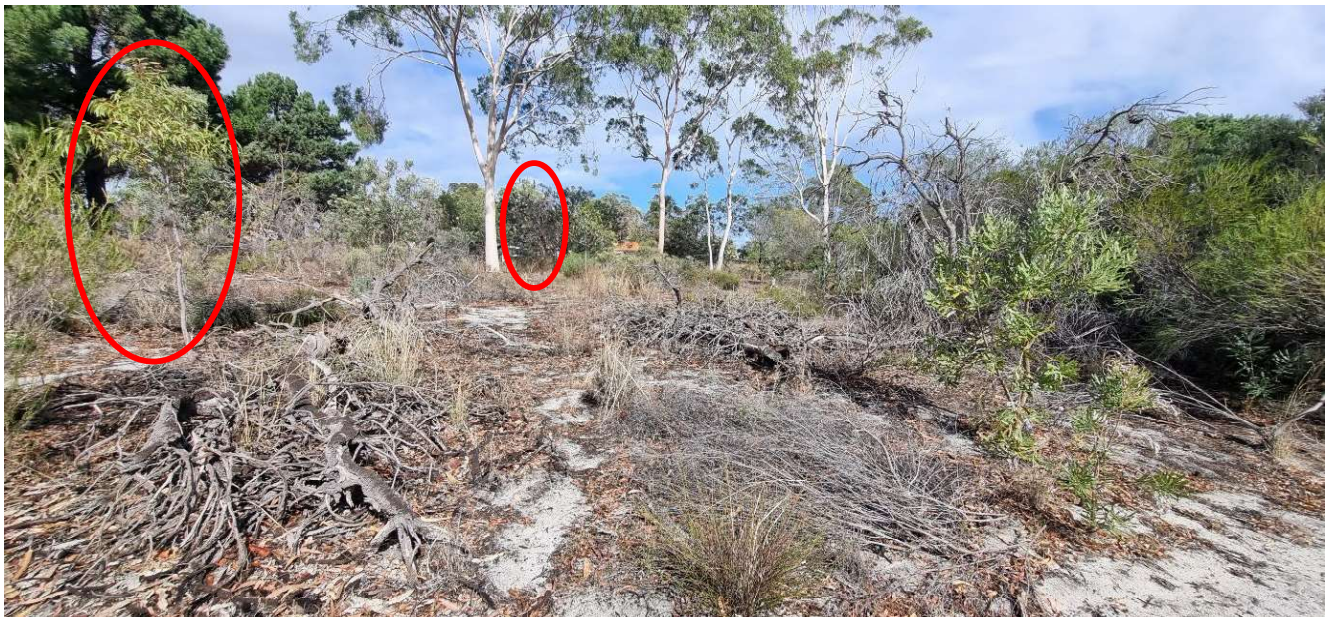
Image 10. Planted non endemic Eucalypts (red circles) and others in the background. The degradation is a suspected Dieback front. Not part of the 2022 spring survey area.

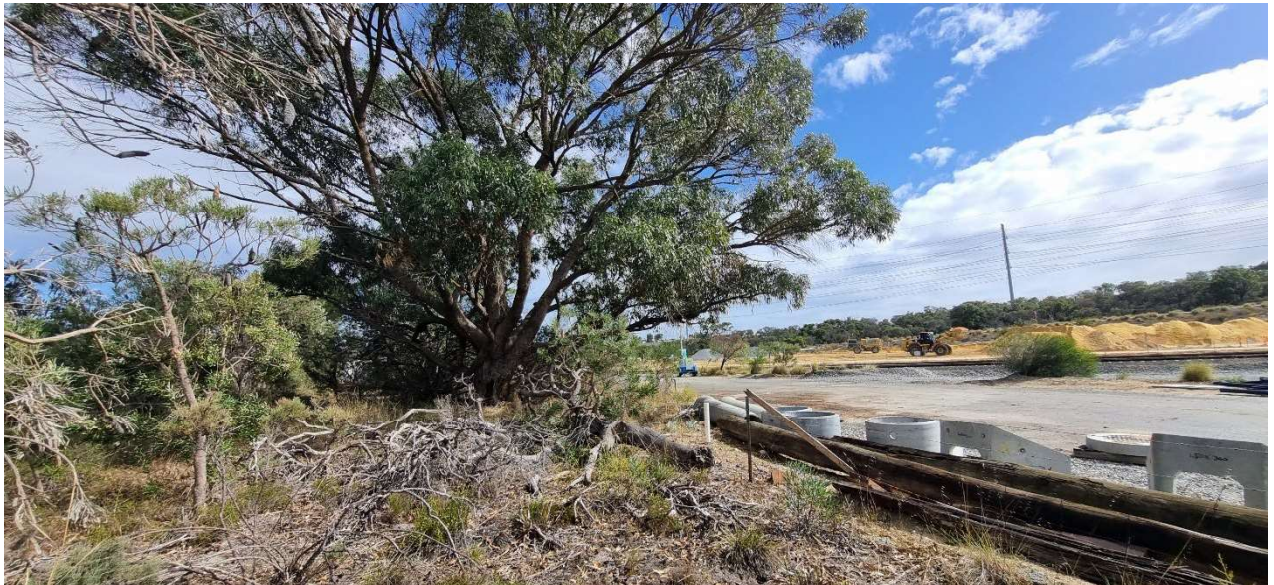
Image 11. Area to the west of the potential Threatened Ecological Community (TEC), and northern boundary of Lot 27. Potential Dieback infestation due to the remnant of dead Banksia's on the surface. Hope Road to the right.

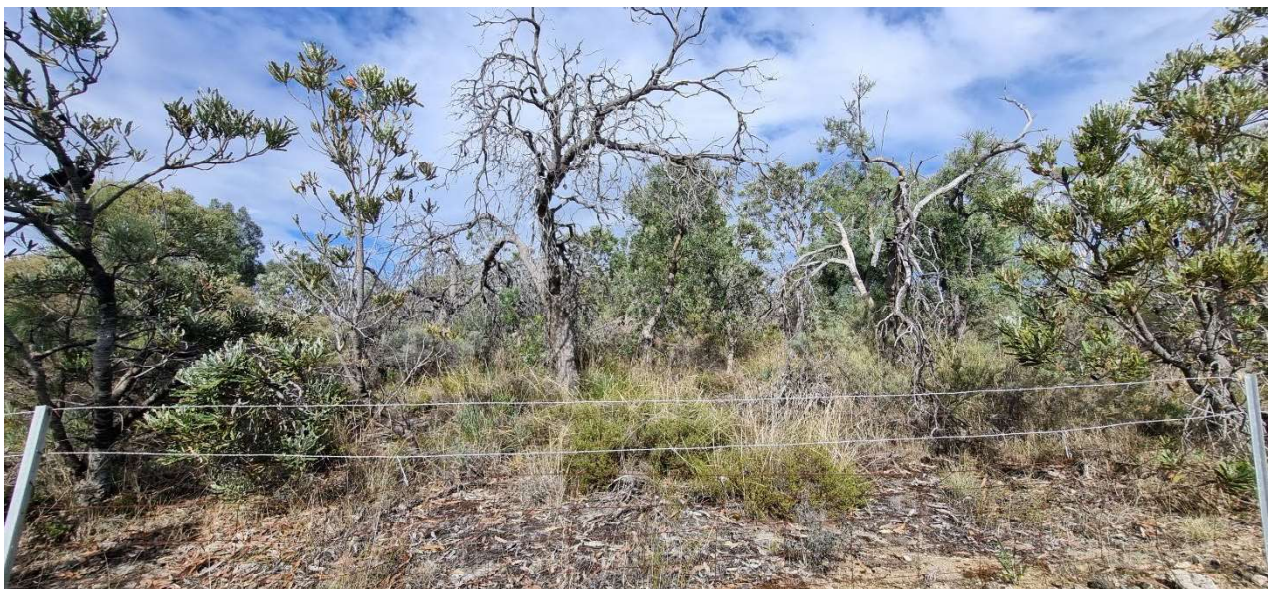
Image 12. Area of TEC in Good condition as part of the 2022 Spring survey and rated as Very Good in the Spring 2020 Survey. Image taken from of the northern boundary from Hope Road.

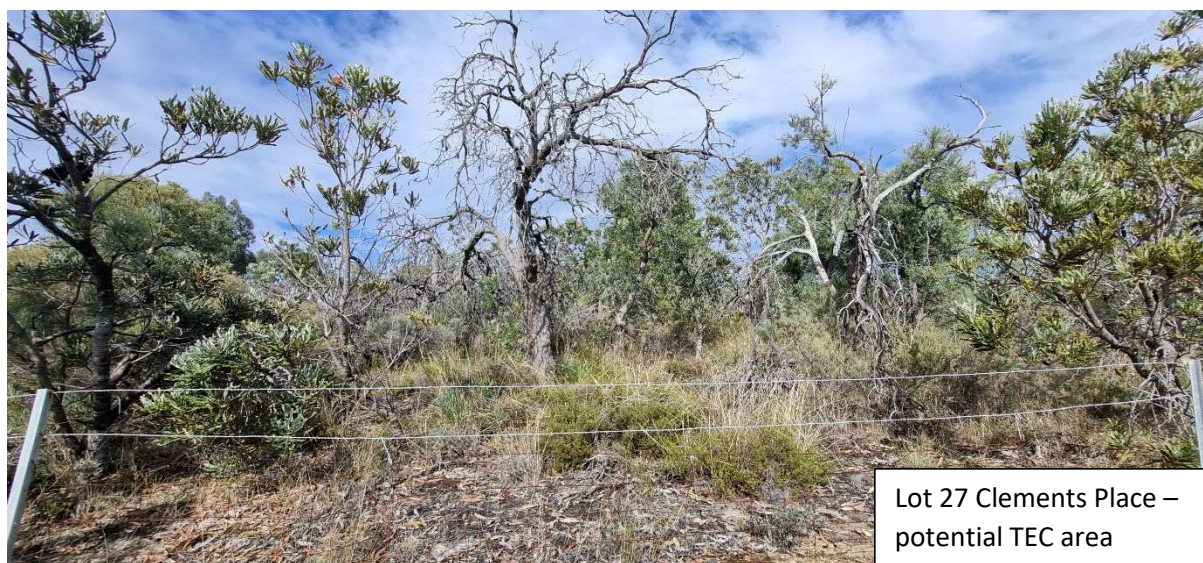
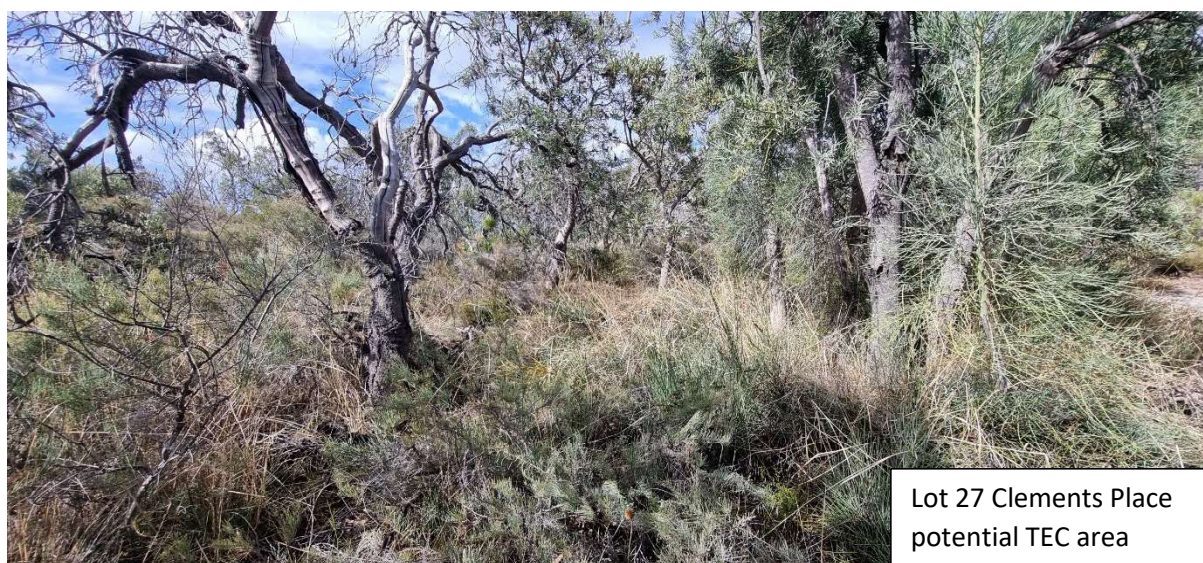
Visual examples of Banksia Woodland at Lot 27 Clements and nearby sites, to highlight the difference in condition. The nearby sites depicted below contain less weeds, more plant species and intact keystone species. Images taken on the 24th of April 2023.
