CPS 10333/1

***Request For Further
Information***

Revegetation Management Plan

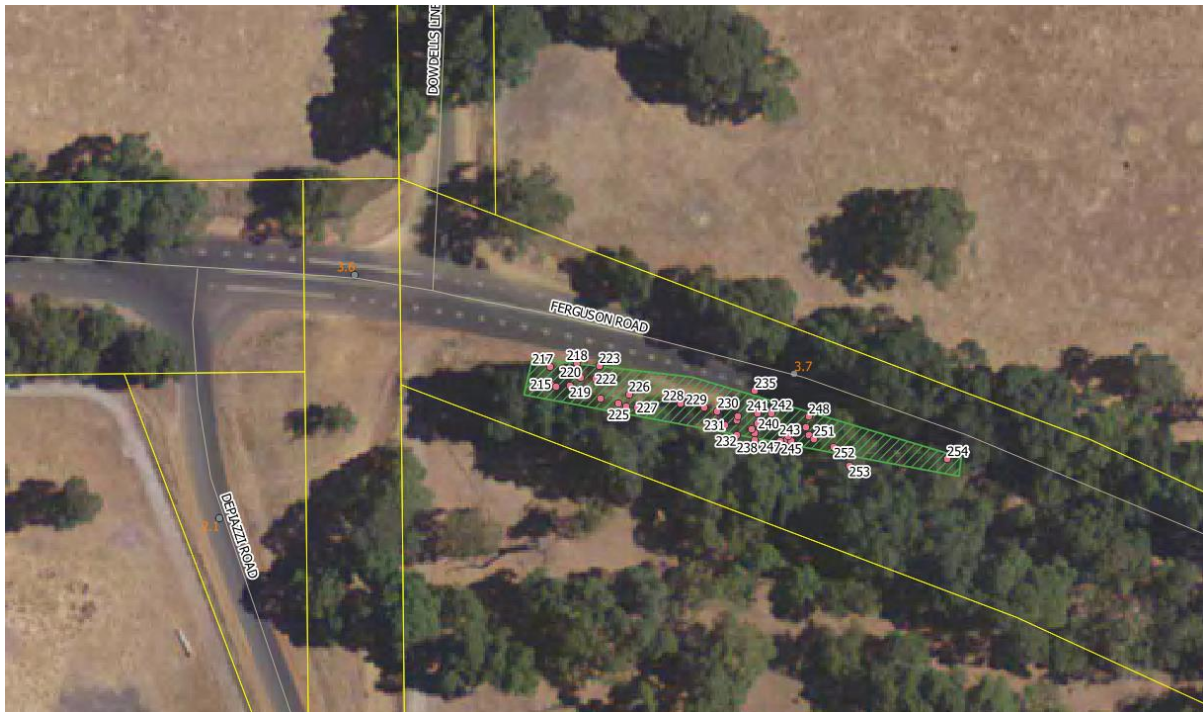
Image 1. Area proposed for clearing.

The clearing location is within a small section (0.07 hectares) of the southwestern side of Ferguson Road Reserve, just east of the Depiazzi Road intersection. Works are planned to implement safety upgrades to the intersection of Ferguson Road and Depiazzi Road, specifically line of sight issues. The Shire of Dardanup is the relevant Local Government with care, control, and management of the land as per Land Administration Act 1997. Please see Table 1 and Image 1 below.

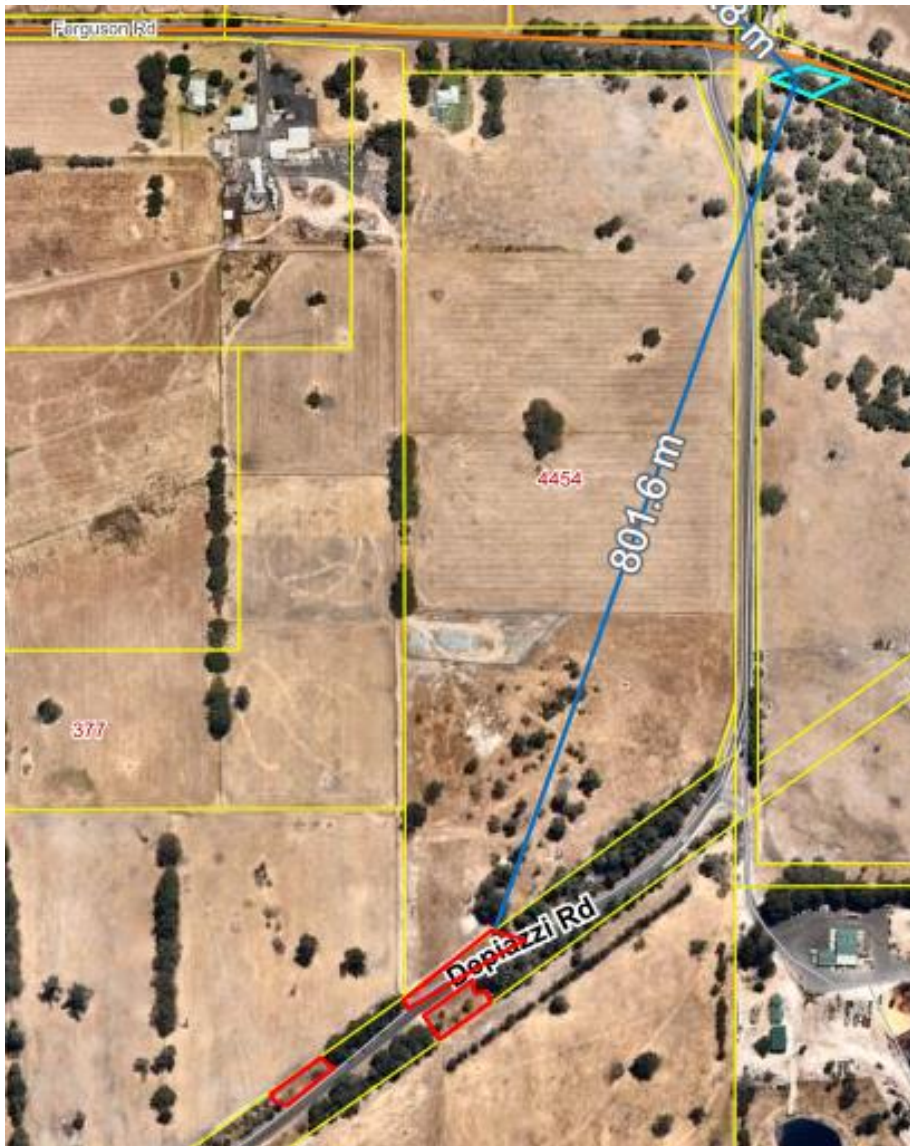
Image 2. Distance from the proposed clearing site (light blue polygon) to the beginning of the proposed revegetation sites (red polygon).

The revegetation sites are located within two nearby road reserves, located 800m+ southwest (as the crow flies) of the clearing permit location to the top of the revegetation areas along the selected road reserves. See Image 2.

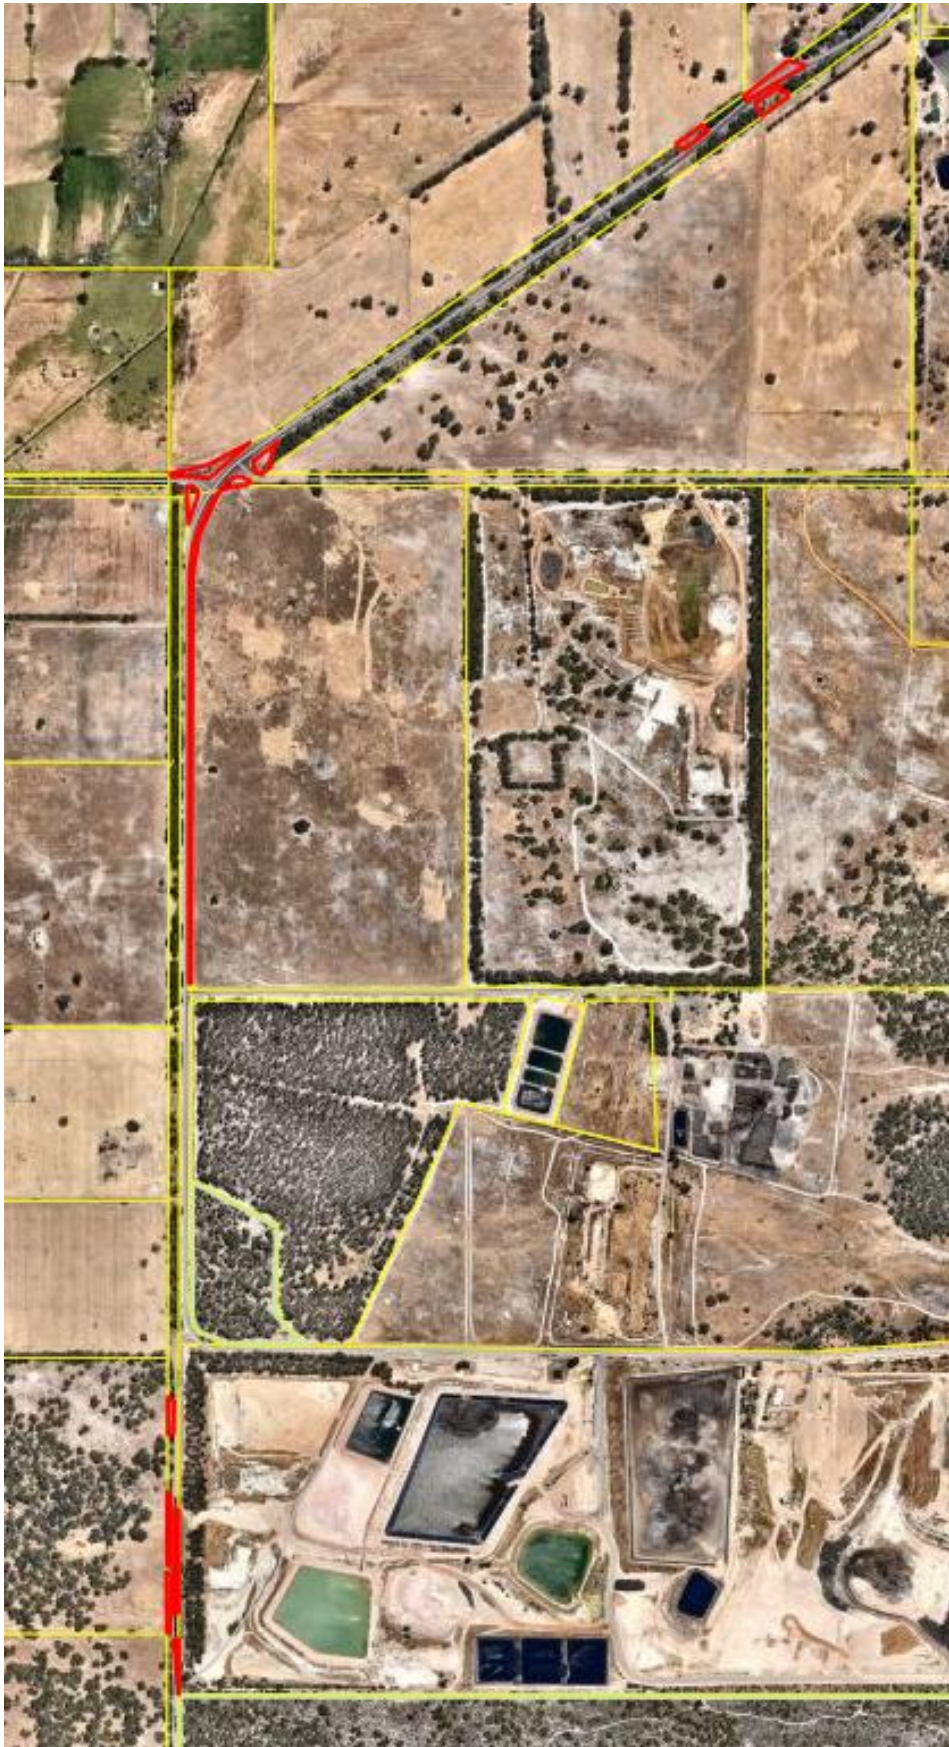
Image 3. Entire proposed revegetation sites along Depiazzi Road and Banksia Road (connection at intersection)

The revegetation locations are within the southern portion of Depiazzi Road Reserve and along the connecting Banksia Road (connected at intersection) See Image 3 further below. This is to link to the DBCA Dardanup Conservation Park.

NOTE: The revised revegetation areas excludes six pockets from image 3 refer to Schedule 1 Figures 2, 3 & 4 of Permit CPS 10333/1

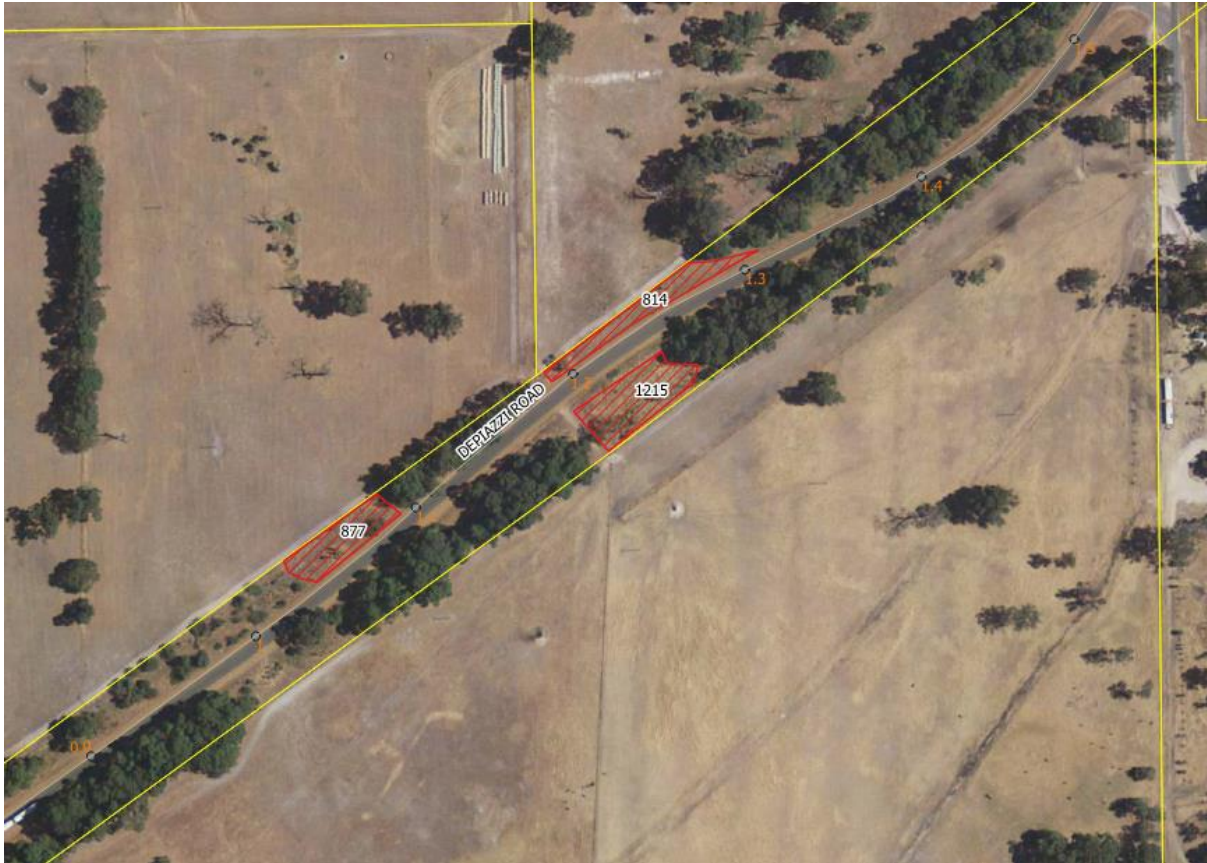
Image 4. Depiazzi Road Revegetation Sites

NOTE: The revised offset of Permit CPS 10333/1 includes all areas of Image 4

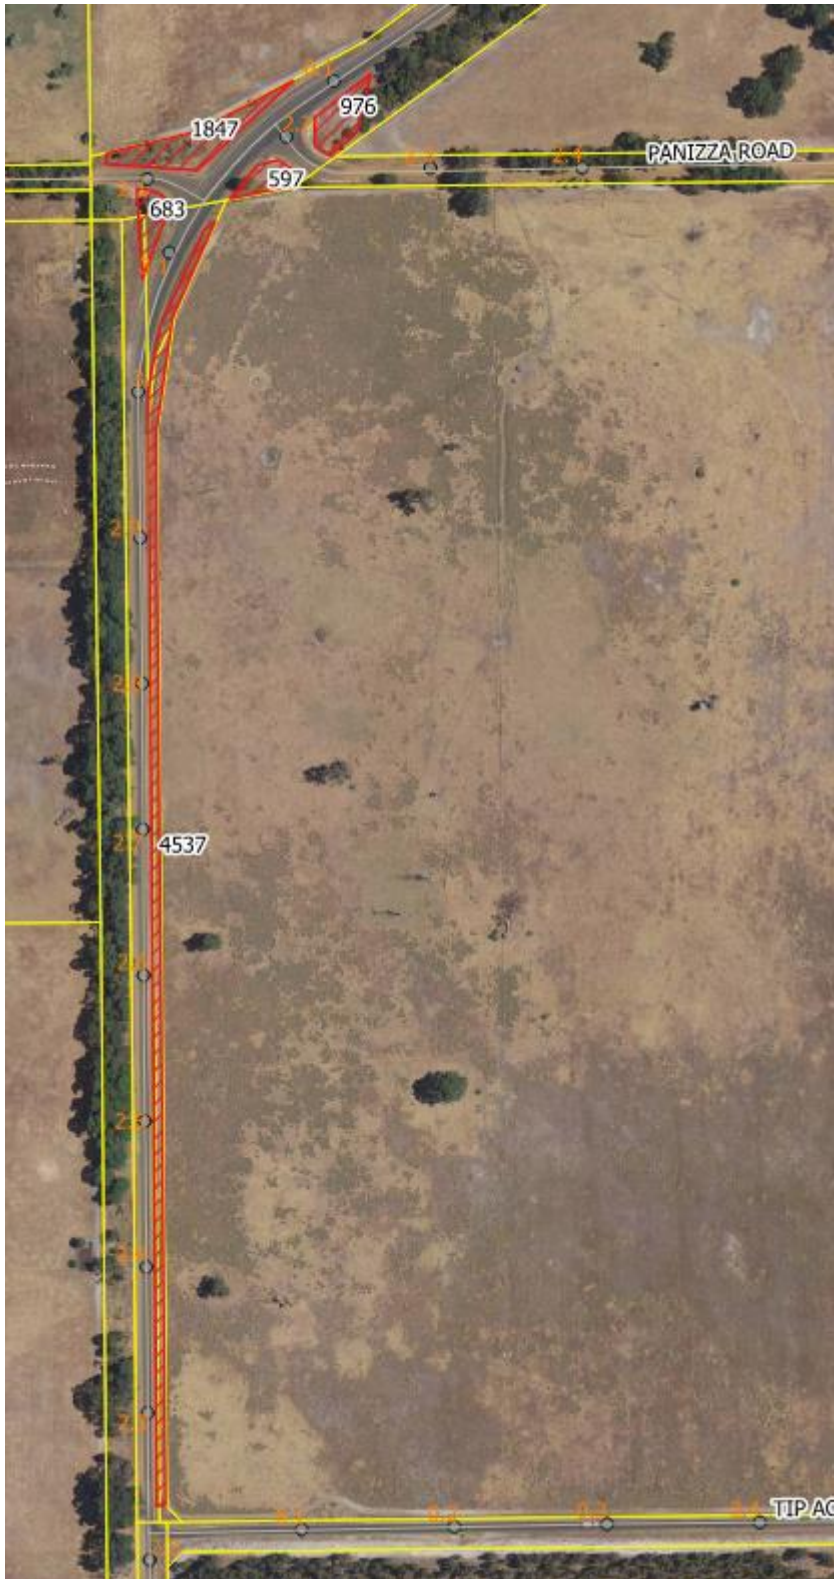
Image 5. Banksia Road (north and mid) Revegetation Sites

NOTE: The revised offset of Permit CPS 10333/1 **includes only** area 1847 depicted in Image 5

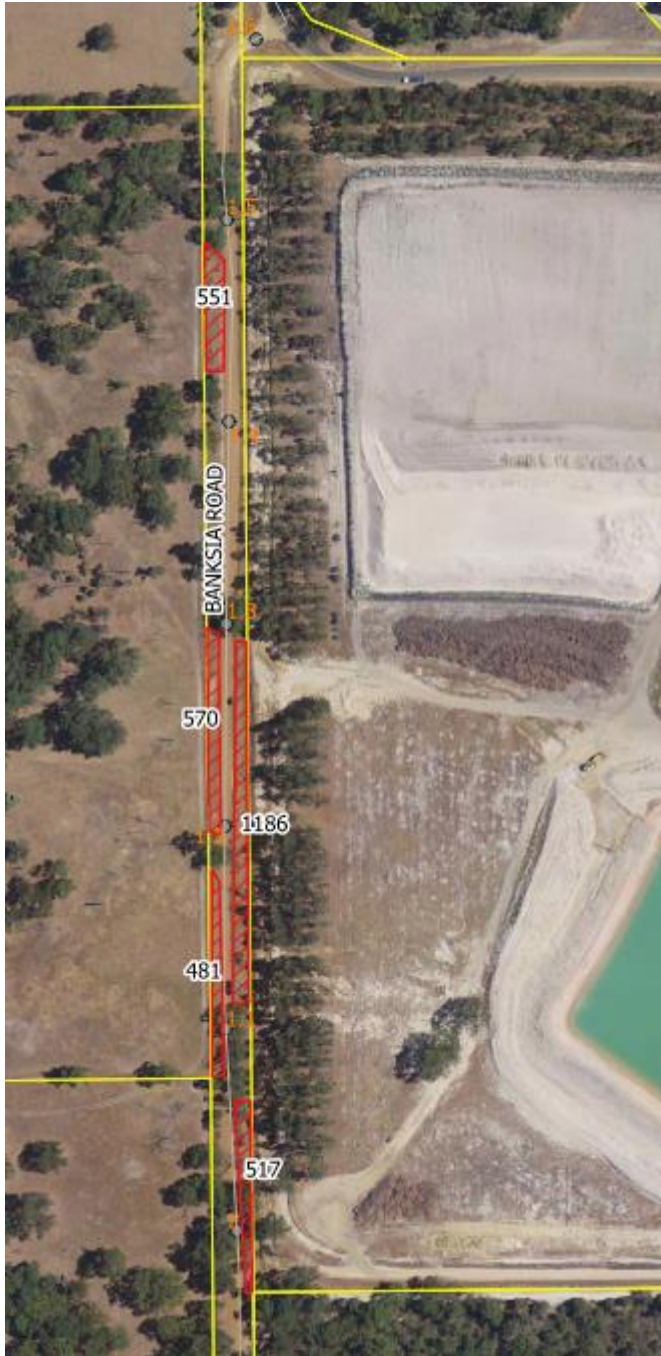
Image 6. Banksia Road (south) Revegetation Sites

NOTE: The revised offset of Permit CPS 10333/1 includes areas 551, 570 1186 depicted in Image 6

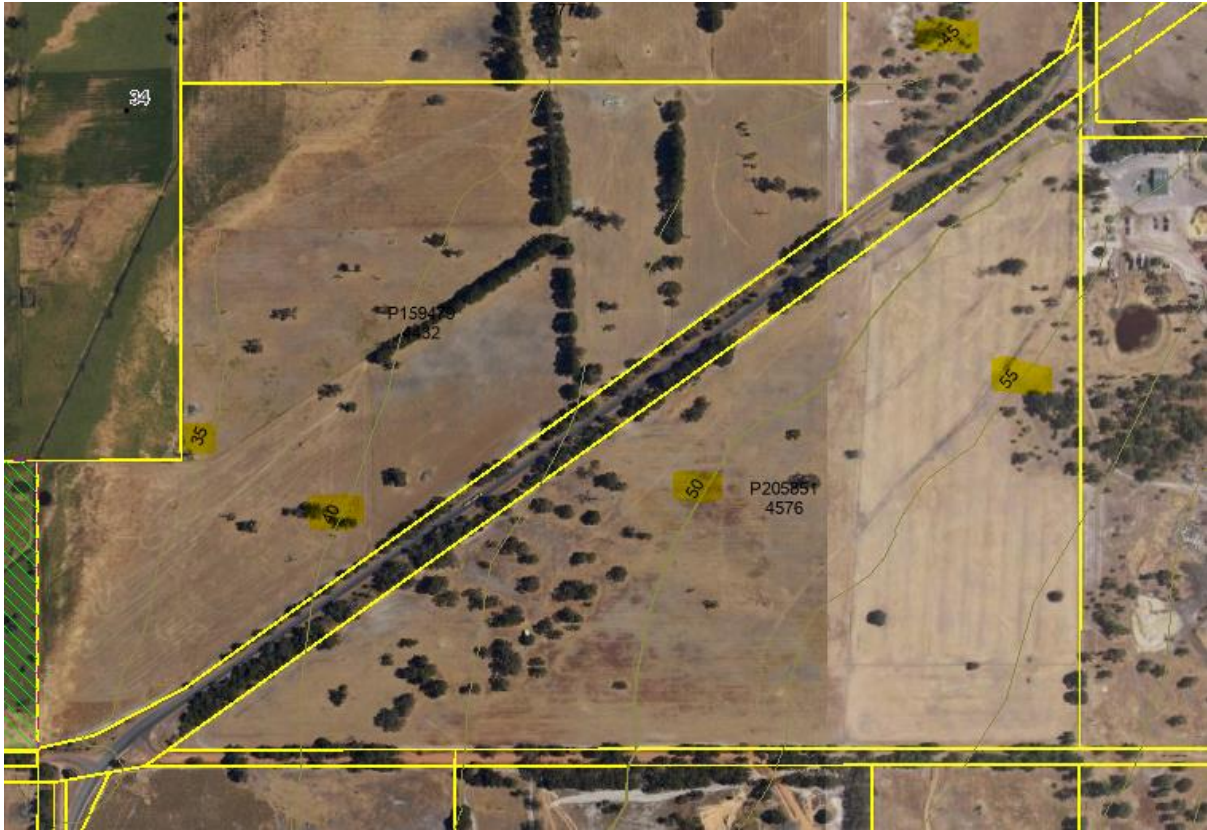
Image 7. Contours

The 213FoCSc landform is noted as neither water gaining nor water shedding, with good infiltration but only moderate storage capacity due to coarse texture. Surface water resource as apart of the Middle Preston (4) Area of the Southwest Division. This catchment flows towards the Leschenault Estuary. The unconfined aquifer is the Perth Swan Superficial. Both surface water and groundwater are classified as unproclaimed. There is a 13 - 15m decline from the most northern portion of Depiazzi Road to the south. Surface water flows in an east direction as shown in the contour mapping within Image 7. below. Banksia Road sits stable at 35m-45m.

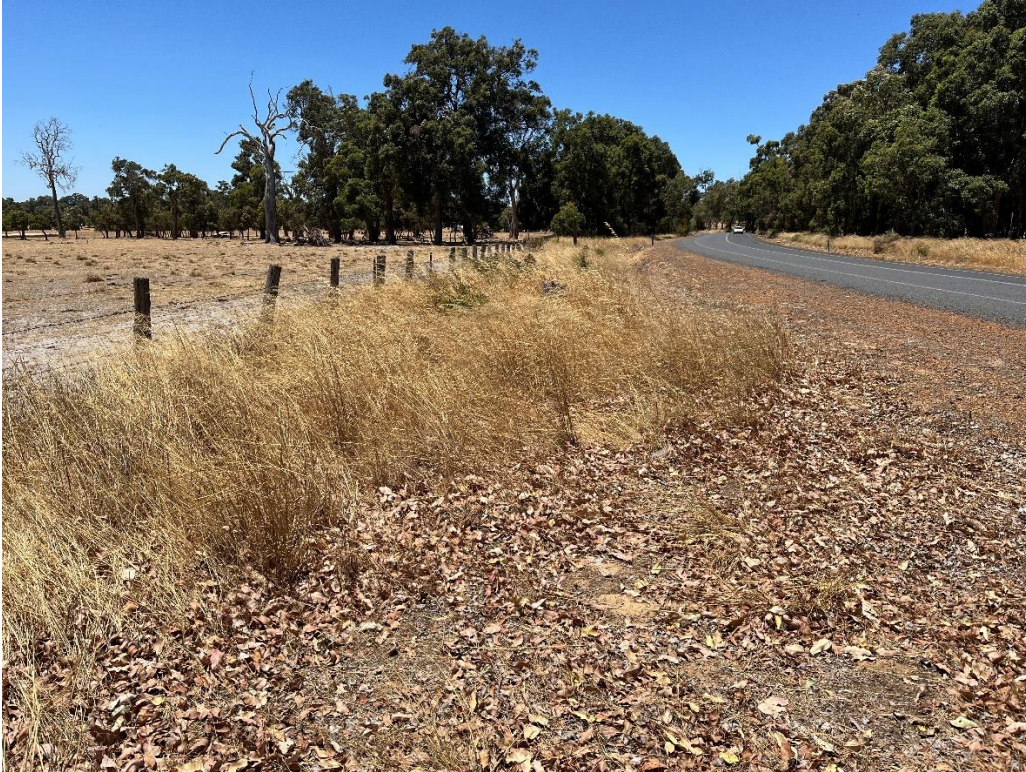
Image 8. West side of Depiazzi Road, looking north

Below are some images of cleared zones in the northern portion of the revegetation sites. Some understorey exists, mainly of *Xanthorrhoea sp.* and *Macrozamia riedlei*. Image 8 shows the west side of Depiazzi Road, looking north. Image 9 shows the east side of Depiazzi Road, looking north.

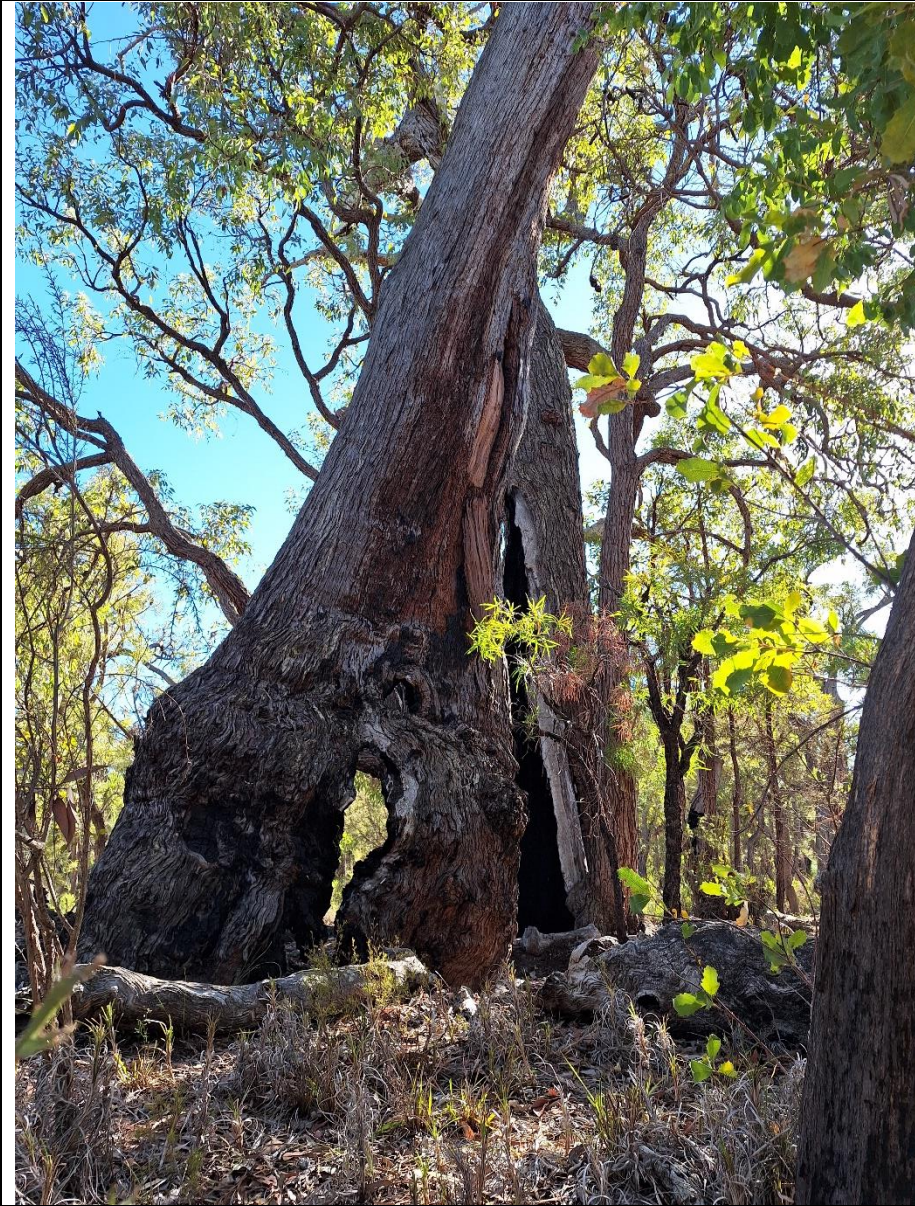
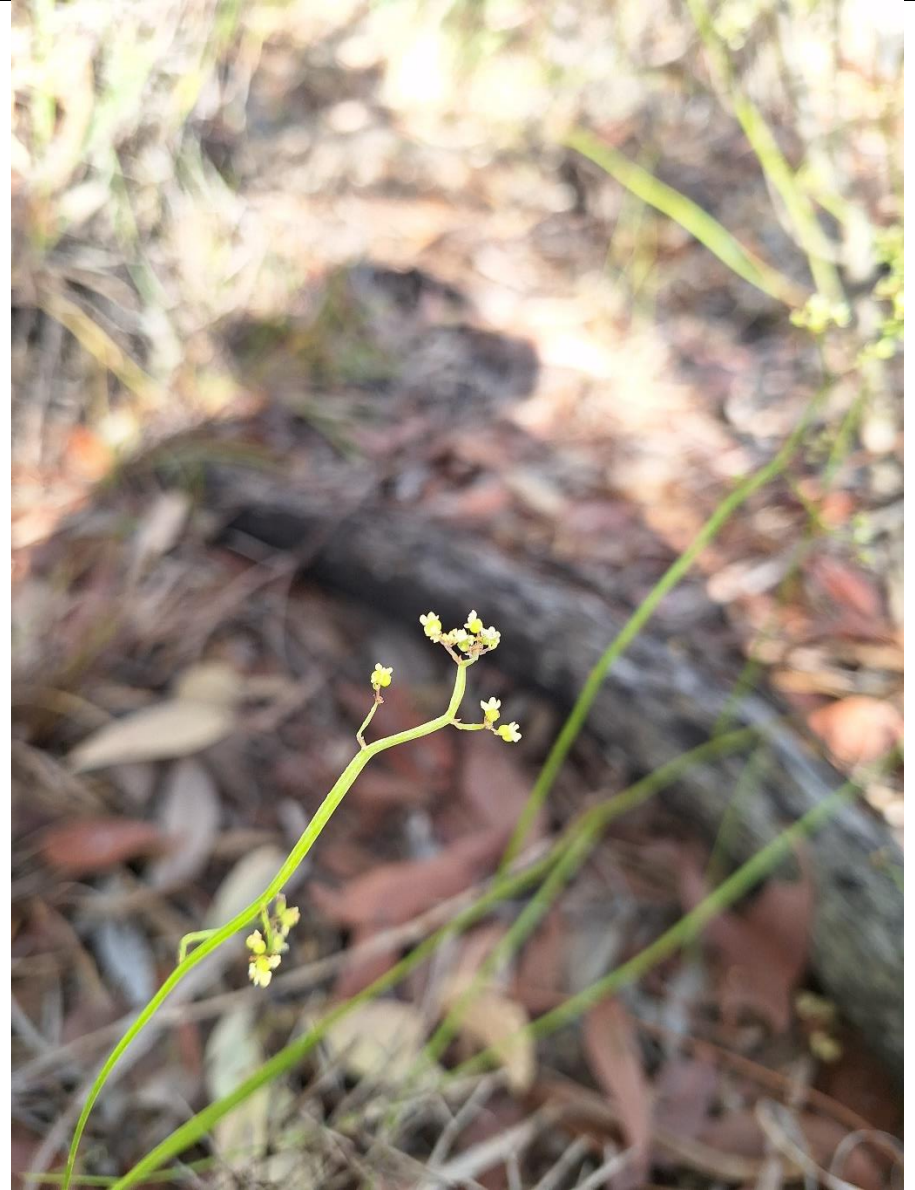
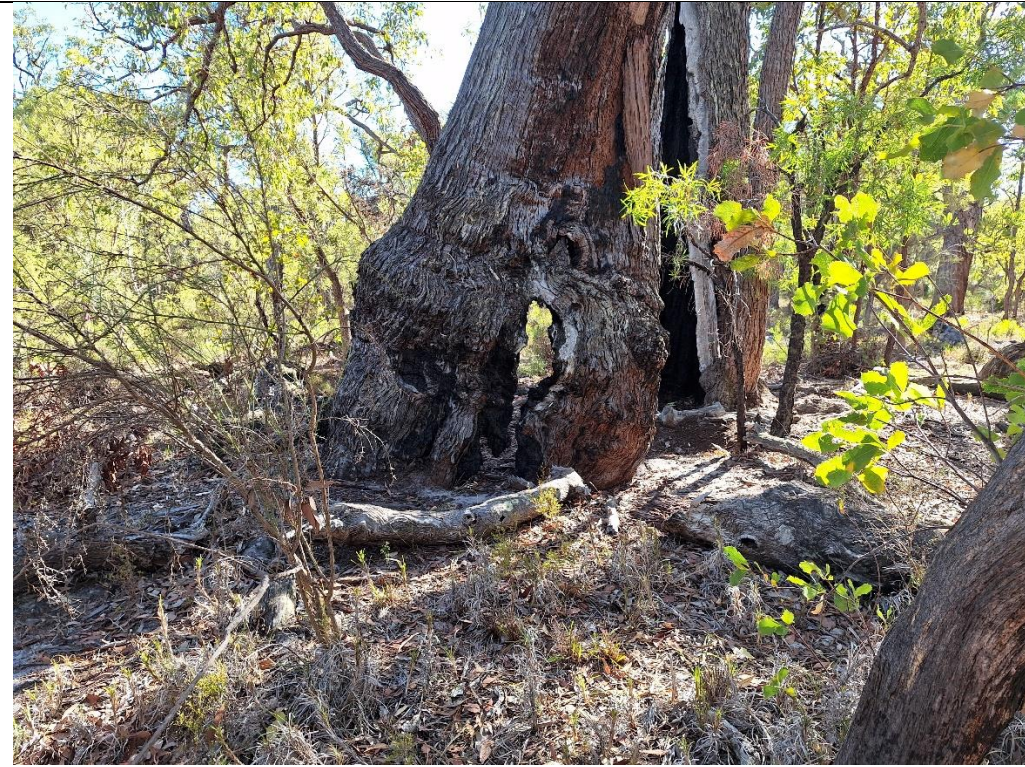
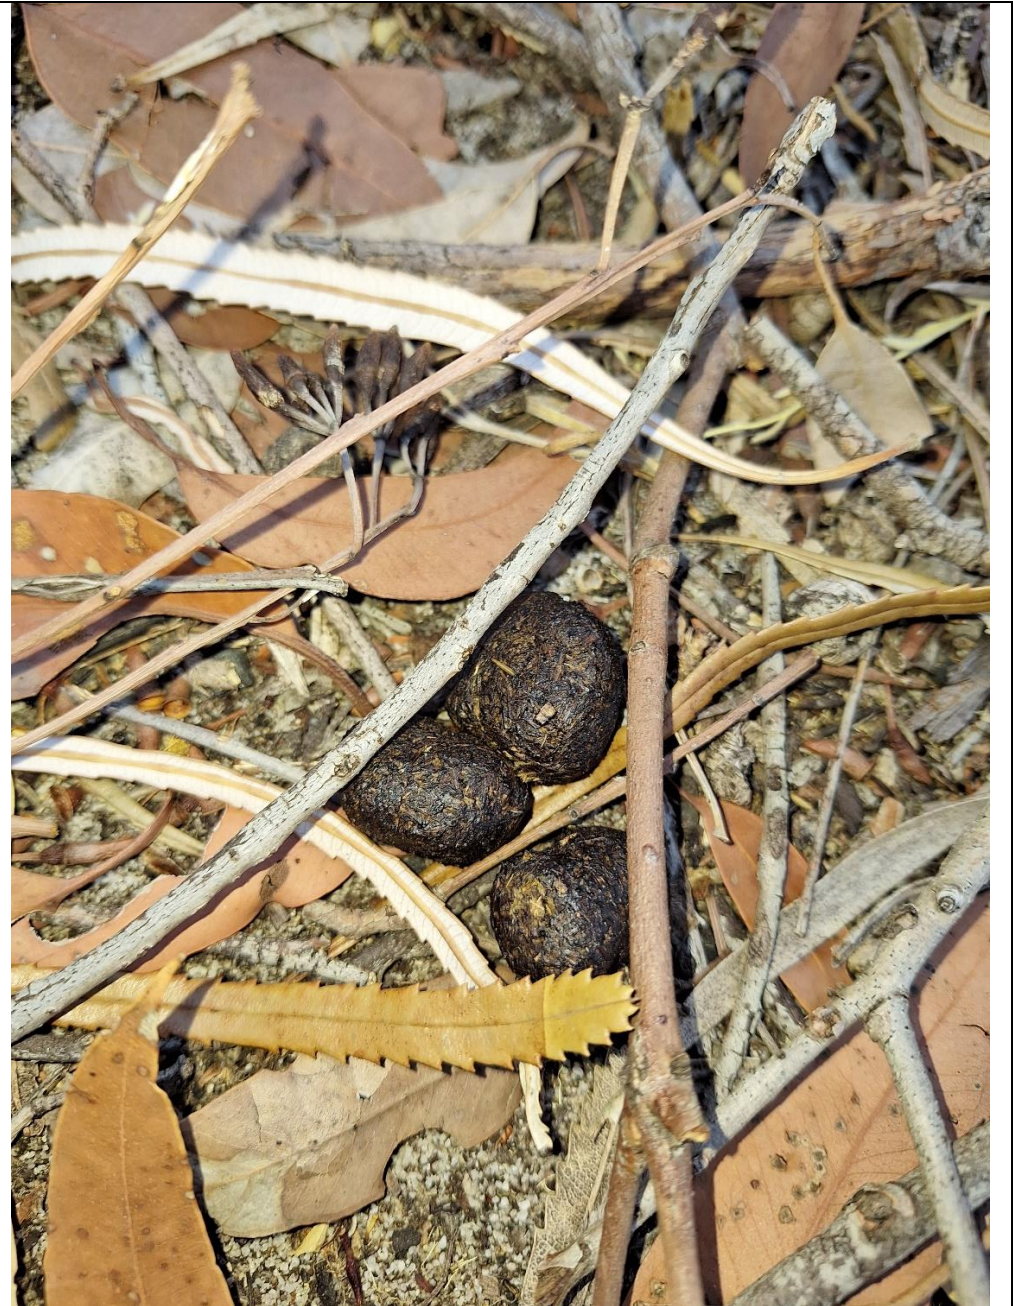
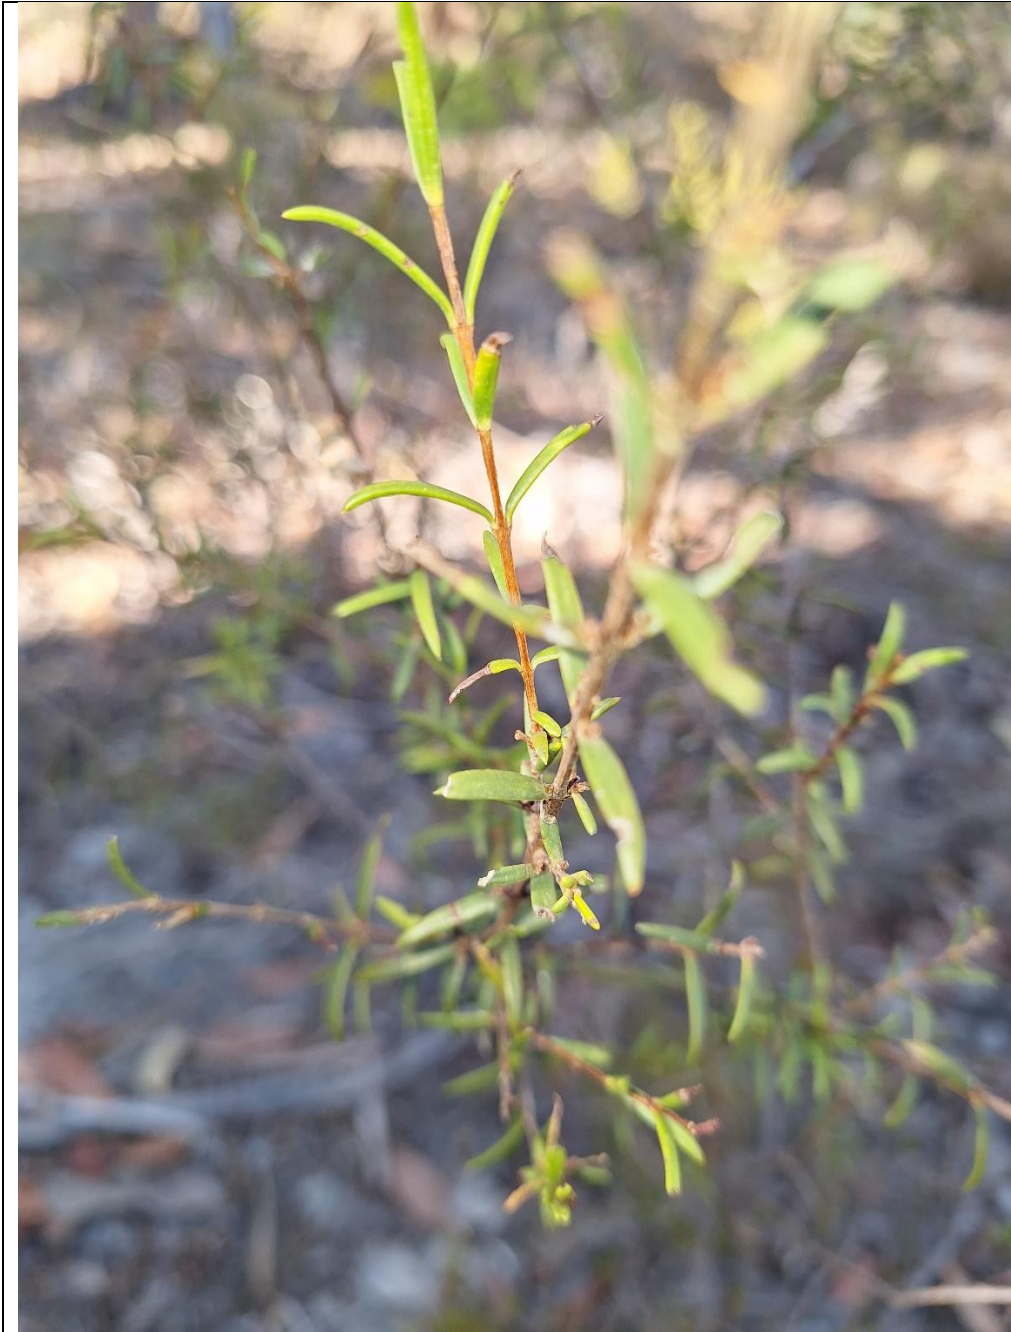
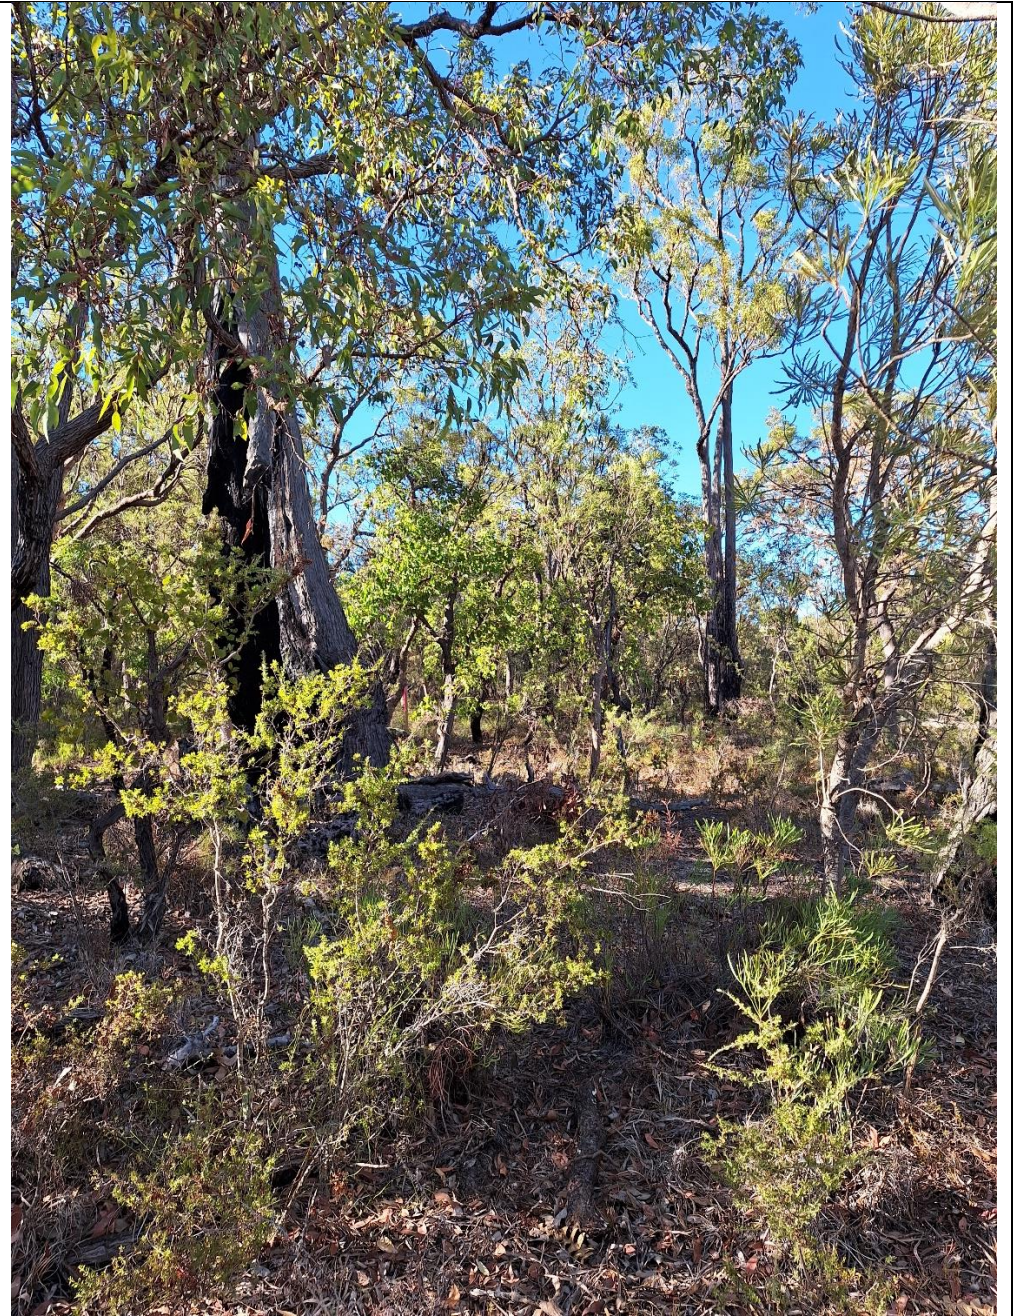
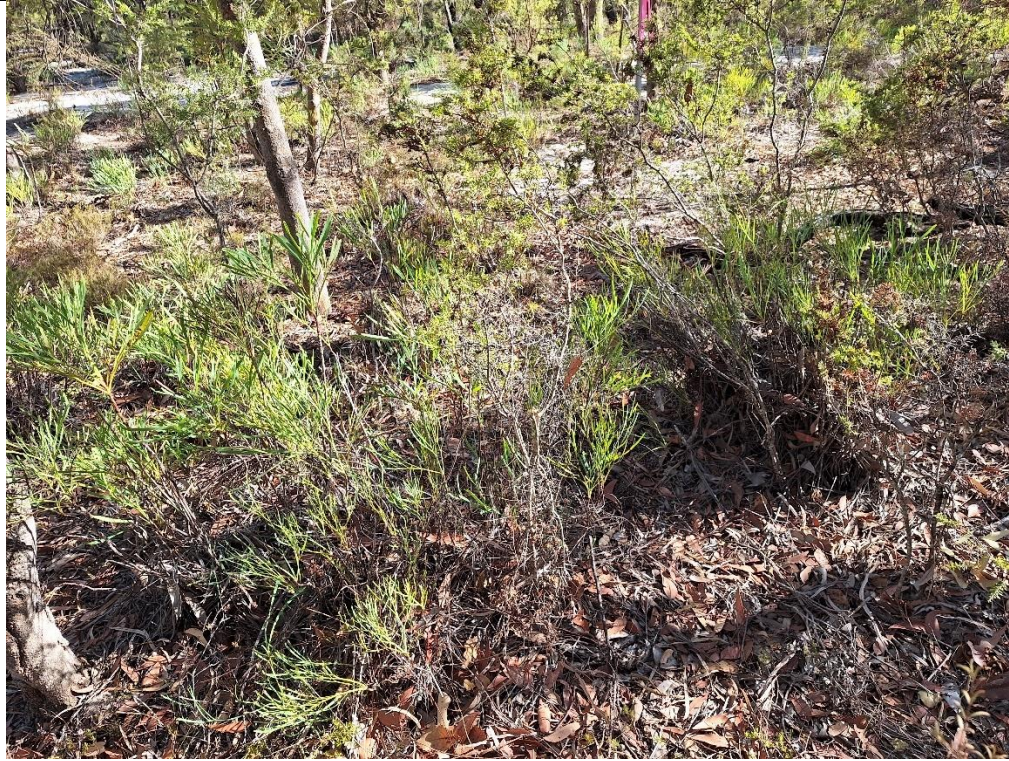
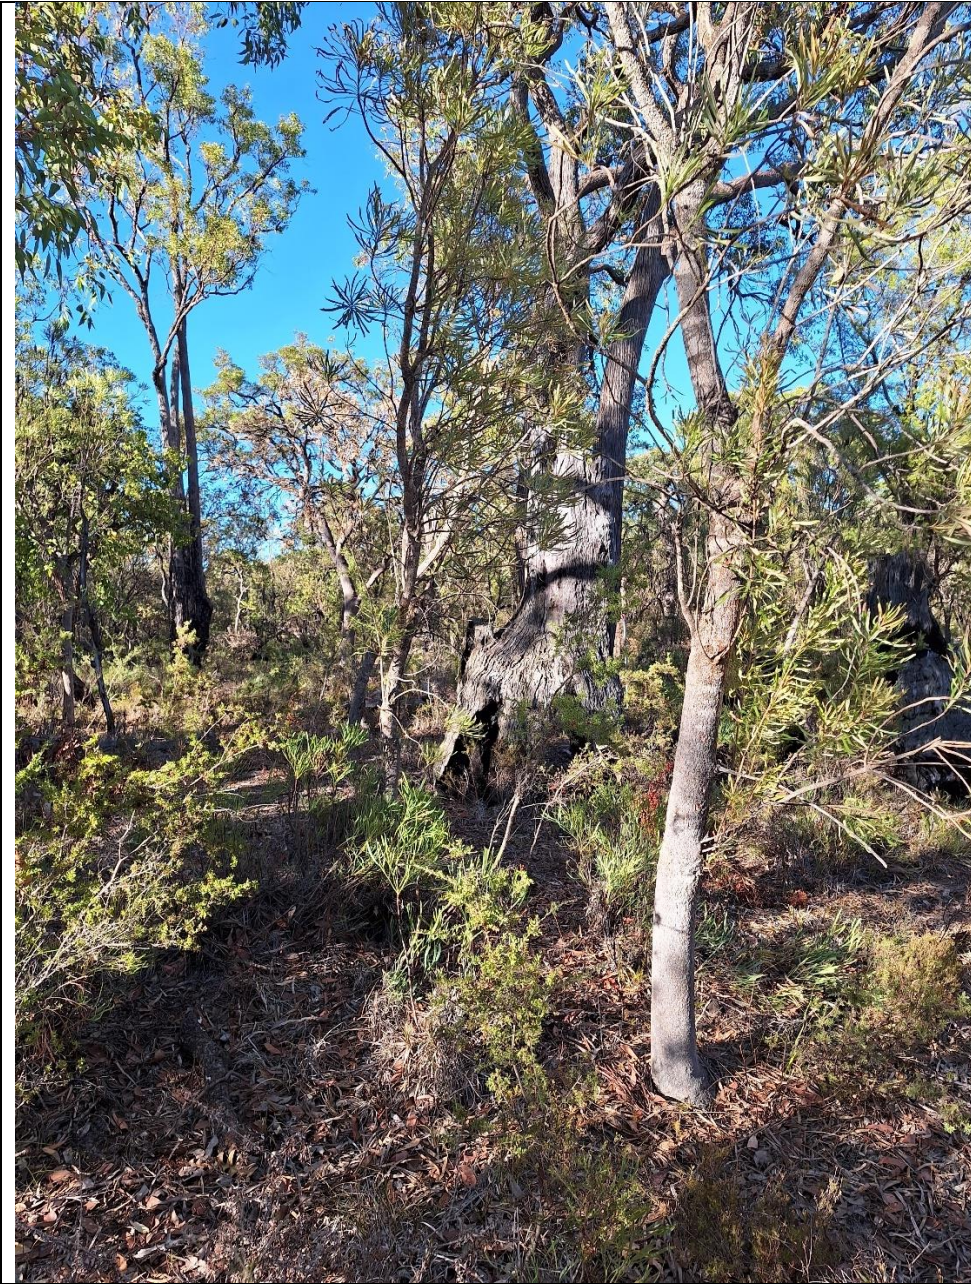
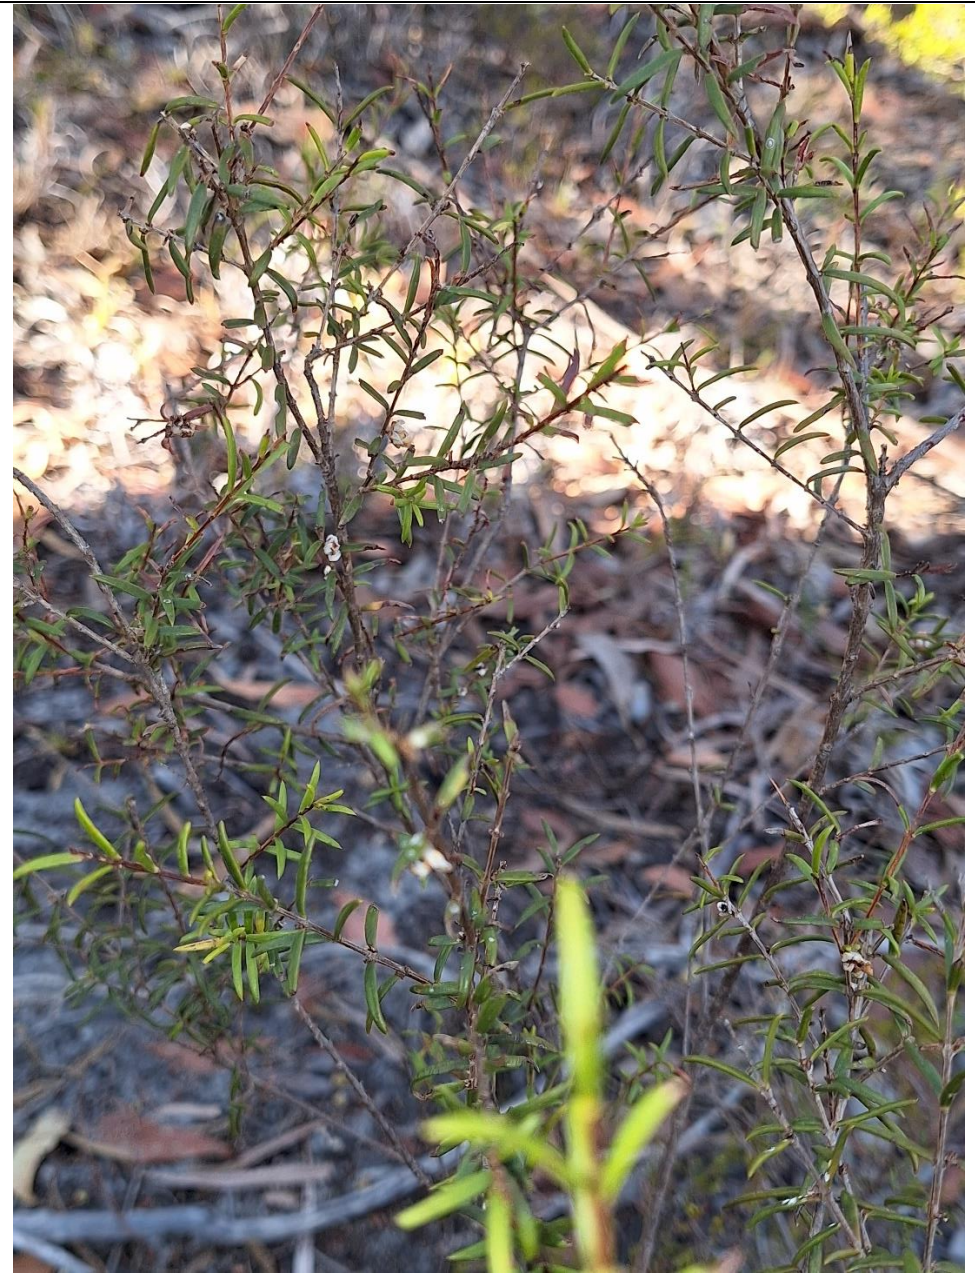
Vegetation structure - Muir (1977)	Low Open Forest to Open Forest	
Vegetation condition - Keighery (1994)	Very Good	No weeds present, vegetation structure altered in the groundcover. Strong evidence of kangaroo grazing (scats)
% Bare ground	60%	See above
Photos	On next five pages
