# Revegetation Management Plan

Dam and Drainage Line at Lots 9951 and 9952,  
Boorara Brook

JUNE 2025

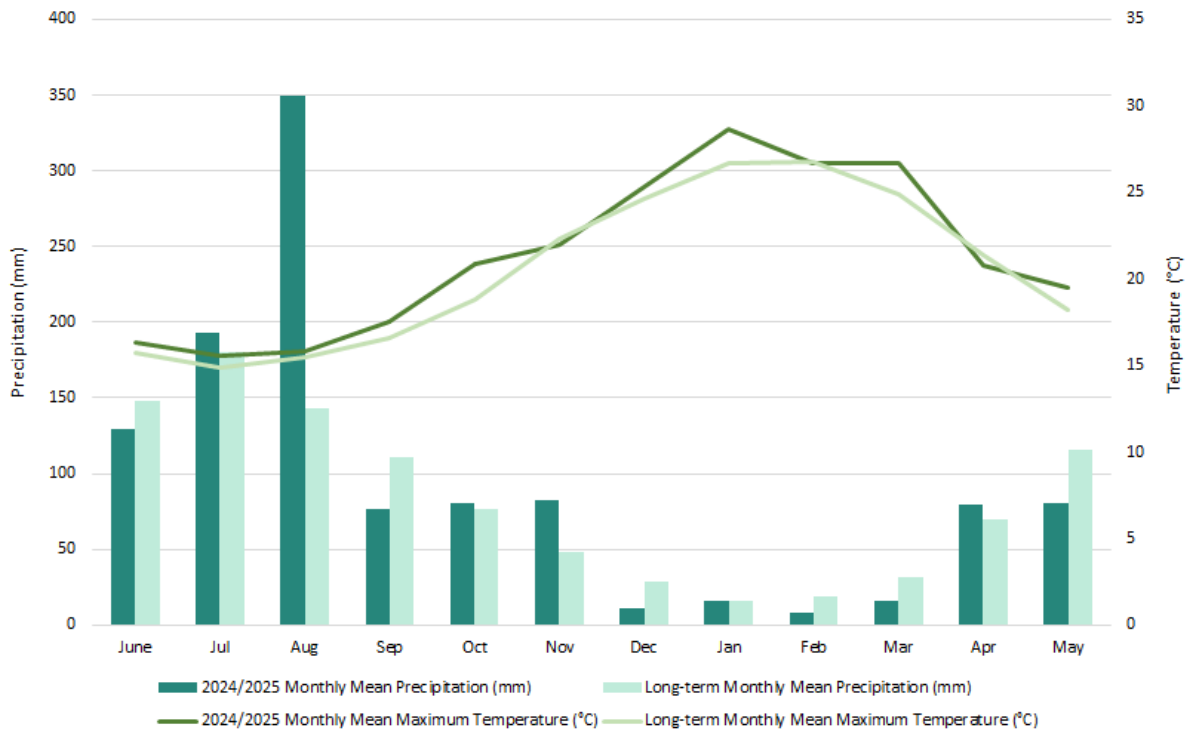
Weather records from 2024/2025 indicate that temperatures have exceeded the long-term average over nine of the 12 months preceding the site visit. Precipitation recorded between June 2024 and May 2025 exceeded the long-term average by ~134 mm. The month of greatest variation between long-term and recent rainfall was experienced in August 2024, with a value ~206 mm above average (Graph 1).

Graph 1 Temperature and rainfall data from the Shannon station (station number 9960) (BoM, 2024)

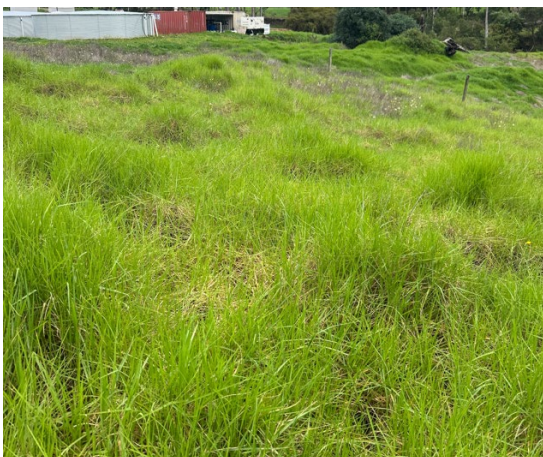
The majority of the revegetation Survey Area consisted of paddock-cleared, weedy grasses and forbs or cleared ground (Photo 3-3, Photo 3-4). Some small patches of remnant vegetation existed in the eastern paddock revegetation area (Photo 3-5, Photo 3-6). The presence of introduced species was high, with weed presence further discussed in Section 4.4.

Photo 3-1 Revegetation area containing weedy grasses and forbs

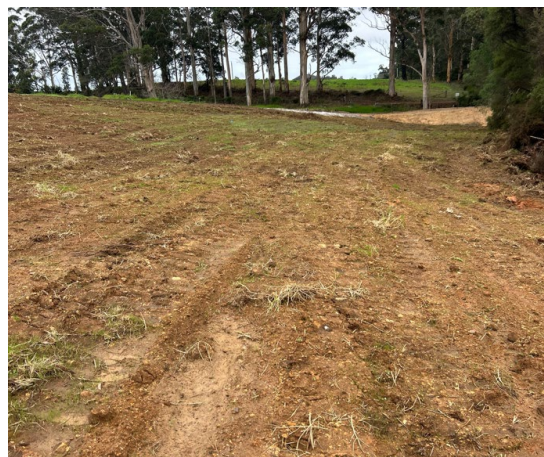
Photo 3-2 Cleared ground within revegetation area

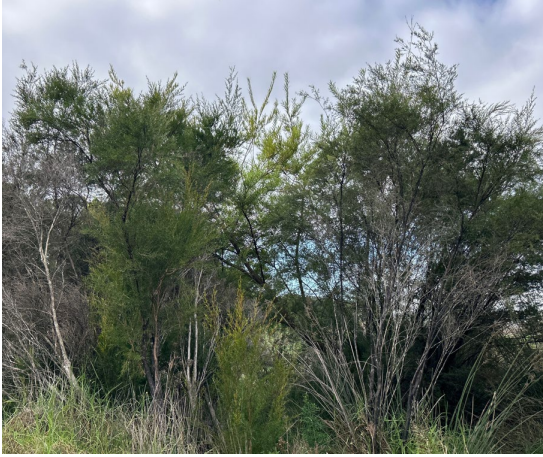
**Photo 3-3** Remnant patch of vegetation in eastern paddock revegetation area

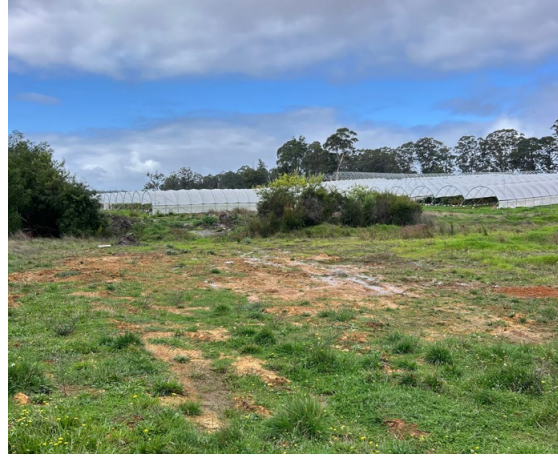
**Photo 3-4** Fragmented patches of remnant vegetation and weeds in eastern paddock revegetation area

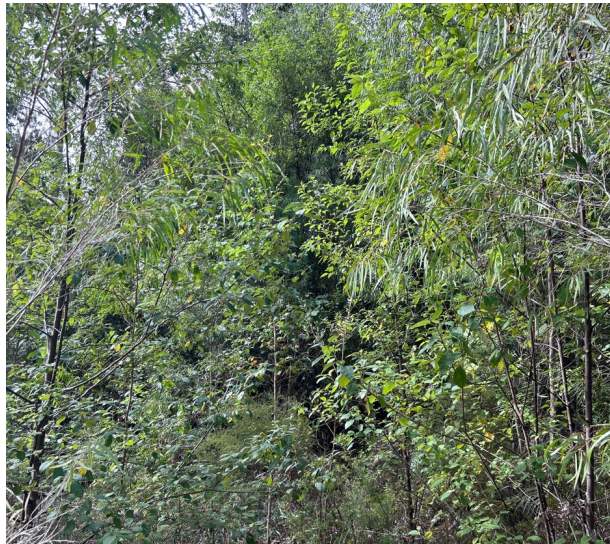
Remnant vegetation adjacent to the Survey Area consisted of *Eucalyptus diversicolor* tall open forest over *Allocasuarina decussata* isolated clumps of mid trees over *Agonis flexuosa* and *Banksia* spp. low trees over closed shrubland over various sedges, ferns and forbs (Photo 3-5). The location of reference vegetation is presented in Figure 2 (Appendix A). The reference site occurred on the same soil type as the revegetation area, and was in Very Good to Excellent vegetation condition (EPA, 2016). A list of vascular flora taxa recorded during the survey, inclusive of species within reference vegetation is presented in Appendix C.

**Photo 3-5** Reference vegetation

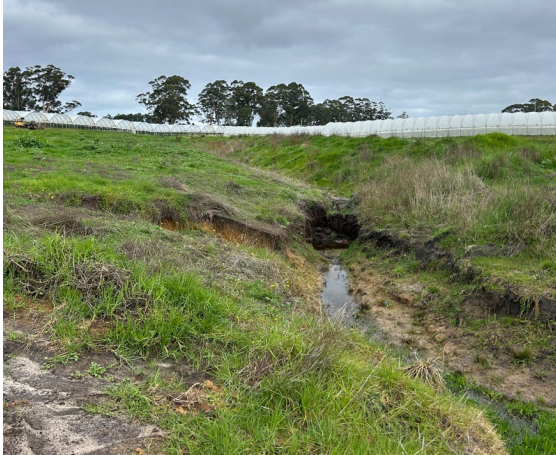
A drainage line runs in a northeast direction through the eastern paddock revegetation area (Photo 3-6, Photo 3-7). An erosion gully has formed along the drainage line.

**Photo 3-6 Drainage line in eastern paddock revegetation area**

To ensure the success of revegetation efforts within the drainage line and surrounding paddock area, the existing drainage line should be widened and reshaped. The drainage line presents a significant erosion risk in its current condition, and ground preparation is required prior to any planting in the area. As aforementioned, the current drainage line has become an erosion gully, with steep banks present.

Ground preparation recommended at the site includes widening of the drainage line banks and reshaping to achieve a gentle gradient of the bank into the waterline. The objective would be to make the drainage line shallower and wider, consequently slowing the water down and achieving channel stabilisation with the added effect of revegetation of channel banks.

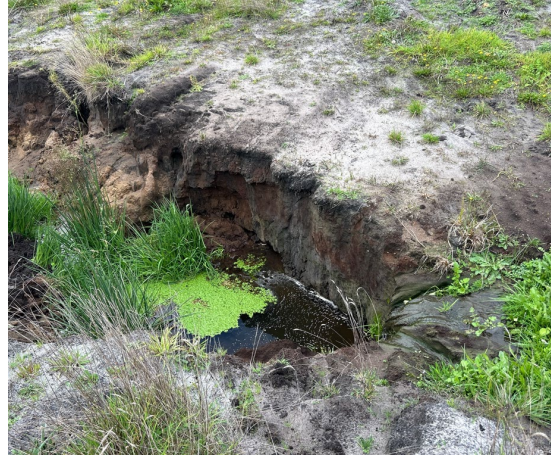
**Photo 3-7 Erosion present along drainage line**

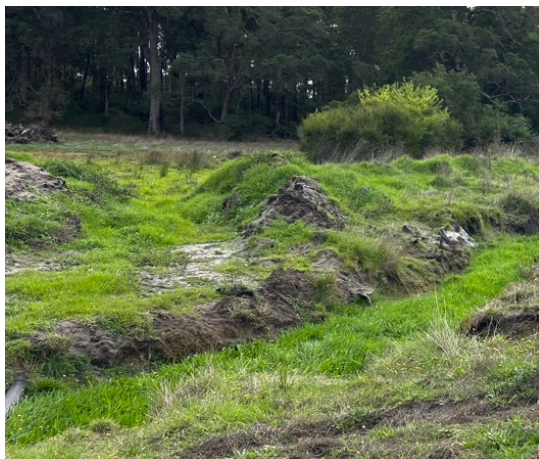
The drainage line and surrounding revegetation area has been subject to environmental degradation through disturbances such as historical clearing, manmade ground disturbance and weed presence. To achieve the greatest chances of revegetation success and create biodiversity values within the eastern drainage revegetation site, the risk of erosion must be managed. Currently, mounds of piled soil are evident surrounding the drainage line from previous ground disturbance at the site (Photo 4-1). The banks of the drainage line have formed an erosion gully (Photo 4-2).

Photo 4-1 Topsoil mounds surrounding drainage line

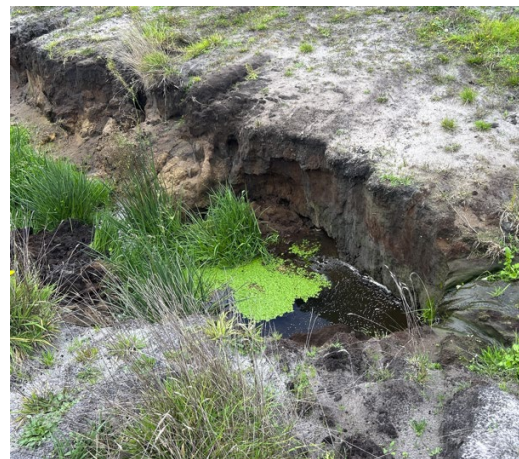
Photo 4-2 Erosion gully

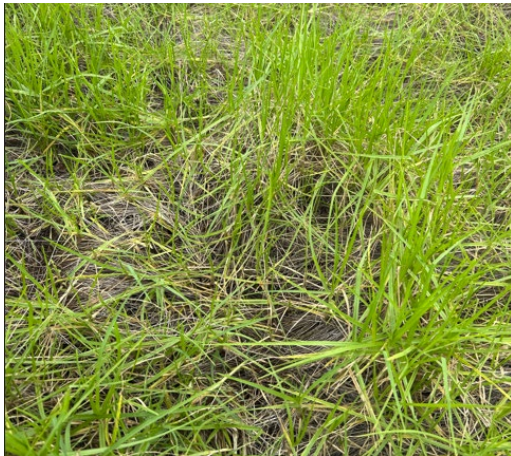
Invasive flora taxa were observed to be proliferating across the entirety of the Survey Area. Predominant weed types within the revegetation areas included widespread grassy weeds (Photo 4-3), broadleaf

Photo 4-3 Dominant Kikuyu (*Cenchrus clandestine*) weedy grass

Various weedy grasses were observed to be proliferating across the site as the dominant ground cover, such as the perennial Kikuyu (*Cenchrus clandestinus*). For initial and ongoing control (during dry season around Summer and in suitable dry weather conditions in months leading up to planting), blanket application using non-selective, river-safe herbicide is recommended for areas invaded with both grass and broadleaf weeds.

For follow-up control following planting, grass-selective herbicide can be utilised to eliminate remaining invasive grasses with caution taken that conditions are suitable and that proximity to waterways or waterlogged soils is not a risk.

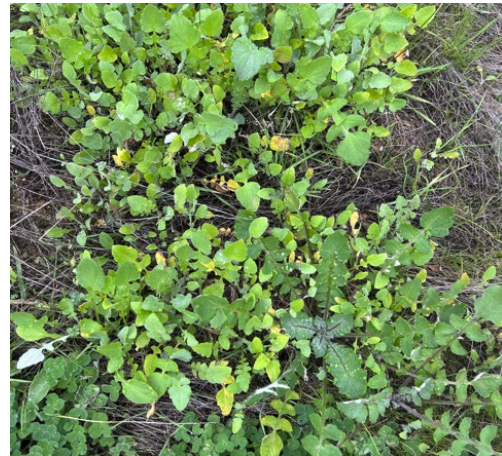
Photo 4-4 Concentrated patch of broadleaf weeds

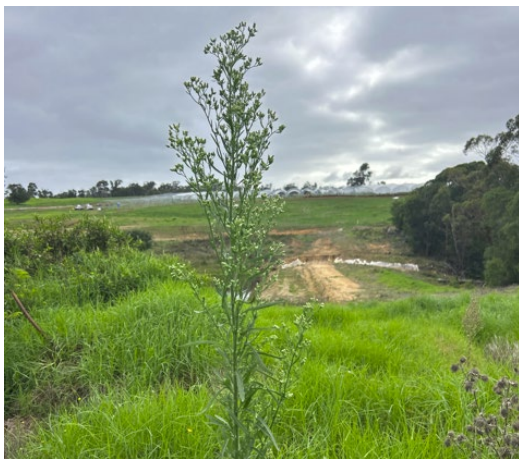
weeds (Photo 4-4) and various other invasive herbs (Photo 4-5), inclusive of *Zantedeschia aethiopica* (Photo 4-6), a Declared Pest under the *Biosecurity and Agriculture Management Act 2007* (DPIRD, 2024b). Multiple observed weeds are capable of high ecological impact and/or rapid invasiveness, as per DBCA's (2023) Warren Impact and Invasiveness Rating system. Weed species observed opportunistically during the site visit are presented in Appendix C.

Photo 4-5 Fleabane (*Erigeron* sp.) in flower

Invasive herbs such as Burr Medic (*Medicago polymorpha*), Thistles (*Cirsium* spp.), Fleabane (*Erigeron* sp.), Docks (*Rumex* spp.), Arum Lily (*Zantedeschia aethiopica*) and Wild Turnip (*Brassica* spp.) were recorded during the site visit. With the widespread occurrence of various invasive herbs scattered amongst dominant grassy weeds, initial non-selective application of river-safe herbicide is recommended, with ongoing monitoring to be utilised as a measure of exclusion effectiveness. Non-selective river-safe herbicide application can occur during both initial and follow-up control periods for the site.

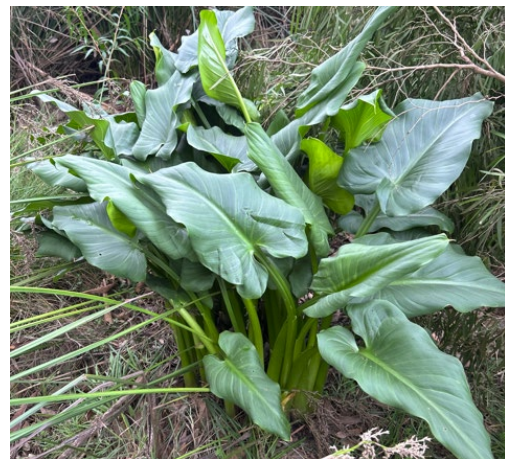
Photo 4-6 Arum Lily (*Zantedeschia aethiopica*) at site

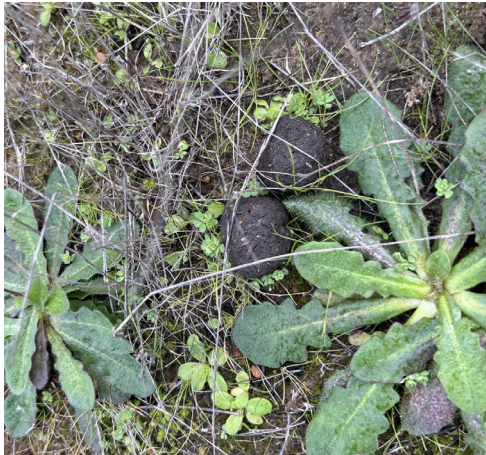
With evidence of Western grey kangaroo (*Macropus fuliginosus*) activity observed within the study area (Photo 3-1, Photo 3-2), it is likely that grazing pressure would be a threat to young seedlings that will be planted during revegetation. Management strategies to exclude grazing pressures include the installation of fencing around revegetation areas. By ensuring that grazing species are excluded from the rehabilitation area prior to the commencement of revegetation works (through fencing installation),

**Photo 4-7 Kangaroo scat**

For the purpose of grazing exclusion – as opposed to ongoing control – it is recommended that boundary fencing around the rehabilitation area is installed prior to revegetation. Currently, rehabilitation areas are unfenced. Fencing is considered to be a more effective and environmentally friendly choice than installing plant guards and will require less maintenance effort long-term. With kangaroos presenting the most significant grazing risk to seedlings, fencing should be at least 1.2 – 1.5 m in height. Ringlock fencing, as opposed to plain wire fencing, is recommended for kangaroo exclusion, with a row of barbed wire across the top. Vermin mesh can also be considered.

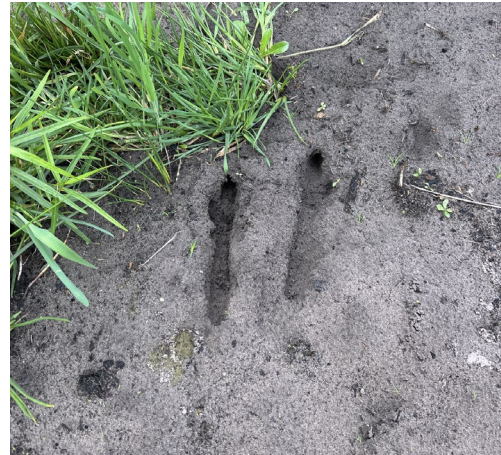
**Photo 4-8 Kangaroo tracks**
