3 OCTOBER 2023

MEMORANDUM – CLEARING OF VEGETATION ASSESSMENT FOR HANDS OVAL STAGE 2 REDEVELOPMENT

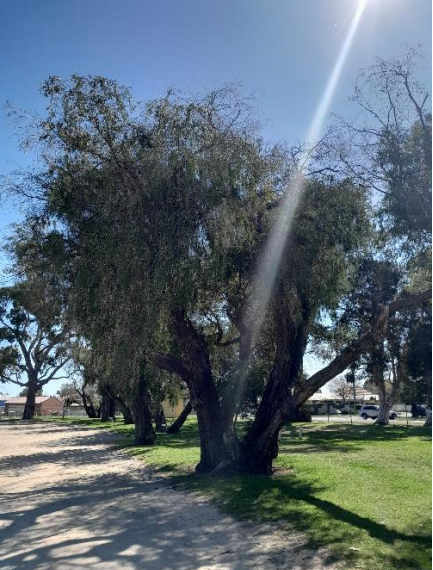
Tree No.	Species	Fauna assessment	Vegetation assessment	Photo
HT6	<i>Agonis flexuosa</i>	<p>1 hollow visible</p> <p>No hollows were identified in the Natural Area Ecological Assessment (2021), however, a small hollow was visible during a site visit on 30/08/2023 (not suitable for black cockatoos)</p> <p>No dreys or scats were visible during a site visit on 30/08/2023.</p>	<p>This tree will be located within the trafficable lane, which was designed to a minimum aisle width in alignment with Australian Standards. Therefore, this tree was unable to be avoided through re-design.</p>

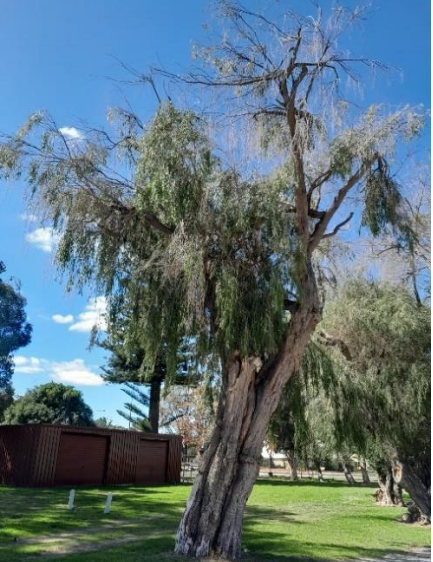
P1	<i>Agonis flexuosa</i>	<p>No visible hollows, dreys or scats during a site visit on 30/08/2023.</p>	<p>This tree will be located within the trafficable lane, which was designed to a minimum aisle width in alignment with Australian Standards. Therefore, this tree was unable to be avoided through re-design.</p>

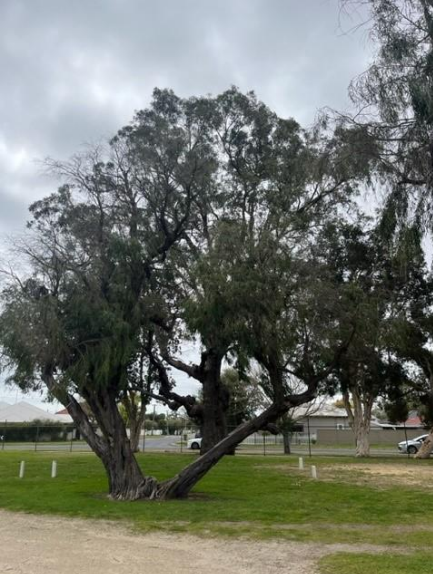
P2	<i>Agonis flexuosa</i>	<p>No visible hollows, dreys or scats during a site visit on 30/08/2023.</p>	<p>This tree will be located within the trafficable lane, which was designed to a minimum aisle width in alignment with Australian Standards.</p> <p>This tree will require heavy pruning and potential removal during construction (to be determined on site). This tree may be retained, if possible, through on-ground avoidance measures.</p>

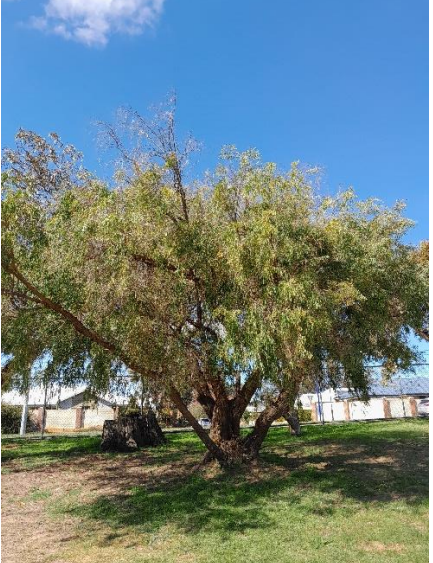
Tree No.	Species	Fauna assessment	Vegetation assessment	Photo
P3	<i>Agonis flexuosa</i>	<p>No visible hollows or dreys during a site visit on 30/08/2023.</p> <p>Possum scats were observed during a site visit on 30/08/2023.</p>	<p>This tree will be located within the batter associated with parking on the eastern boundary of the oval and the ring-road, which is required to allow vehicles to back out. Due to the sloped topography, excavation associated with the batter is required and the removal of this tree is unavoidable.</p>

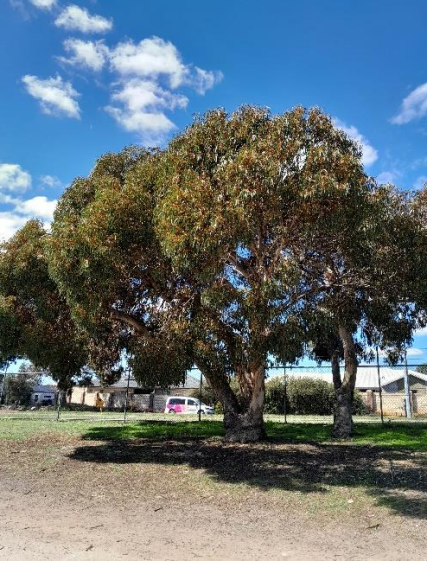
E1	<i>Eucalyptus sp.</i>	<p>No visible hollows, dreys or scats during a site visit on 30/08/2023.</p>	<p>This tree will be located within the batter associated with parking on the eastern boundary of the oval and the ring-road, which is required to allow vehicles to back out. Excavation associated with the batter is required and the removal of this tree is unavoidable.</p> <p>However, another tree (<i>Eucalypt sp.</i>) located approximately 2 m behind E1 was able to be retained by shaping the batter around the root zone.</p>

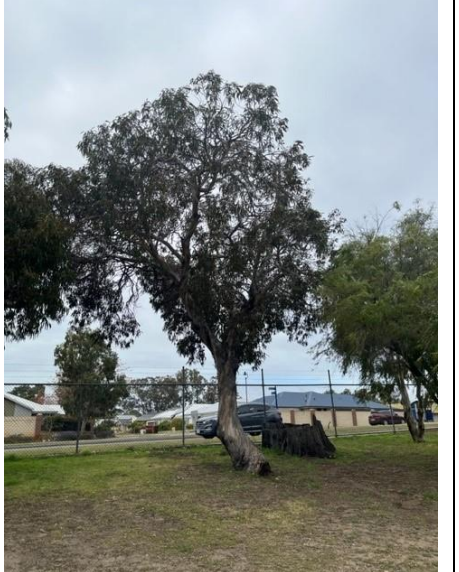
Tree No.	Species	Fauna assessment	Vegetation assessment	Photo
E3	<i>Eucalyptus sp.</i>	No visible hollows, dreys or scats during a site visit on 30/08/2023.	This tree will be located within the batter associated with parking on the eastern boundary of the oval and the ring-road, which is required to allow vehicles to back out. Excavation associated with the batter is required and the removal of this tree is unavoidable.
