Clearing Permit Application Supporting Document

320 Gull Road, Keralup

Prepared for C-Wise

Project Number: TW21124

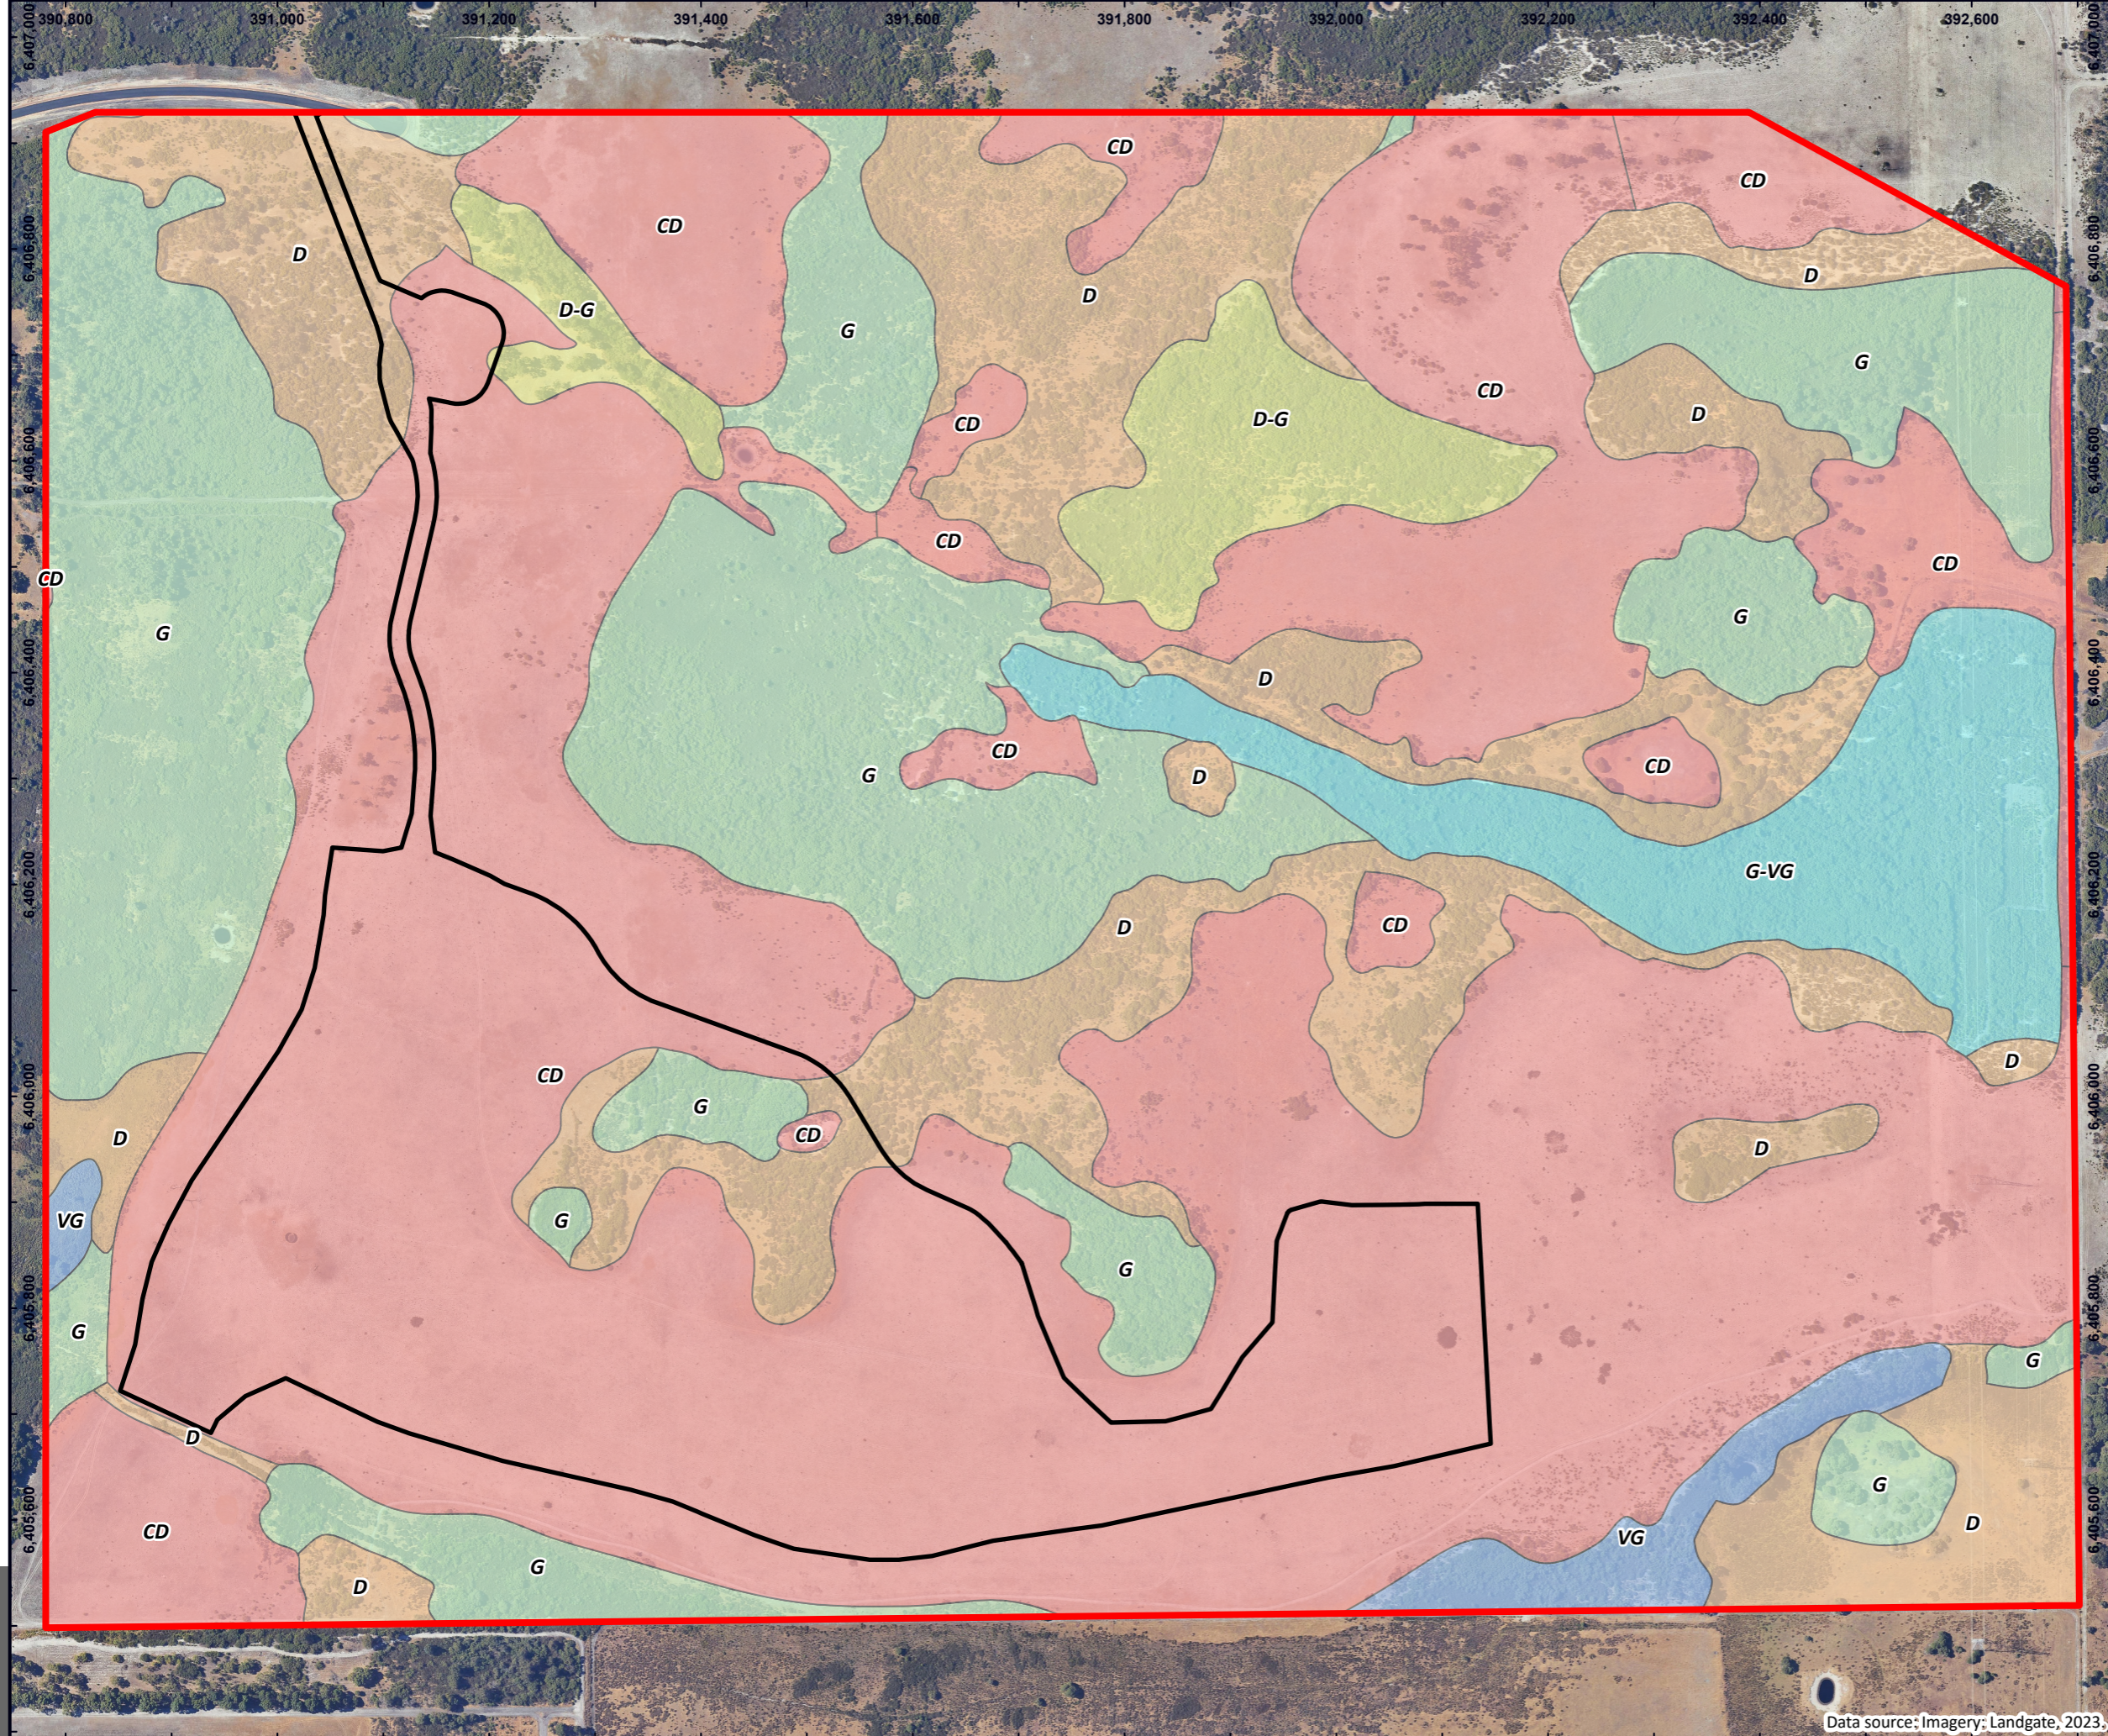
VEGETATION CONDITIONS

The condition of vegetation at across the Site ranges from Completely Degraded to Very Good (Figure 8) and is summarised in Table 2-3.

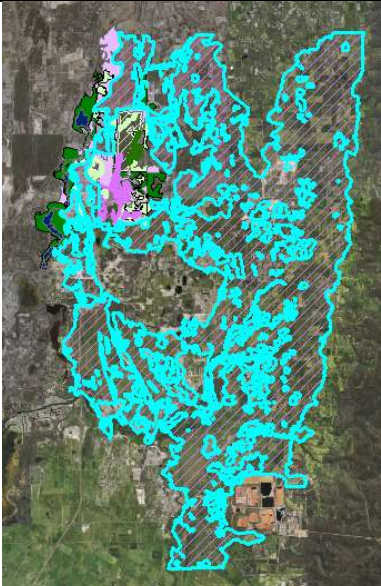
<p>Very large palusplain wetlands.</p> <p>Small areas of better-quality wetland identified in the FV mapping and field visit.</p> <p>Some minor boundary changes increasing and decreasing the boundary.</p>	<p>MUW – Minor boundary changes adjacent to other UID</p>
3905_7333	REW (ME from CCW in V1.3 – 0.490822)

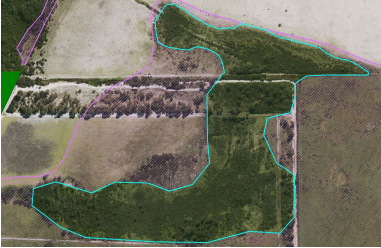
<p>Manually evaluated in V 1.3 to REW.</p> <p>Partial FV mapping G-VG. Field visit agreed G-VG from N boundary. Boundary modified to include vegetation observed in the field. Reverted to CCW considering G-VG and that rest of imagery for the UID appears similar.</p>	<p>CCW – with minor boundary changes</p>
3905_7336	REW (ME from CCW in V1.3 – 0.592696)

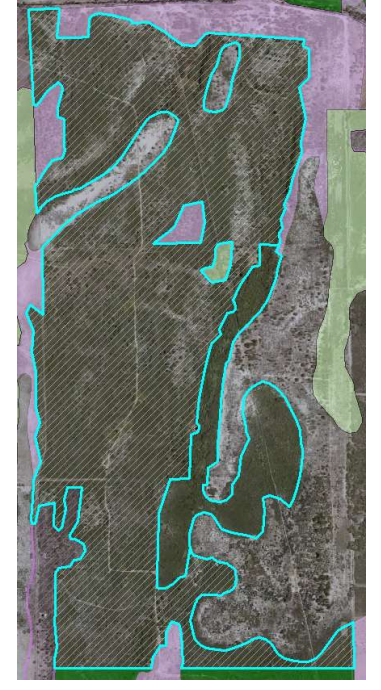
<p>Manually evaluated in V 1.3 to REW UID Mostly covered by FV mapping.</p> <p>The majority of the UID showed variable land use history – FV mapping was Native regrowth, Plantation with NR, Plantation and Native Remnant. The majority of the very low diversity with parches of better vegetation but with very no to nil weeds. Changed to REW.</p> <p>A portion along the south east was not mapped with FV mapping. The Dec 2020 field trip found it was in very good to excellent condition which was obviously better condition than the rest of the UID. This area was divided off the UID, generally along the FV mapping line, reverted to CCW. Quenda and quenda activity noted in the on near</p>	<p>REW & CCW</p>

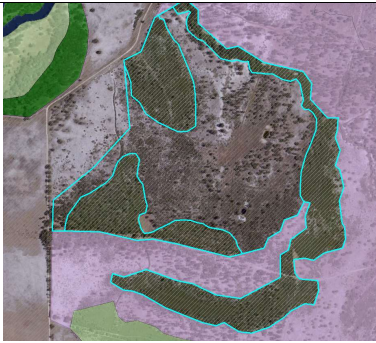
Manual Evaluation V1.3 to REW Variable condition. FV mapping plantation with native regrowth, cleared and native remnant. Field visit shows some areas have significant introduced over storey with little to no understorey. Area mapped as native remnant and areas visited that had better condition regrowth have been separated from the UID and retained the evaluation of REW (3 portions) The remainder was ME as MUW (1 portion central)	REW and MUW
3905_7359	REW (0.363789)

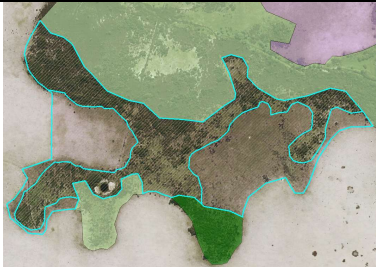
FV mapping D to CD. Aerial imagery and site visit indicate variable condition with clear portions on either side. Separated into 3 portions, Cleared areas have been removed from the polygon and assigned MUW, remainder to stay REW.	MUW and REW
3905_7365	REW (ME from CCW in V1.3 – 0.5875)

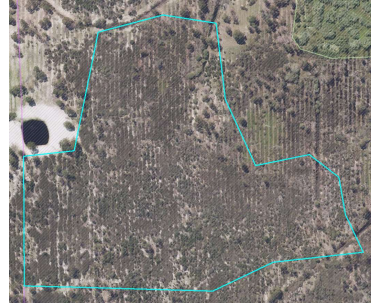
Higher value was derived from the Native veg mapping layer i.e., Habitat, habitat buffer, veg com and surrounding bushland viability. No evidence for these values appears ex-plantation in poor condition Therefore changed to MUW.	MUW

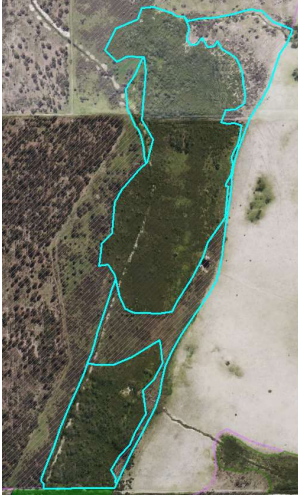
<p>FV mapping G, VG and degraded.</p> <p>The G and better section at south and north were separated and attributed CCW.</p> <p>The rest D and CD changed to MUW.</p> <p>There were some boundary changes into the adjoining UID 3905_7368.</p>	CCW and MUW
3905_7368	REW (0.410831)

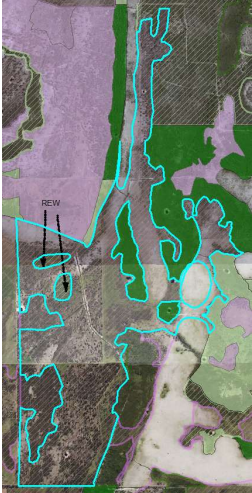
<p>Part of a large UID. some boundary changes. Justified in UID 3905_7368.</p> <p>Also 2 areas of likely melaleuca overstorey identified from aerial imagery.</p> <p>Separated as REW</p>	MUW and REW
3905_7376

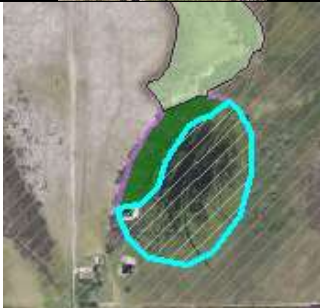
<p>Seasonal open water connected to vegetation buffer probably under mapped habitat. Some altered hydrology (drain) and largely cleared.</p> <p>ME to REW</p>	REW

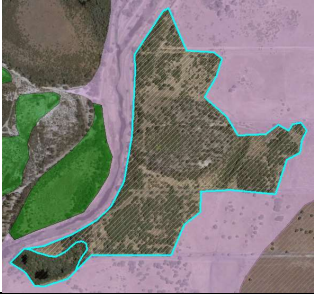
Vegetation cover is variable REW, Sumpland at south confirmed with lidar - basin. Separated sumpland at southern end based on lidar CCW	REW and CCW
-----------	--	--	---	-------------

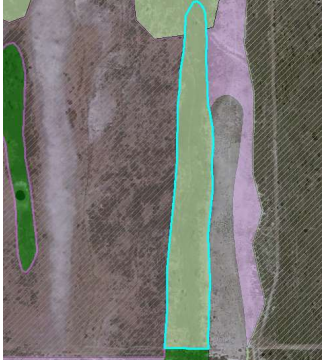
No FV mapping, was divided off prior to V2. No FV mapping, looks in poorer condition the original southern portion. NVL regrowth above 20%. Field visit confirmed younger regrowth with lower diversity (looking from the southern end)	REW
3905_7338	CCW

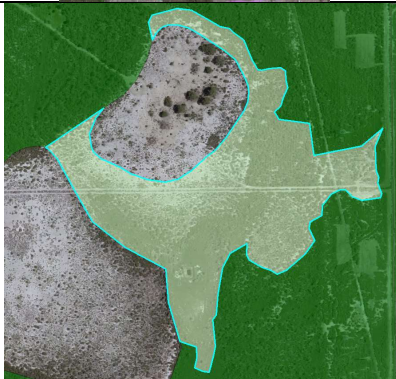
Manually evaluated in V 1.3 to REW. FV - D and D-CD, Half the area is also mapped in the plantation, the section marked as cleared in this area now appears to have cover. The remainder is Plantation with native regrowth. The southern portion of this polygon appears to be in better condition.	REW

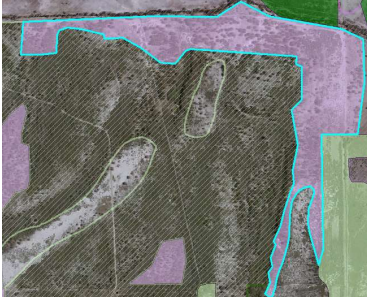
<p>FV mapping mostly plantation. Aerial imagery shows poorer condition. Field visit showed poor native cover at western extent.</p>	MUW
3905_7344	REW
