Our Ref: P22.100A-LRP-FVSR-Joondalup Tunnel 2\_1\_FINAL

**SUBJECT: PTA RADIO SYSTEMS REPLACEMENT (RSR) PROJECT – BIOLOGICAL ASSESSMENT,  
SITE #76 JOONDALUP TUNNEL 2**

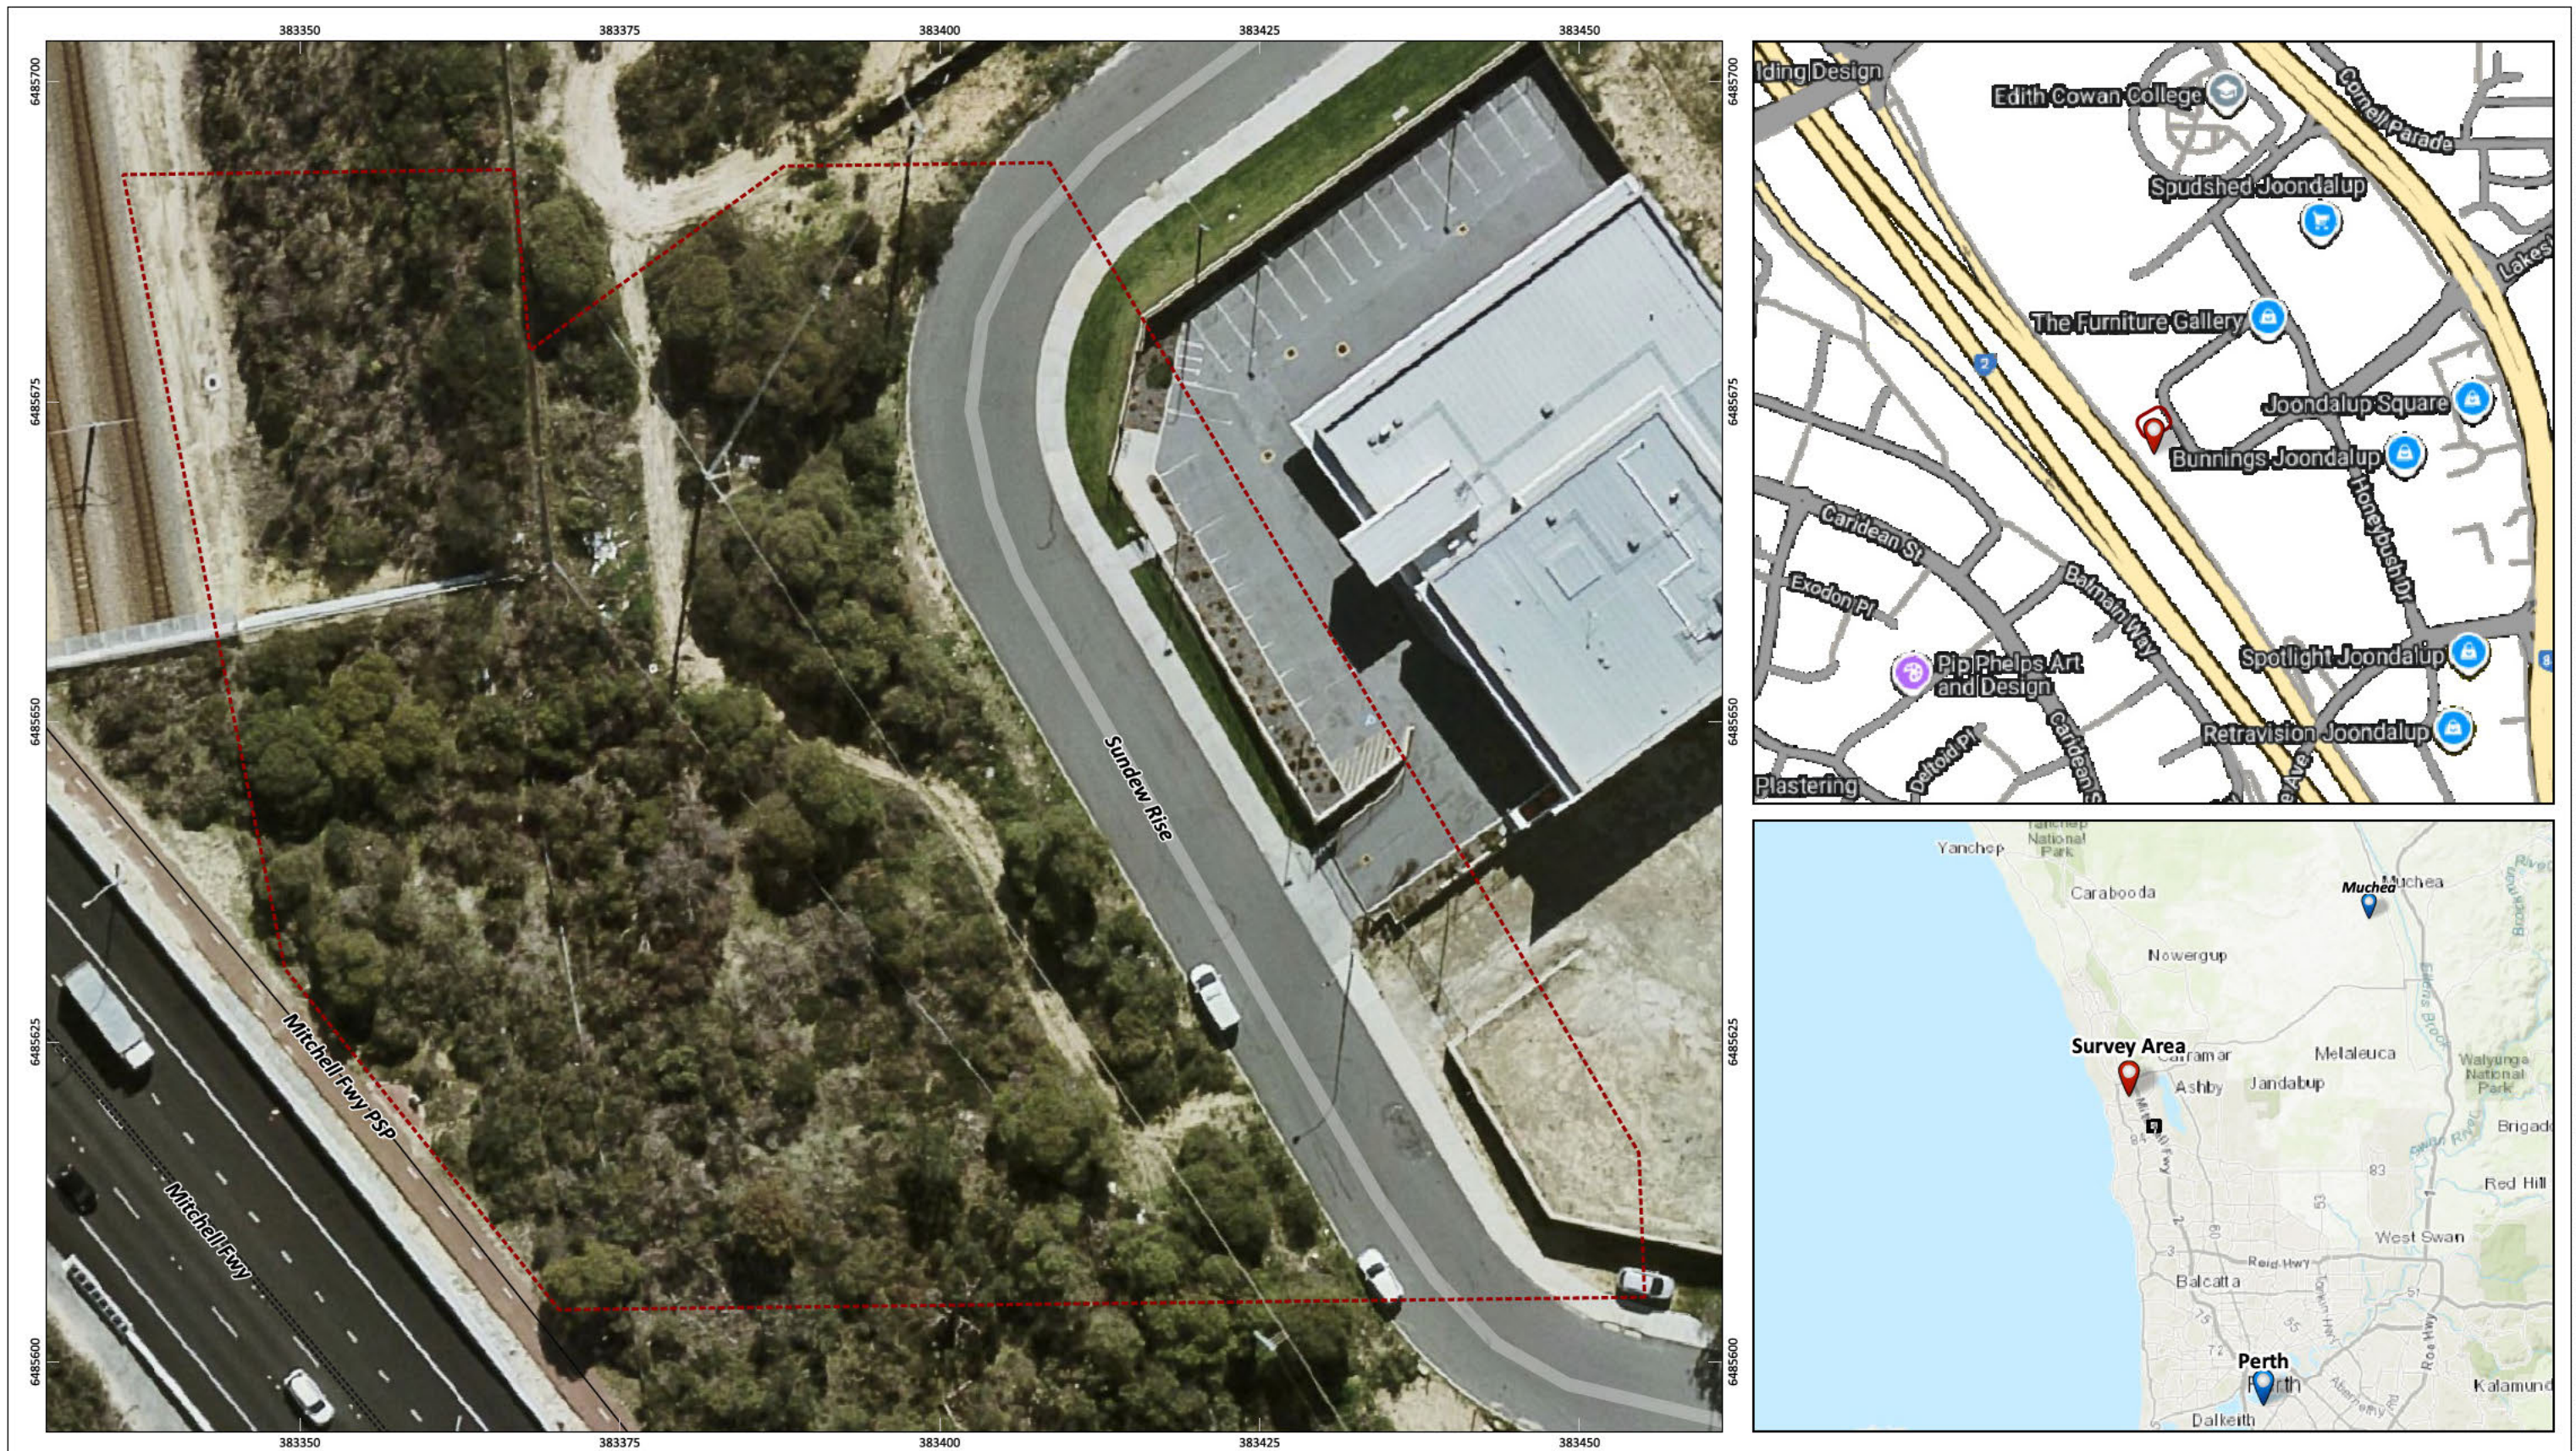
Figure 1: Site Location – Site #76 Joondalup Tunnel 2 Country End & Tunnel Portal

Based on the survey findings and the site reference designs provided by UGL, site #76 – Joondalup Tunnel 2 was identified requiring a Native Vegetation Clearing Permit under Part V of the *Environmental Protection Act 1986* (EP Act). Site location and clearing extent are displayed in Figure 1.

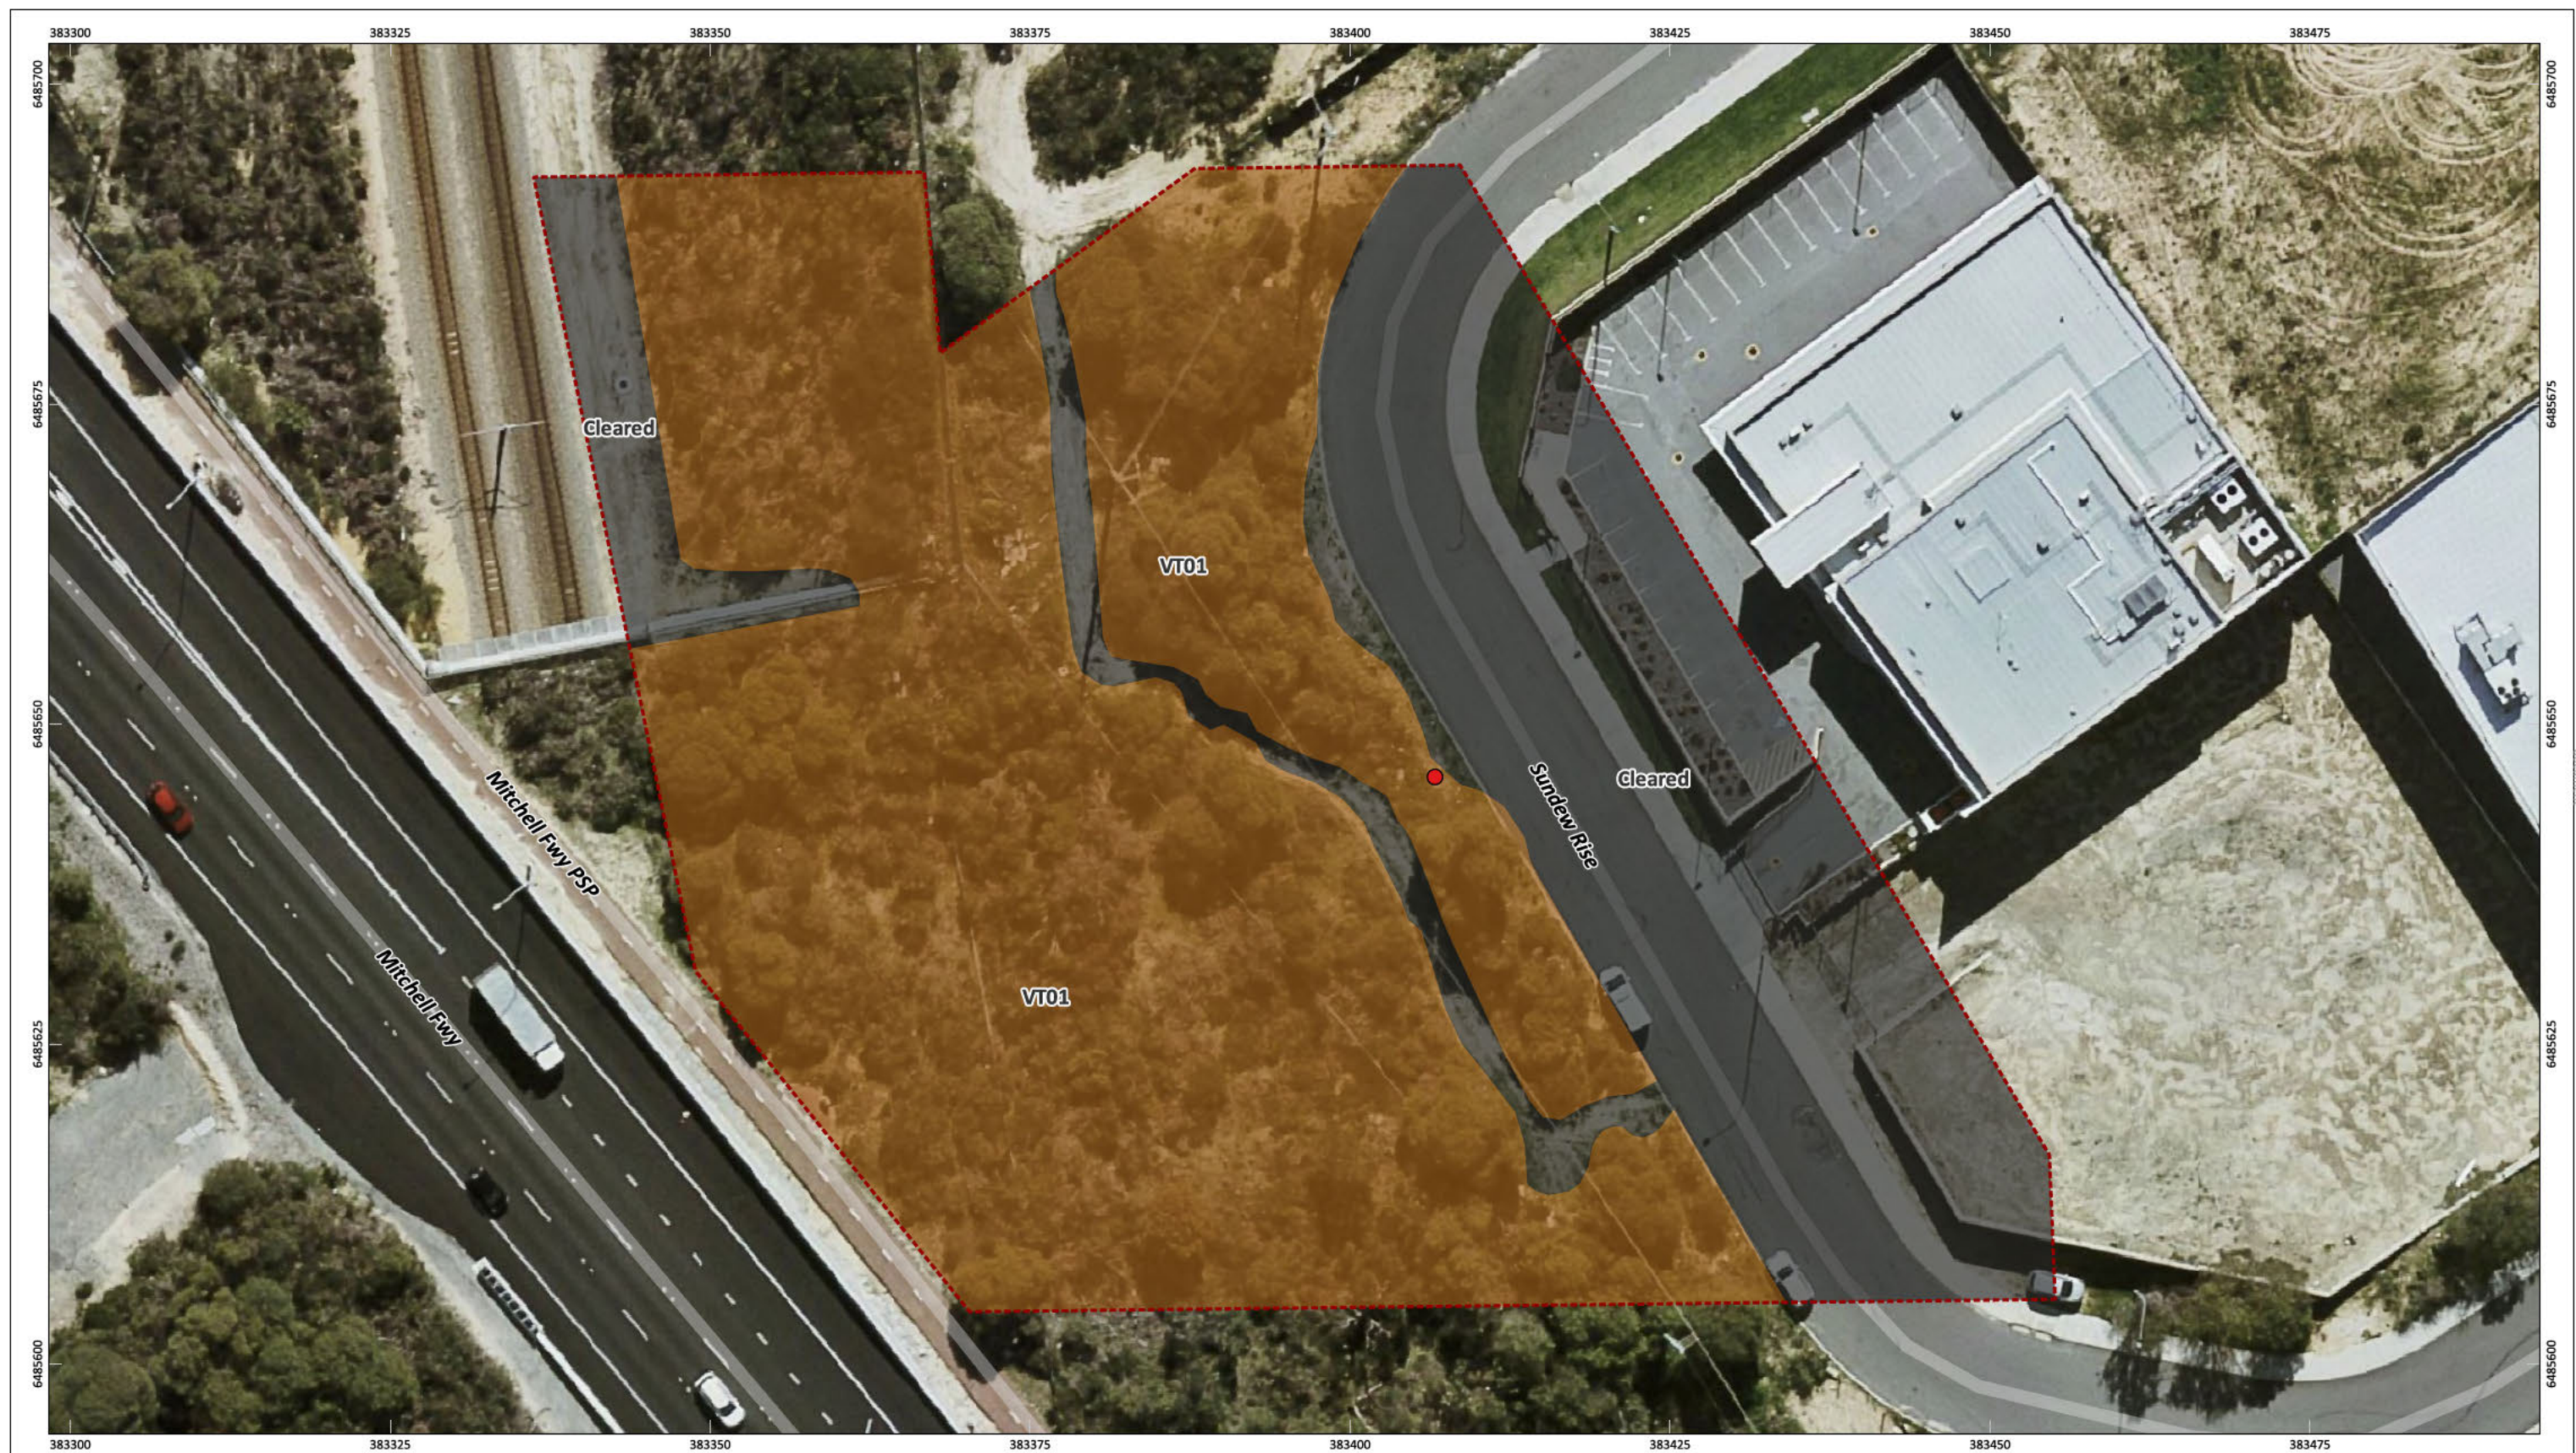
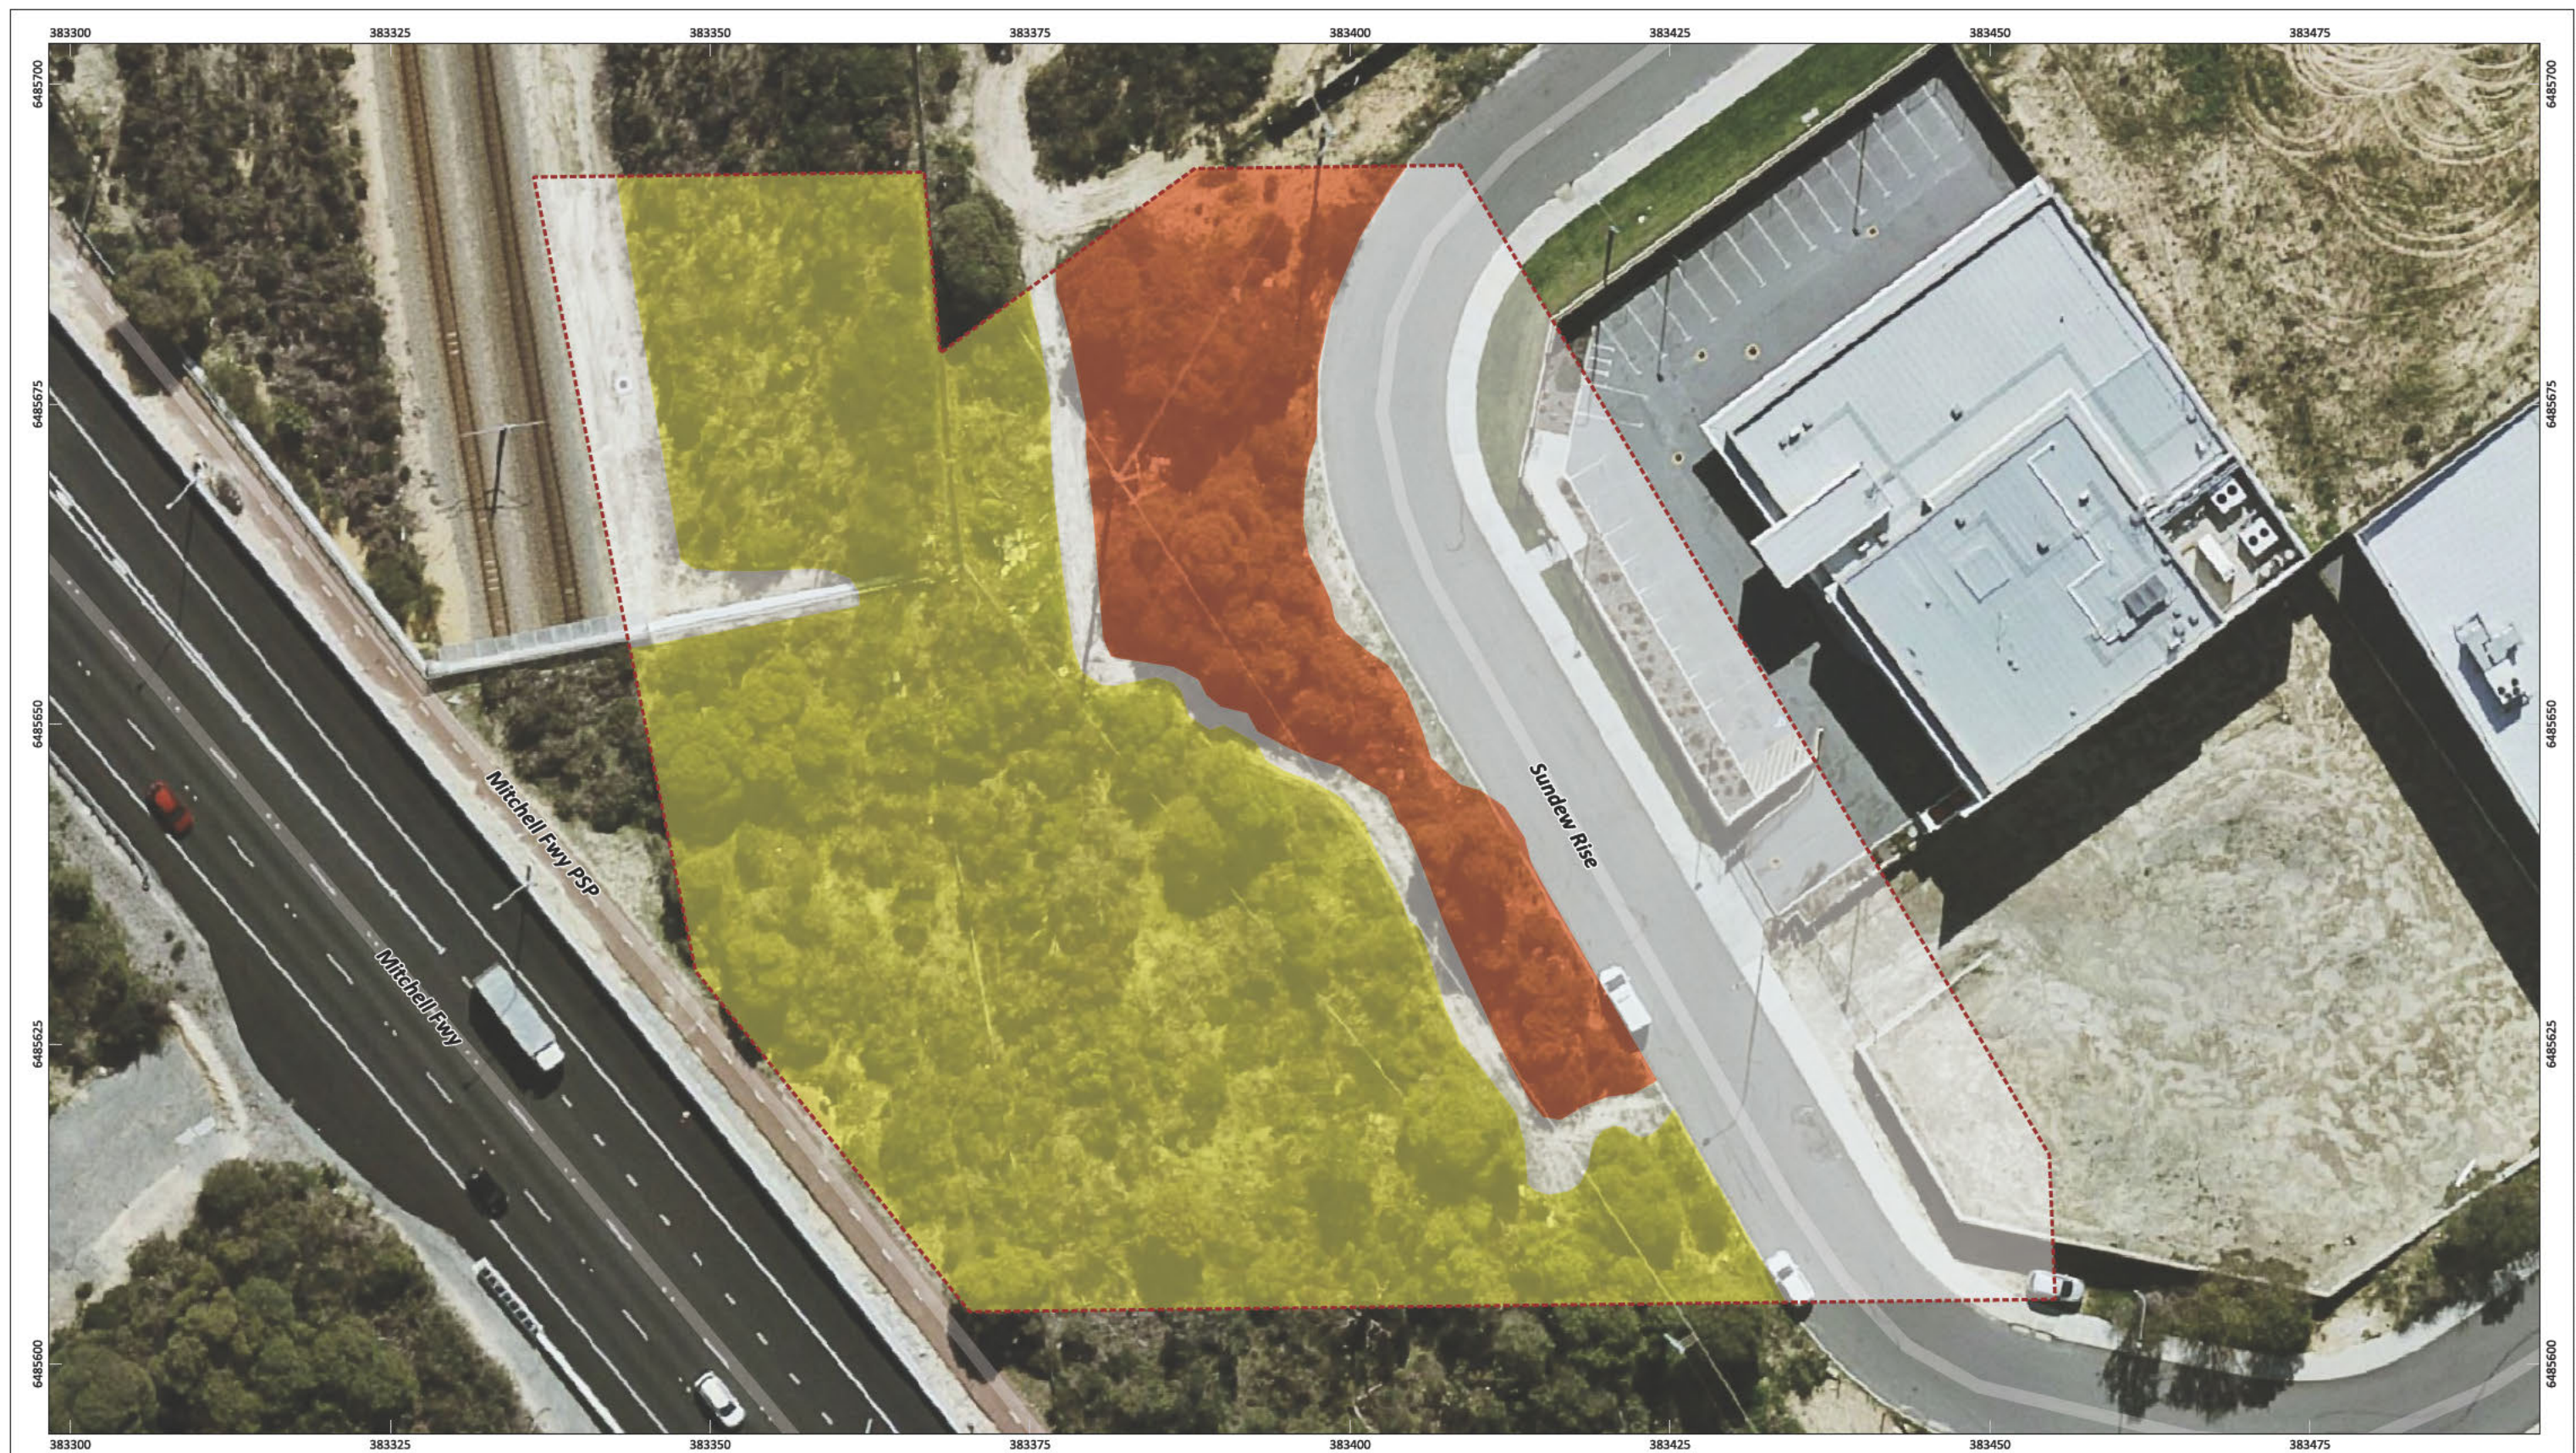
The results of the assessment are presented in Table 2 and displayed in Figure 2 below.

Black cockatoo roosting habitat	No		
Black cockatoo breeding habitat	No ( <i>Eucalyptus</i> sp. are too young to have value for black cockatoo)		
Fauna evidence	No		
Site Photos	See Appendix A		
General Comments			
<p>Vegetation appears to be a mixture of landscaping/revegetation. Vegetation is partially representative of that naturally occurring in adjacent areas outside the rail corridor and is therefore considered native under the EP Act.</p> <p>The vegetation within the clearing extent was assessed as VT01 – Acacia shrubland with a total extent of 0.49 ha. The clearing extent contains an additional 0.27 ha of cleared land.</p> <p>Scattered <i>Banksia sessilis</i> is present within the clearing extent. The species has forging value for Threatened Carnaby's black cockatoo.</p> <p>A patch of One-leaved Cape tulip (<i>*Moraea flaccida</i>) (5-25 individuals), was recorded from one location within the clearing extent. One-leaved Cape tulip is a Declared Pest (DP) under the <i>Biosecurity and Agriculture Management Act 2017</i> (BAM Act).</p> <p>See Figure 2 for vegetation mapping.</p>

- The following two vegetation types have been identified within the survey area:
  - VT01: *Acacia* shrubland over weedy understory. The vegetation is in Good to Degraded condition. The vegetation is considered representative of the native vegetation in surrounding areas. Therefore, the vegetation is considered native under the EP Act. The vegetation extent within the clearing extent was assessed as 0.49 ha.
  - Out of the 0.49 ha of vegetation to be cleared, 0.38 ha is in Good condition and 0.11 ha is in Degraded condition.
  - Scattered *Banksia sessilis* with foraging value for Carnaby's black cockatoo was identified within the clearing extent.
- The clearing footprint comprises a total area of 0.76 ha, with 0.49 ha of native vegetation (VT01) and 0.27 ha of Cleared land in Completely Degraded condition.

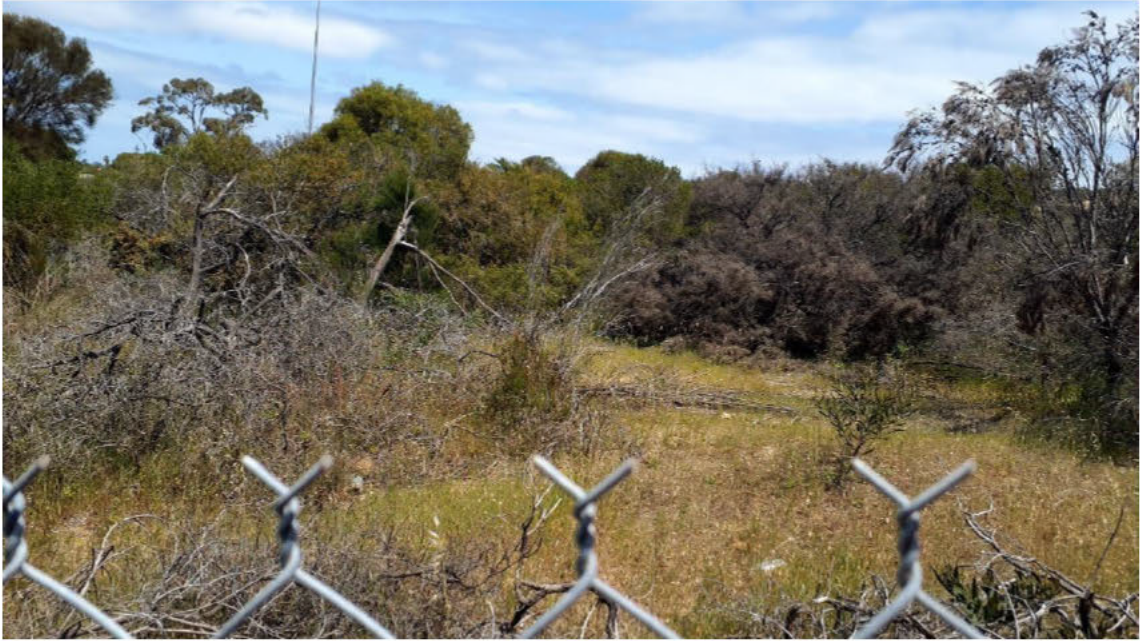
**Photo 1**

**Description:** Vegetation within VT01 Acacia shrubland within clearing footprint, Degraded

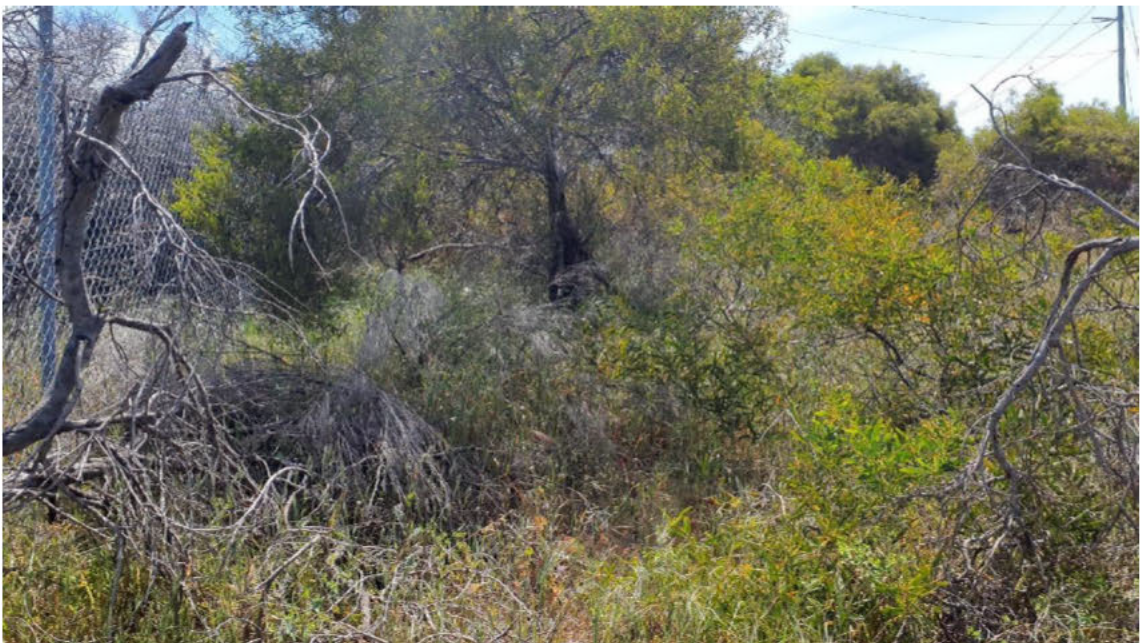
**Photo 2**

**Description:** Vegetation within VT01 Acacia shrubland within clearing footprint, Degraded

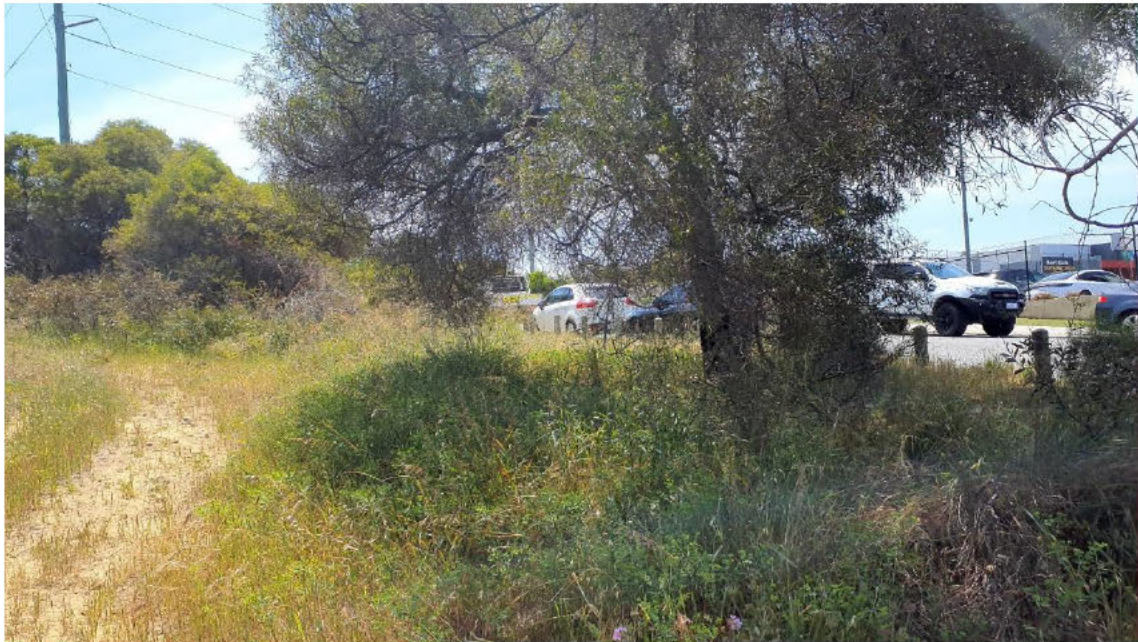
**Photo 3**

**Description:** Cleared path and VT01 Acacia shrubland within clearing footprint, Degraded

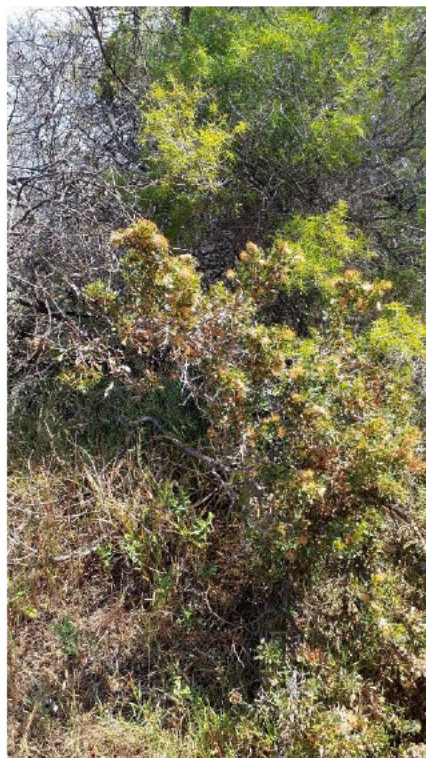
**Photo 4**

**Description:** Vegetation within VT01 Acacia shrubland, scattered *Banksia sessilis*, within clearing footprint
