32 – Canning Bridge Station Mandurah

Environmental Site Assessment

P22.100-RPT-ESA__Canning Bridge Station_MandurahLine_1_FINAL

24-Mar-2024

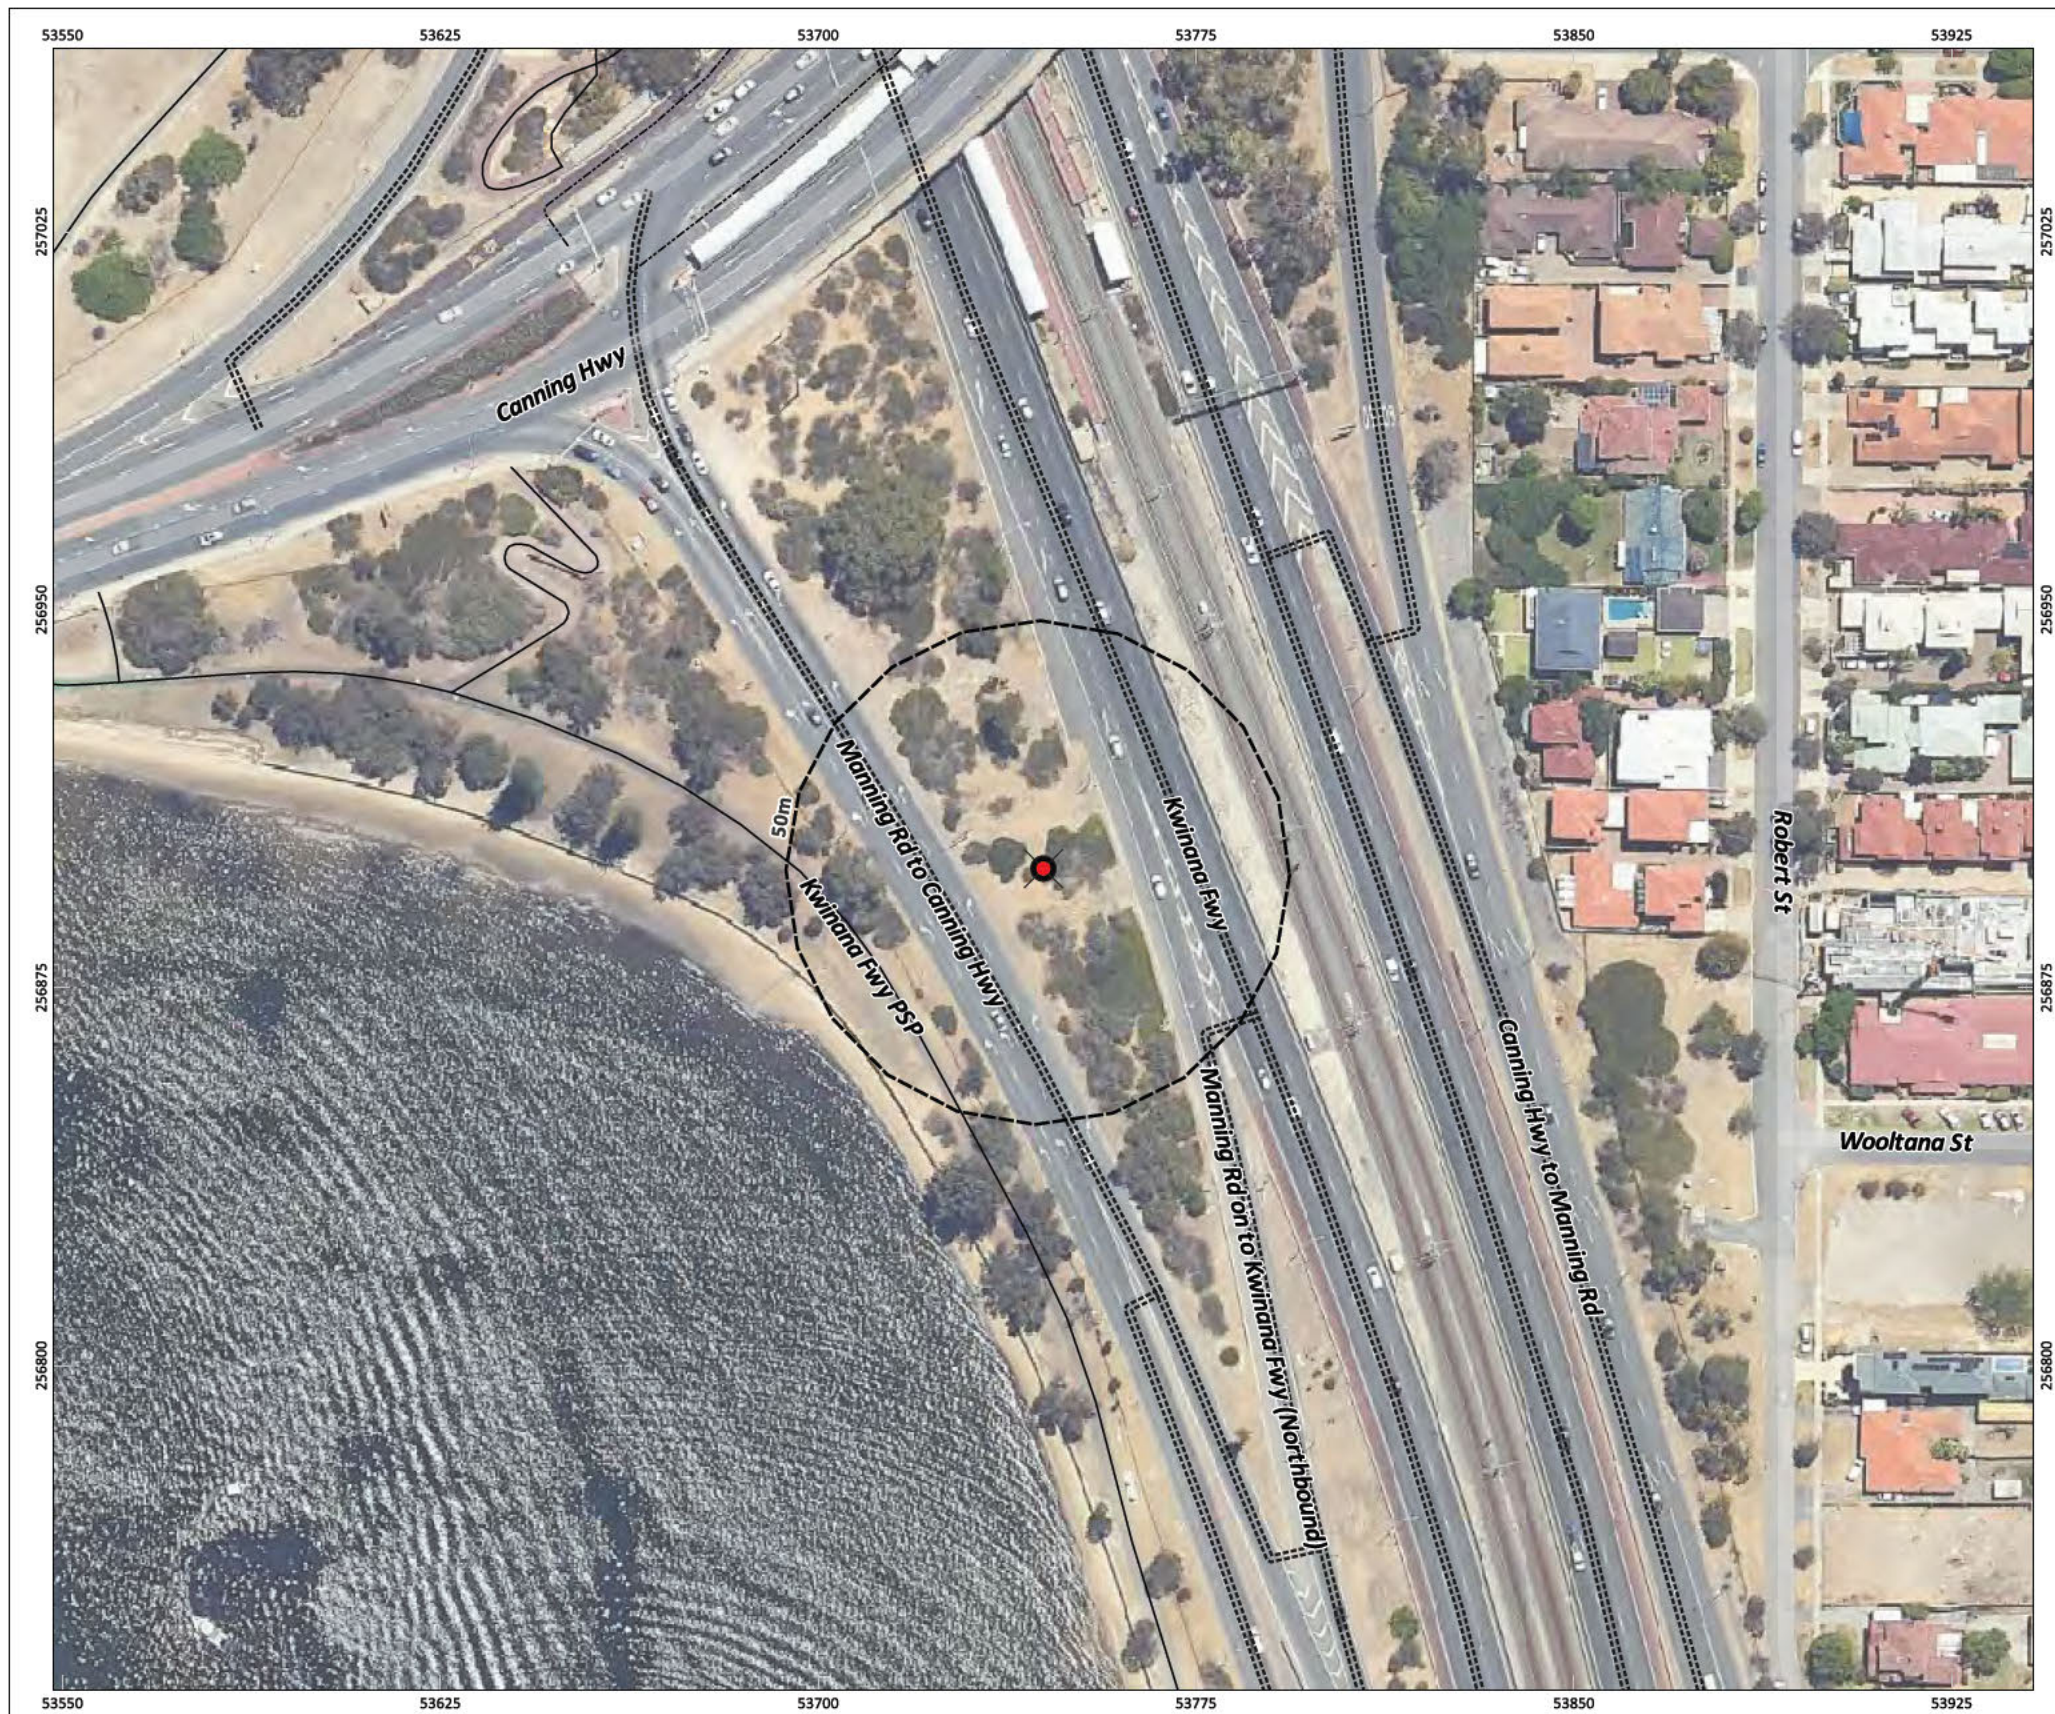
Figure 1: Site Location

The Site is identified as Lot 0 on Plan P ROAD and is located approximately 6.6km S the Perth Central Business District (CBD) (Figure 1). The analysis buffer encompasses a total area of around 7725.4 square meters.

Site identification details are summarised in Table A, and the location is shown on Figure 1.

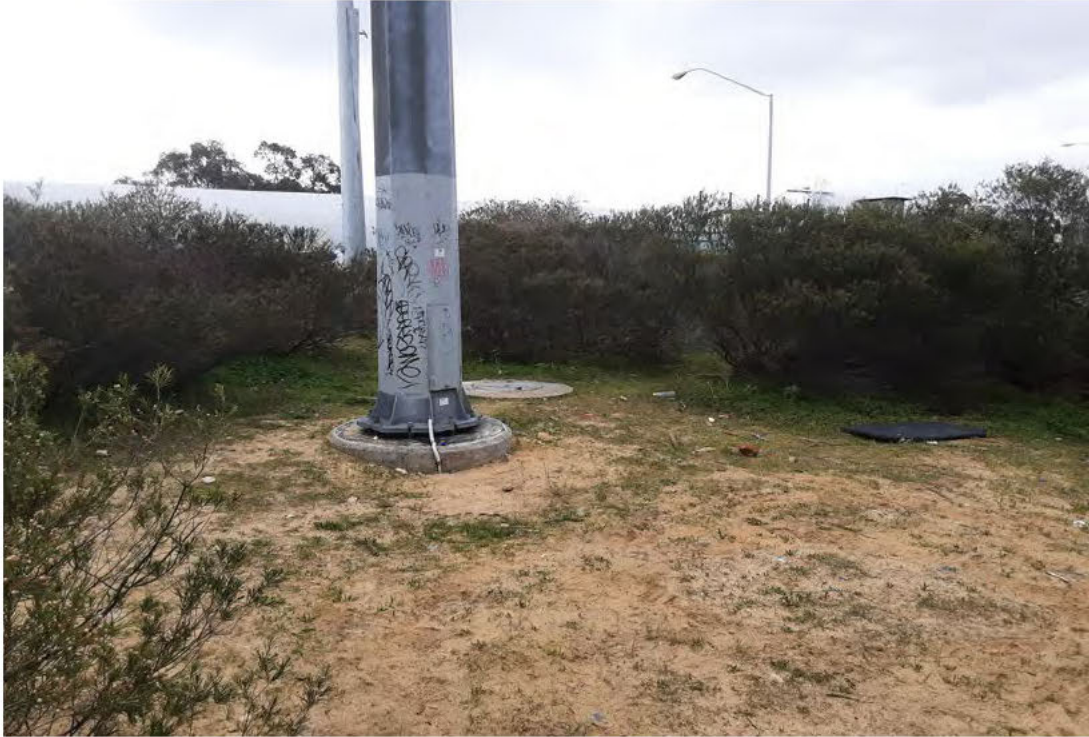
Photo 1

Site Photos	See Appendix C			
General Comments				
<p>Pale yellow sand on surface with trace bricks and general waste plastic, wood etc with evidence of squatters and fires, communications services present.</p>

Description: Image of site facing north.

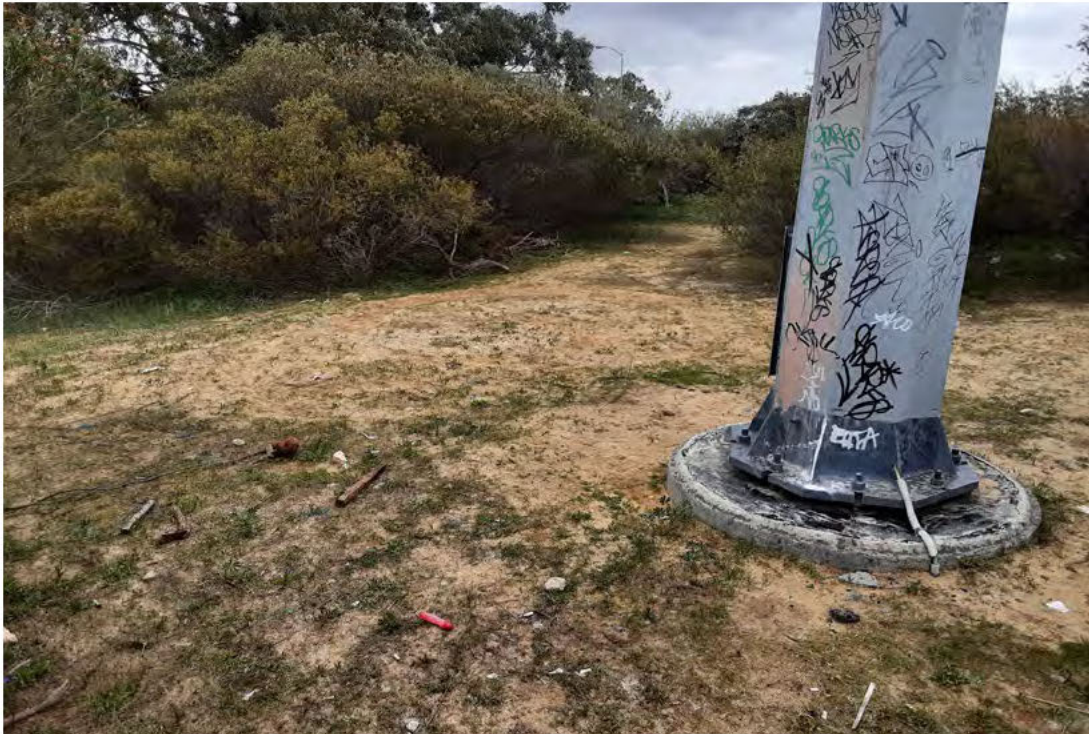
Photo 2

Description: Image of site facing south.

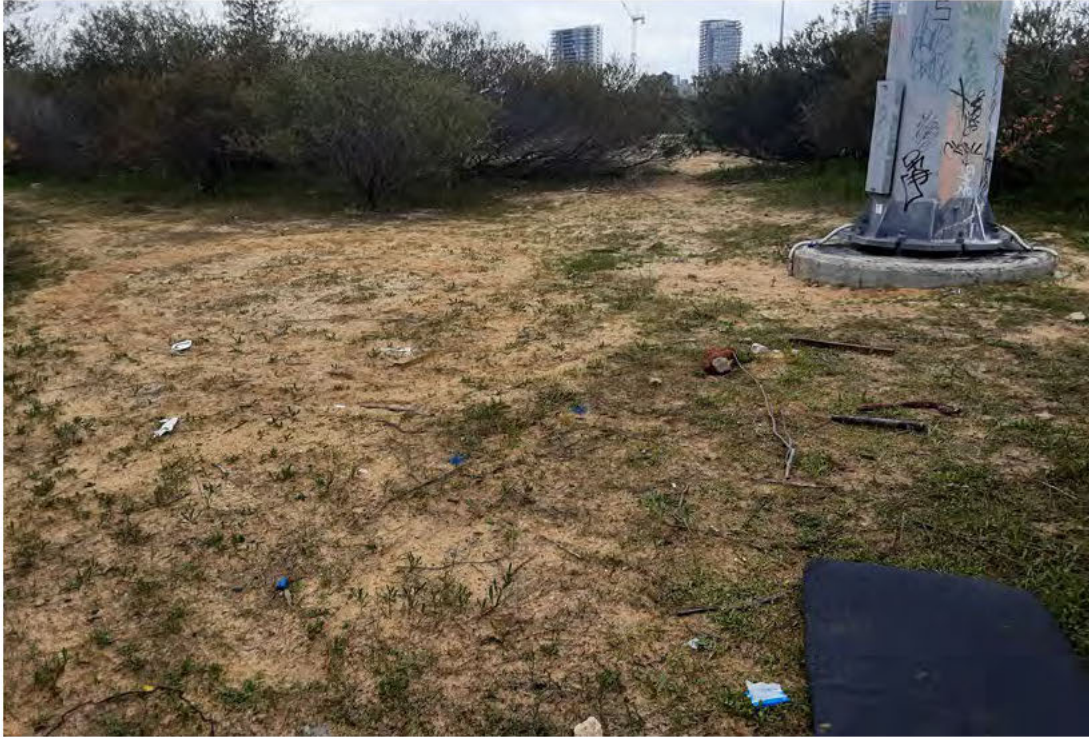
Photo 3

Description: : Image of site facing west.
