SUBJECT: PTA RADIO SYSTEMS REPLACEMENT (RSR) PROJECT – BIOLOGICAL ASSESSMENT,

SITE #84 TAMALA PARK

PTA RSR Project - NVCP Application Supporting Documentation

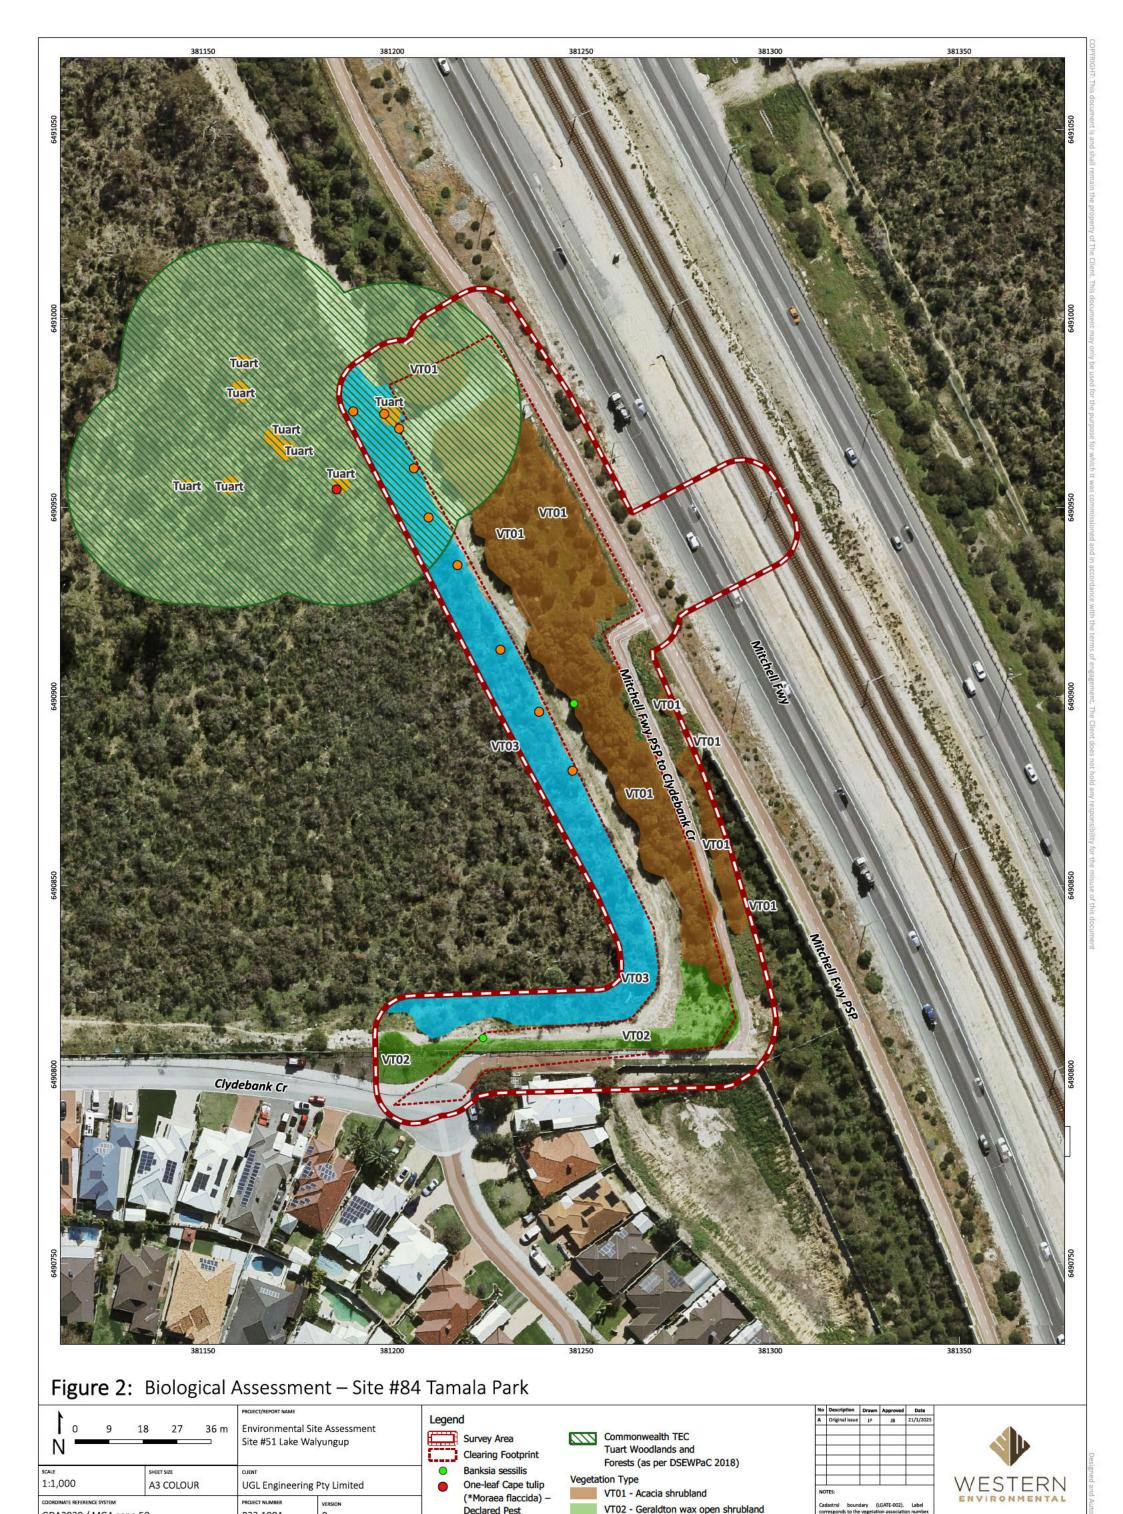
Vegetation and clearing footprint mapping are presented in Figure 2.

Baeckea sp. Limestone

Lyons 1425) - Priority 1

VT03 - Acacia and Banksia sessilis Woodland

**Tuart Woodland TEC**

The Priority 1 species *Baeckea* sp. Limestone (P1, as listed by DBCA) was recorded along the edge of the Banksia Woodland (VT03), outside of the clearing extent. Nine populations were recorded in total, as displayed in Figure 2. Impacts have been avoided.

One Tuart has been recorded within the northern portion of the survey area within VT03 (Figure 2).

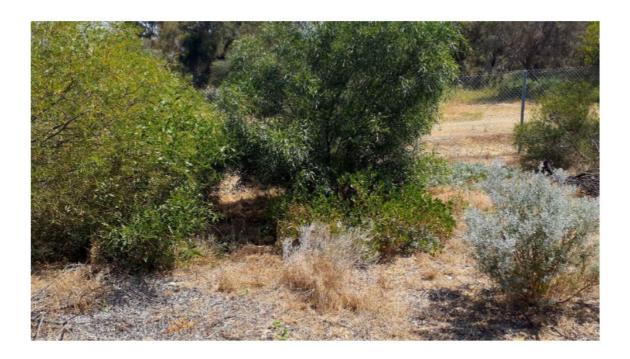
Photo 1 Date: 18 October 2024

Description: Vegetation within VT01 Acacia shrubland, within clearing extent, west of cycle path, Degraded

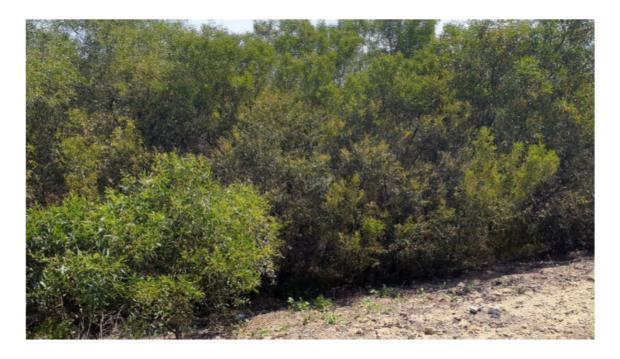
Photo 2 Date: 18 October 2024

Description: Vegetation within VT01 Acacia shrubland, within clearing extent, west of cycle path, Degraded

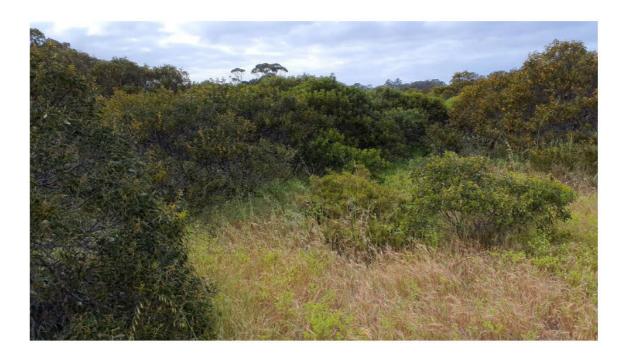
Photo 3 Date: 18 October 2024

Description: Vegetation within VT02, Acacia shrubland, Degraded

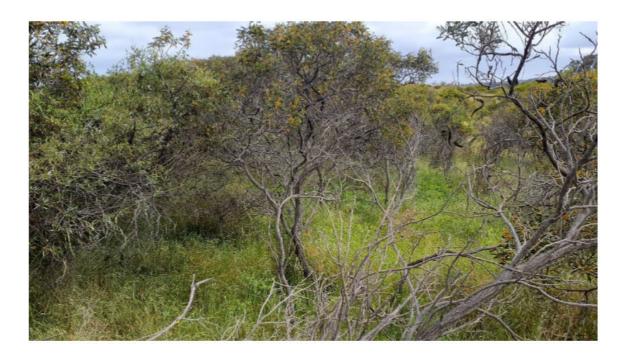
Photo 4 Date: 18 October 2024

Description: Vegetation within VT02, Acacia shrubland, Degraded

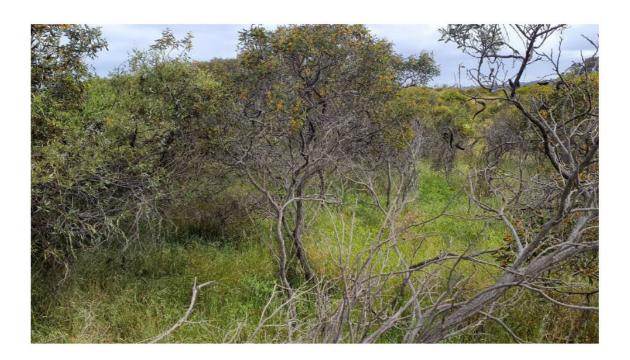
Photo 4 Date: 18 October 2024

Description: Vegetation within VT02, Acacia shrubland, Degraded
