Clearing Permit Decision Report

Permit number:	CPS 10452/1
Permit type:	Area permit
Applicant name:	Shire of York
Application received:	14 December 2023
Application area:	One native tree
Purpose of clearing:	Reconstructing river crossing culverts and roadway
Method of clearing:	Mechanical Removal
Property:	Crown Reserve 19039, Malebelling
Location (LGA area/s):	Shire of York
Localities (suburb/s):	Malebelling

The clearing application was submitted by the Shire of York (the Shire) for an Area Permit to clear one native tree (*Eucalyptus rudis* (flooded gum)) within Crown Reserve 19039, Malebelling, for the purpose of reconstructing river crossing culverts and a roadway (Shire of York, 2023a).

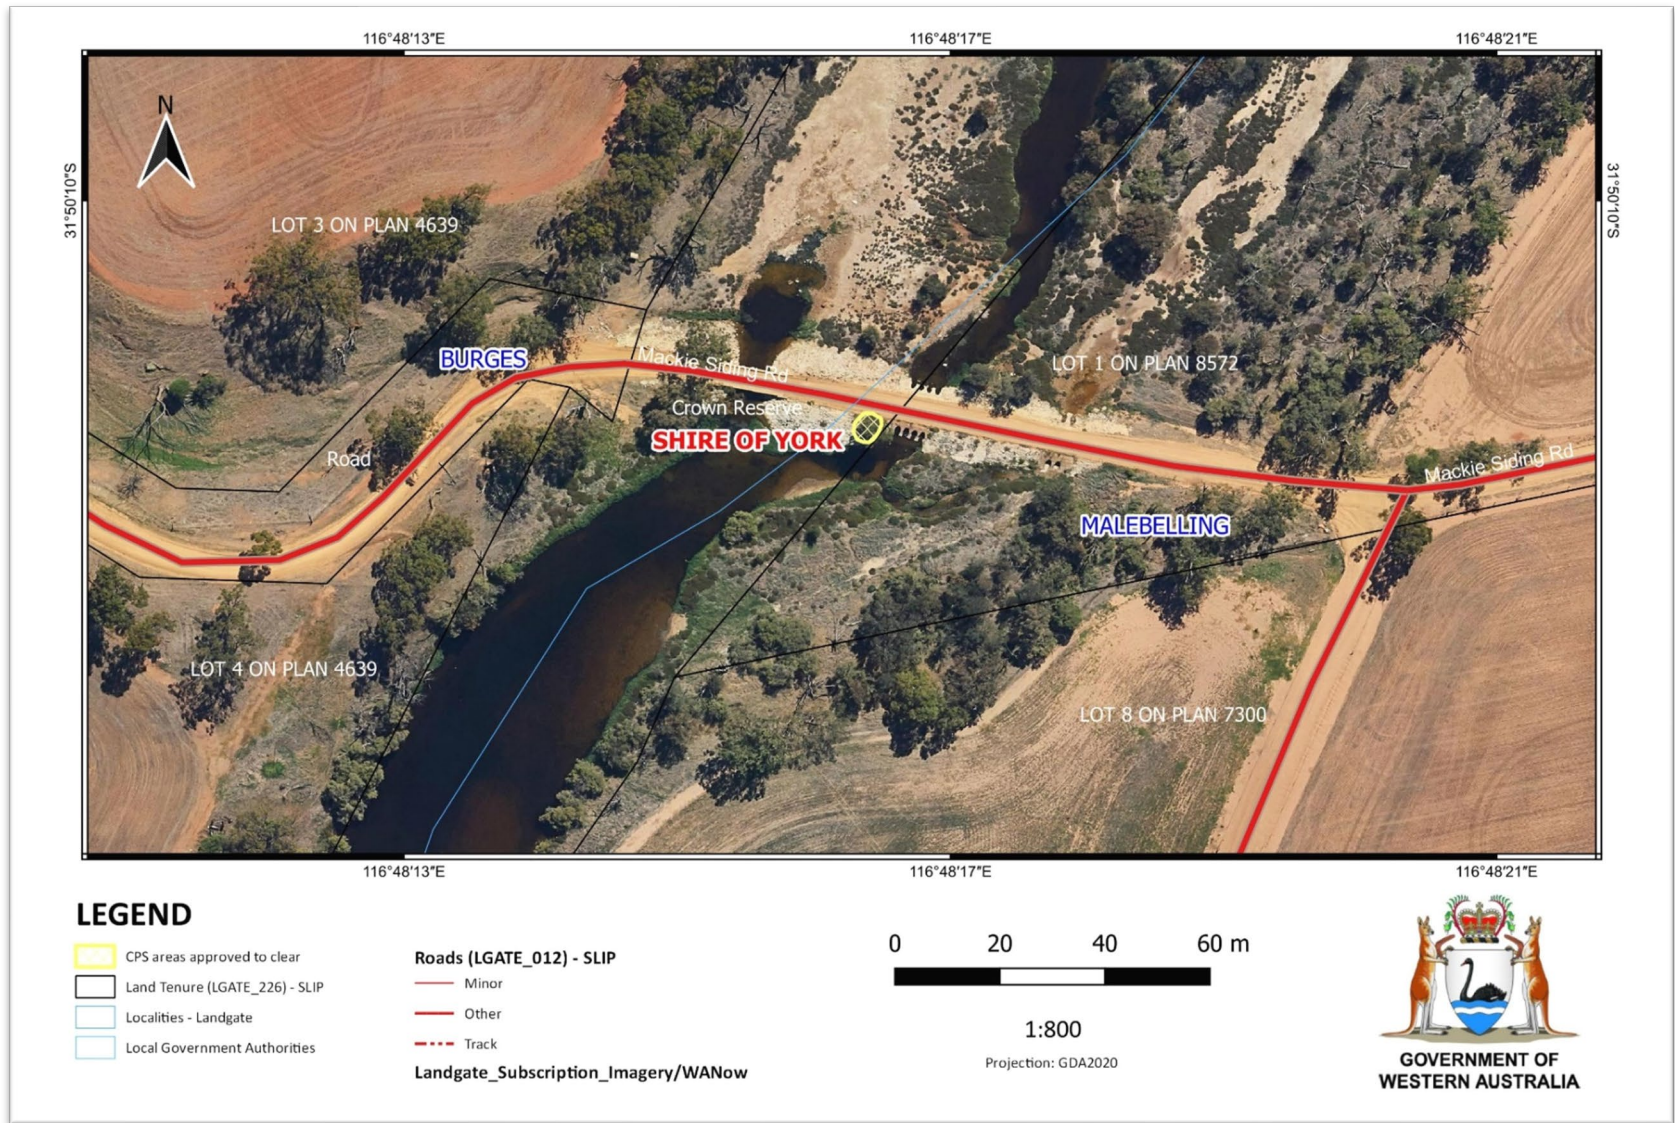
Figure 1: Map of the application area CPS 10452/1. The area crosshatched yellow indicates the area authorised to be cleared under the granted clearing permit.

The tree proposed to be cleared is an isolated tree that is located on a bank in the middle of the Avon River, where the river branches out to a tributary (see Figure 1) and is adjacent to four collapsed culverts. The concrete, rock pitching and embankment will require demolition, in order to repair the road crossing (Shire of York, 2023a).

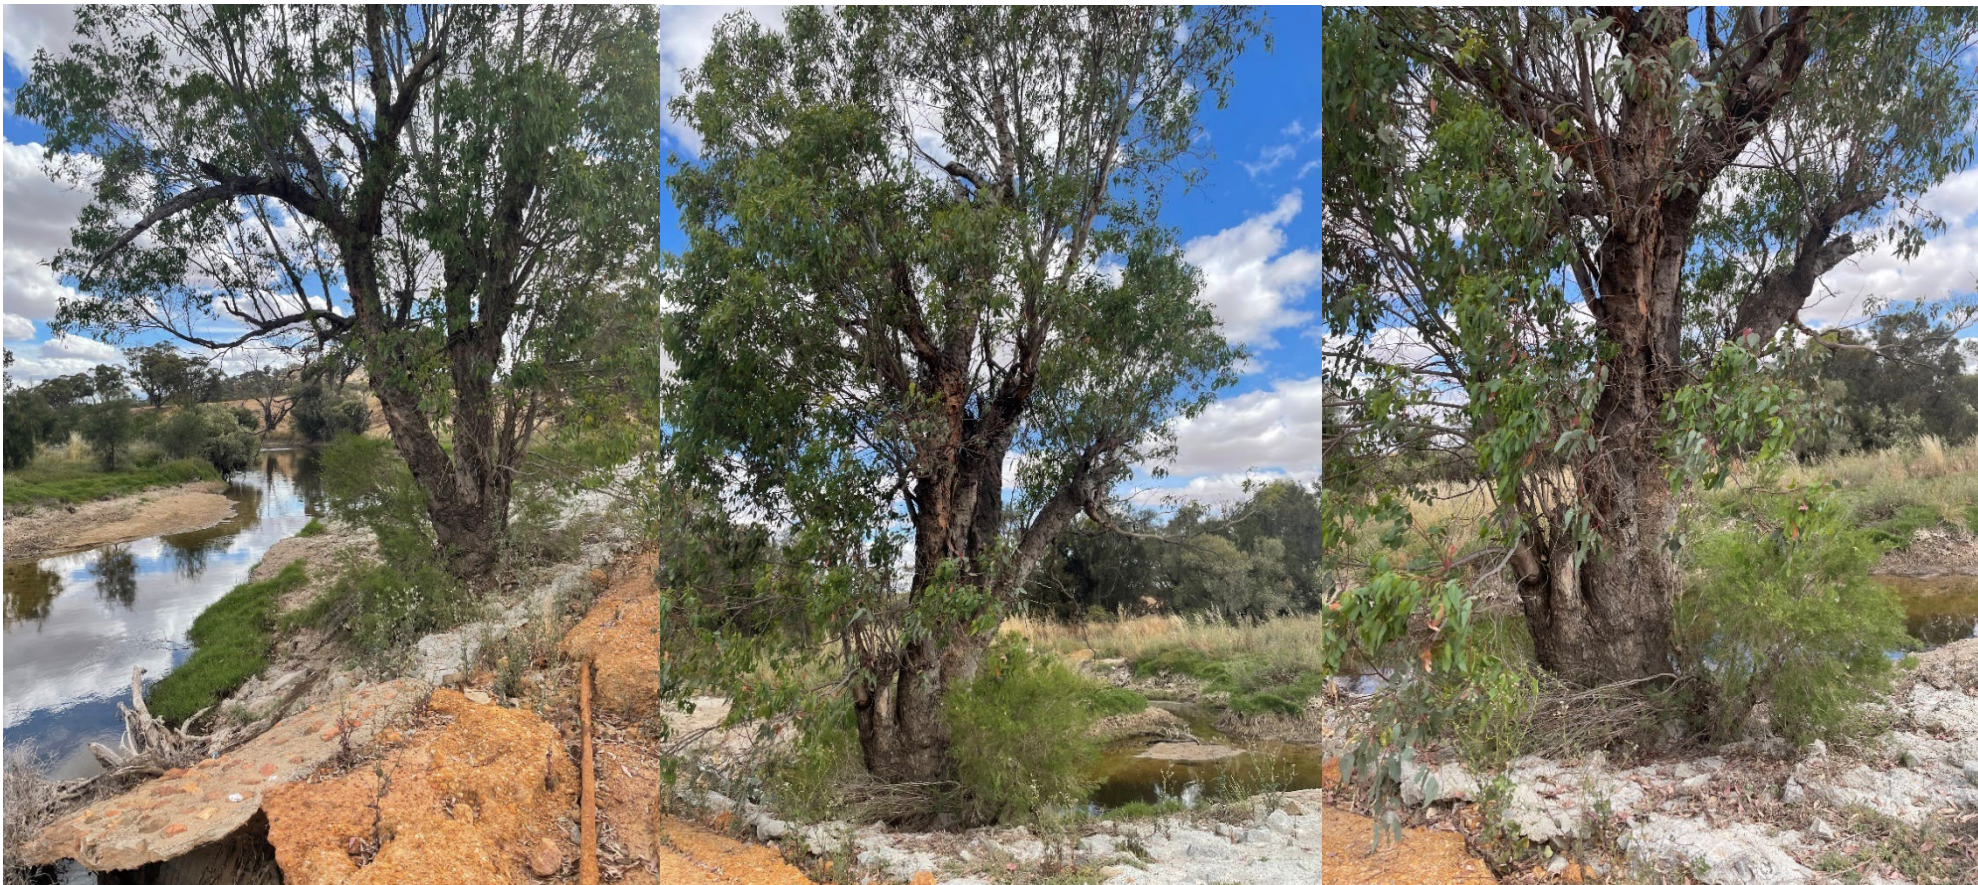
Figure 2: *Eucalyptus rudis* (flooded gum) located within the area proposed to be clearing in clearing application CPS 10452/1 (Shire of York, 2023b)

The Shire completed an inspection of the tree proposed to be cleared and provided photographs (Appendix F - Figure 2 and 3), concluding that this flooded gum is unlikely to be tall enough to be suitable for black cockatoo roosting (Shire of York, 2024c). In addition, the hollows available within this tree are small, located within the canopy and at the incorrect angle, appearing to be unsuitable for Carnaby's black cockatoos (Shire of York, 2024c).

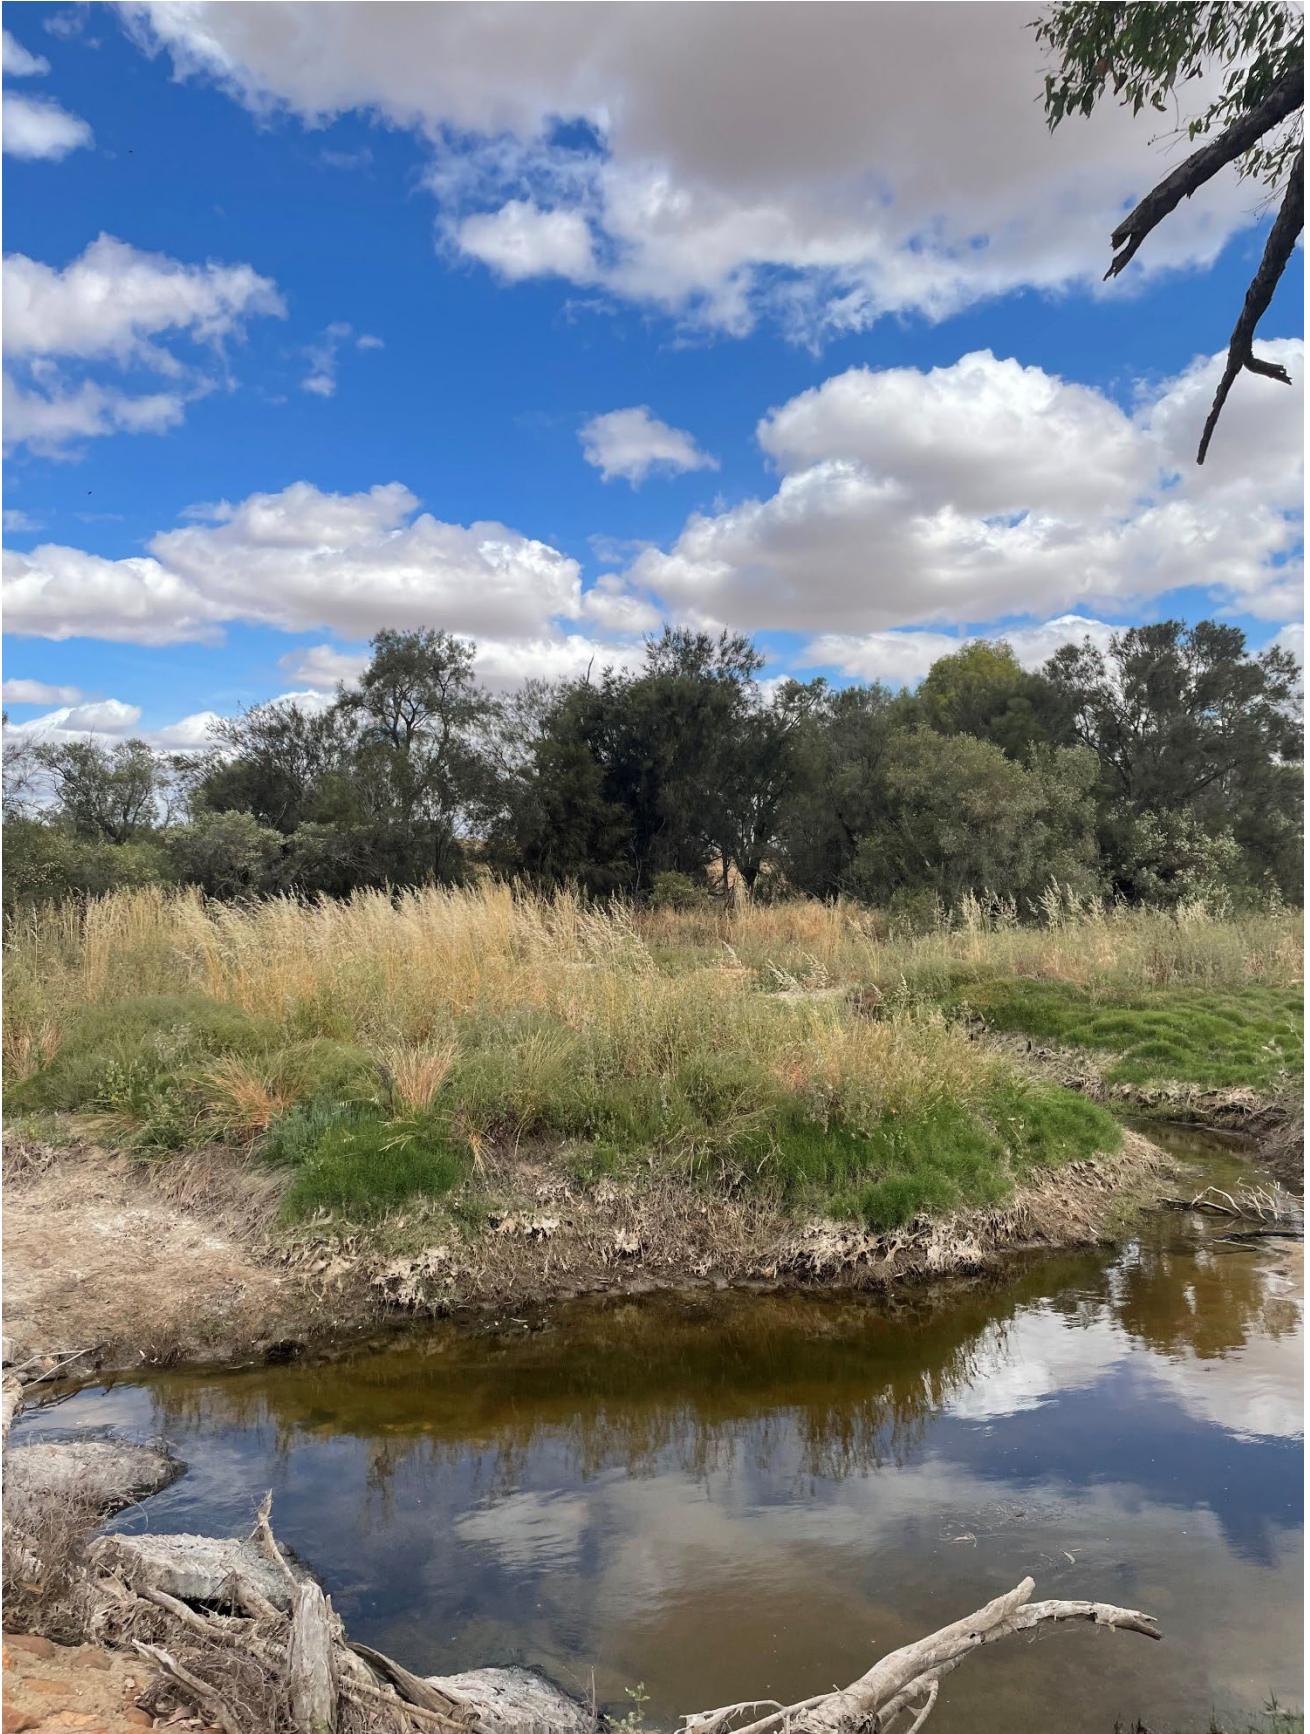
Figure 3: Photograph of the area in which revegetation is to occur to mitigate the clearing associated clearing application CPS 10452/1 (Shire of York, 2023a)

To mitigate the loss of this tree the Shire plans to revegetate an adjacent area of riparian zone. Species selection will be made in conjunction with the York River Conservation Society who are experienced in riparian restoration in the Avon River. The Shire have noted that their revegetation would include up to ten flooded gum tube stock and accompanying ground and mid layer species (Shire of York, 2023a).
