BIRD VIEWING STRUCTURES

Feasibility Study - Yellagonga Regional Park

City of Wanneroo

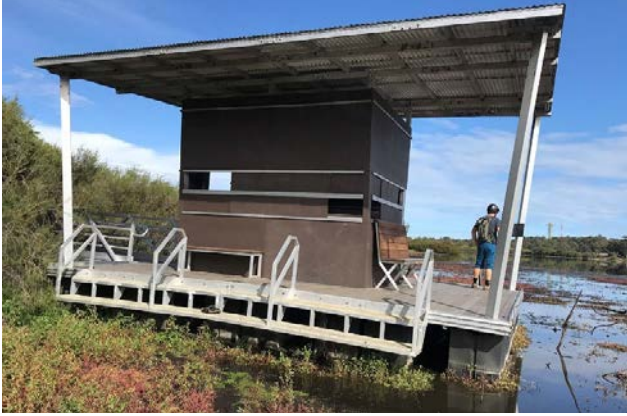
Image 1: Narma Kullarck Bird Hide

The pontoon and shelter type comprises of a boardwalk spanning from the shoreline to a floating pontoon structure that is situated on the water. The boardwalk requires a gangway articulated ramp link at the shore to allow for water level fluctuations. The span of the boardwalk can range from 20m to 80m depending on site conditions and may require additional gangways to achieve the levels required. The pontoon structure is of a larger scale, more suited to popular destinations where more users are expected. It has accessible deck to all sides that can be supplemented with steps to the water's edge and has the advantage of providing views to all sides including back towards the shore for late-afternoon photography. An example of this boardwalk structure is the Narma Kullarck Bird Walk at Bibra Lake.

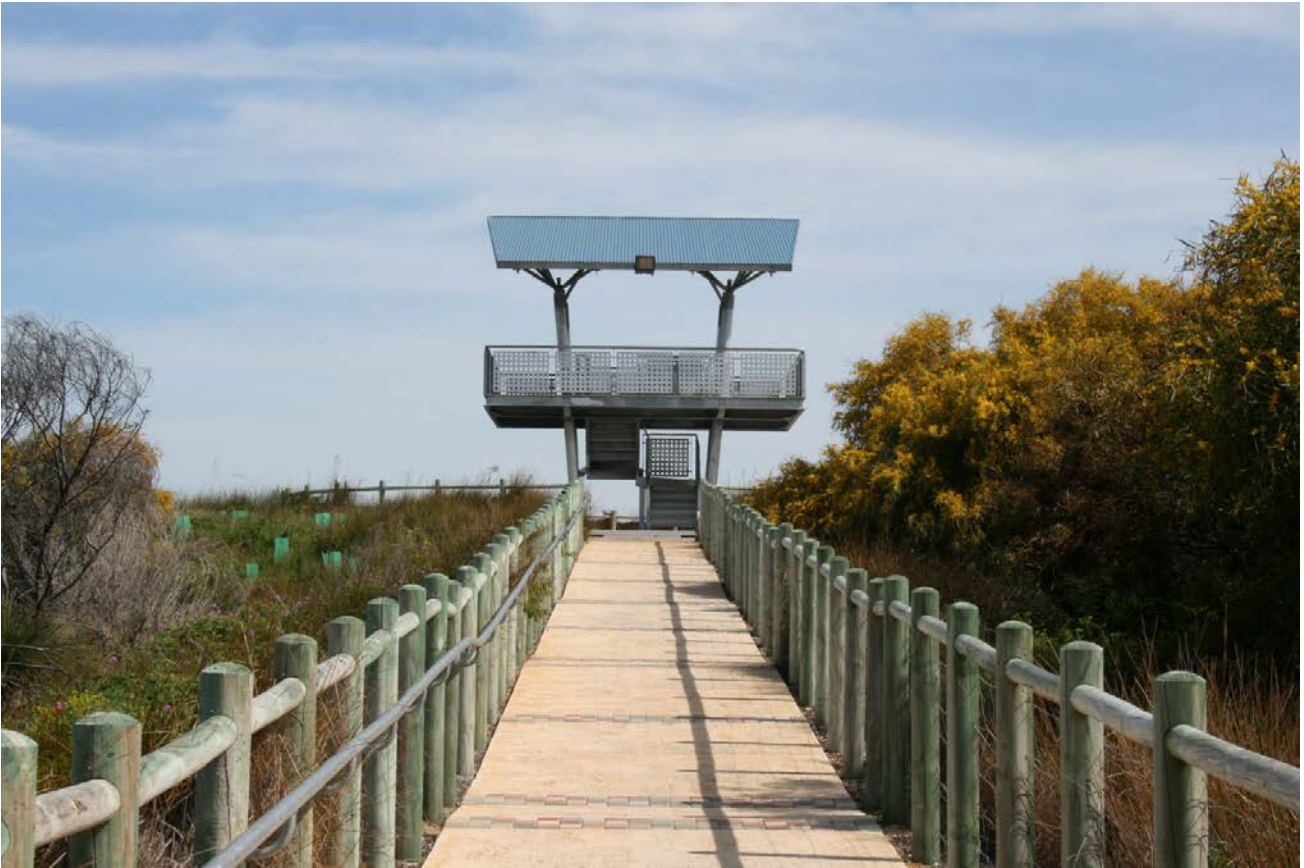
Image 9: Lookout tower, Lake Richmond, Rockingham

The popularity of a tower structure may outweigh these considerations and should be seen in the context of the overall recreational strategy for the lake that could benefit from such an attraction.

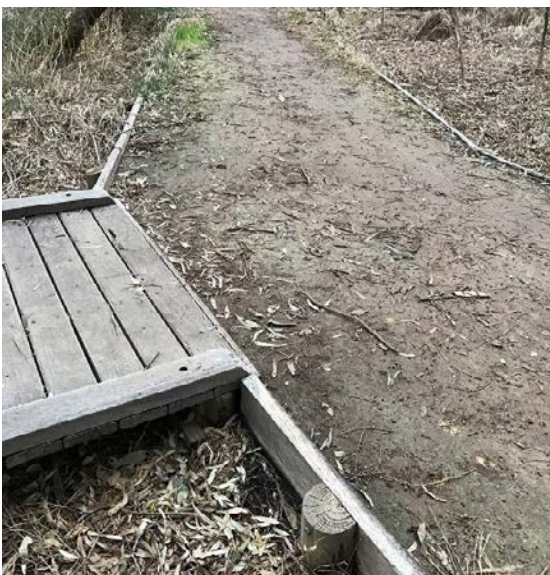
Image 10: Abutment edge connecting to the approach path

- Minimise impact to the lake environment from piles and footings.
- Avoid disturbance of acid sulphate soils in the lake bed
- Consider use of floating Styrofoam-filled, pontoons to minimise disturbance of the lake bed
- Consider non-concrete or pile-less anchoring systems
- Design to avoid impact to fauna that may inhabit or seek refuge in the structure
- Design abutments and surrounding landscape to control public access and minimise damage to vegetation
- Minimise level changes to reduce the need for handrails and balustrades
- Design to avoid bushfire ember attack and other fire related damage
- Design to anticipate movement, loads and irregular settlement of the structure on fixings and connections.

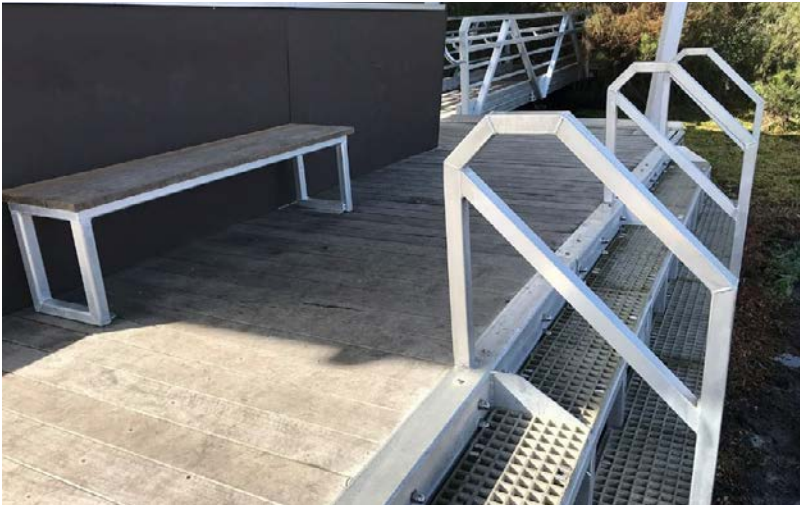
Image 16: External deck seating and steps down to water's edge for dab-netting

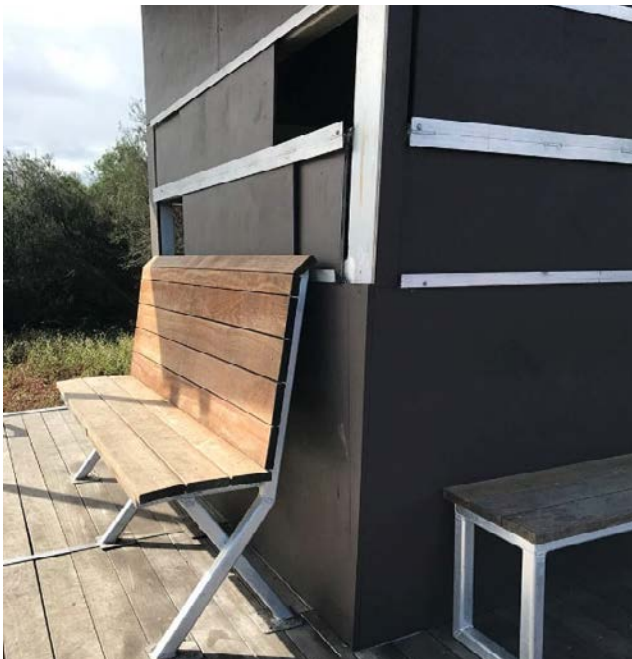
Image 18: External furniture that allows views from the interior increasing the functionality of the hide and structure

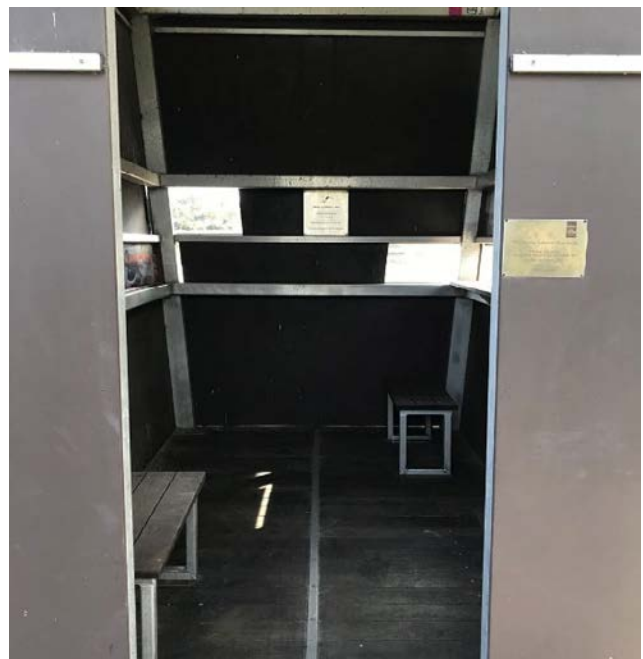
Image 19: Interior of the hide with window at varying heights to allow for a range of users

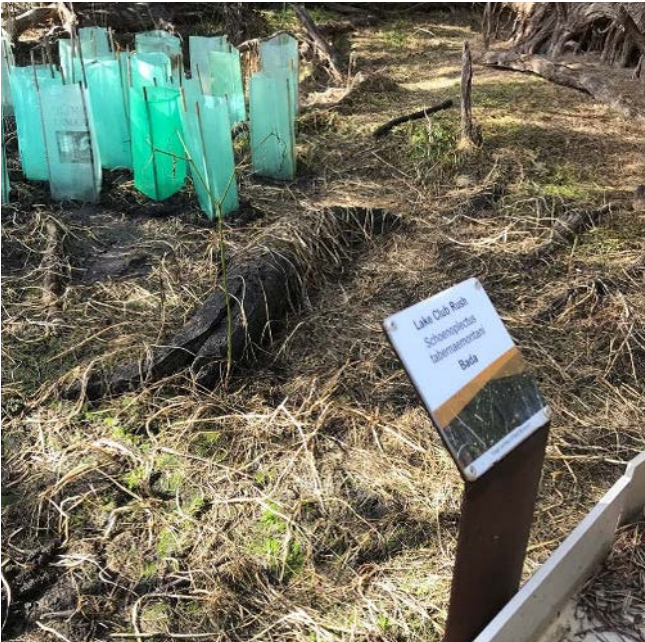
Image 20: Informational signage showing plant species and Noongar naming in line with the City's Reconciliation Action Plan

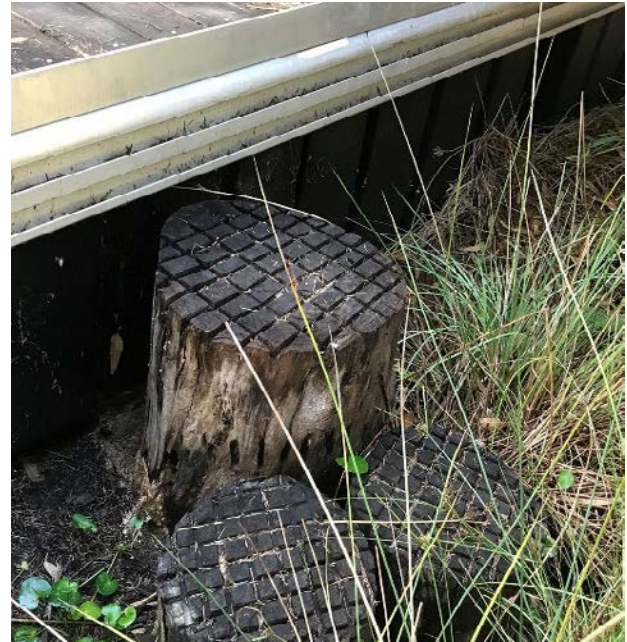
Image 21: Informal step-downs into bushland for access

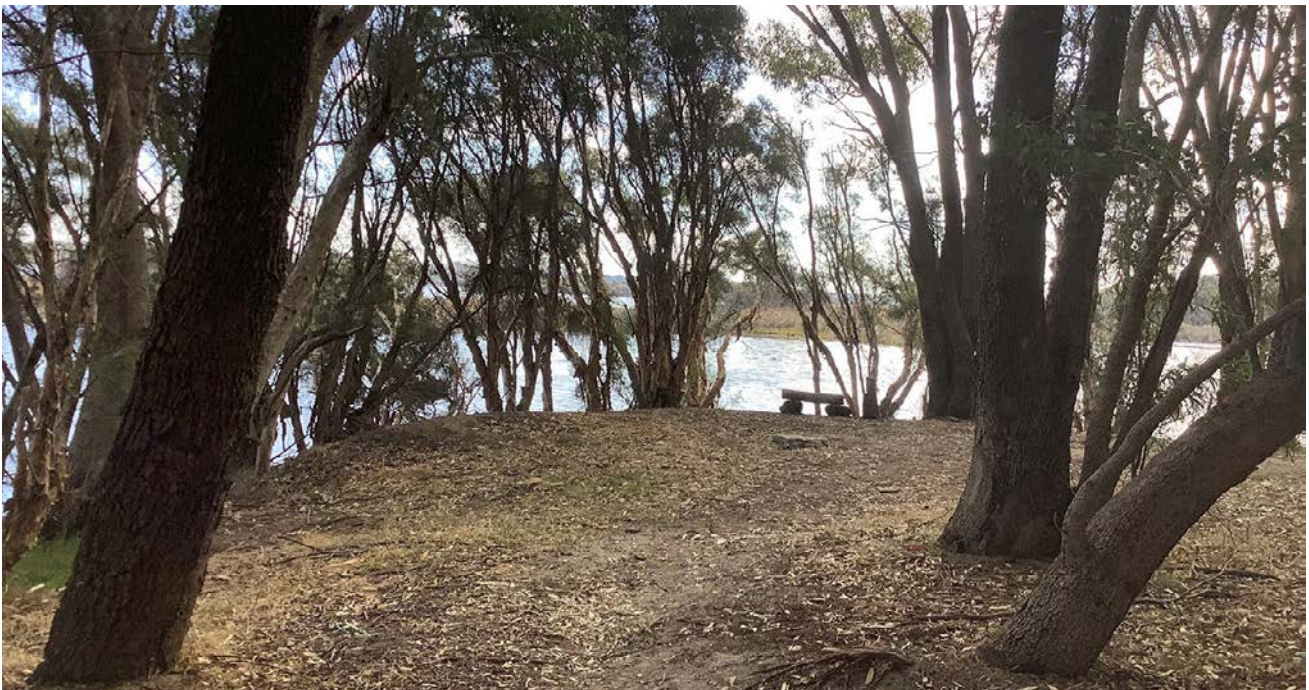
Image 22: Site 1 view facing north

The approach to the site is via the unsealed management track that is an extension of Ariti Avenue. The track is well connected to the local neighbourhood street and the Lake Joondalup Shared Path. A single track trail also approaches the site from the south. The track is in good condition and appears well used. It is possible to access the water from the path relatively easily. Due to the extensive tree canopy provided by *Eucalyptus rudis* stands the access is well shaded and sheltered. The natural trail experience that has evolved here and is valued by lake visitors should be considered in the siting of a structure that is likely to require new surfaces and materials.

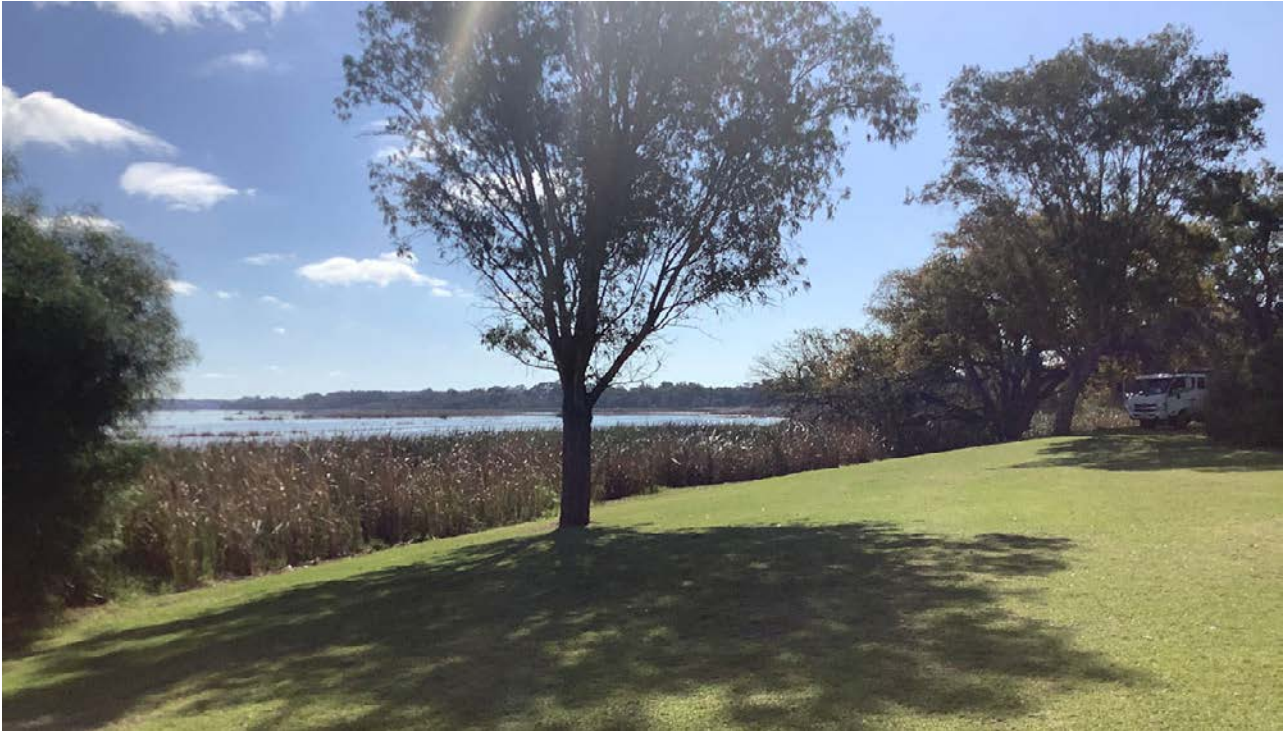
Image 23: Site 2 view facing north

Current access to the site is from the car park on Scenic Drive, at Clarkside Park, or from the Opportunity Park and recreational centre. The Joondalup Lake Shared Path is aligned to Scenic Drive and there is not a path to access the location. The approach to the site is across the open lawn and does not pass through any natural areas before arriving at the lake. The Recreation Precinct Master Plan has recommendations for significant changes to access in the location that should be taken into consideration, including relocation of the shared path alongside the site.

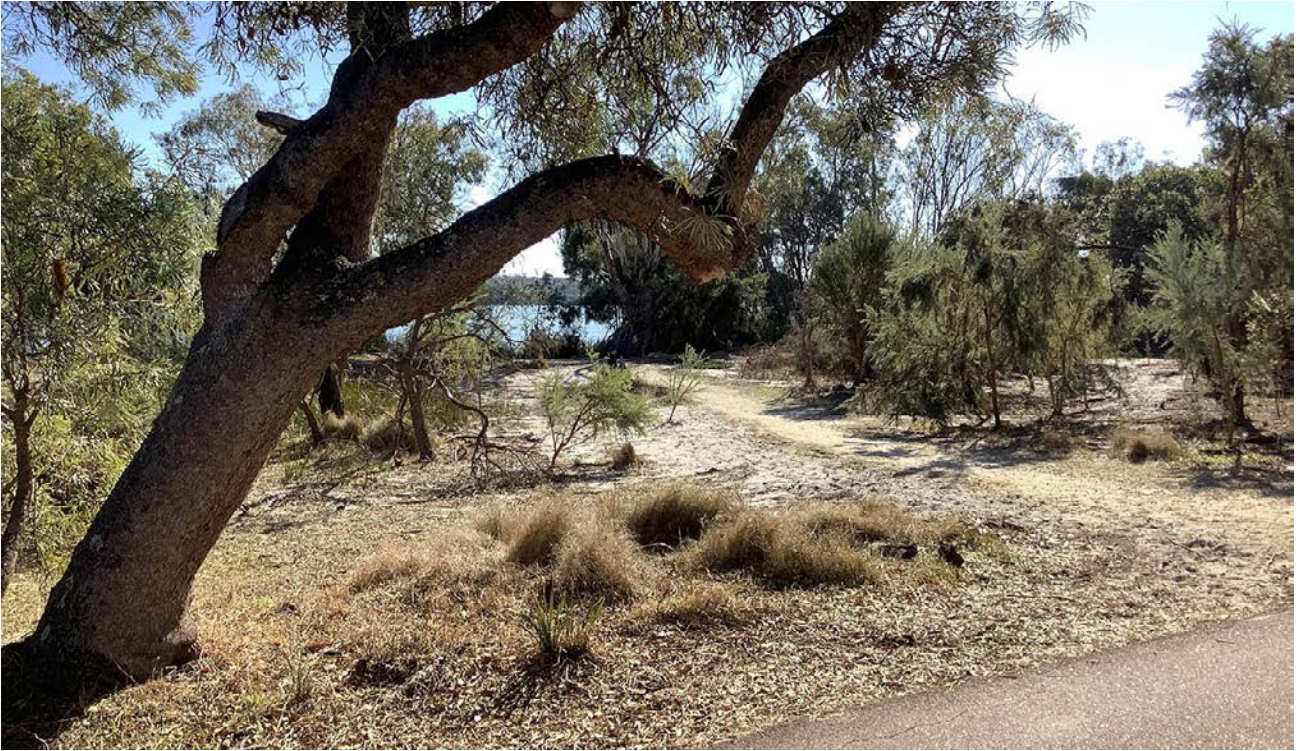
Image 24: Site 3 view from approach

The site approach passes through Banksia Jarrah woodland and features several mature specimens that are exemplars of the species and are important contributors to the landscape character. The shoreline is defined by mature Melaleucas and further inland Banksia and Jacksonia forming a natural enclosure to the site entry. Historical clearing and vehicle use of the area has degraded the understorey, which presents an opportunity for revegetation planting to be incorporated into the design. Sedge and rushes in the location extend from the shore to 5-10m into the water.

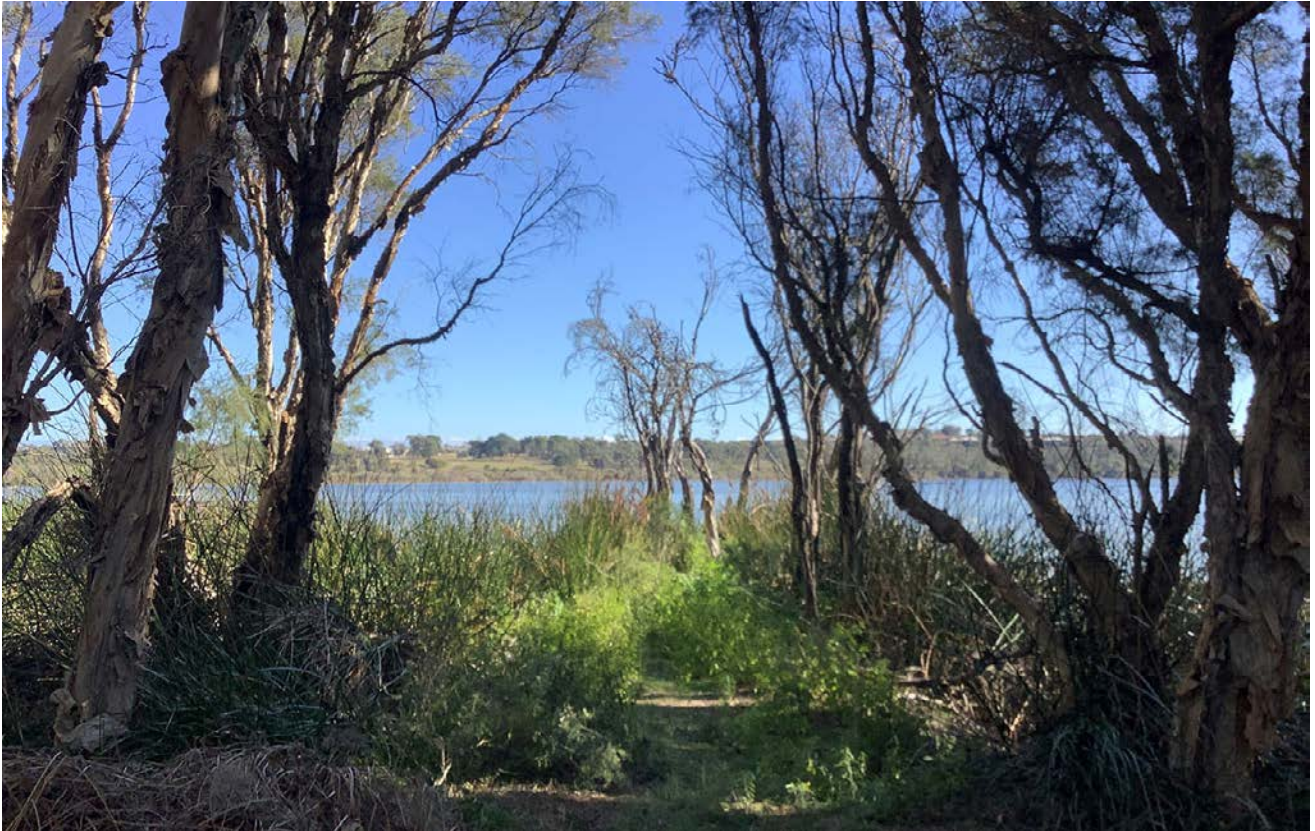
Image 25: Site 4 view on approach to spur from Melaleuca stand and clearing

The vegetation of the site includes Banksia woodland with a degraded understorey of low shrubs. Closer to the lake the vegetation composition transitions to Melaleuca stands with an understorey of sedges and rushes that extend approximately 15m from the shoreline into the lake. This creates a continuous physical barrier broken only by the spur that forms the current viewing location. The Melaleucas create an open enclosure and threshold for the access. On the upper areas of the site, extensive revegetation has resulted in a young understorey occurring on rehabilitated tracks. Several large Banksia and Eucalypt trees occur here and define the approach to the site from the car park.

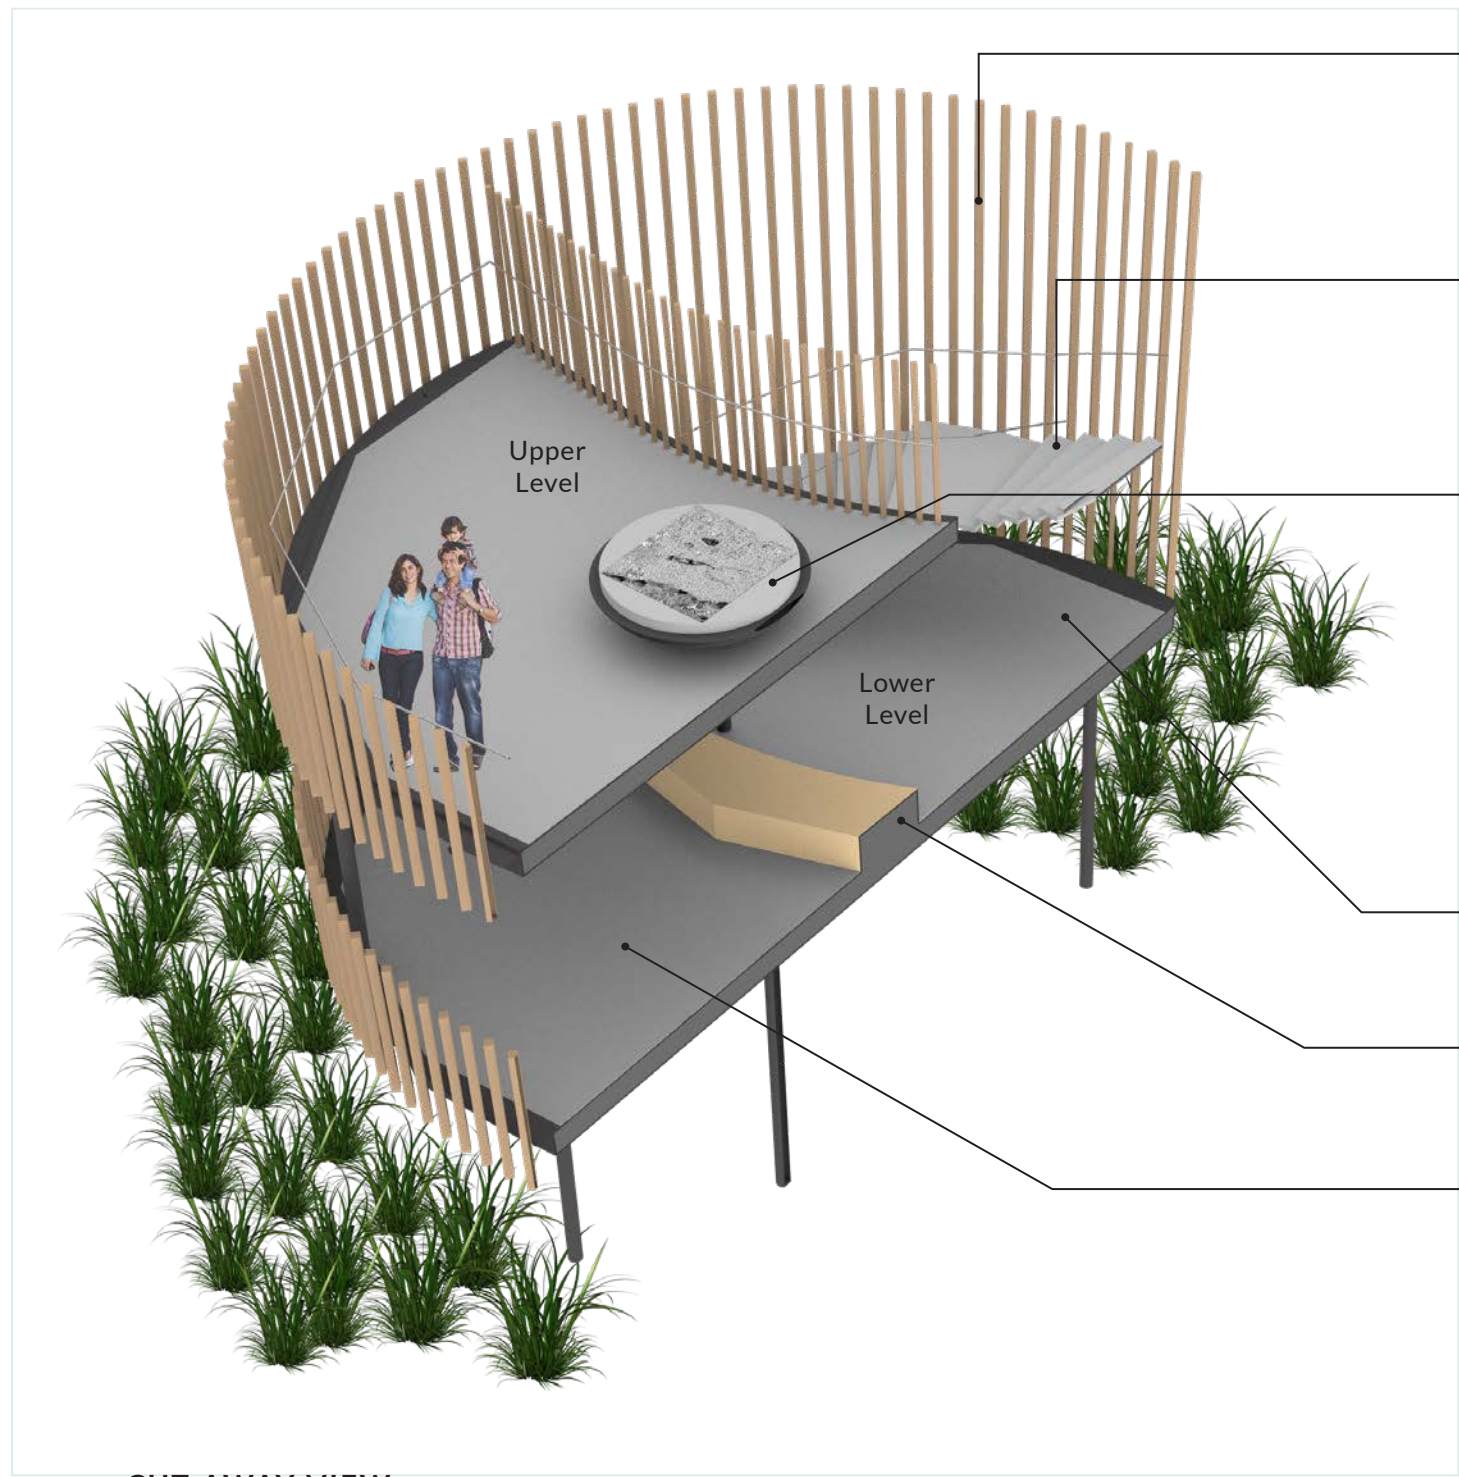
CUT-AWAY VIEW

Sculptural timber batten screen creating nest-form providing enclosure to rear face of lookout and balustrade to all other areas.

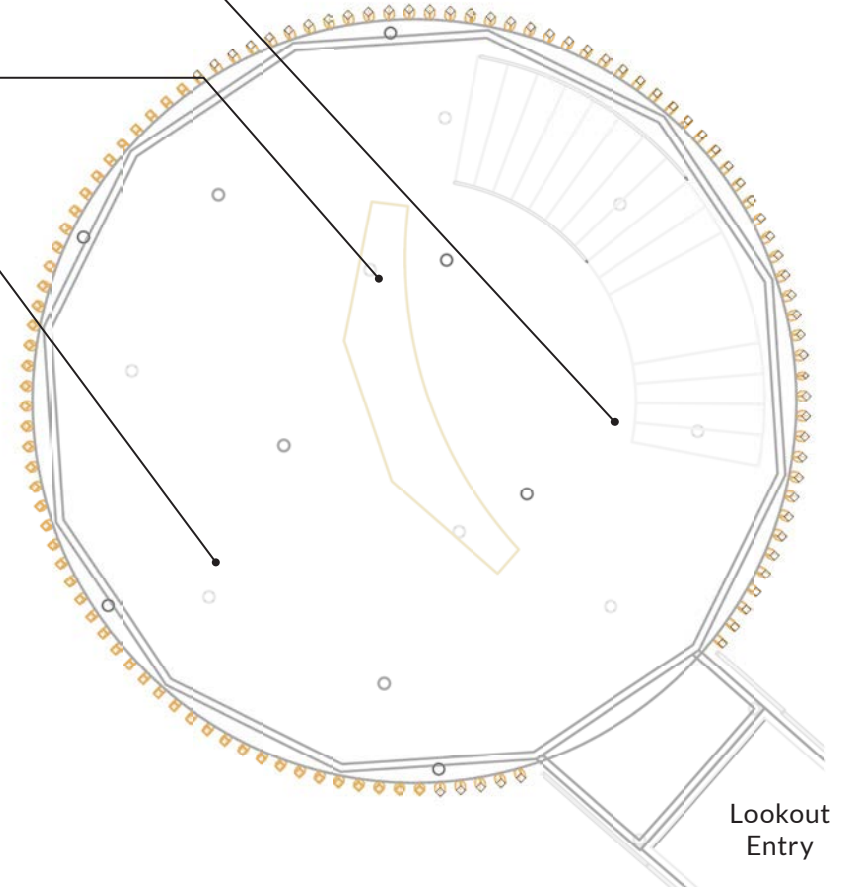
LOWER LEVEL FLOOR PLAN

Lower level viewing area, wheelchair accessible
