# **CPS 10482-1 Revegetation Plan Yellagonga Bird Watch**

Lookout Spot Option B (Scenic Drive)

Lot 137 on DP 10027 Lot 143 on DP 10445

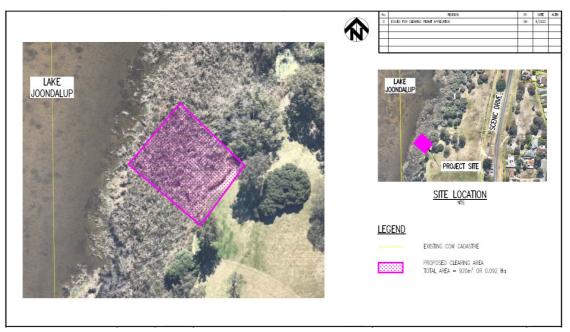
Figure 1: Clearing Plan.

The proposed clearing is located on the eastern edge of Lake Joondalup (City of Wanneroo side), on Lot 501 on DP 73317. Clearing will primarily involve the removal of 0.092 hectares (ha) of *Typha orientalis*. This species has become naturalized in Western Australia and exhibits invasive characteristics within wetland ecosystems. As a result, the City of Wanneroo (hereinafter referred to as the City) will not be implementing a "like for like" revegetation offset. Instead, the City will revegetate using species representative of reference site shown in **Figure 4** below. Species list can be found in **Section 4**, **Table 4**. Please see **Table. 2** below with details of the proposed clearing site and **Figure. 1** showing a map of the proposed clearing area.

Clearing Details	
Location of Clearing Site	On the eastern edge of Lake Joondalup
	(City of Wanneroo side) approximately 665
	metres south of Revegetation area
Property Details	Lot 501 on DP 73317
Clearing size	0.092 ha
Purpose of clearing	Clearing to facilitate the construction of
	the Bird Watch (Lookout Spot Option B)

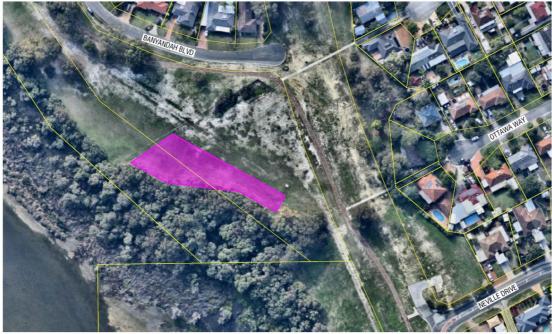
Figure 2: 0.18 ha Revegetation Area.

To counter the impact of clearing bush forever site 299 the City plans to revegetate 0.18 ha of land north of the construction site. Please see below details of the revegetation site and Map in **Figure 2**. illustrating the area proposed for revegetation. The revegetation site is degraded land located on Lot 137 DP 10027 and Lot 143 DP 10445.

Revegetation Site	
Location of Revegetation site	On the eastern edge of Lake Joondalup (City of Wanneroo side) approximately 665 metres north of clearing area
Property details	Lot 137 DP 10027 Lot 143 DP 10445
Size of revegetation	0.18 hectares
Reserve Purpose	Public Recreation

Lot 137 DP 10027 and Lot 143 DP 10445 (the Revegetation site highlighted in **Figure.2**) are both Crown Land and managed by the City. The land is currently zoned as 'Public Recreation'. The proposed area is currently within Bush Forever site 299. Bush Forever ensures the protection of the revegetation area in the future. The area to the east of the revegetation area is predominantly residential. Lake Joondalup is located to the west.

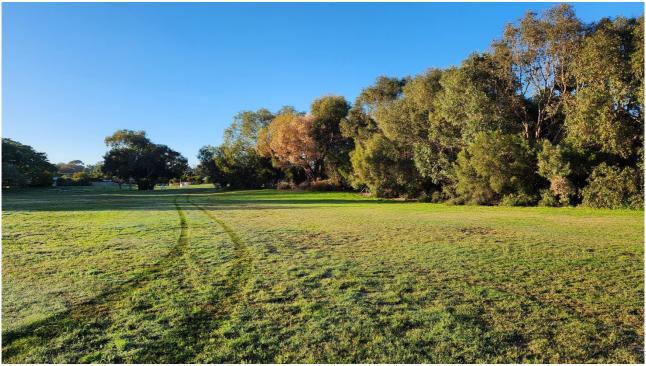
Figure 3: Revegetation Site Photo looking south (taken by the City, 19 June 2024).

Aerials retrieved from Landgate 2024 show that the proposed revegetation area had been completely cleared since 1970. Since then, there has been no vegetation replanted or regrown in the area. **Figure 3** below shows the remnant vegetation adjacent to the degraded revegetation site.

The revegetation site was previously cleared in 1970 and is now completely degraded. The site was cleared to facilitate public recreational activities in the park land areas, resulting in intentional landscaping with *Pennisetum clandestinum* (near the wetland) and *Cynodon dactylon* (in the dry areas). Since the 1970s, the area has been regularly mowed (Landgate, 2024). Currently, the site is predominantly covered with grass weeds including:

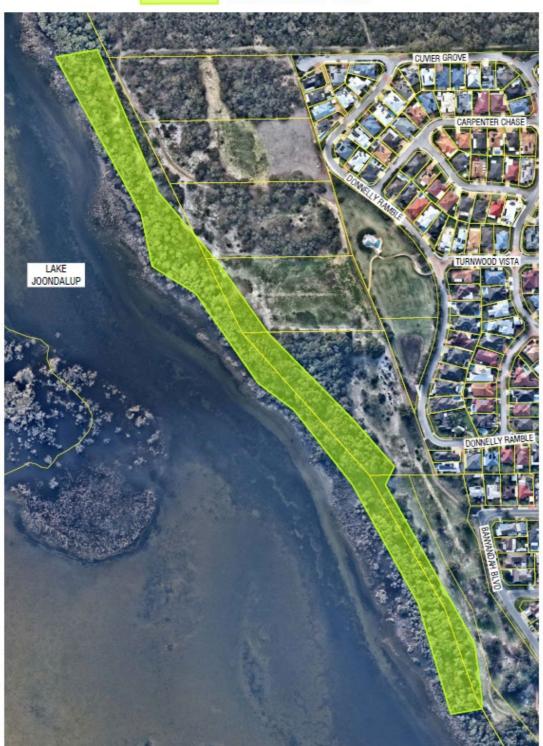
# YELLAGONGA BIRD WATCH REVEGETATION PLAN CPS 10482-1 REFERENCE SITE

survey of this area, as illustrated in **Figure 4.** From this assessment, the City developed a comprehensive species list suitable for the revegetation of both wetland and dryland areas.

REFERENCE SITE AREA = 3.727 Ha

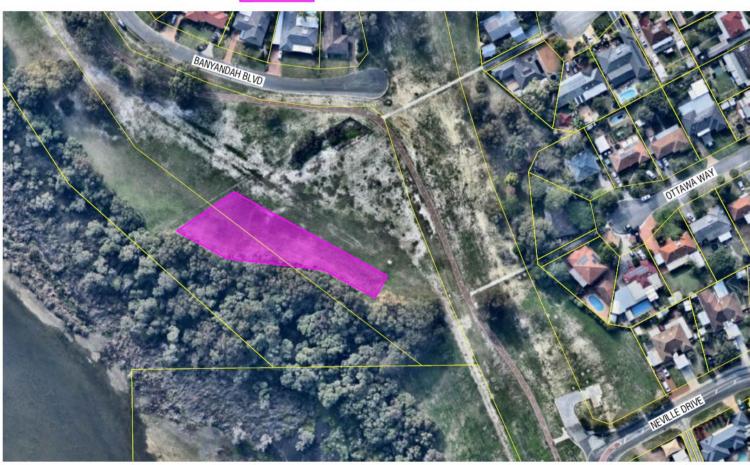
# YELLAGONGA BIRD WATCH REVEGETATION PLAN CPS 10482-1 REVEGETATION SITE

REVEGETATION SITE AREA = 0.184 Ha

The site is directly adjacent to parkland. To distinguish between the revegetation area and the parkland, a conservation fence (TS 01-4-2) will be installed to the north and east of the revegetation site. However, the western portion of the revegetation area will not require fencing as it borders the riparian vegetation of Lake Joondalup. This fence will facilitate the free movement of fauna in the area.
