3650 Toodyay Road, Bailup

LANDSCAPING PLAN

**[for a Vegetative Screen adjacent Site access and intersection with
Toodyay Road]**

September 2021

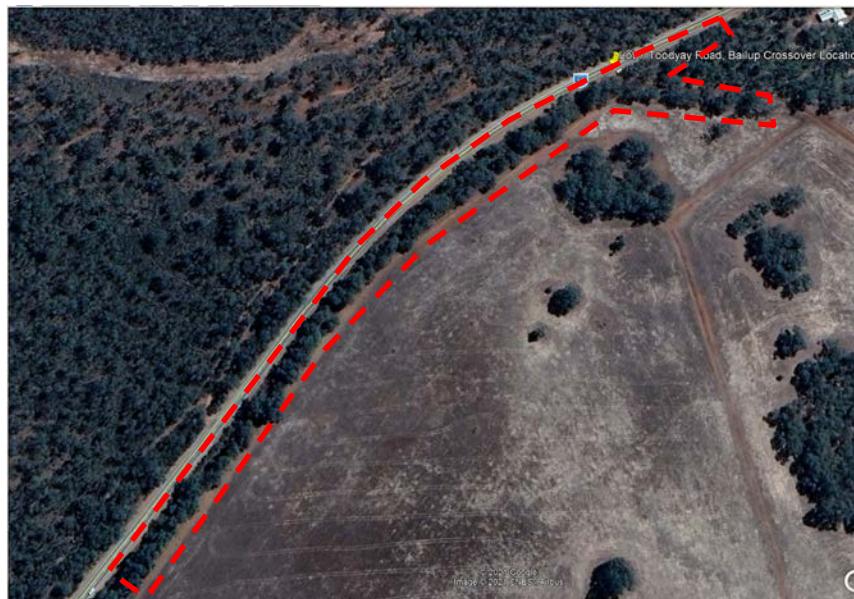
IMAGE 1 – AERIAL OF VEGETATION SURVEY AREA

Image 1 illustrates the approximate survey area and vegetation within the southern verge of Toodyay Road.

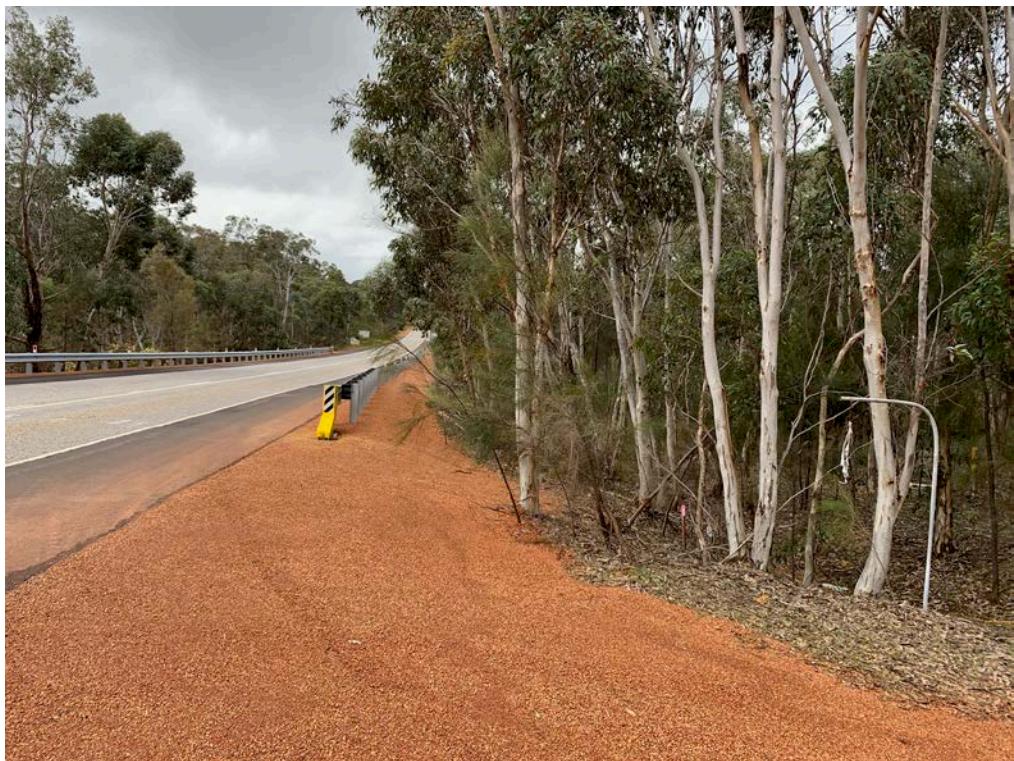
IMAGE 2 – TOODYAY ROAD SOUTHERN VERGE, LOOKING EAST, CHG 00

From the location of the existing crossover, the construction footprint extends approximately 260 metres to the east but is relatively close to the existing road (approximately 10 metres or less from the southern painted lane line). A strip of new asphalt shoulder had been recently constructed by Main Roads and there is a further gravel road shoulder. The proposed construction footprint will not encounter substantial vegetation in this area other than several immature trees which are immediately adjacent the existing crossover, as seen in Image 2.

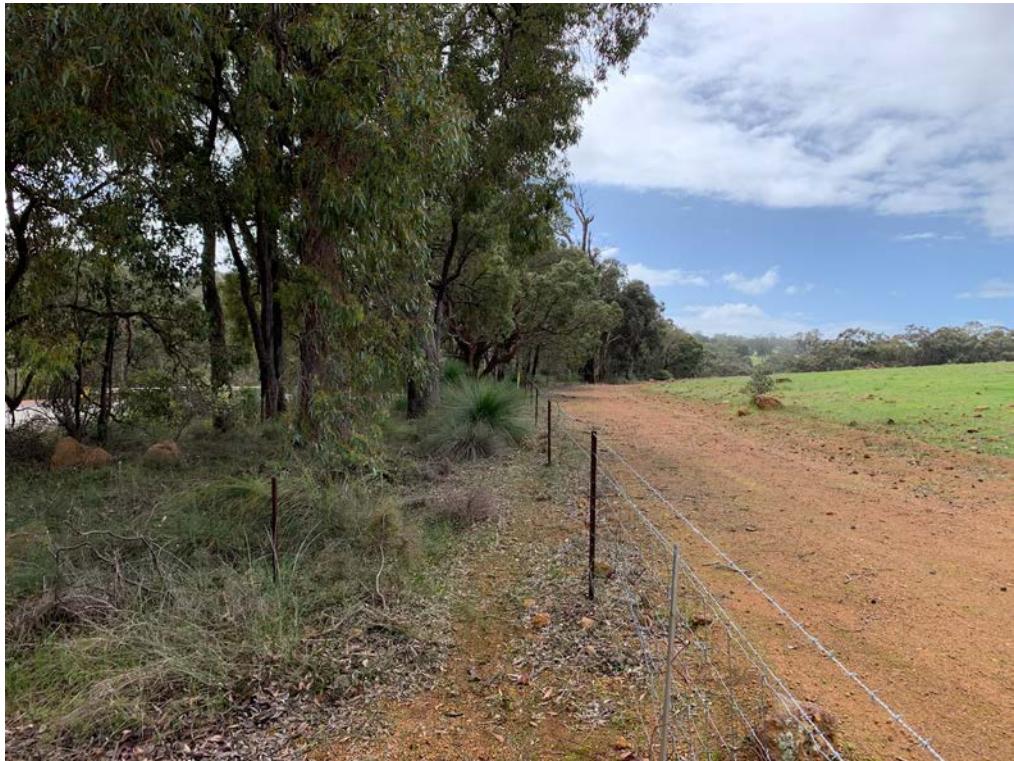
IMAGE 9 – TOODYAY ROAD SOUTHERN VERGE BOUNDARY TO SITE, LOOKING EAST, CHG -200

A wire fence in the vicinity is not located precisely on the boundary. It varies up to 10 metres south into the Site. Land south of the fence (within the Site) is cleared of all vegetation as it has been developed for agriculture cropping and grazing activities. There is also a firebreak [as seen in image 9]. The fence line is relatively close to the limit of earthworks as noted on the engineering plans and has been used to identify the limit of clearing.

The construction footprint extends into the Site by a further 10 metres however there is no vegetation to be cleared south of the boundary [as seen in image 9]. Vegetation along the verge is set back from the southern lane at an approximate average of 5 metres where there is an asphalt shoulder, gravel shoulder and v-drain [as seen in images 3-7]. Vegetation adjacent to the existing crossover within the Site is also impacted and has been surveyed [image 8].

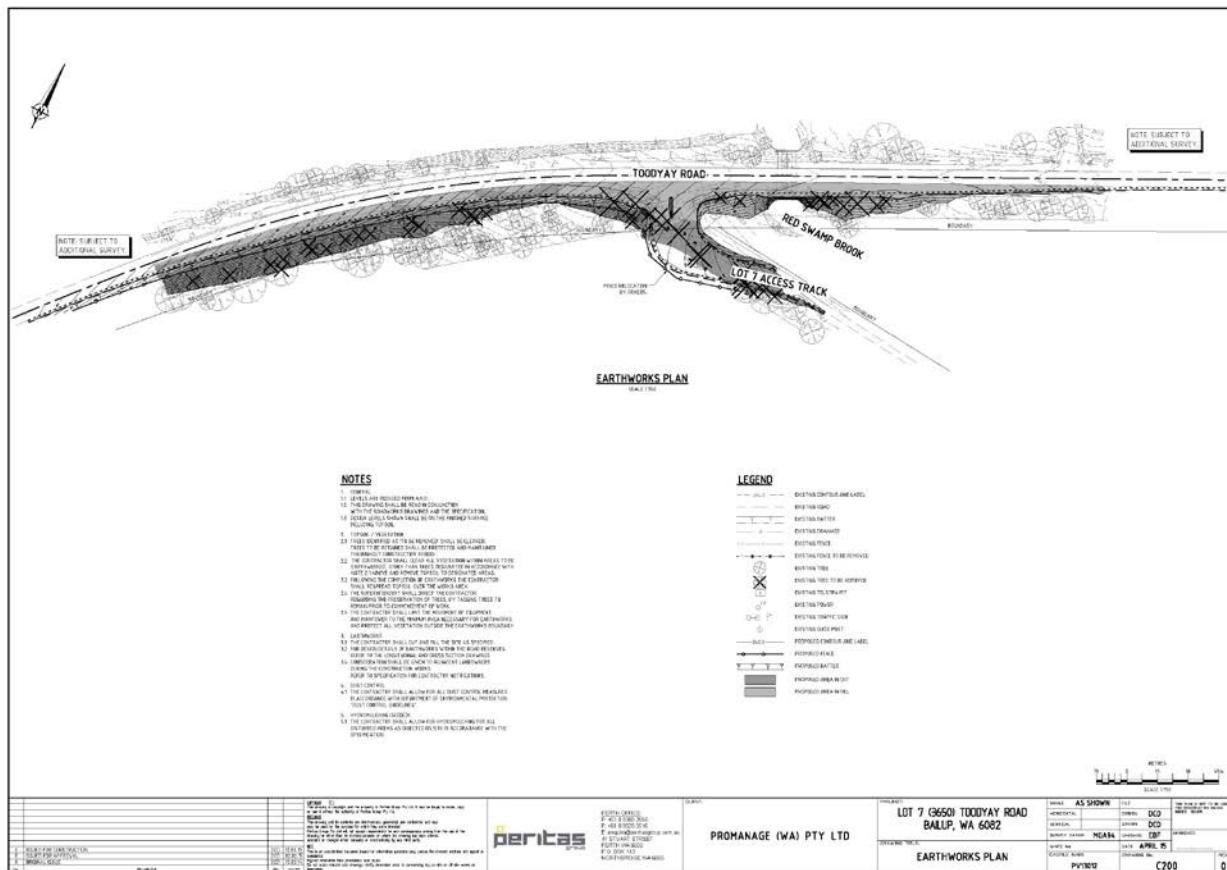
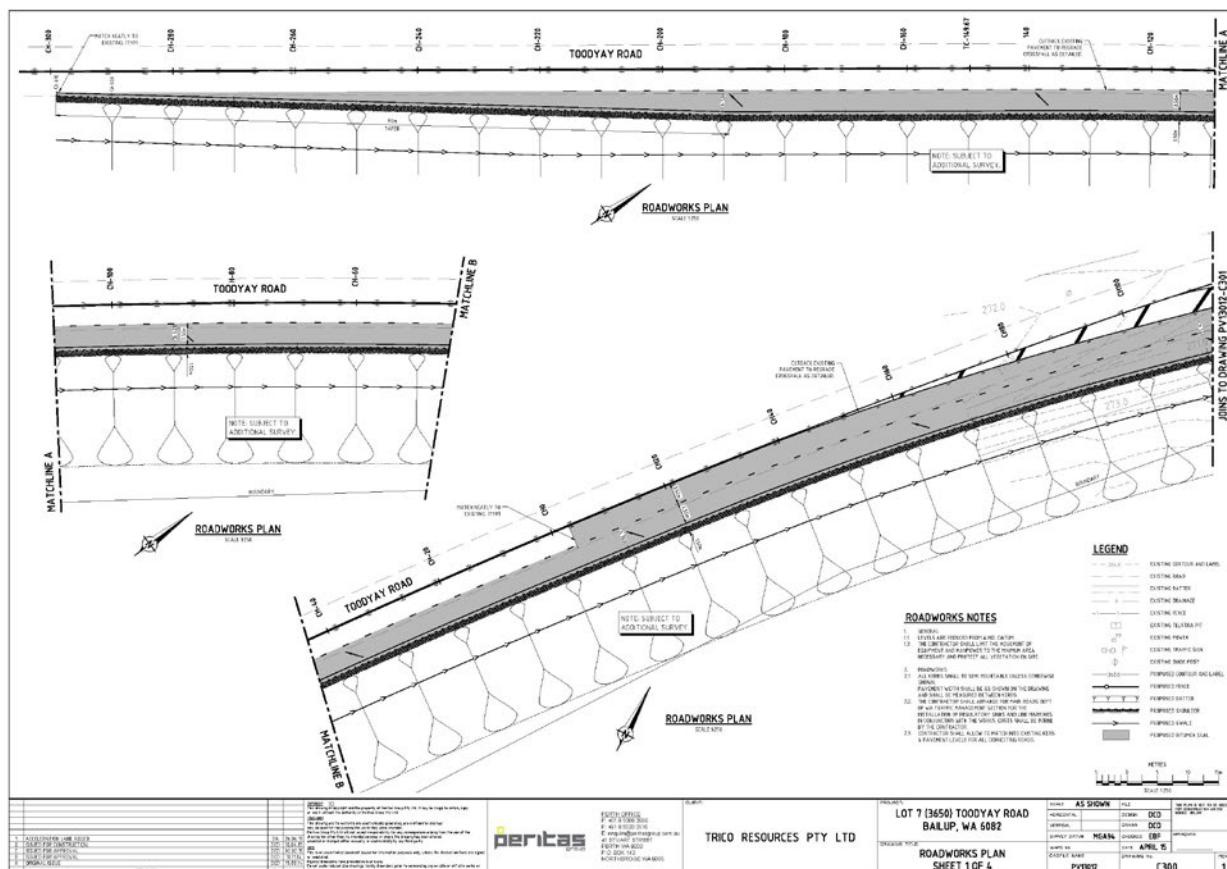
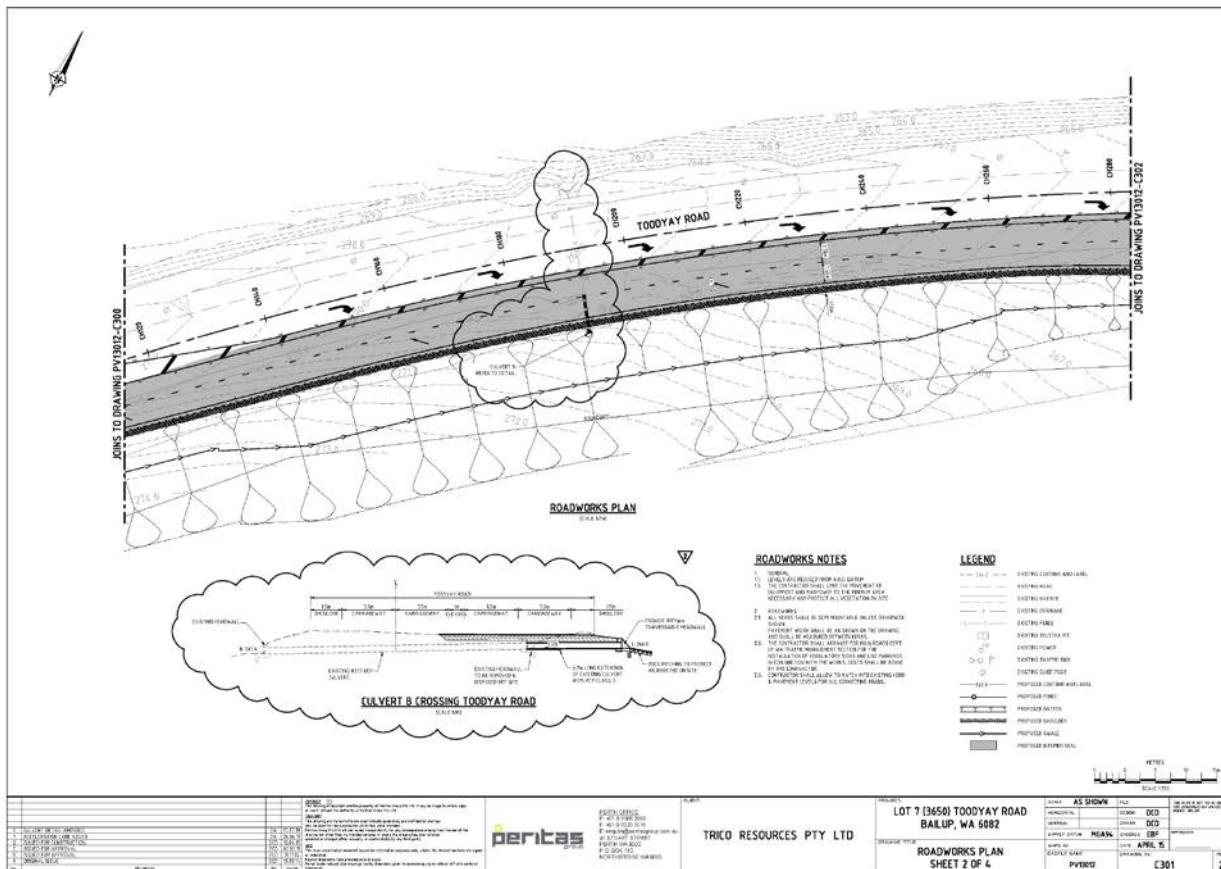
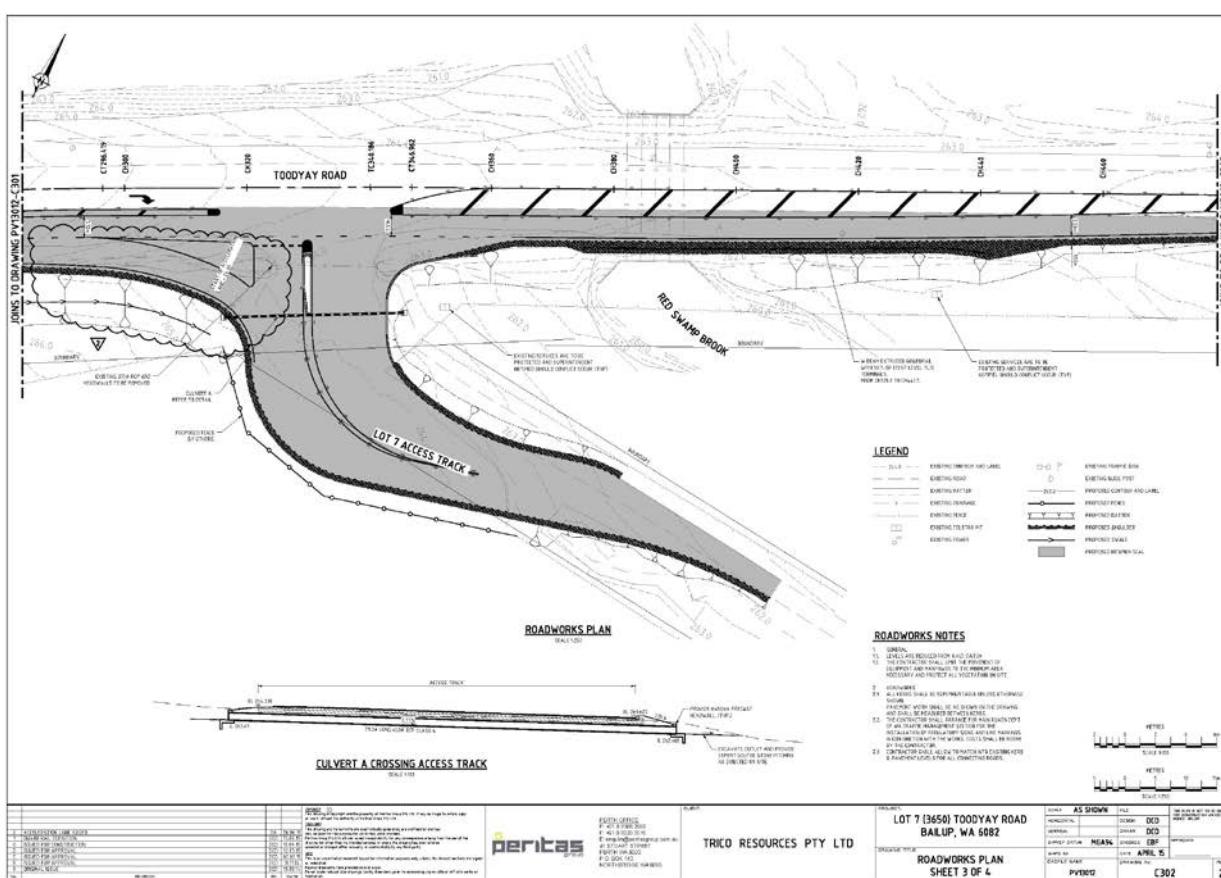
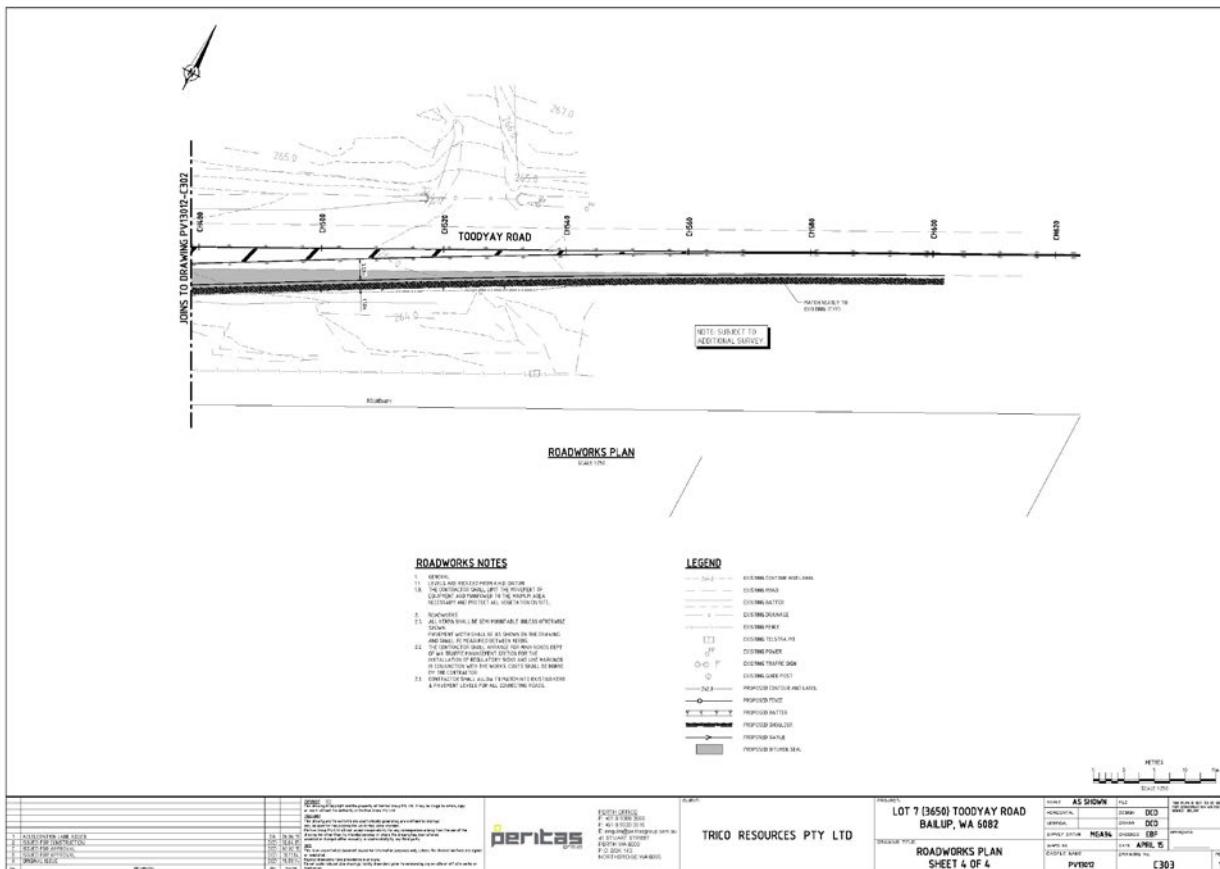
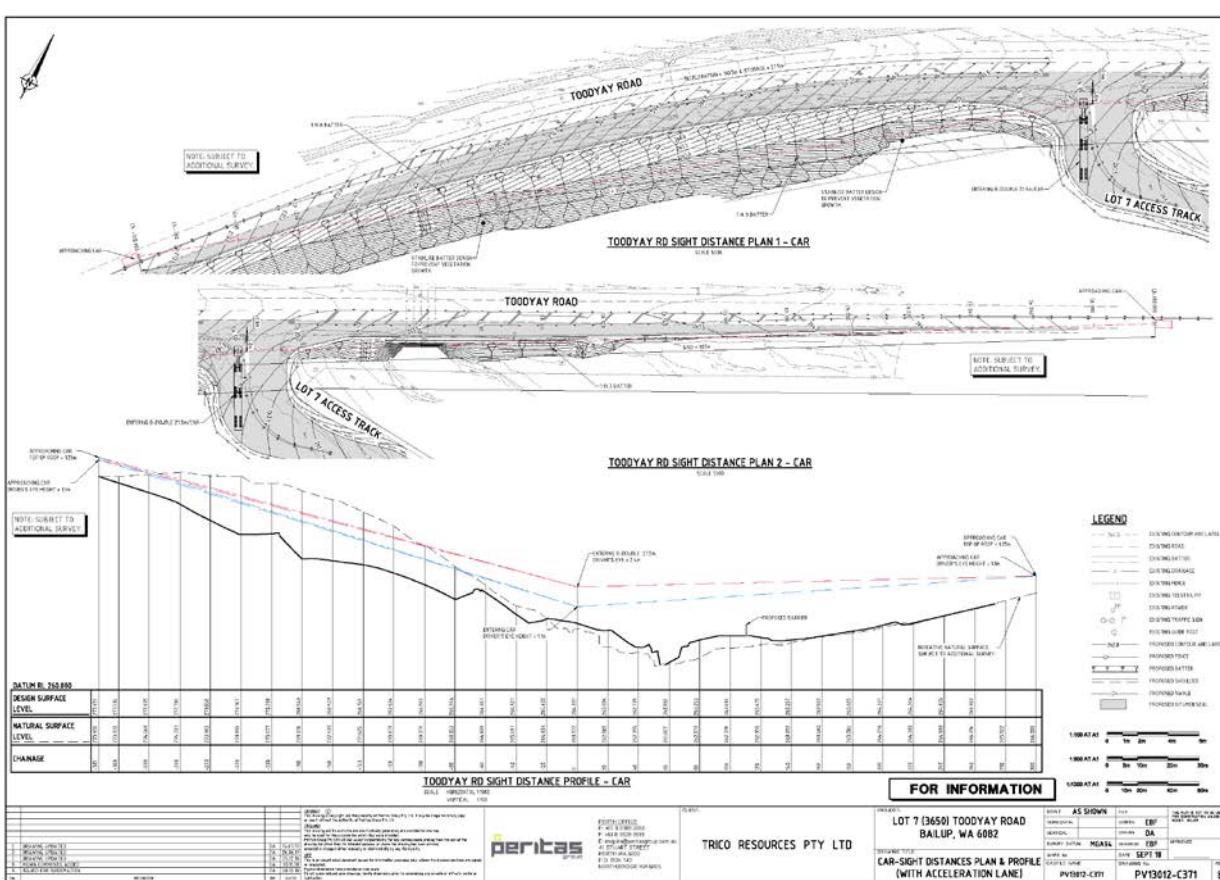
APPENDIX B – Intersection design drawings

Given that the intersection design is not yet fully approved by Main Roads, this report shall rely on the most recent revision of the engineering plans which identify the extent of earthworks/clearing. Relevant engineering drawings used for this Landscaping Plan are as follows [copies found at Appendix B]:

C200	Earthworks Plan	Rev 0
C300	Roadworks Plan Sheet 1 of 4	Rev 1
C301	Roadworks Plan Sheet 2 of 4	Rev 2
C302	Roadworks Plan Sheet 3 of 4	Rev 2
C303	Roadworks Plan Sheet 4 of 4	Rev 1
C371	Car-Sight Distances Plan and Profile (with Acceleration Lane)	Rev E
C800	Land Protection Plan	Rev F
