Offset Revegetation Plan Circle Valley Locality

Shire of Esperance 2023/24 Strategic Purpose Permit
Site C – Circle Valley Road, SLK 1.32-7.68

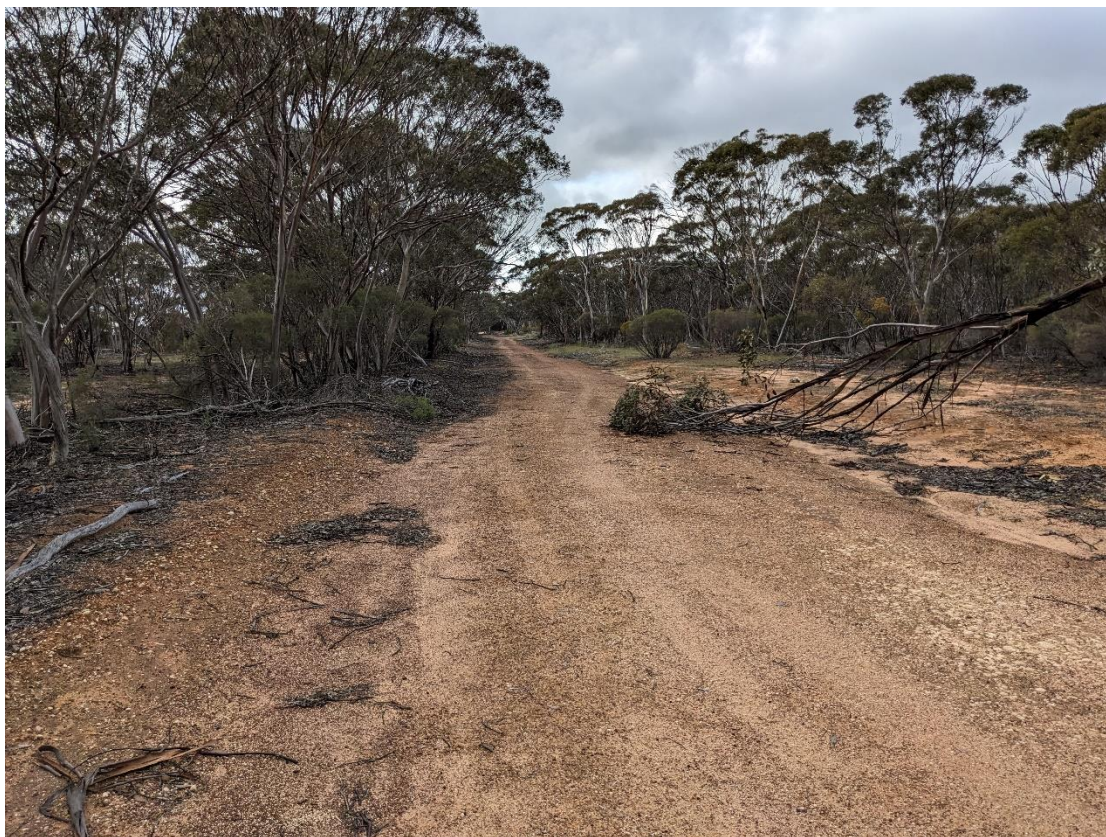
Figure 1. Photo of Proposed revegetation area. Photo taken by Kathrine Walkerden on the 20.09.2024.

Revegetation works will consist of ripping a historic track within Reserve 24007 and the Circle Valley Road Reserve while the road project is being completed, this area will be planted and brushed.

A road grader will be used to rip the historic track to a depth of 200-350mm, reducing the compaction within the track, this will be completed concurrently with the road construction project.

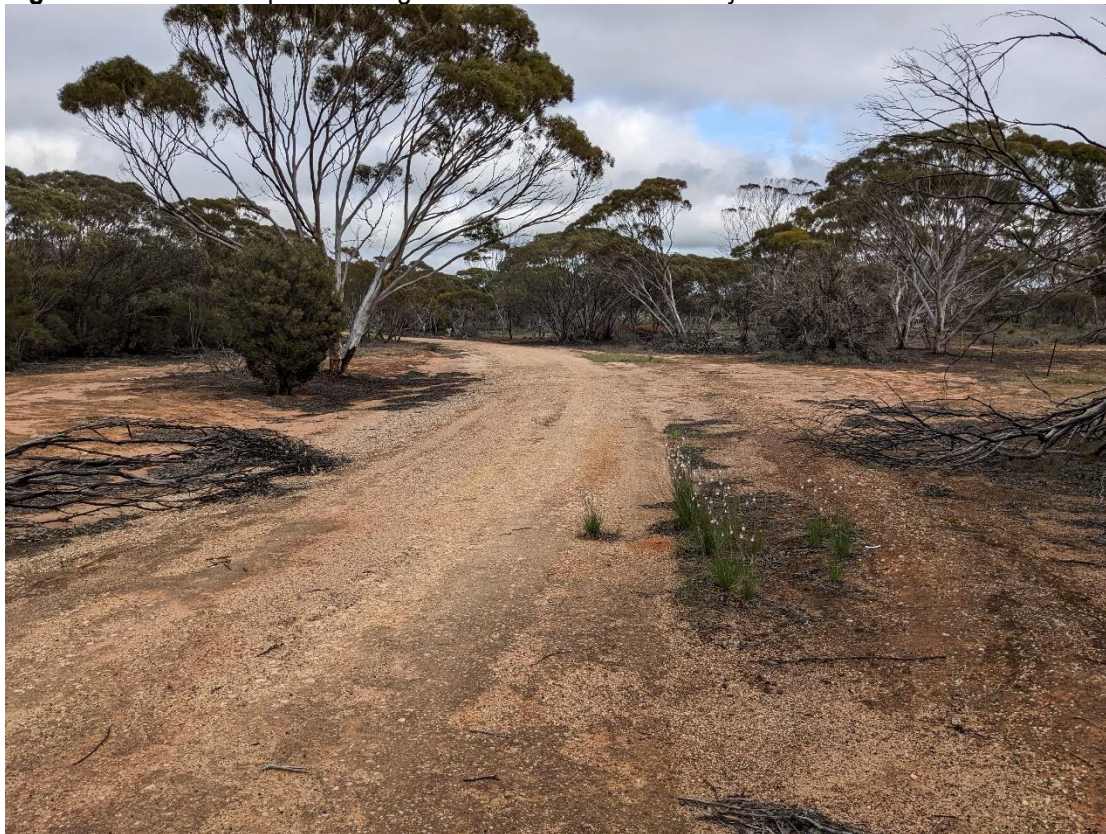
Figure 2. Photo of Proposed revegetation area. Photo taken by Kathrine Walkerden on the 20.09.2024.
