BEEBYN-W11 IRON ORE PROJECT

CPS 10636/1 AMENDMENT APPLICATION
SUPPORTING INFORMATION

Tenements: M51/869, L20/92

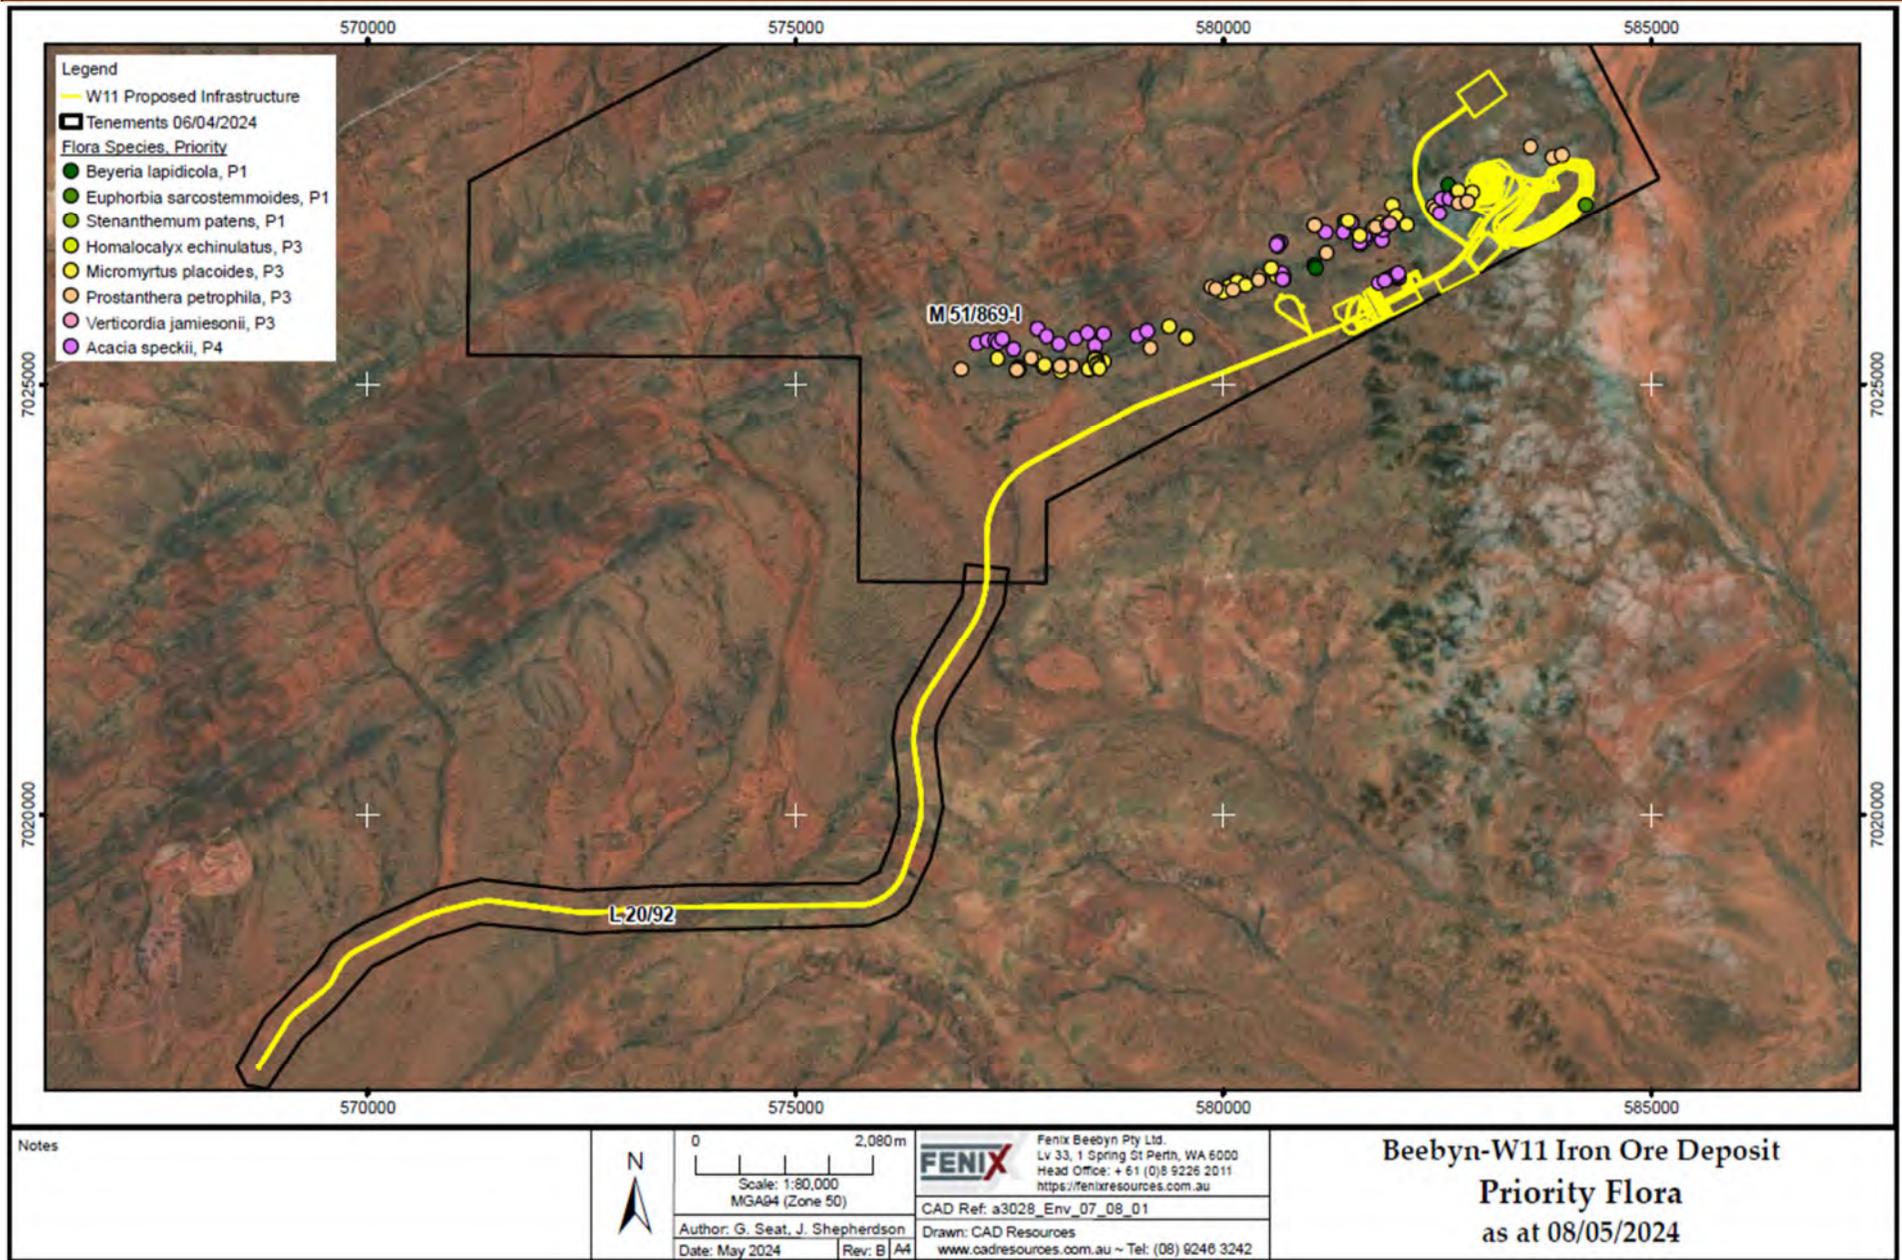
Figure 2.3: Previously recorded Priority flora locations within the proposed Beebyn-W11 project area.

The distribution of Priority species recorded historically and in the APM (2024) survey in relation to the proposed development infrastructure is shown on Figure 2.3 and Figure 2.4.

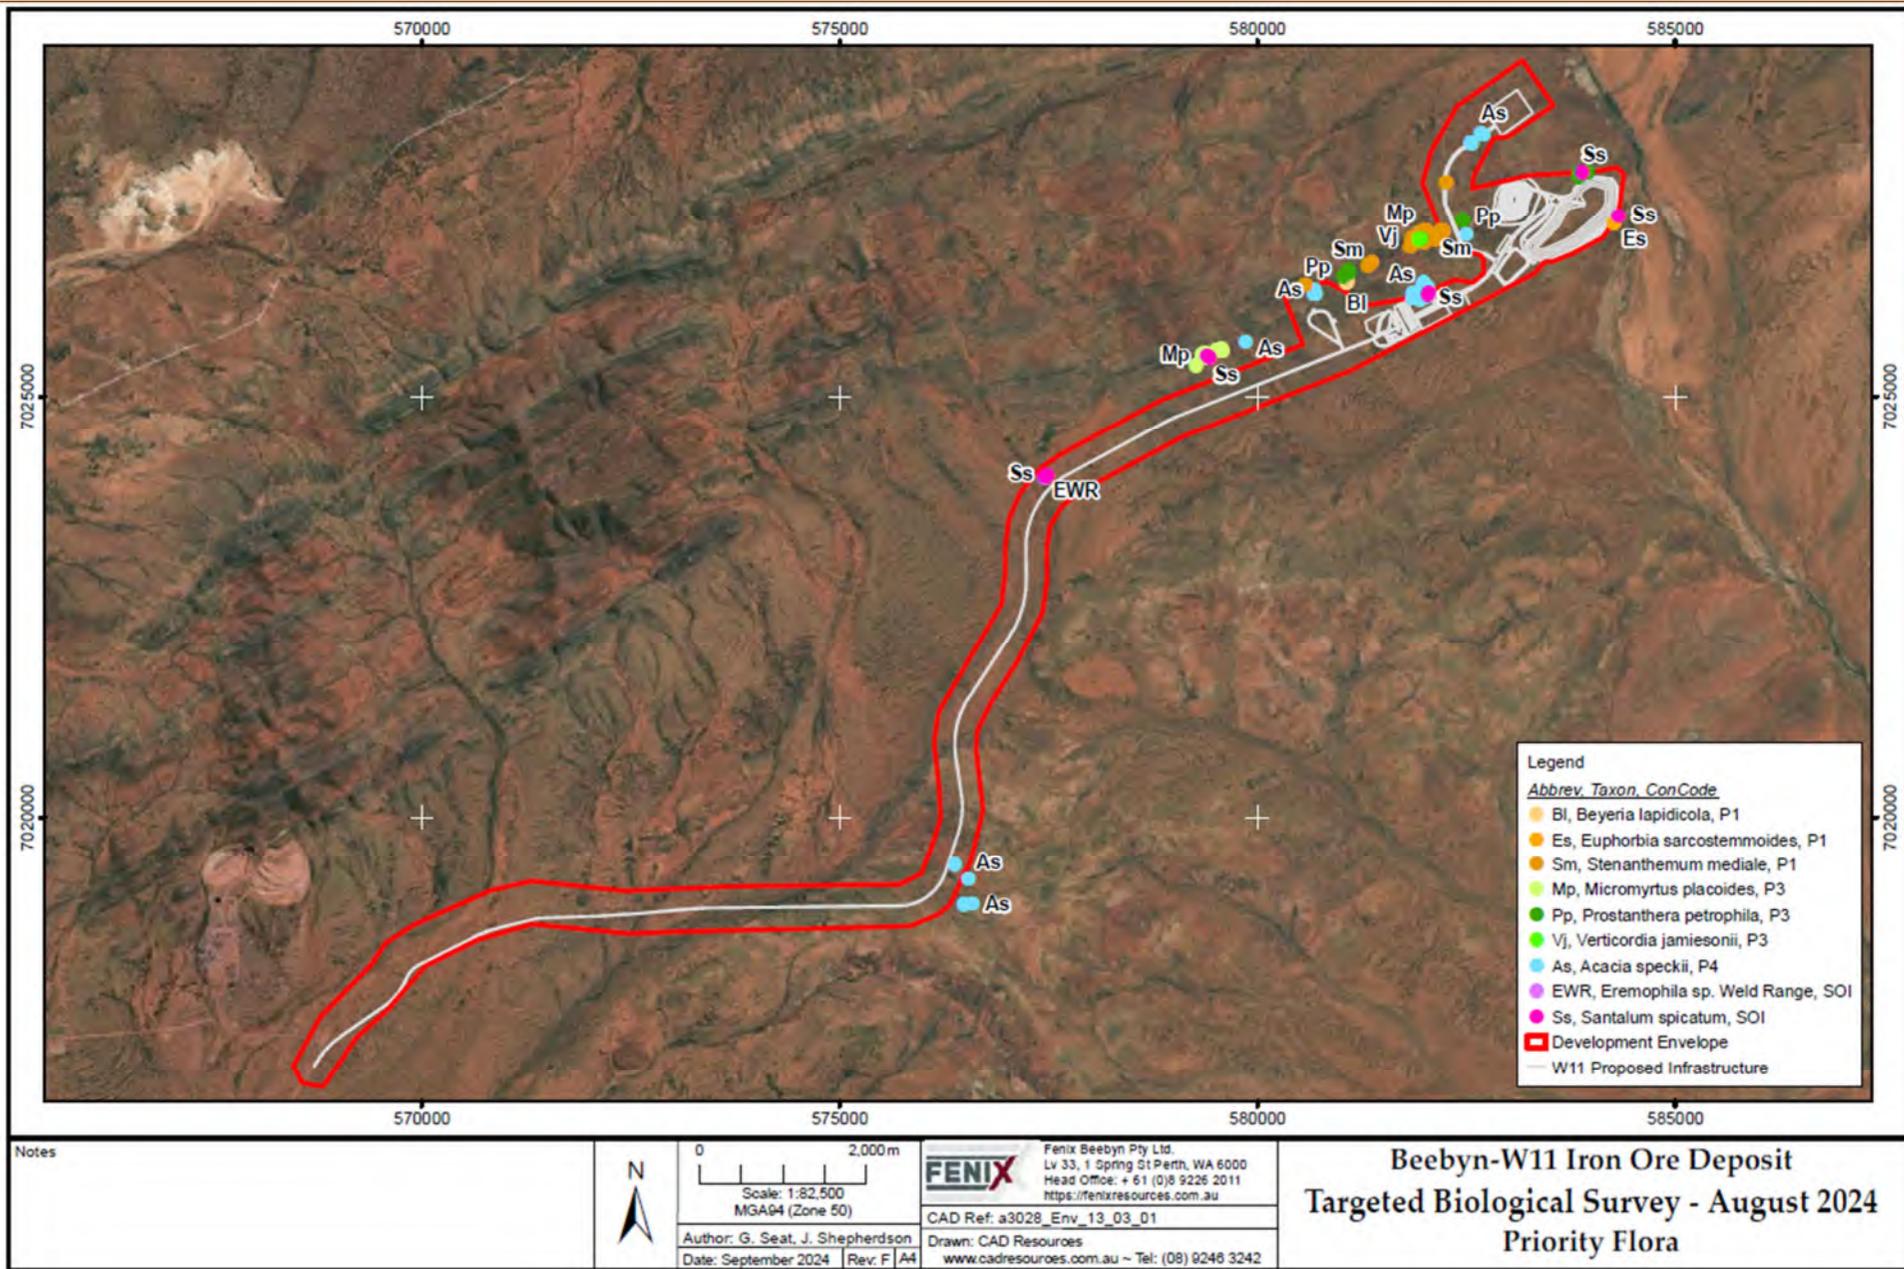
Figure 4.1: Priority flora recorded during the survey - overview.

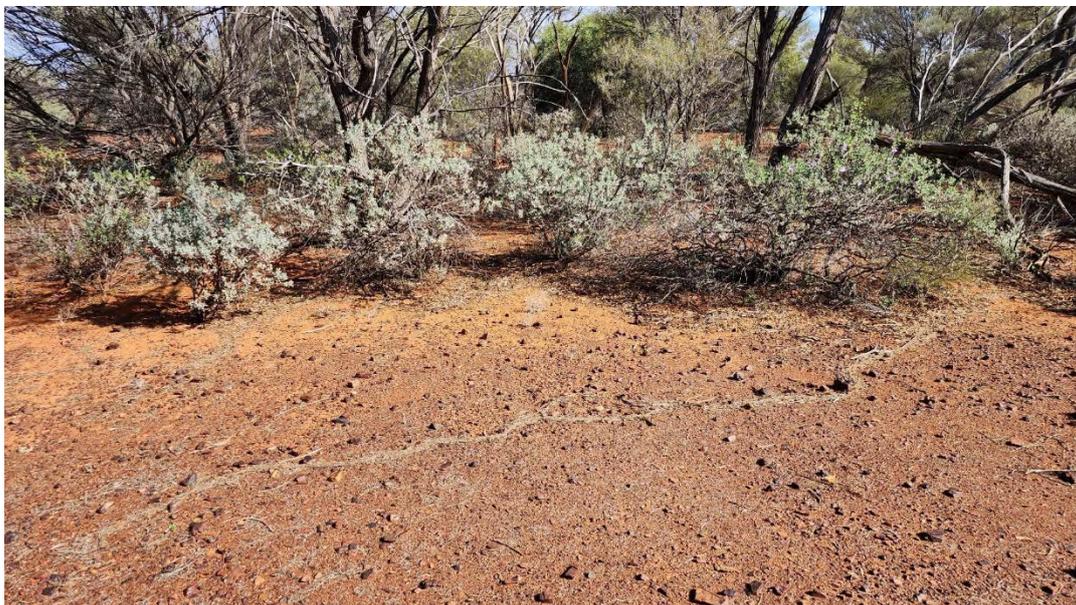
Photograph 4.12: Evidence of sheet flow. Trapdoor burrows were found beneath the trees in the background.

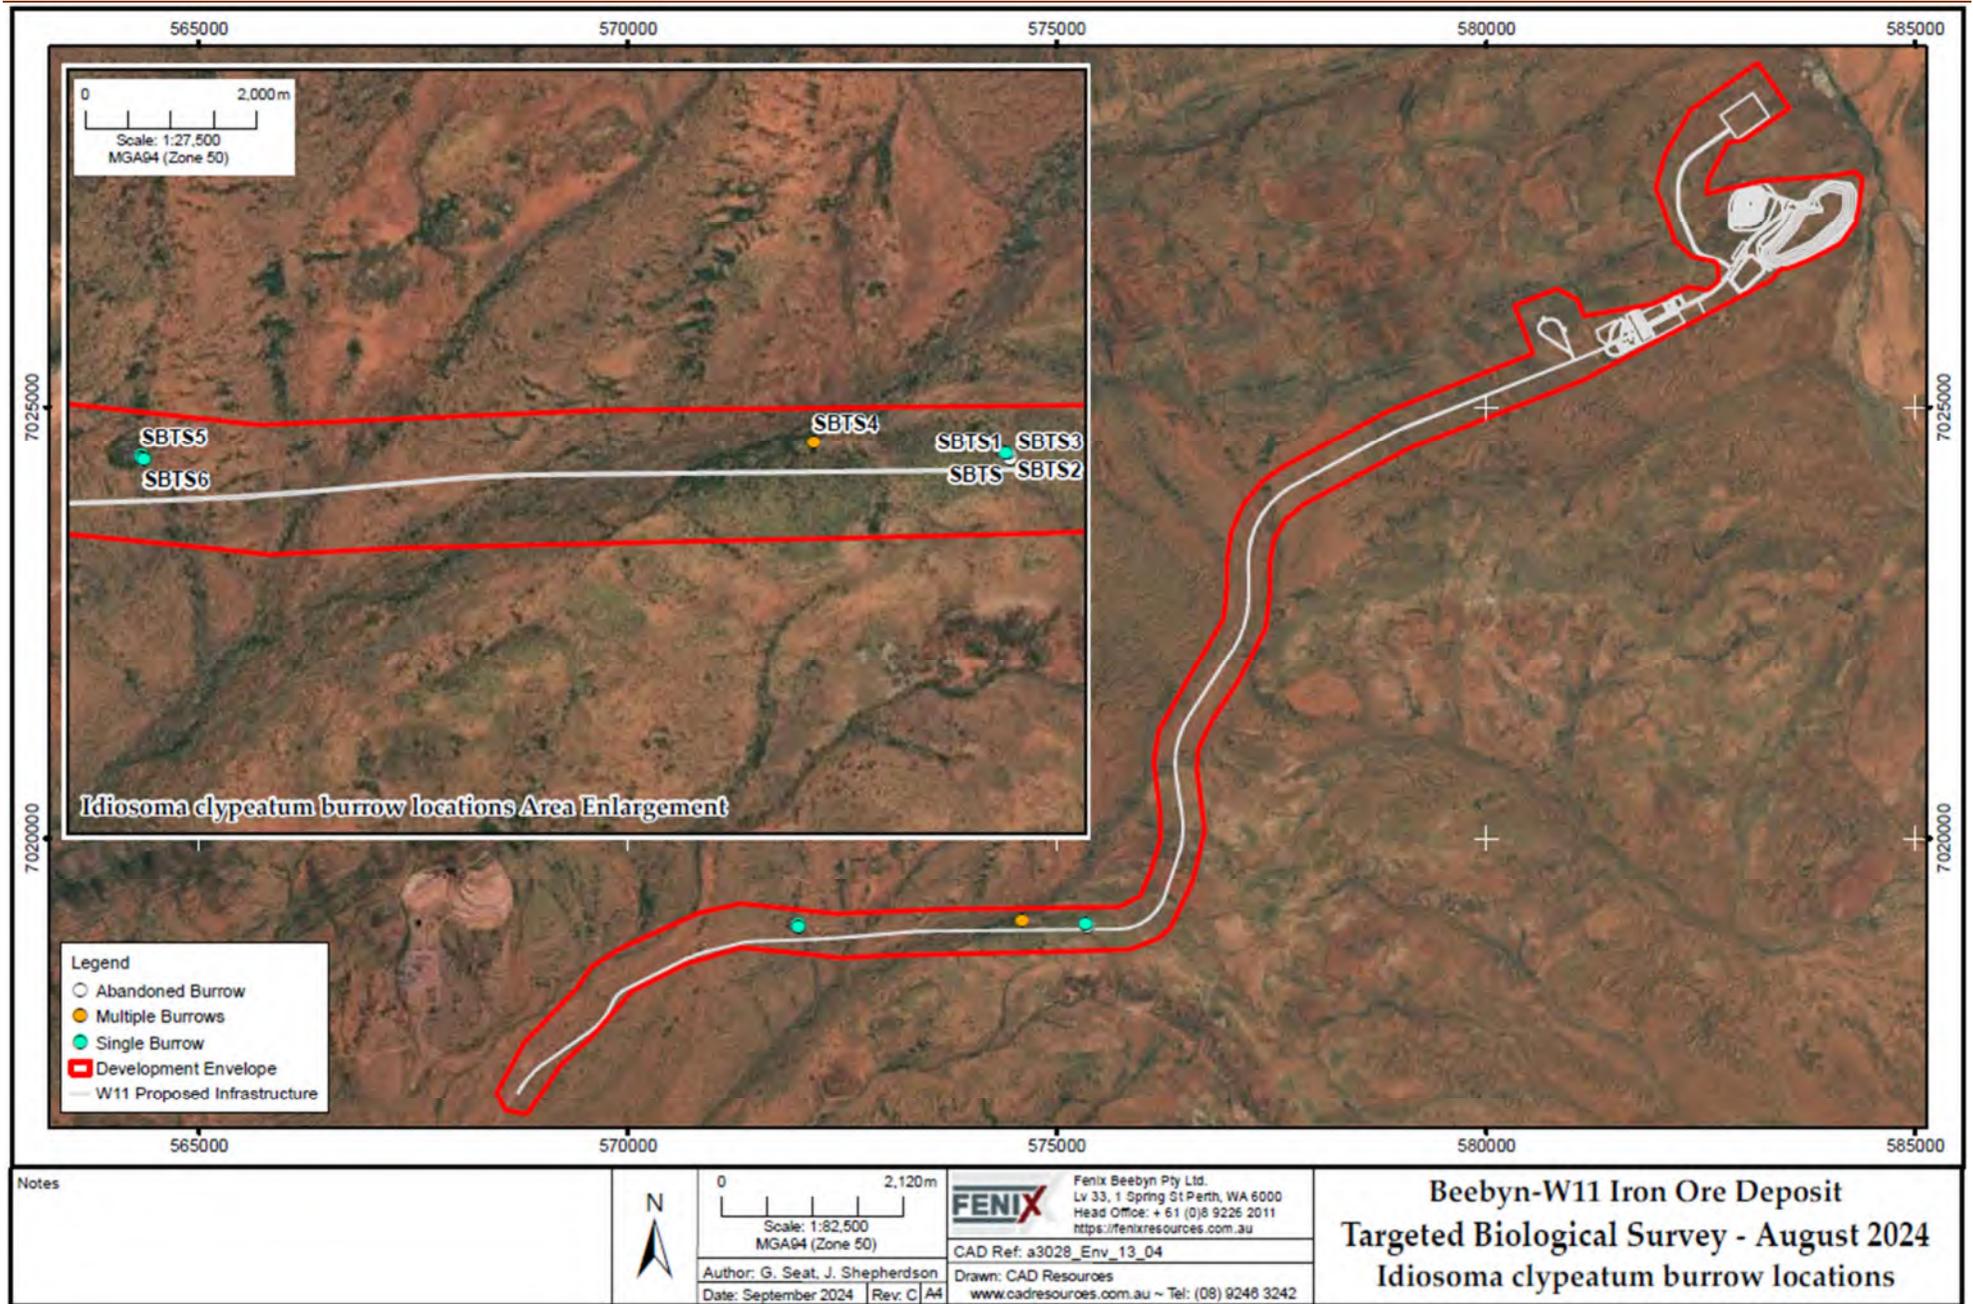
Figure 4.20: Locations of *Idiosoma clypeatum* burrows recorded during the survey.

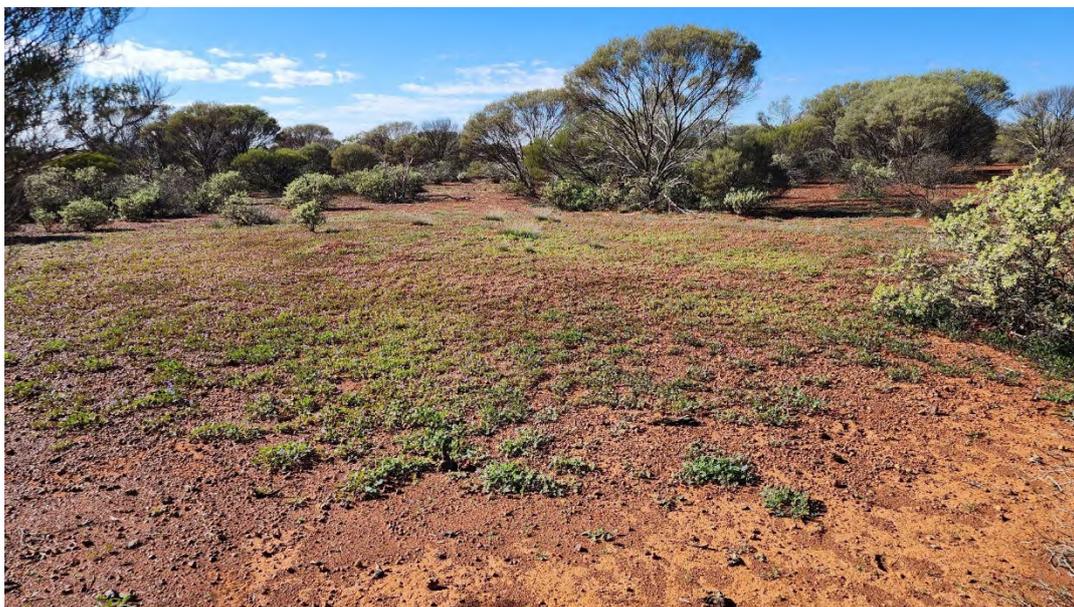
Photograph 4.15: A possible long-extinct malleefowl mound at the eastern end of the project area.

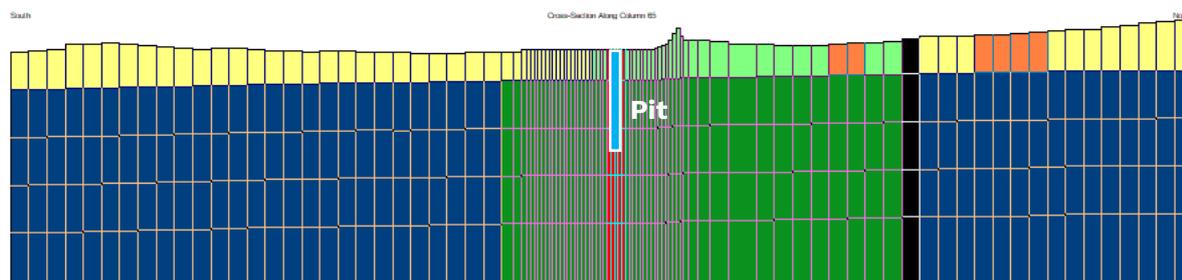
Figure 13 Model geometry (Column 65 - South to North) (see Figure 15 for legend)

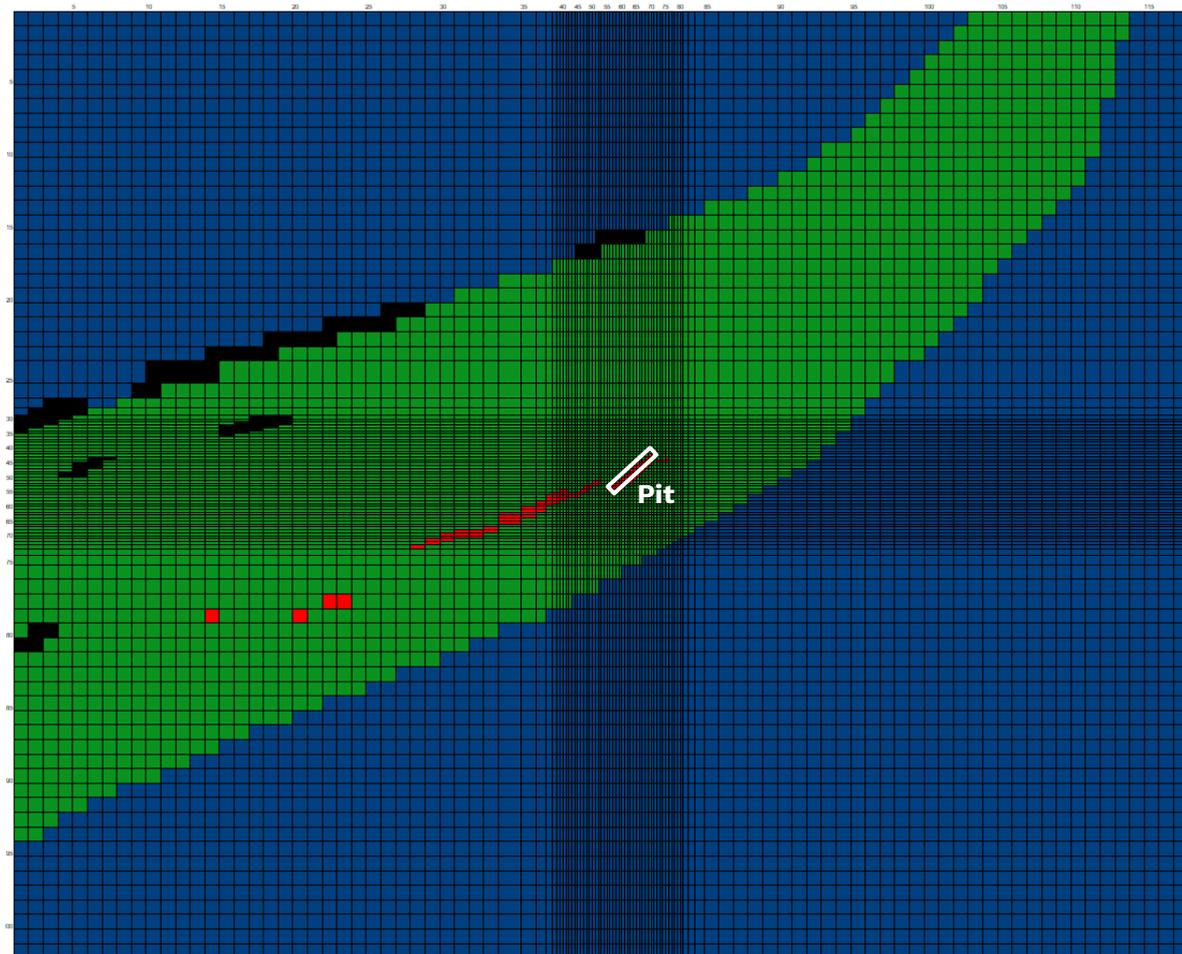
Figure 15 Model geometry (Layers 2 to 5)

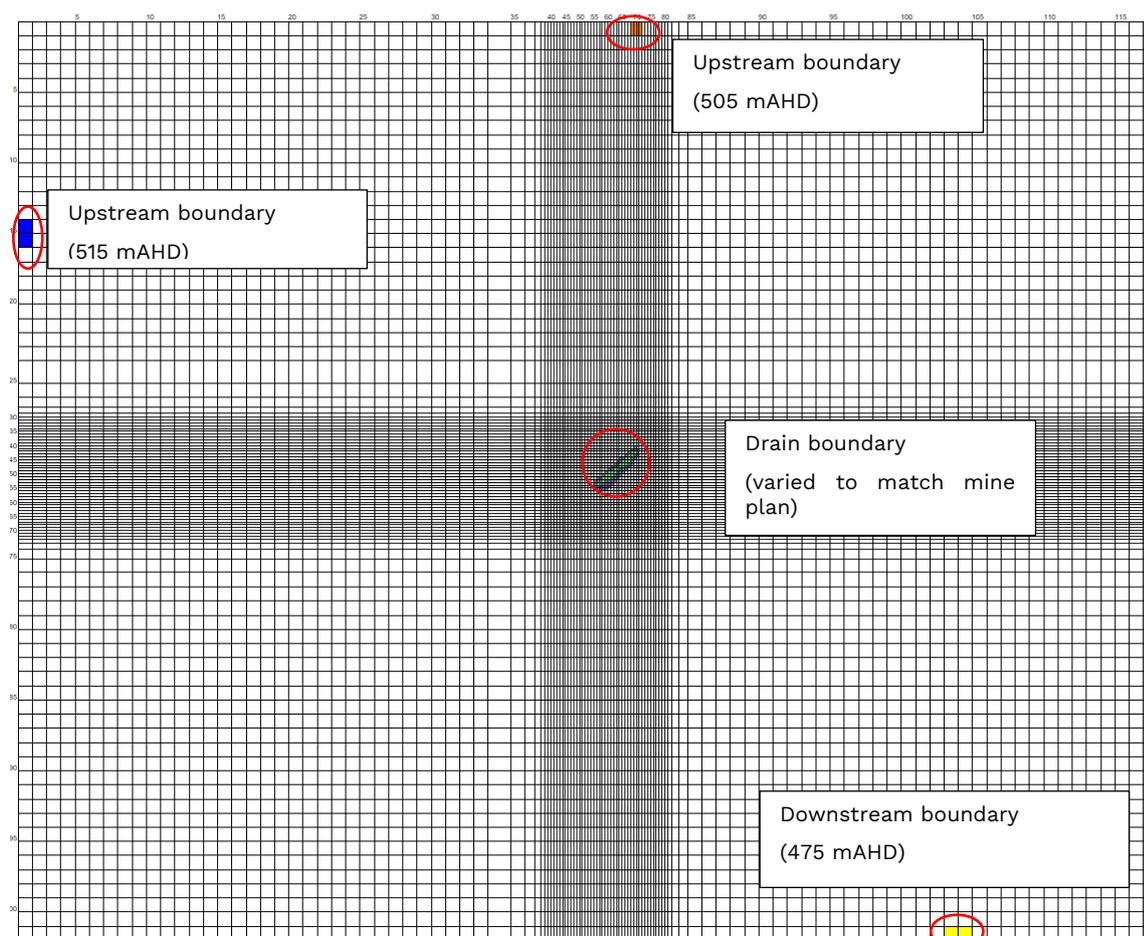
Figure 16 Model grid and boundaries (grid size (13 km north-south, 16 km east-west))

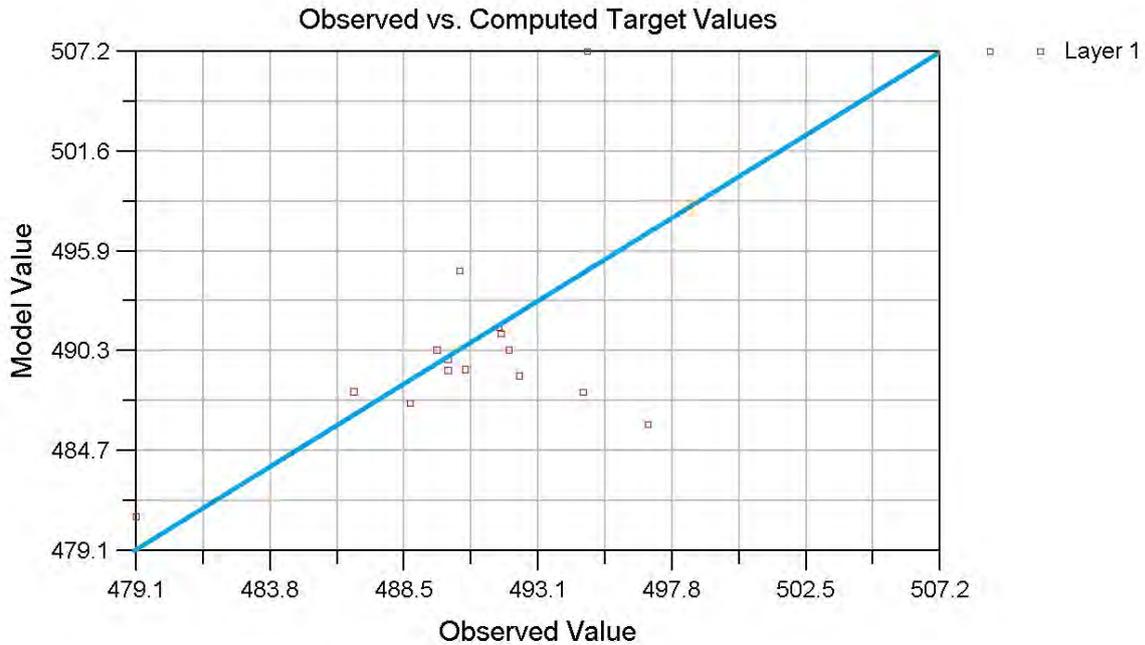
Figure 17 Observed vs. modelled target values

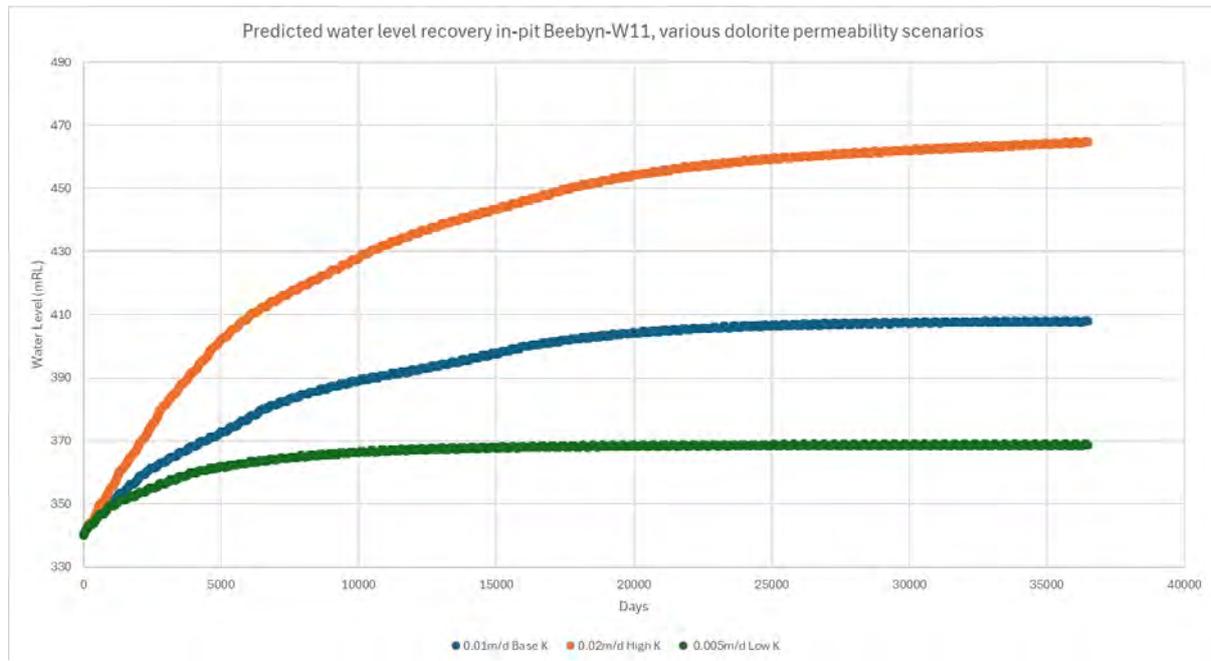
Figure 24 Water level recovery (various scenarios) at Beebyn-W11 pit
