————— Shire of —————
Donnybrook Balingup

Desktop Assessment for Native Vegetation Clearing Application

Spring Gully Road Upgrade Project

CPS 7693/2

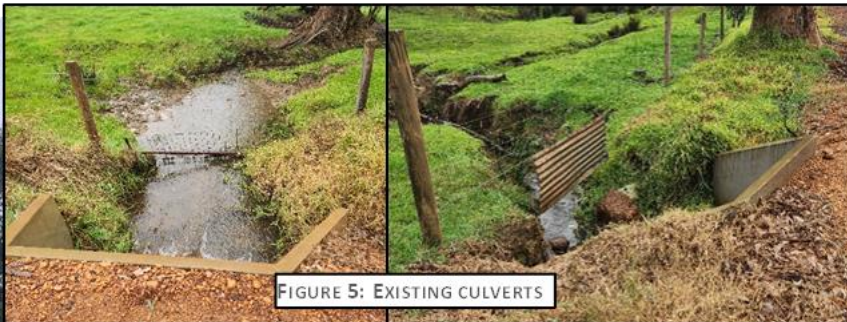
FIGURE 5: EXISTING CULVERTS

f) It is growing in, or in associated with an environment associated with a	Not at Variance	Project intersects two unnamed watercourses (creek running through agricultural land). Works include extending the existing pipework on two culverts to allow for the wider road. No vegetation will

watercourse or wetland		be removed; currently bare gravel/pasture. Impact to the bed of the watercourse will be minimal as only .5m of pipe will be added in length on either side of the road. Works will be undertaken under dry conditions to avoid temporarily altering water flow or quality. The structure, soils and flow regime of the watercourses will not be altered in any other way. All outdoor workers abide by arrive clean/leave clean procedures to avoid contamination of weeds and other organisms.

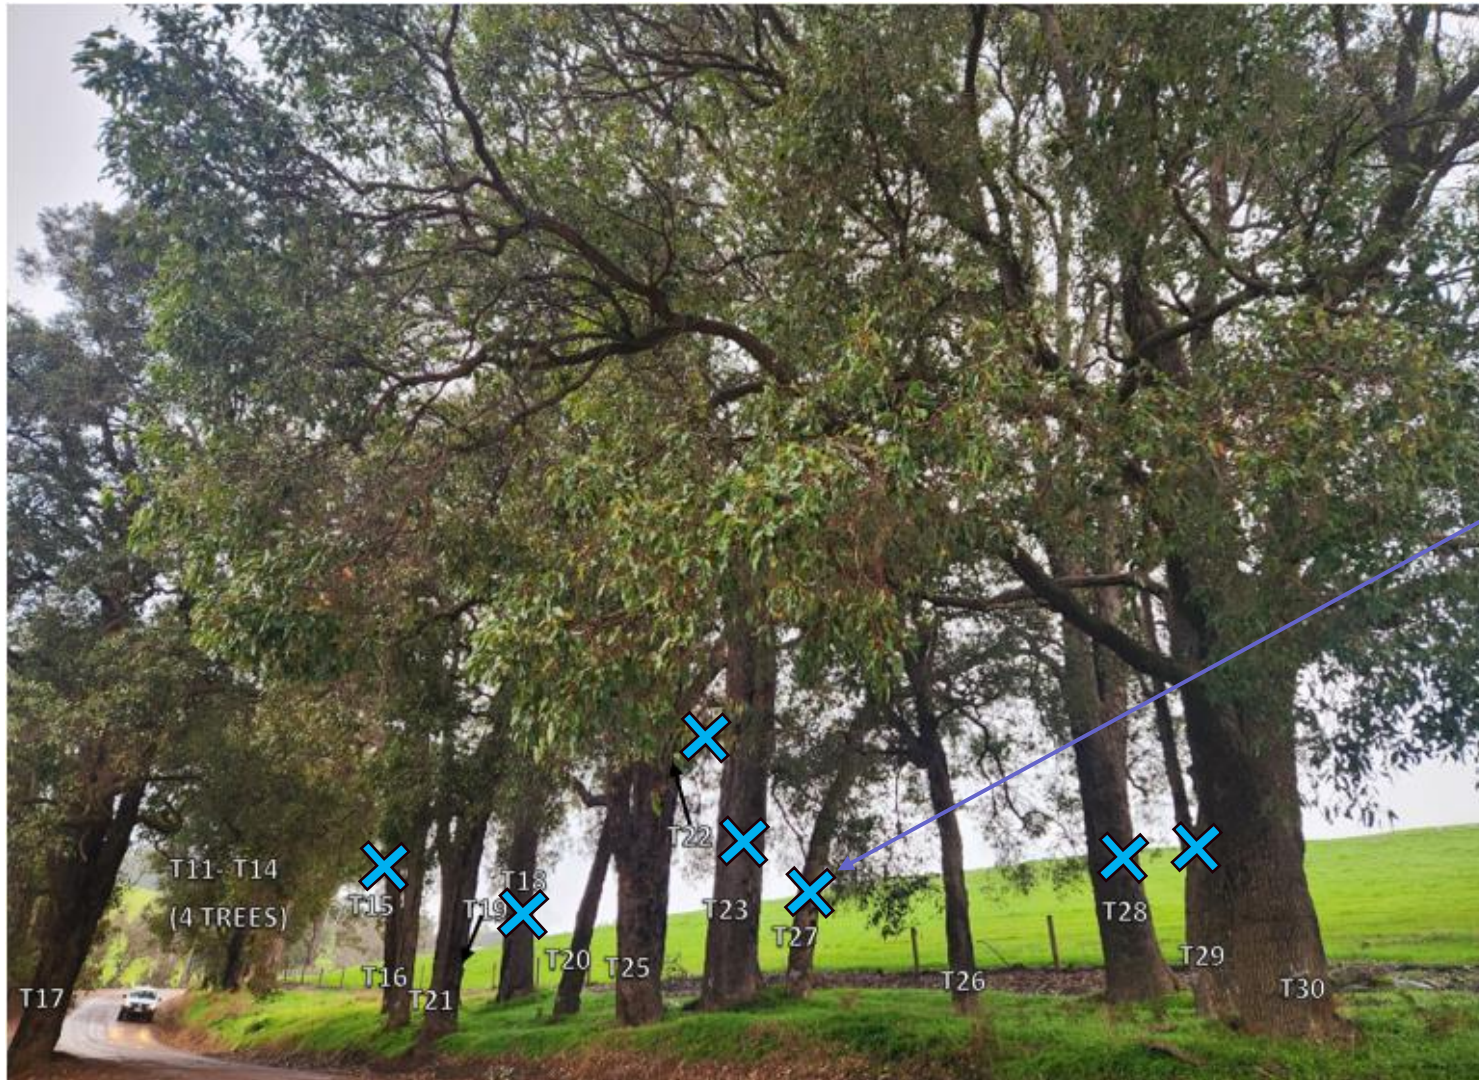
X Trees to be retained:
T13, T14,
T15, T18, T19,
T22, T23, T27,
T28, T29.

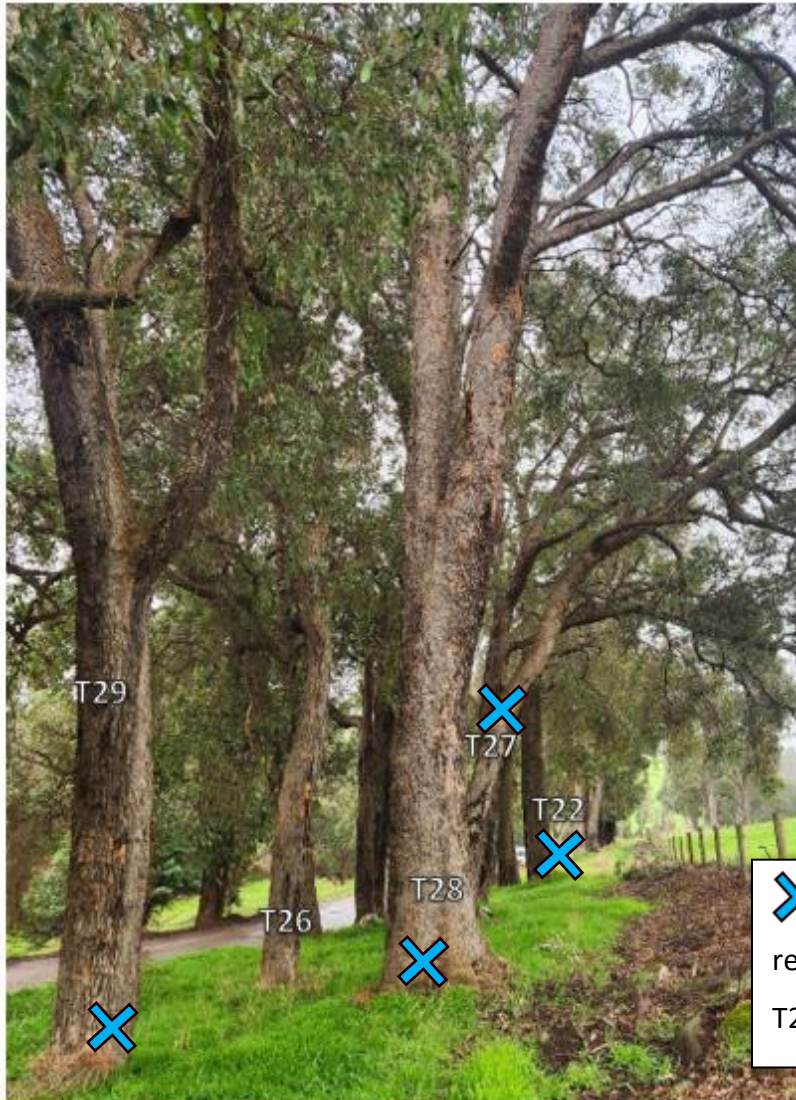
X Trees to be retained:
T22,T27,T28,T29.
