City of Joondalup Typha Clearing Reference Site Photos

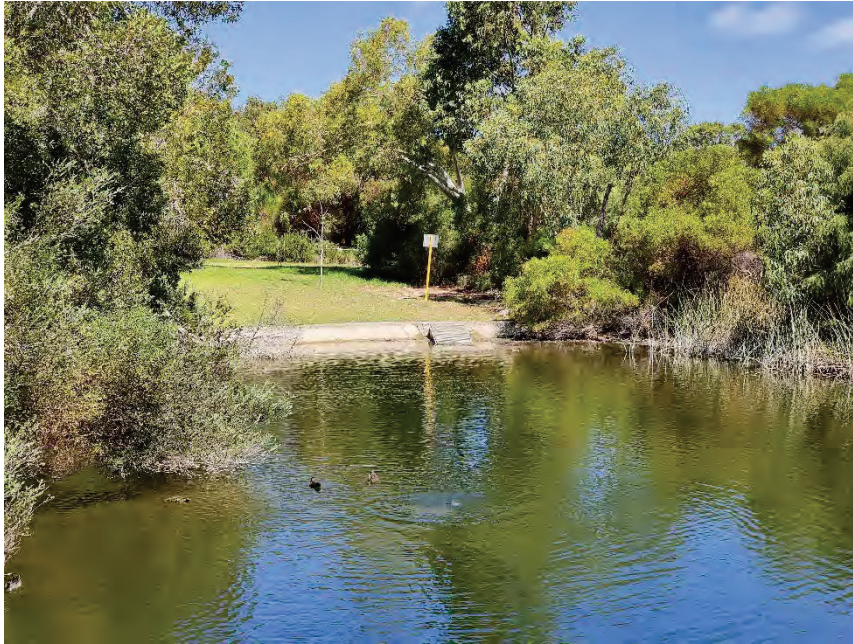
Plate 1: Beaumaris Park Lake in Ocean Reef, high biodiversity at risk of future Typha infestations if the City is unable to undergo maintenance of the invasive species. Taken from Western extent.

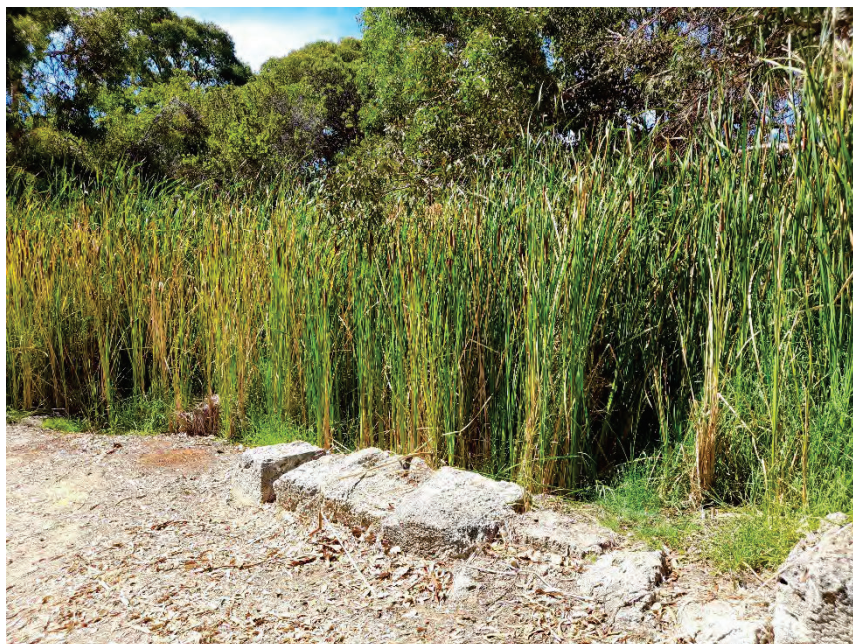
Plate 2: Blue Lake Park in Joondalup, Stream overgrown by Typha, causing damage to the structure and watercourse. Taken from Southern side of stream.

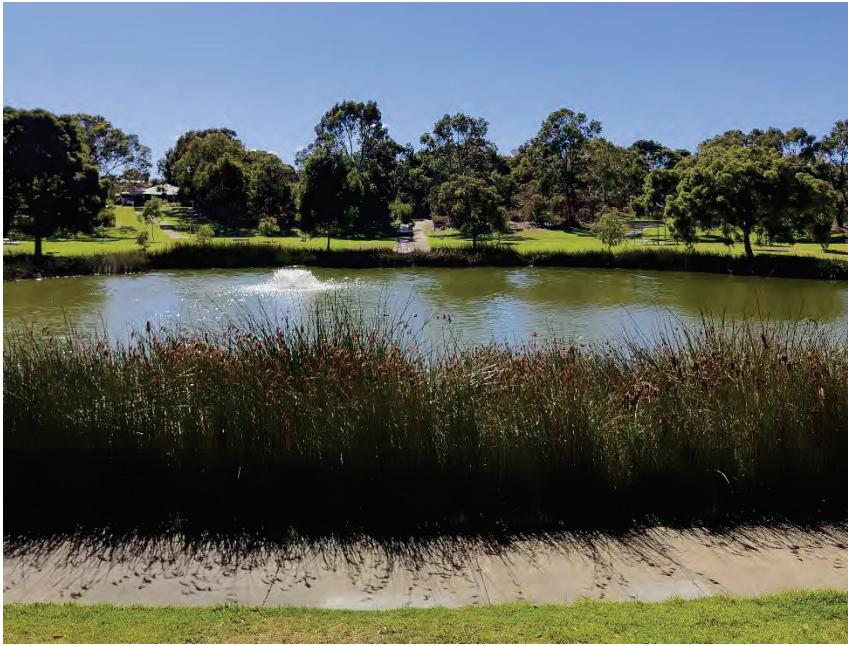
Plate 3: Blue Lake Park in Joondalup, Lake contains a good diversity of native sedges and rushes. Lake at risk of *Typha* infestation due to close proximity and connection to *Typha* infested watercourse (Plate 5). Taken from Northwestern edge.

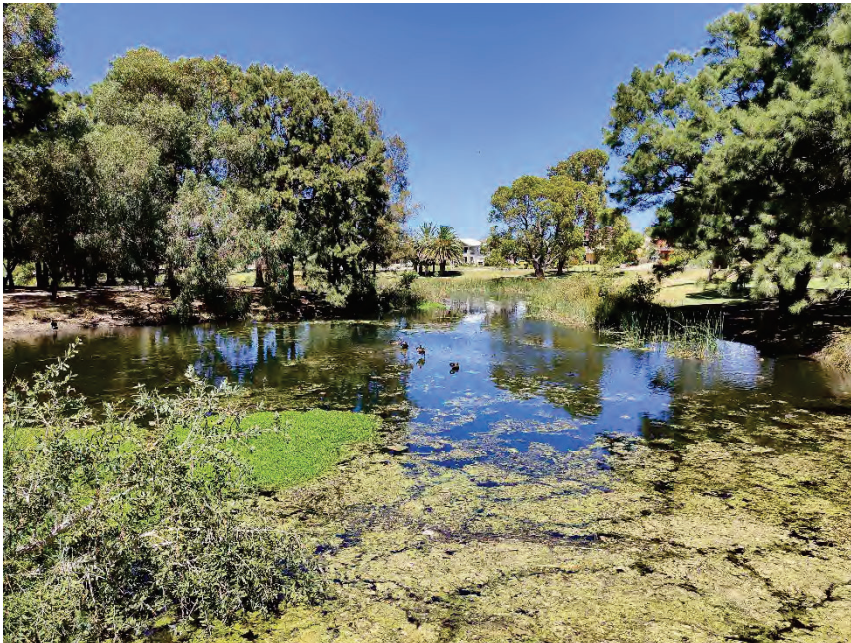
Plate 4: Broadbeach Park in Hillarys, high biodiversity at risk of future *Typha* infestations if the City is unable to undergo maintenance of the invasive species. Taken from Northeastern viewpoint.

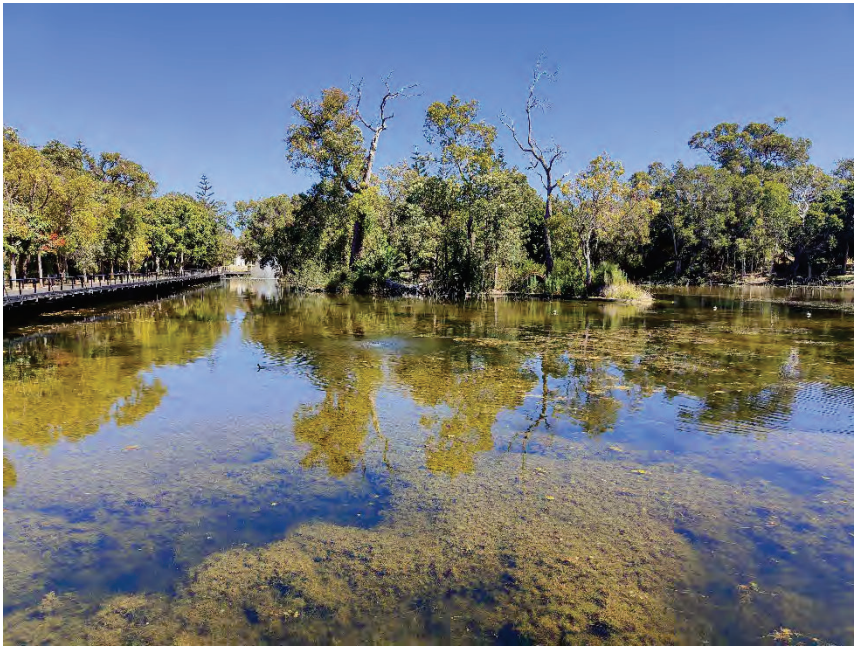
Plate 5: Central Park main lake in Joondalup, high biodiversity at risk of future Typha infestations if the City is unable to undergo maintenance of the invasive species. Taken from Southeastern edge.

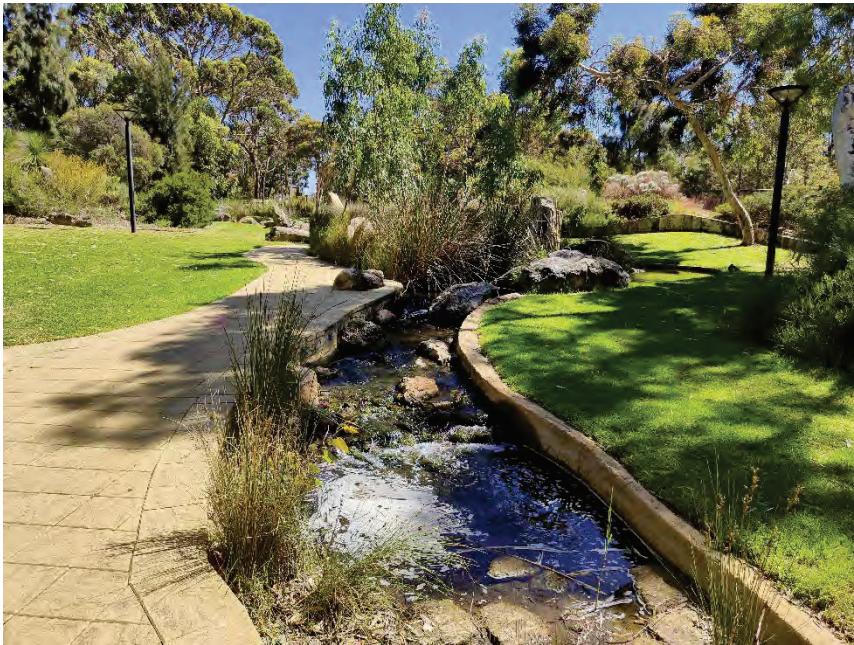
Plate 6: Central Park stream in Joondalup, high biodiversity at risk of future Typha infestations if the City is unable to undergo maintenance of the invasive species. Taken from southern end of stream.

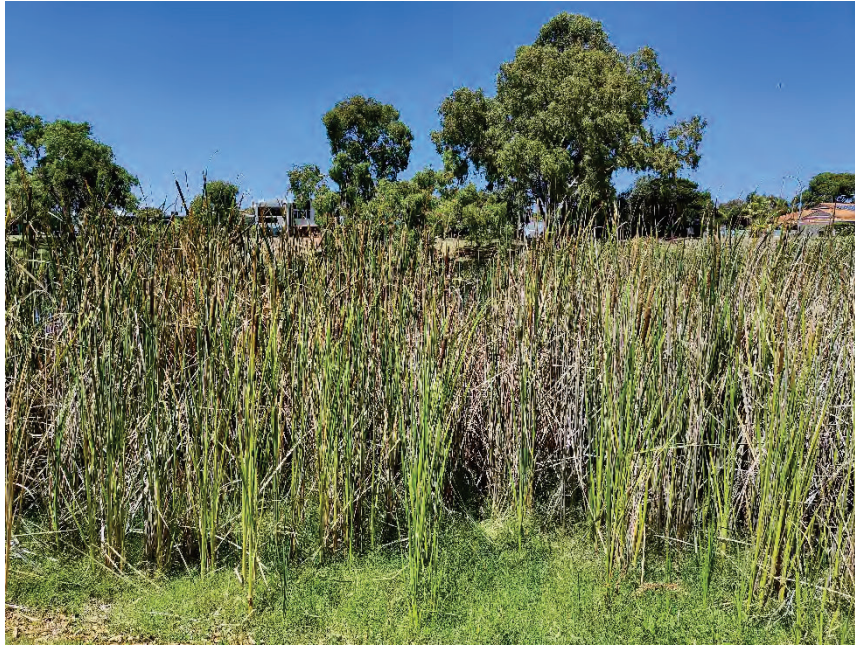
Plate 7: Conica Park Lake in Hillarys, excessive Typha growth outcompeting other native species. Taken from the Northeastern Extent.

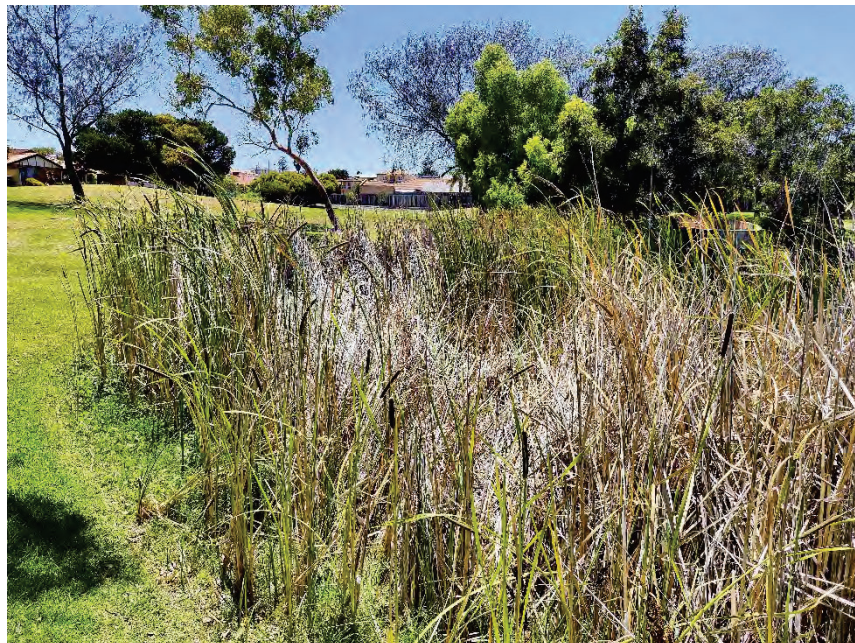
Plate 8: Conica Park Lake in Hillarys, excessive Typha growth outcompeting other native species. Significant amount of decaying vegetation. Taken from the Northern edge.

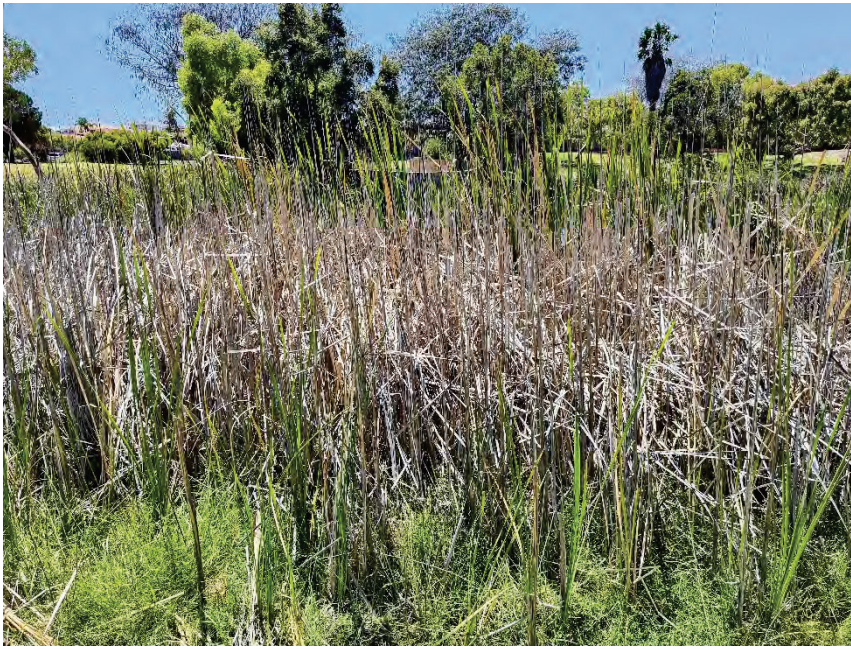
Plate 9: Conica Park Lake in Hillarys, excessive Typha growth outcompeting other native species. Significant amount of decaying vegetation. Taken from the Western edge.

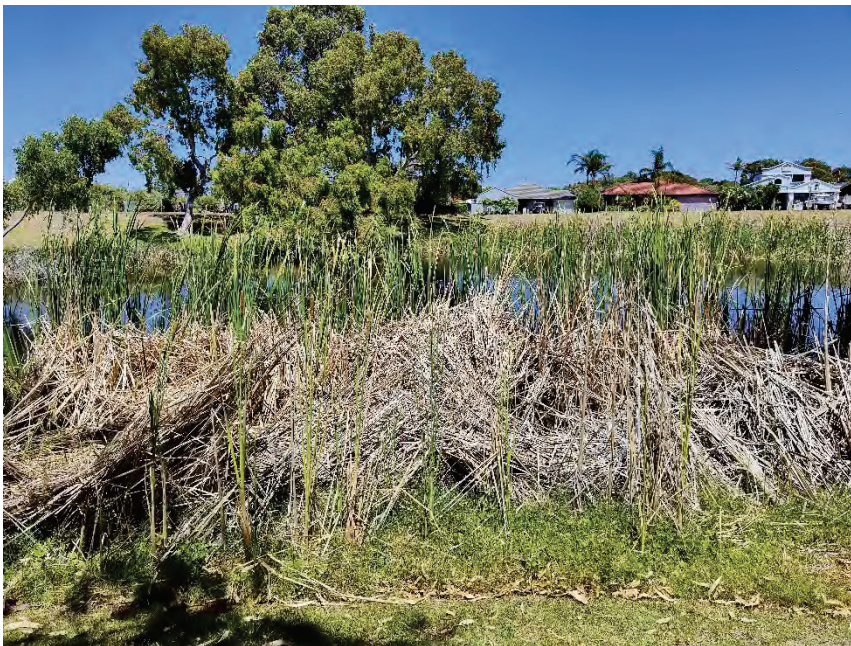
Plate 10: Conica Park Lake in Hillarys, excessive Typha growth outcompeting other native species. Significant amount of decaying vegetation. Taken from the Eastern edge.

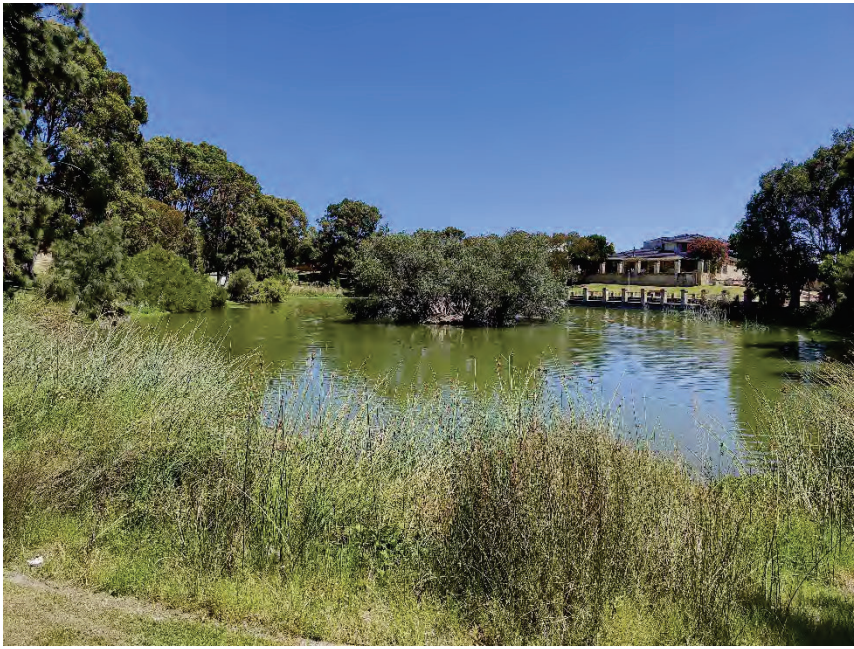
Plate 11: Flinders Park northern lake in Hillarys (Waterston Park), high biodiversity at risk of future Typha infestations if the City is unable to undergo maintenance of the invasive species. Typha is present within the area. Taken from Southern extent.

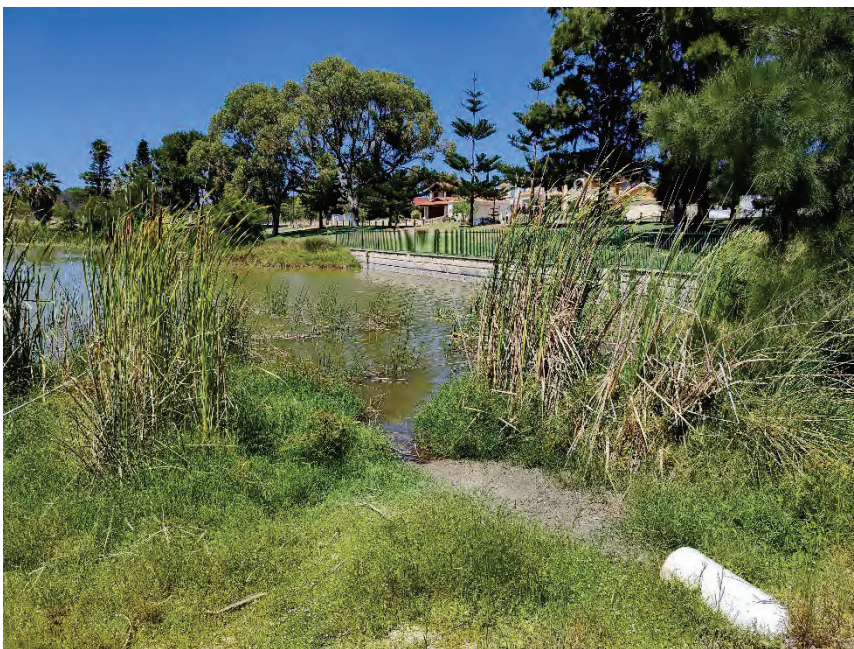
Plate 12: Flinders Park south lake in Hillarys, Typha growth proximal to drain. Potential for future overgrowth to impact infrastructure and hydrology. Taken from Northern edge.

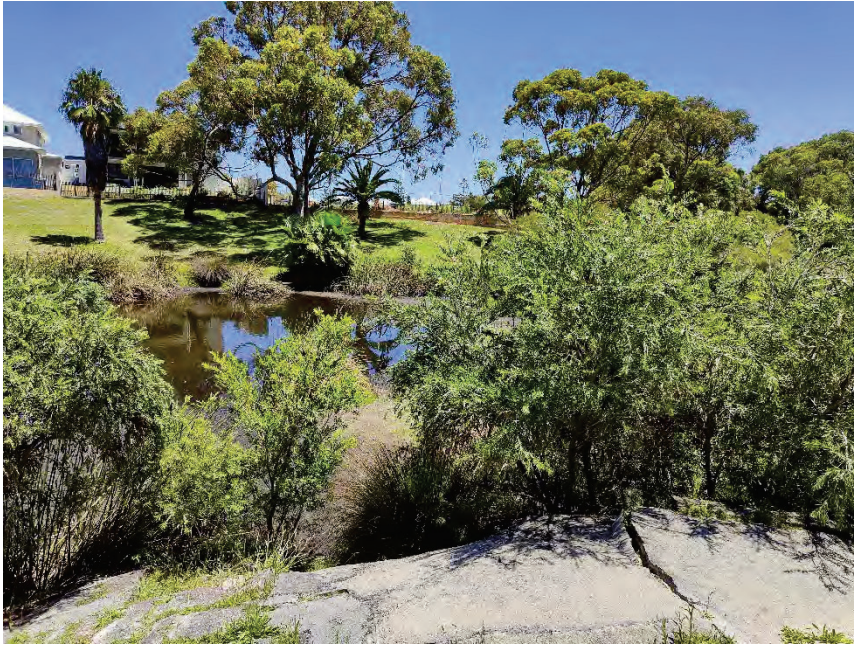
Plate 13: Lacepede Park in Sorrento, high biodiversity at risk of future *Typha* infestations if the City is unable to undergo maintenance of the invasive species. Take from Southern drain.

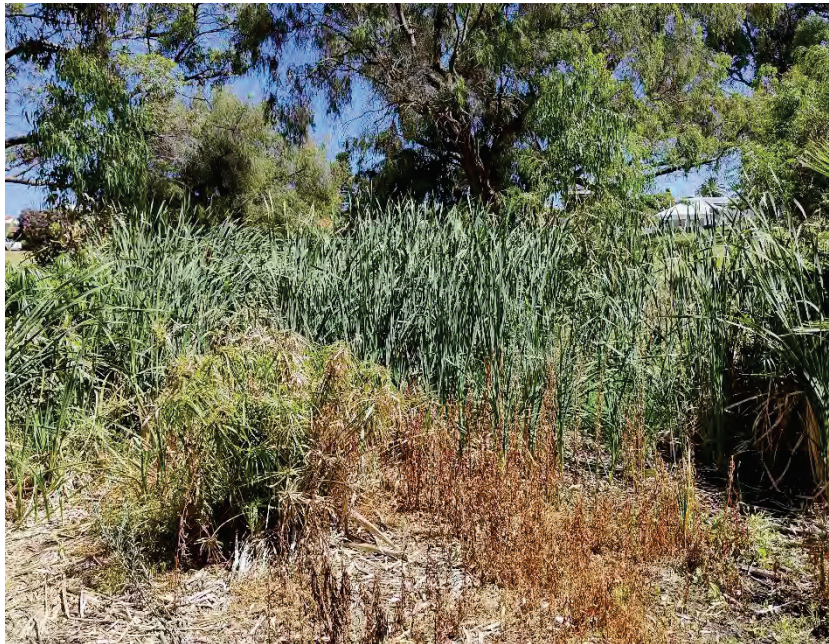
Plate 14: Mawson Park in Hillarys, excessive *Typha* growth causing blockage of drainage system and proving refuge for introduced weed species. Northward view of drain on Northern edge of lake.

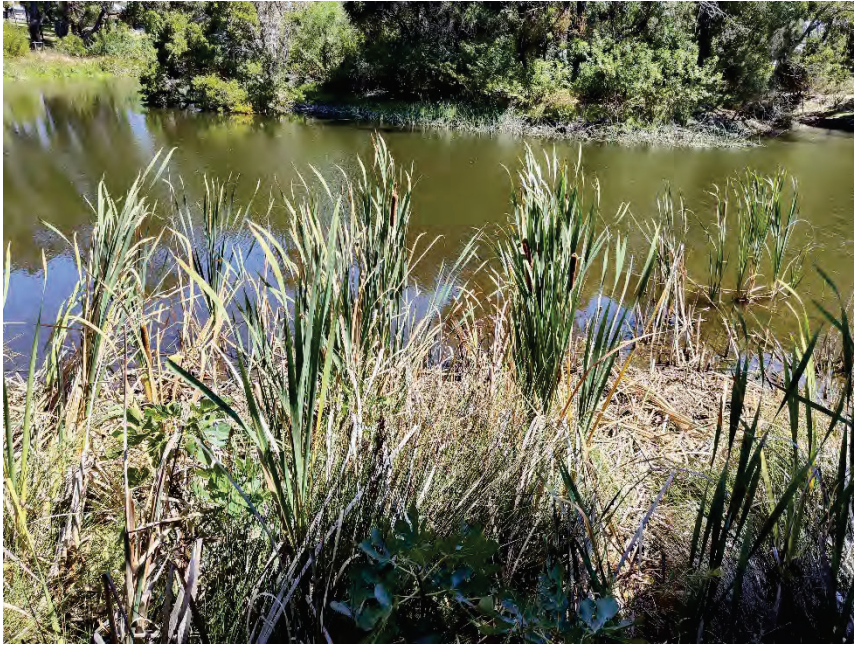
Plate 15: Mawson Park in Hillarys, excessive Typha growth proving refuge for introduced weed species. Significant amount of decaying vegetation. Northward view from Southern edge of lake.

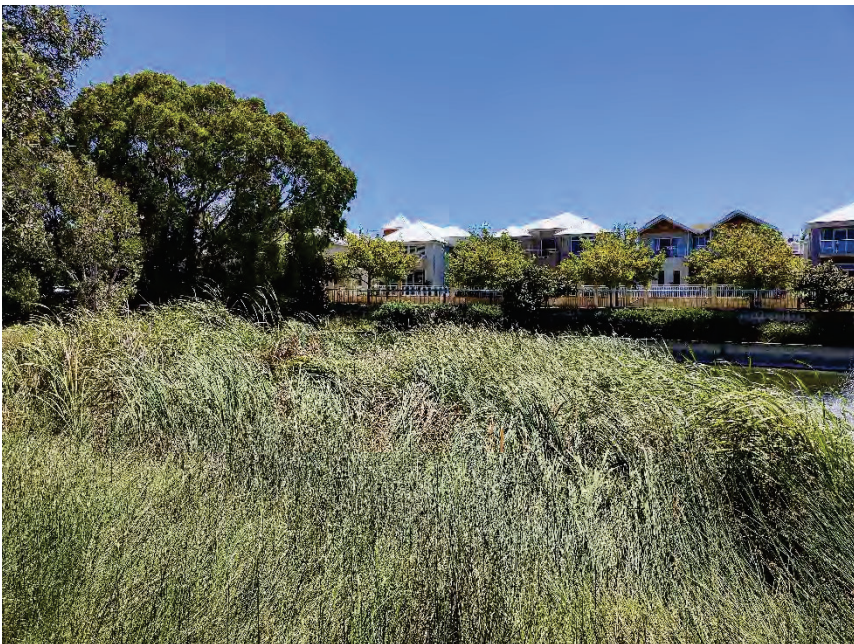
Plate 16: Oahu Park in Hillarys, excessive Typha growth. Vegetation proximity to water features posing future impacts to infrastructure, Typha has begun to outcompete native species. Taken from Western viewpoint.

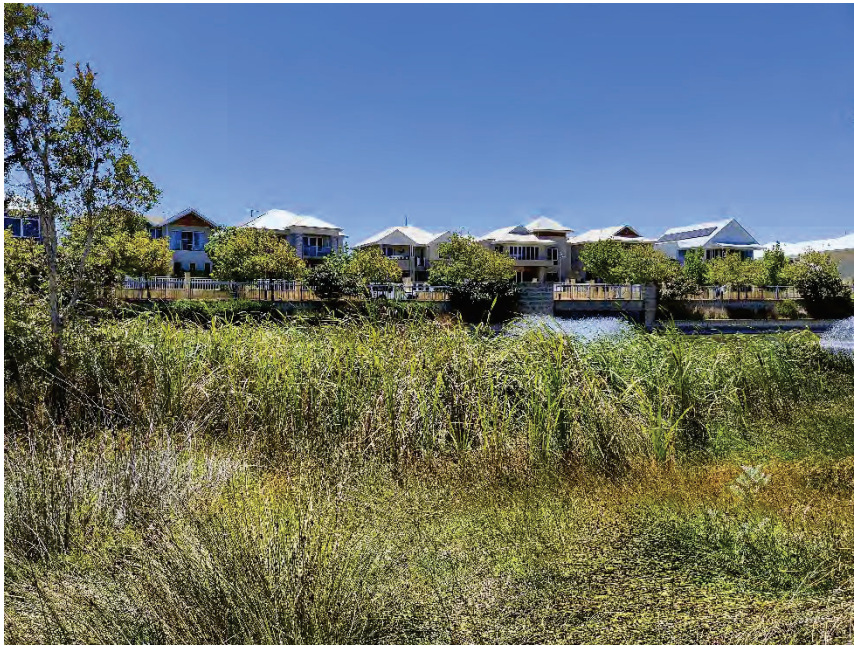
Plate 17: Oahu Park in Hillarys, excessive Typha growth. Vegetation proximity to water features posing future impacts to infrastructure, Typha has begun to outcompete native species. Taken from Western edge of garden bed.

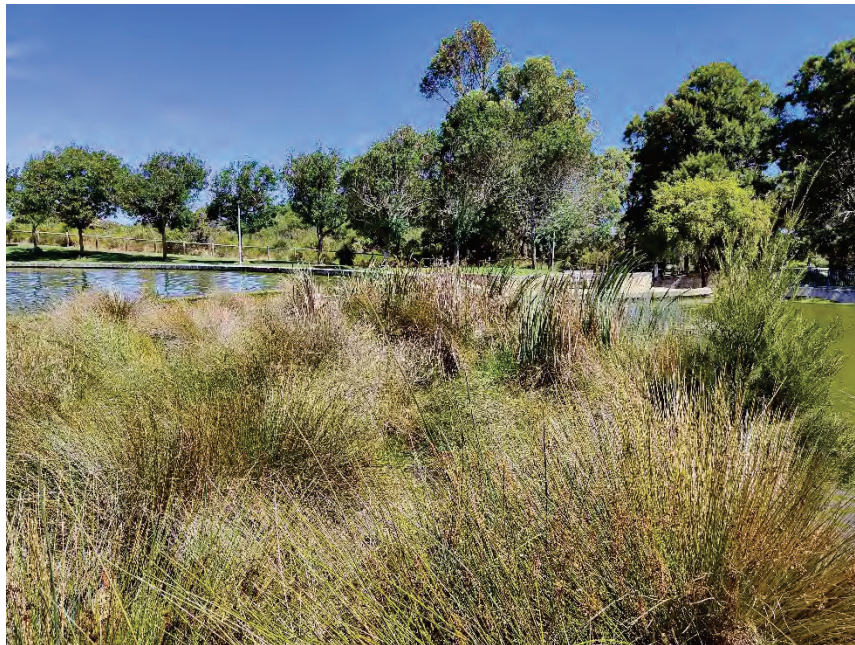
Plate 18: Sir James McCusker Park in Iluka, high biodiversity at risk of future Typha infestations if the City is unable to undergo maintenance of the invasive species. Typha is present within the area. Taken from Northern extent of central vegetation.

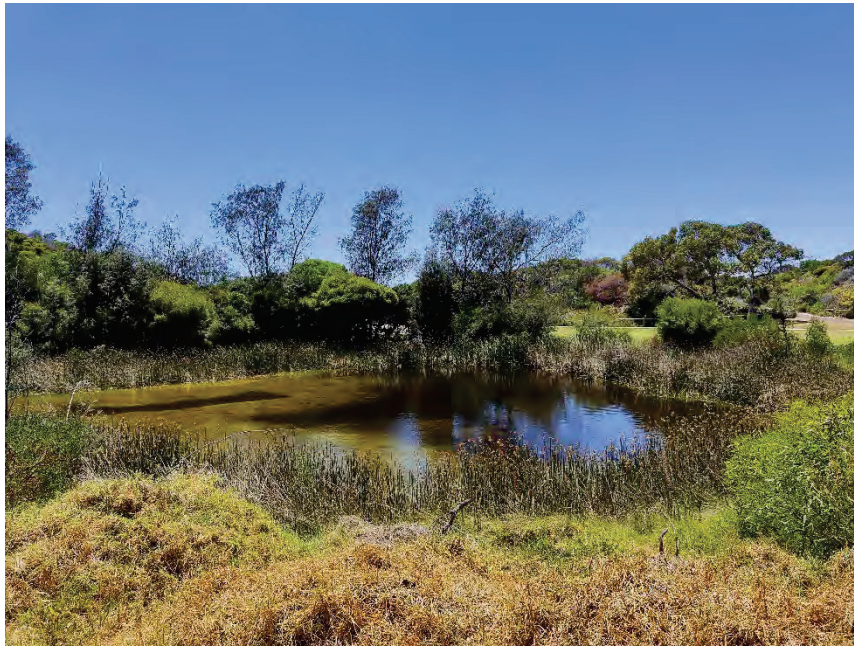
Plate 19: Hillarys Marina Lake (Whitfords Nodes) in Hillarys, high biodiversity at risk of future Typha infestations if the City is unable to undergo maintenance of the invasive species. Taken from Western extent.

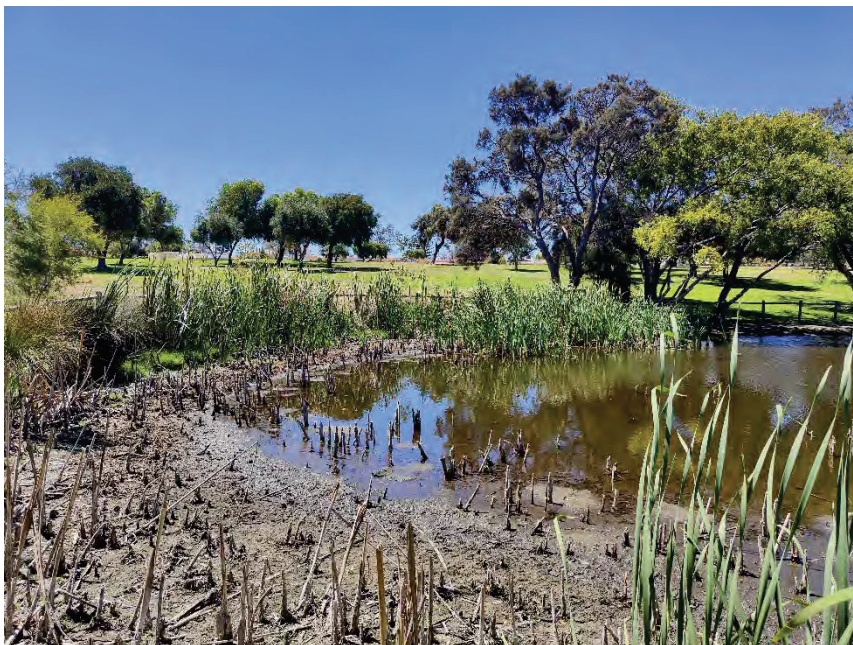
Plate 20: Wolinski Park in Mullaloo, Typha growth range depicting past and current extent. Potential for future overgrowth based on past growth patterns. Taken from Western fence line.

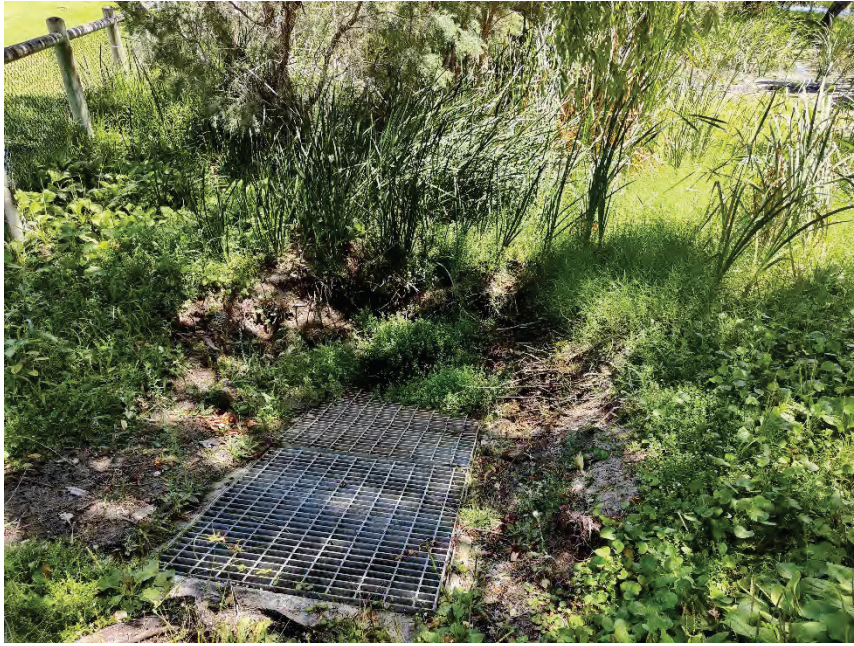
Plate 21: Wolinski Park in Mullaloo, Typha growth proximal to drain. Potential for future overgrowth to impact infrastructure and hydrology. Taken from Eastern fence line.
