Lake Goorly Contracting

MINE CLOSURE PLAN FOR THE LAKE GOORLY GYPSUM OPERATION, FEBRUARY 2022 VERSION 4 REVISION 0

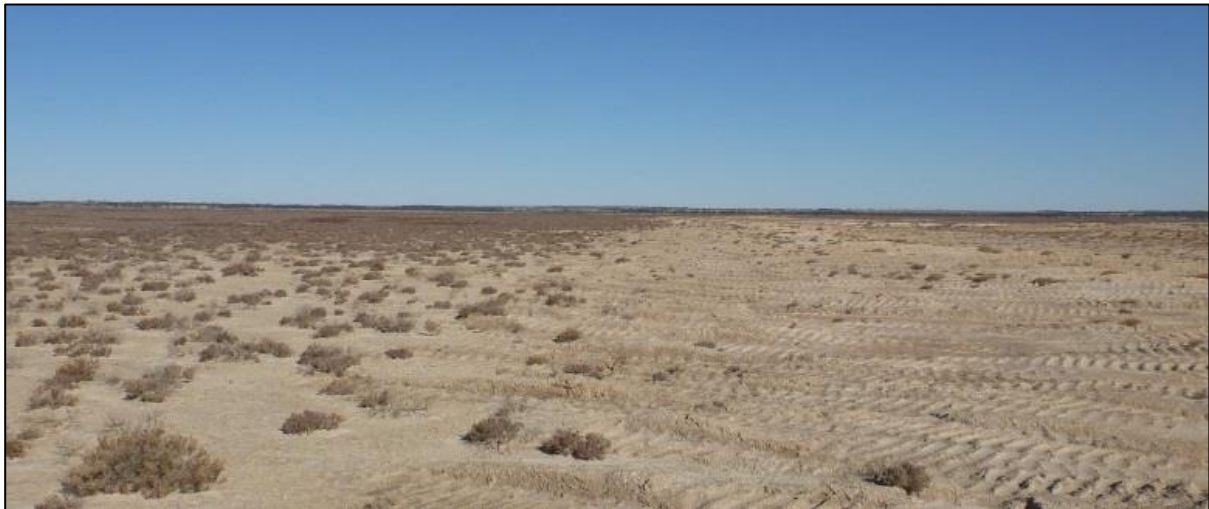
View of natural lakebed LHS versus rehabilitation earthworks RHS

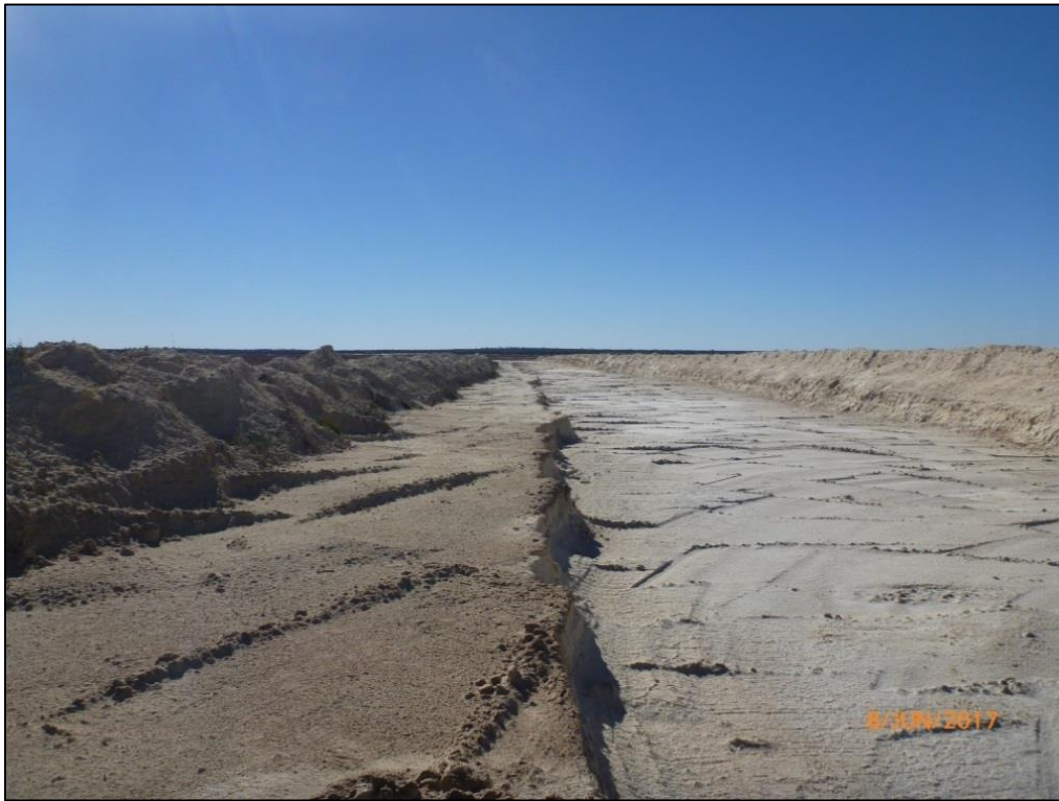
Plate 13: Mining area on M70/1118 showing resource depth

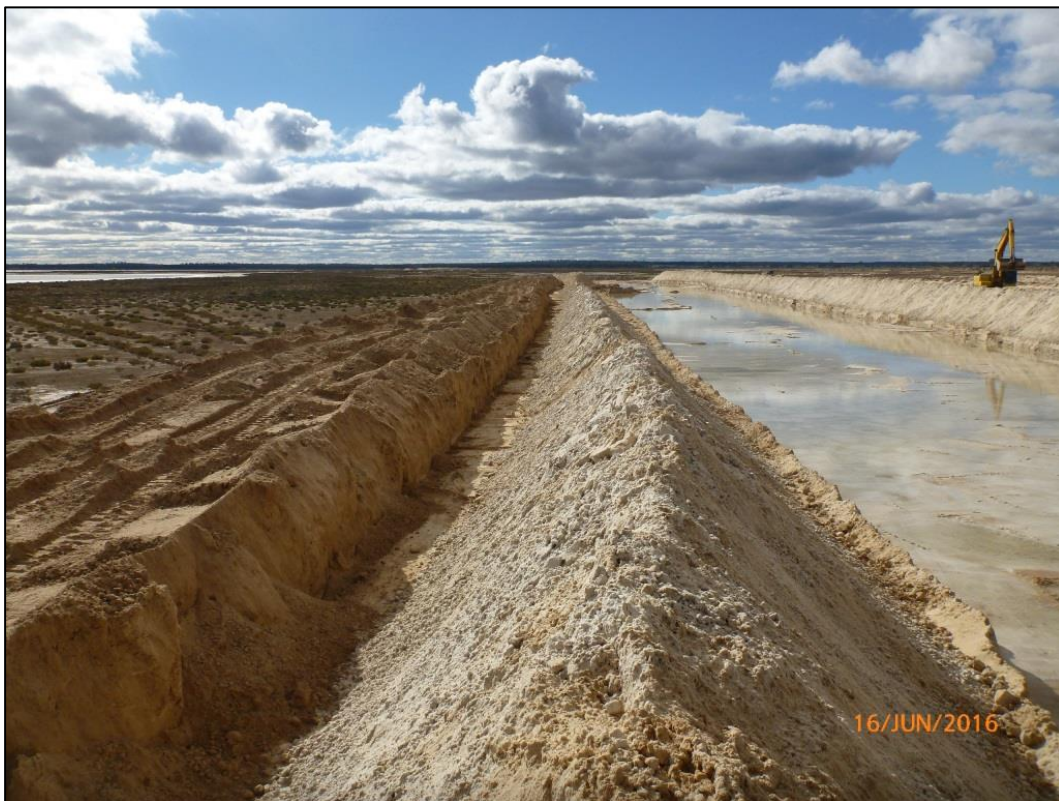
Plate 14: Strip mining sequence showing of quarry excavation (RHS), gypsum windrow (middle) and topsoil material as outer windrow (LHS)

- The mined-out area is then landscaped to natural looking lakebed contours and the topsoil and vegetation windrow is replaced back across the rehabilitated surface. The rehabilitated surface then commences the regeneration process into a natural looking lakebed environment (Plates 15 to 30).

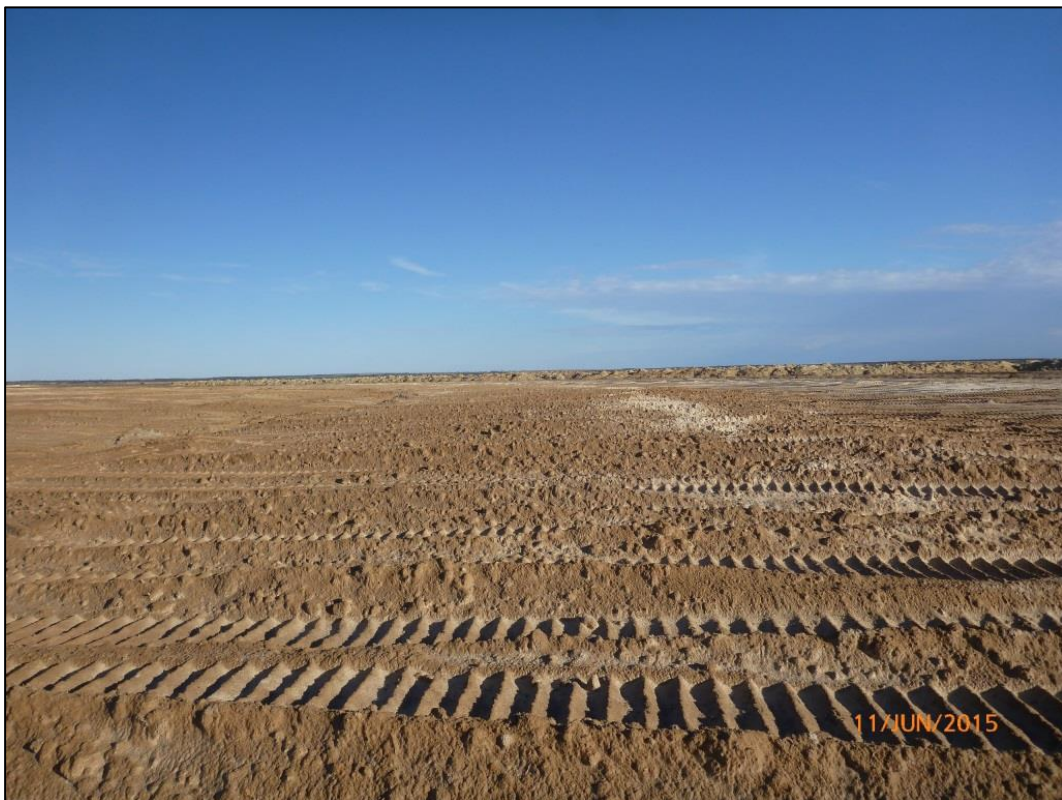
Plate 16: Ground surface immediately after rehabilitation earthworks at M70/1191

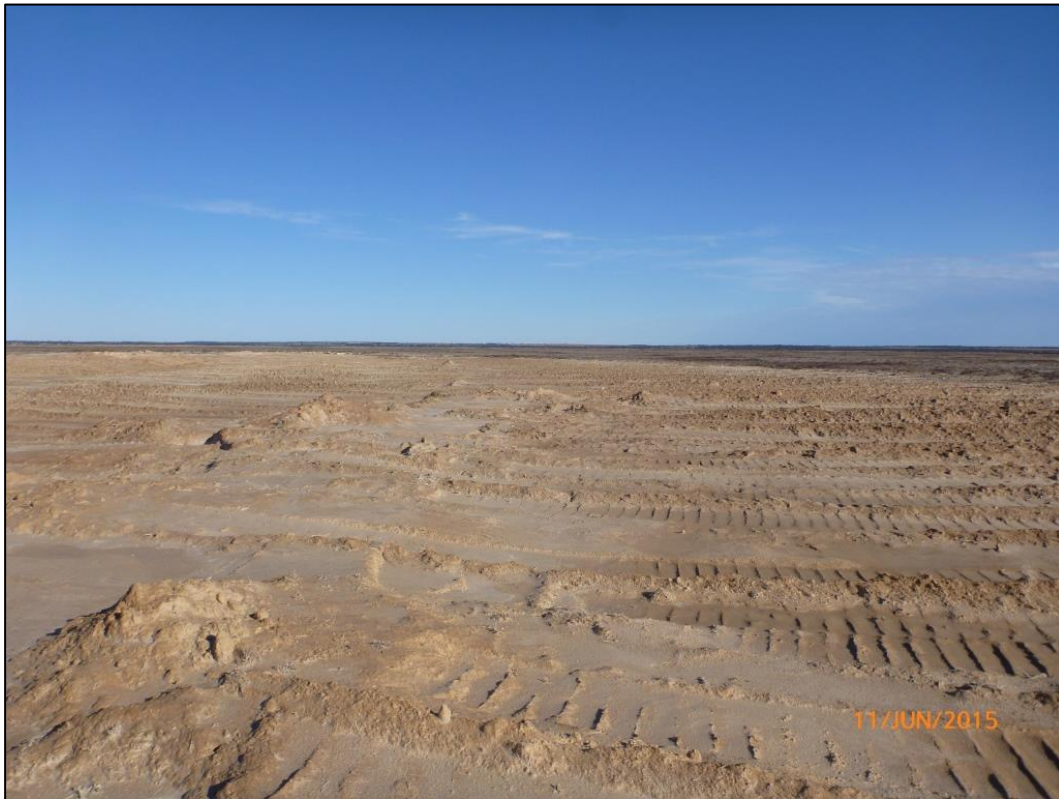
Plate 17: Monitoring Site 5 in 2015 (immediately after rehabilitation earthworks)

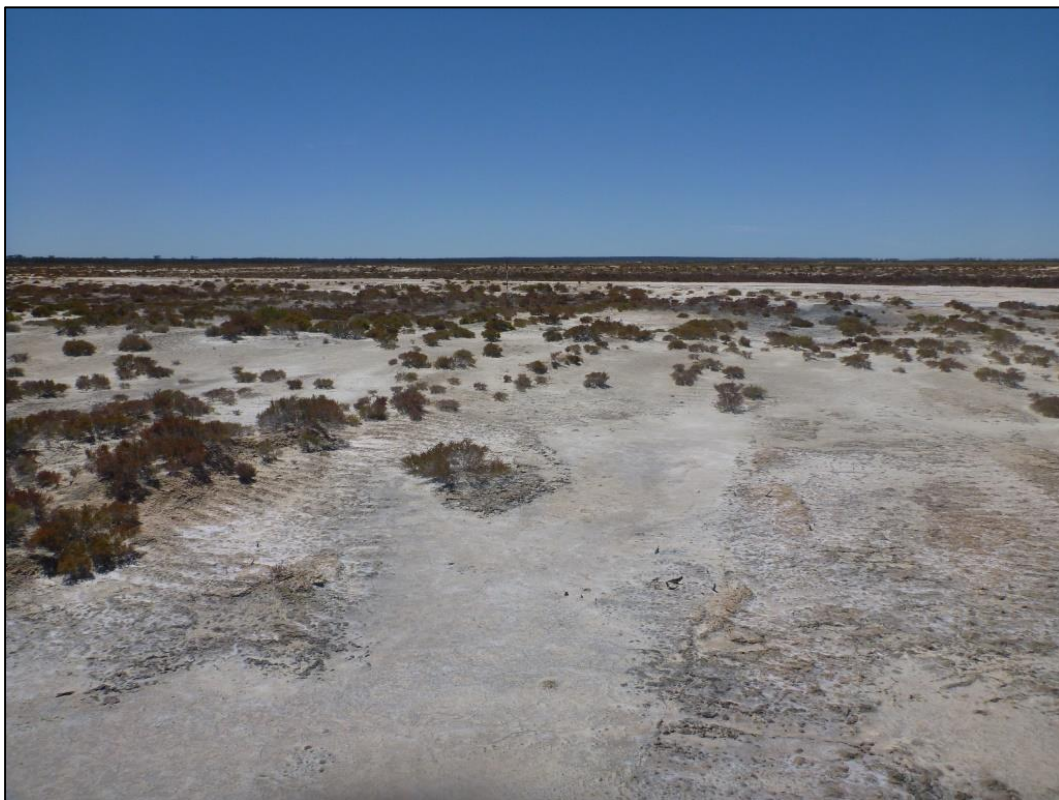
Plate 18: Monitoring Site 5 in 2021 (six years after rehabilitation earthworks)

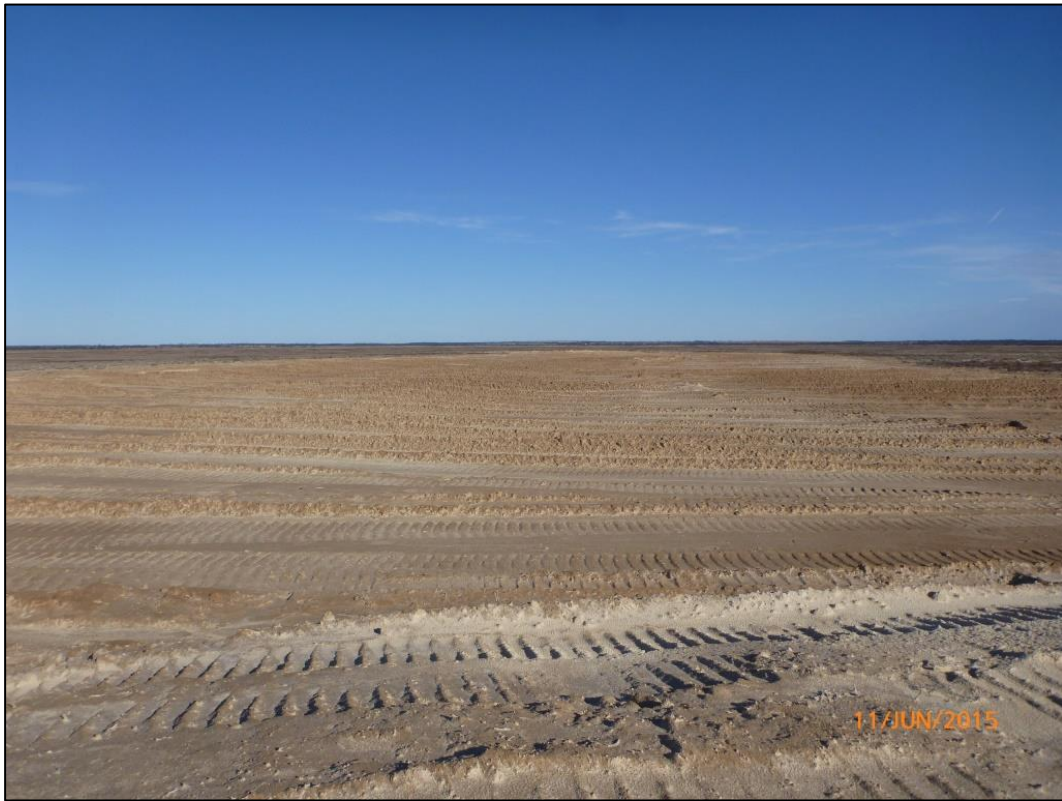
Plate 19: Monitoring Site 7 in 2015 (immediately after rehabilitation earthworks)

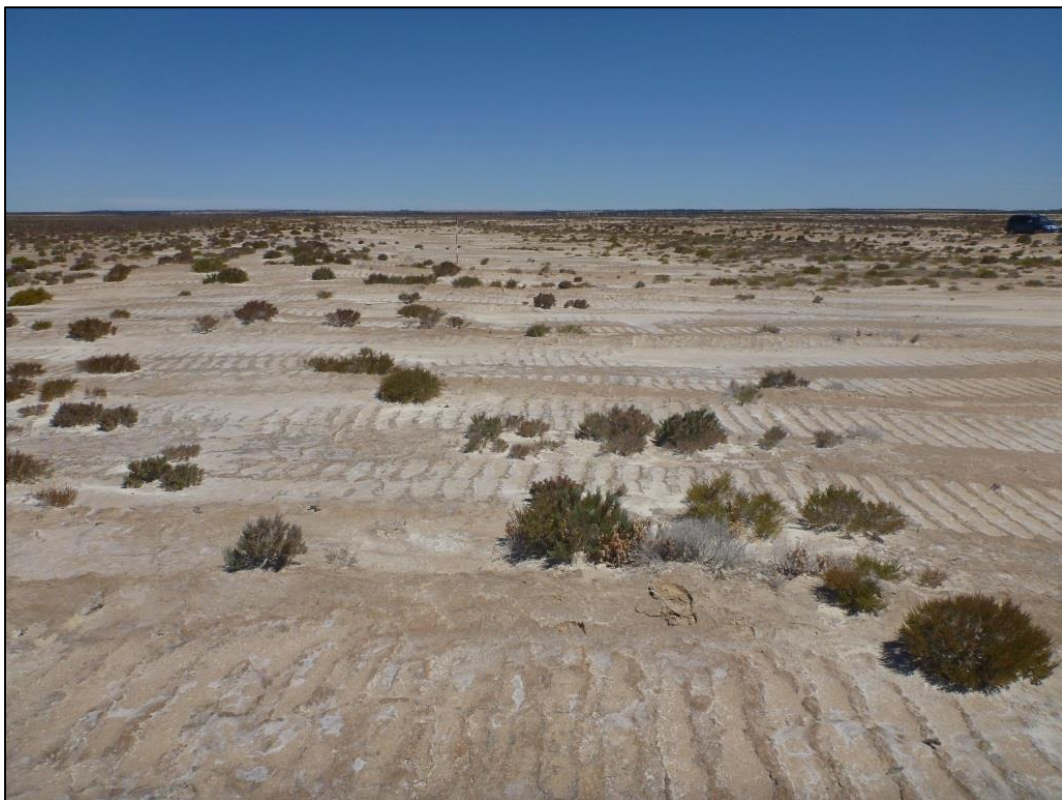
Plate 20: Monitoring Site 7 in 2021 (six years after rehabilitation earthworks)

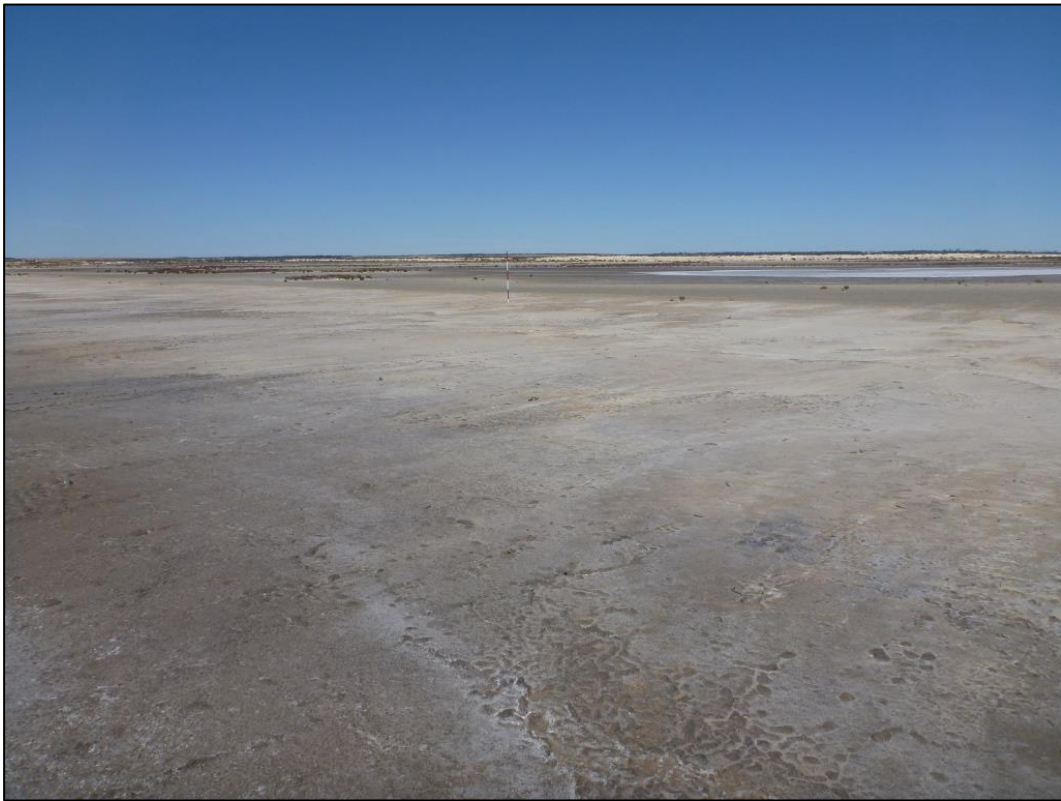
Plate 27: Monitoring Site 3 in 2021 (six years after rehabilitation earthworks)

With reference to Plates 27 to 29, some mined areas had no vegetation prior to mining and are thus rehabilitated to the original landscape of barren lakebed. It should be noted that the barren areas of lakebed are no longer mined due to poor gypsum availability.

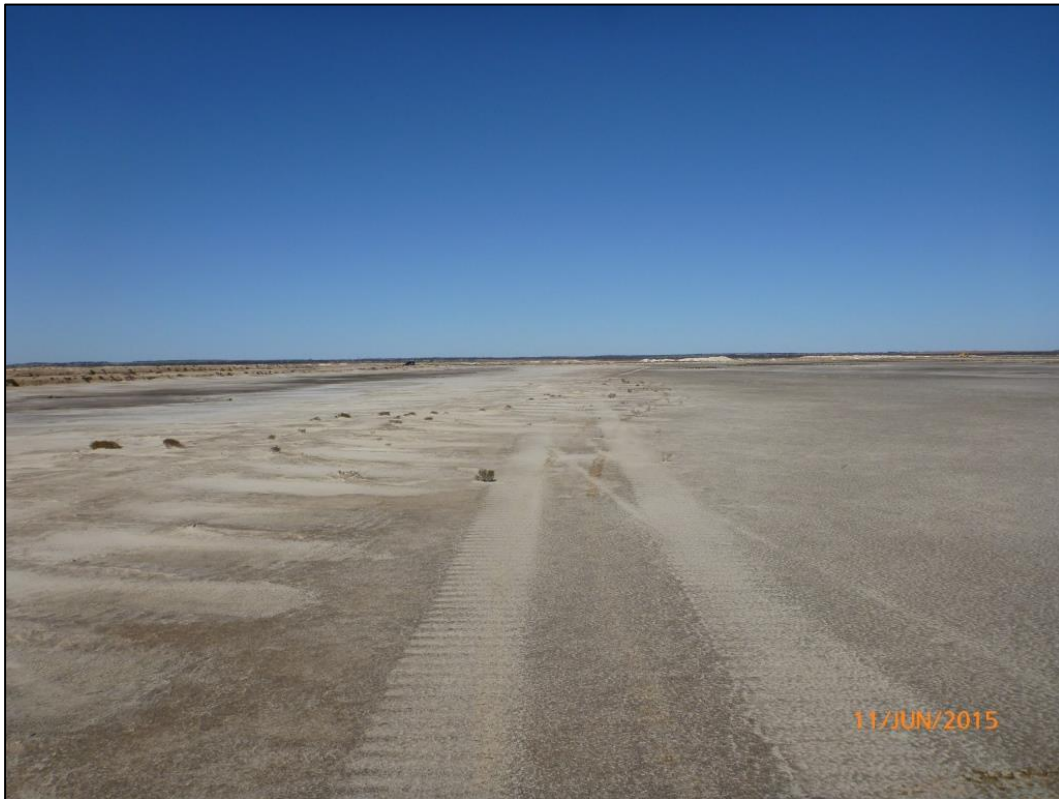
Plate 29: View of Monitoring Site 3 LHS after rehabilitation earthworks in 2015 and natural lakebed RHS

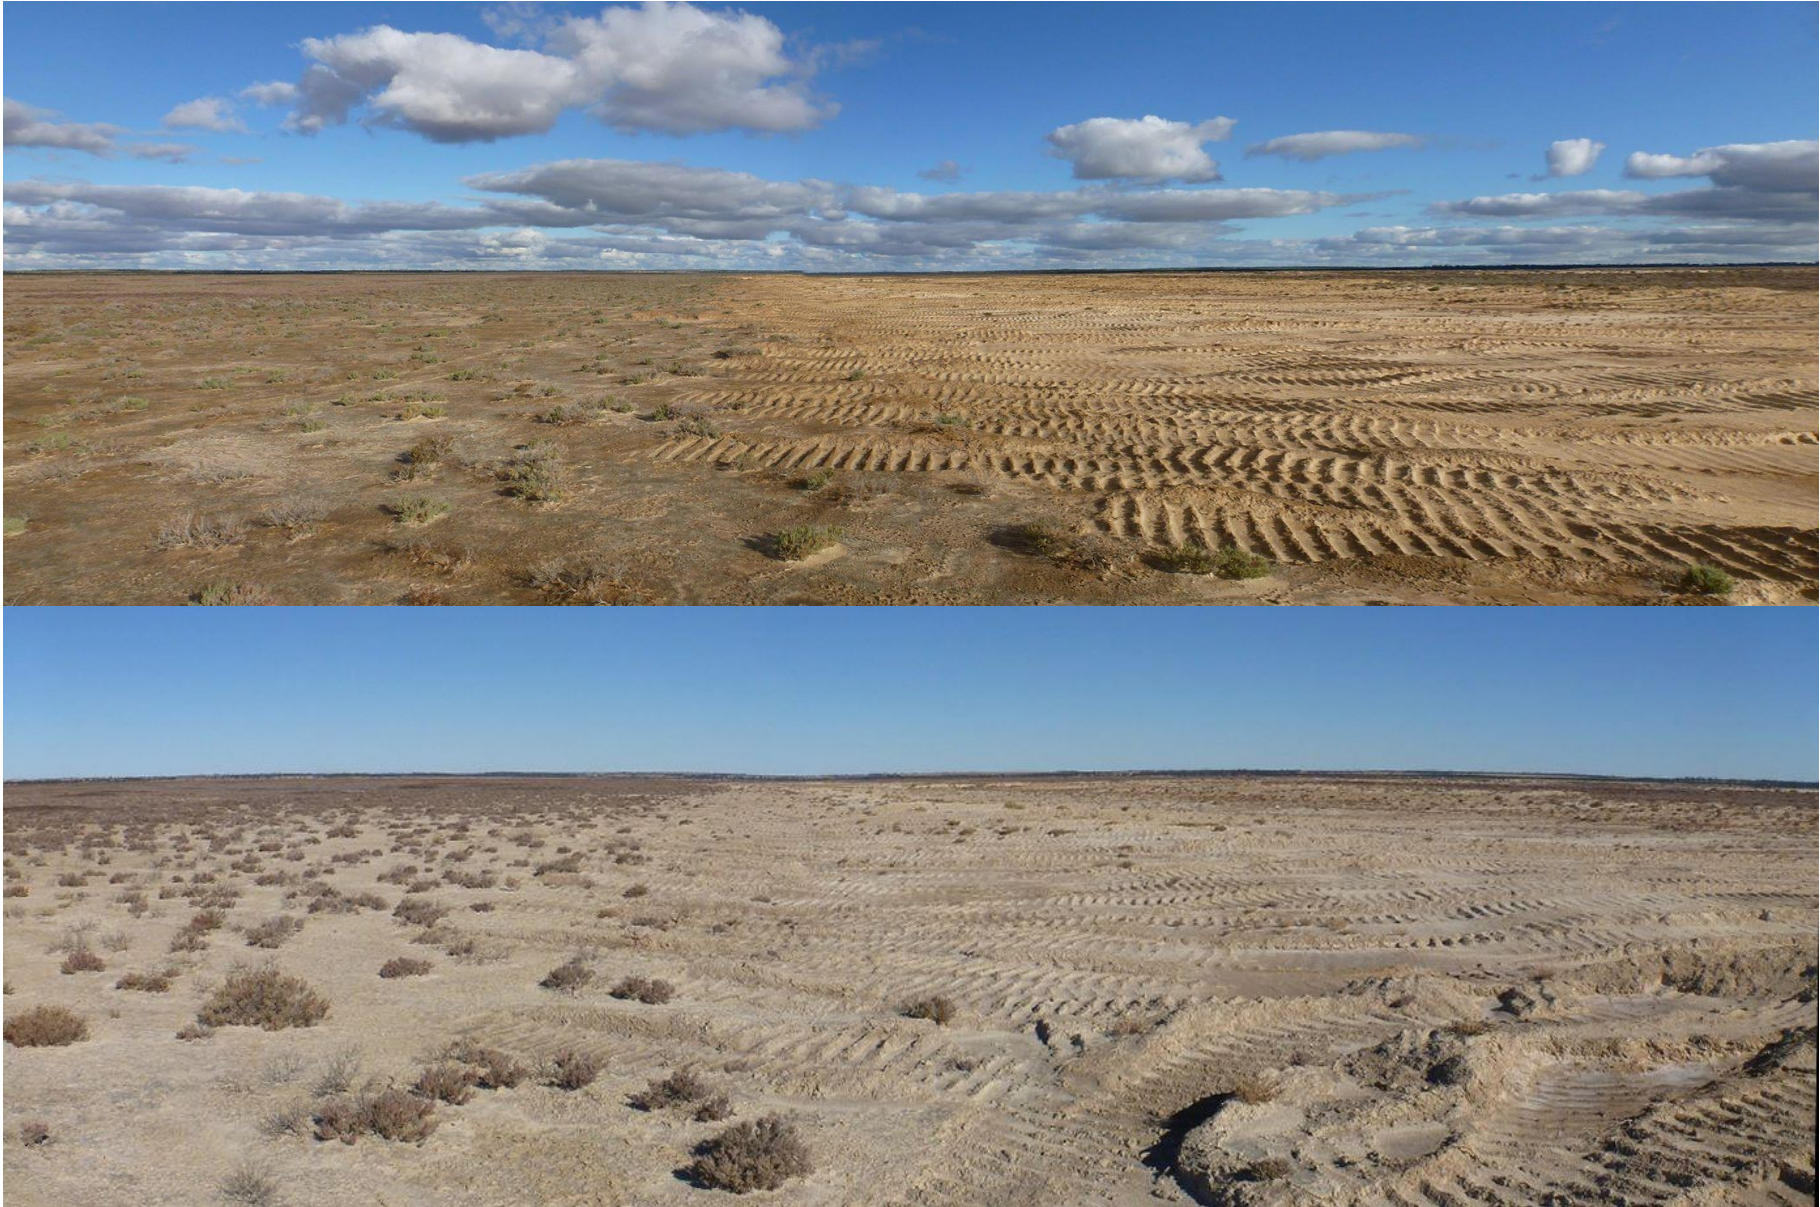
Plate 30: Panoramas showing integration of rehabilitated landform RHS into the natural lakebed surface LHS

Mine closure requirements will be discussed with the District Inspector of Mines closer to likely completion dates. The relevant legislation is outlined in Appendix D Part E and comes into effect just prior to closure. The District Inspector of Mines will inspect the site prior to closure to provide advice on decommissioning requirements. It is likely that abandonment bunds will not be required given that the final landform will have no pit walls or potential fall from height hazards (refer to Plate 30).

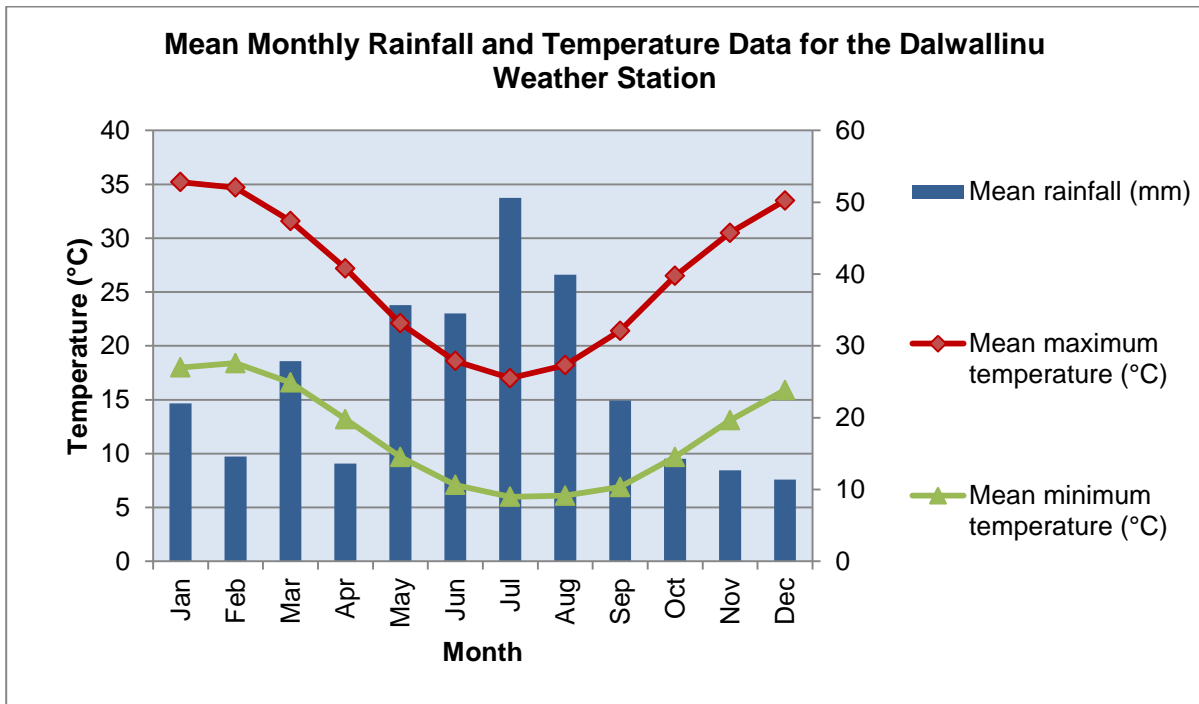
Figure 8: Mean monthly rainfall and temperature data for Dalwallinu BOM Station 8297

The summer temperature range is extreme with a mean maximum temperature exceeding 35°C and as high as 46.9°C. Winter temperatures are milder but still warm, with mean maximum temperatures in excess of 17°C. Mean minimum temperatures vary from 18.4°C in summer to 6.0°C in winter (Table 6).
