# RE – Lot 4 (HSE 2774) Caves Road, Yallingup - Clearing Permit Application

Please find herein information pertaining to a clearing permit (area) application on behalf of Cape Sand Supplies Pty Ltd.

Cape Sand Supplies Pty Ltd (the applicant) is proposing to extract sand from a 9.14 hectare (ha) area (herein referred to as the subject site) located within Lot 4 (HSE 2774) Caves Road, Yallingup (refer to **Figure 1** and **Figure 2**). The subject site is located within the municipality of the City of Busselton, approximately 10 km south-west of the Dunsborough town centre and approximately 200 km south of Perth.

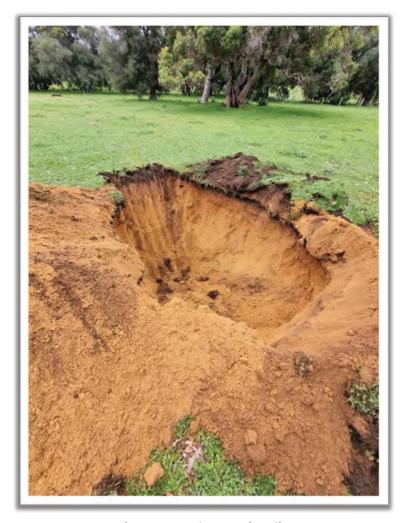
Plate 1. Test pit 1, sandy soils.

Soils were comprised of yellow/orange sands (refer to **Plates 1 – 3**). No groundwater was observed in any of the test pits. Accordingly, at an approximate elevation of 71 m AHD, no groundwater was encountered to a depth of 3.5m BGL, denoting that the maximum groundwater level is below 67.5 m AHD. Furthermore, no clay or impermeable layers were identified in the sandy substrate.

To determine onsite maximum groundwater levels, three test pits were excavated to a maximum depth of 3.5 m below ground level (BGL) on the 24<sup>th</sup> August 2023 (refer to **Figure 2** for test pit locations). The test pits were located in proximity to the lowest elevation of the proposed extraction footprint (approximately 71 m AHD) to determine groundwater levels.

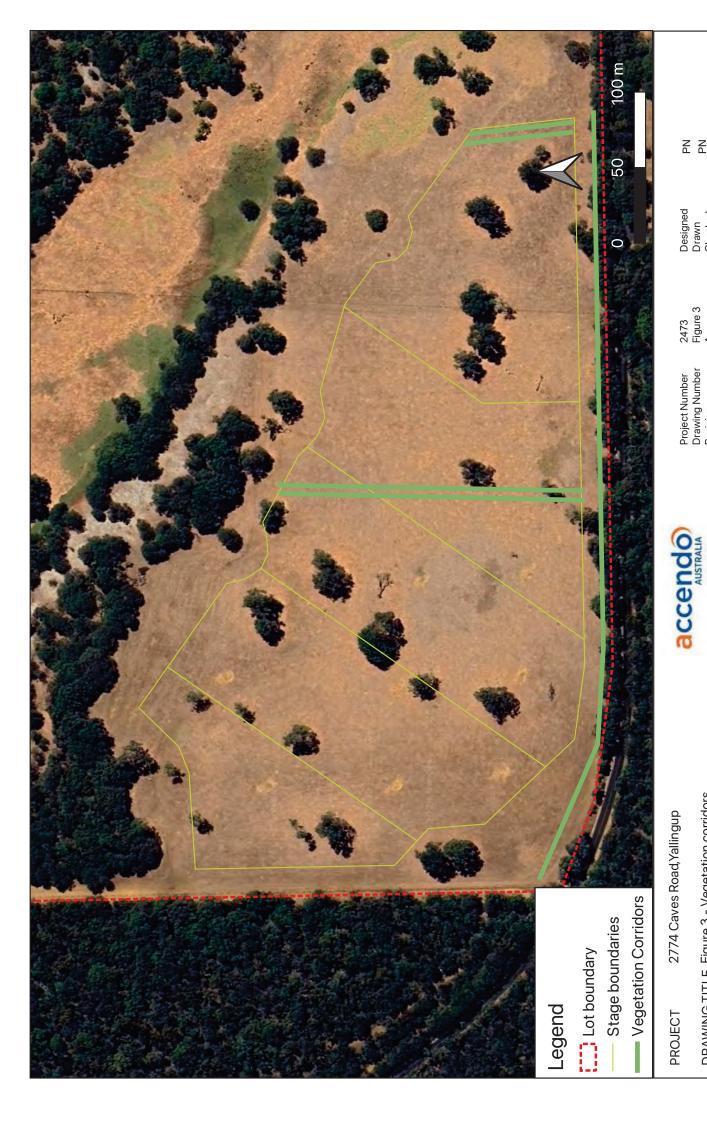
DRAWING TITLE Figure 3 - Vegetation corridors

On completion of works, vegetation corridors comprised of two rows will also be planted with *Agonis flexuosa* (Peppermint) and *Corymbia calophylla* (Marri) at 5 m spacings within the subject site (refer to **Figure 3**).

To replace the potential habitat proposed for clearing, revegetation of approximately 0.93 ha with preferable foraging species will be undertaken. Upon receipt of the relevant approvals and prior to commencement of extraction activities (excluding the months December to March), a row of vegetation (*Agonis flexuosa* and *Corymbia calophylla*) will be planted at 5 m spacings between the noise bund and fence line along Wyadup Road.
