City of Rockingham

Palm Beach Boat Ramp West Redevelopment Environmental Management Plan

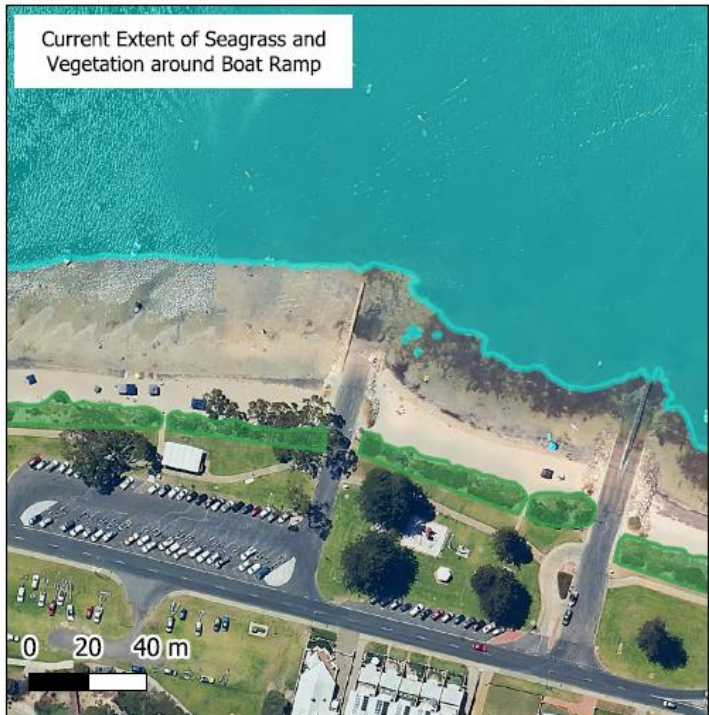
Figure 3: Clearing footprint
27

Trees to be retained

The refurbishment works will result in some clearing of terrestrial vegetation and seagrass (Figure 3) the City will be submitting a clearing permit application to DWER, this Environmental Management Plan has been prepared in support of this application.

A seagrass meadow consisting of *Posidonia* spp, is located adjacent to the project area (Figure 3). The extent of the seagrass meadow has been determined based on a comparison of aerial imagery with available mapping (BMT, 2017). Ground truthing to confirm the presence of seagrass was undertaken by City of Rockingham in 2024.

The terrestrial clearing footprint totals 219m² (Figure 3). A clearing permit application will be submitted to the DWER.

There are existing seagrass meadows less than 4m from the existing jetty which will be impacted by the project. Total seagrass clearing footprint will be 52m² (Figure 3). A clearing permit application will be submitted to the Department of Water and Environmental Regulation (DWER).

The project footprint will be limited to that identified in Figure 3.
