Mattice Consulting Pty Ltd

MEMORANDUM: Proposed Expansion Area associated with the Gas Facility to the south of the South 32 Collie Refinery

APPENDIX A: PHOTOGRAPHIC RECORDS OF PROPOSED CLEARING ACTIVITIES ON THE COLLIE REFINERY GAS FACILITY UPGRADE

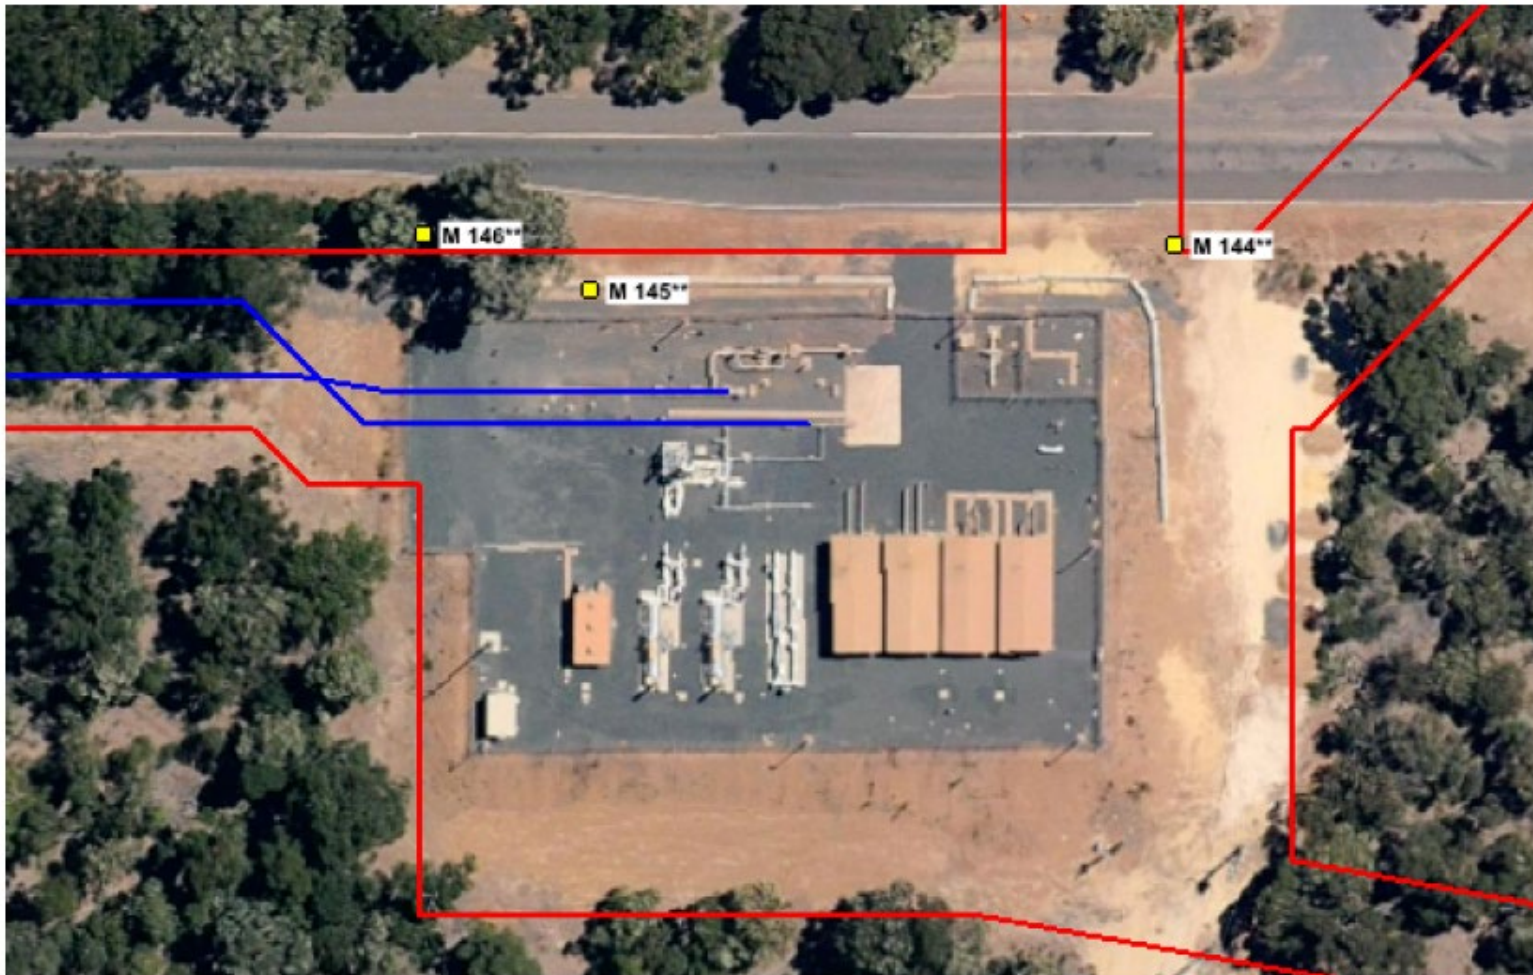
Figure 1: Proposed clearing areas (red lines) on the edges of the current Gas Facilities and the Gas Pipelines to the west (blue lines), Gastaldo Road to North of Gas Facilities

The following is a summary of the work completed on the proposed expansion area (see Figure 1) near the Gas Facility located on the southern side of Gastaldo Road that runs east-west to the south of the main operational areas at the South32 Collie Refinery.

The proposed expansion occurs within the largely cleared fringes of current Gas Facility and within the current gas pipeline easement to the west which is maintained for "Line of Sight" by the gas pipeline operators, Figure 1.

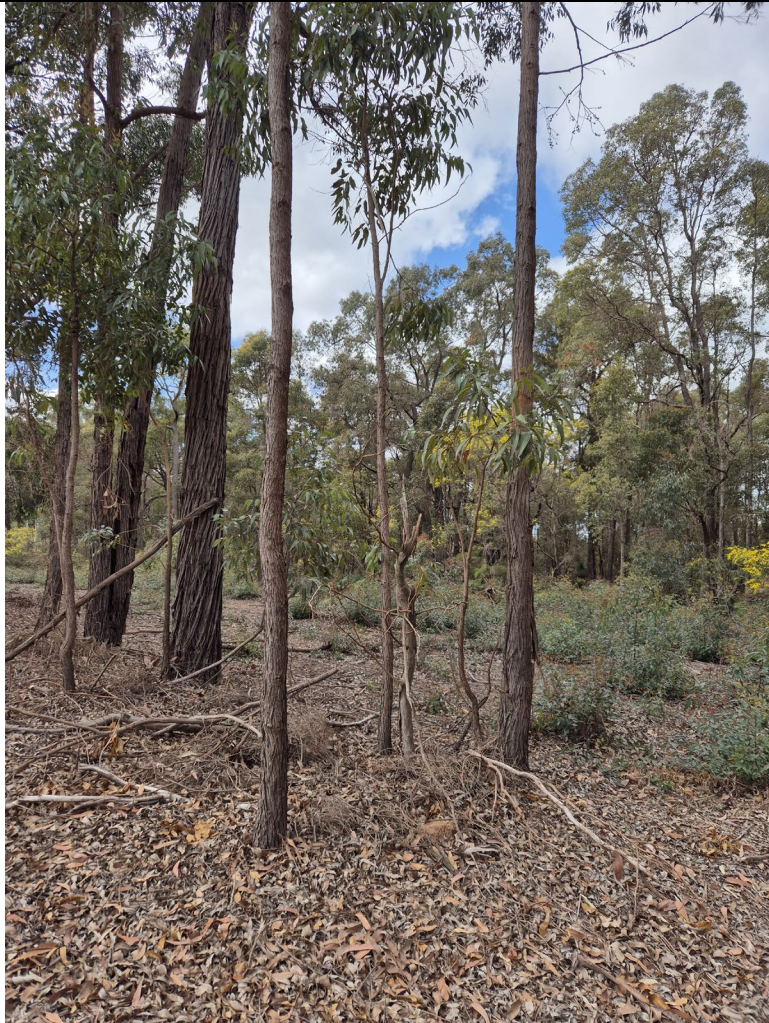
Photograph 1: Planted *Eucalyptus resinifera* on road verges northwest of the current gas facilities with Gas Pipeline alignment behind the road plantings

2. Planted *Eucalyptus resinifera* along the fringes of the Gastaldo Road.
3. The presence of a few *Corymbia calophylla* near the fringes of Gastaldo Road and the forested areas to the east and south. Three of these trees had evidence of foraging and only the tree on the north-east corner of the proposed expansion area (see Photograph 8 in Appendix A). The tree on the north-eastern corner has been flagged to avoid clearing and minimize disturbance.

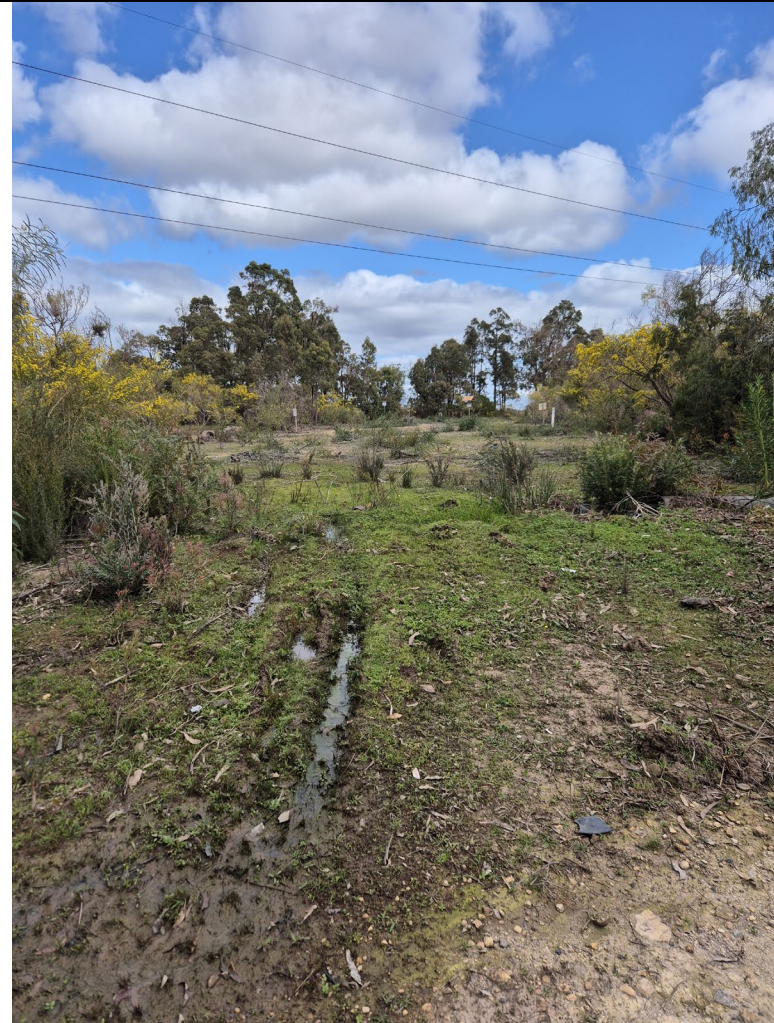
Photograph 2: Looking westward along current Gas Pipeline; note some local water-logging

4. The regrowth on the gas pipeline corridor (see Appendix A – photographs 2, 3 and 4) reflect the growth of *Bossiaea aquifolium*, *Acacia pulchella*, *Billardiera fusiformis* and seedlings of *Eucalyptus marginata* and *Corymbia calophylla*. The pipeline alignment is pruned to ensure line of sight along the pipeline route which is required for safety and visibility.

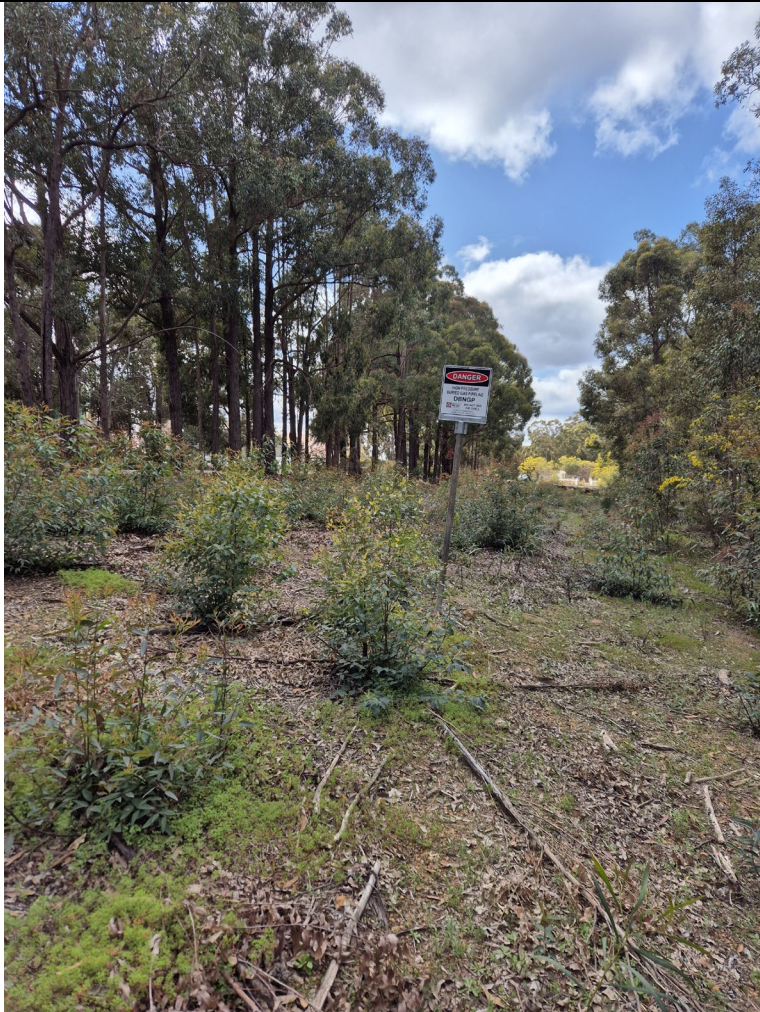
Photograph 3: Looking eastwards along current Gas Pipeline alignment towards the current Gas Facility

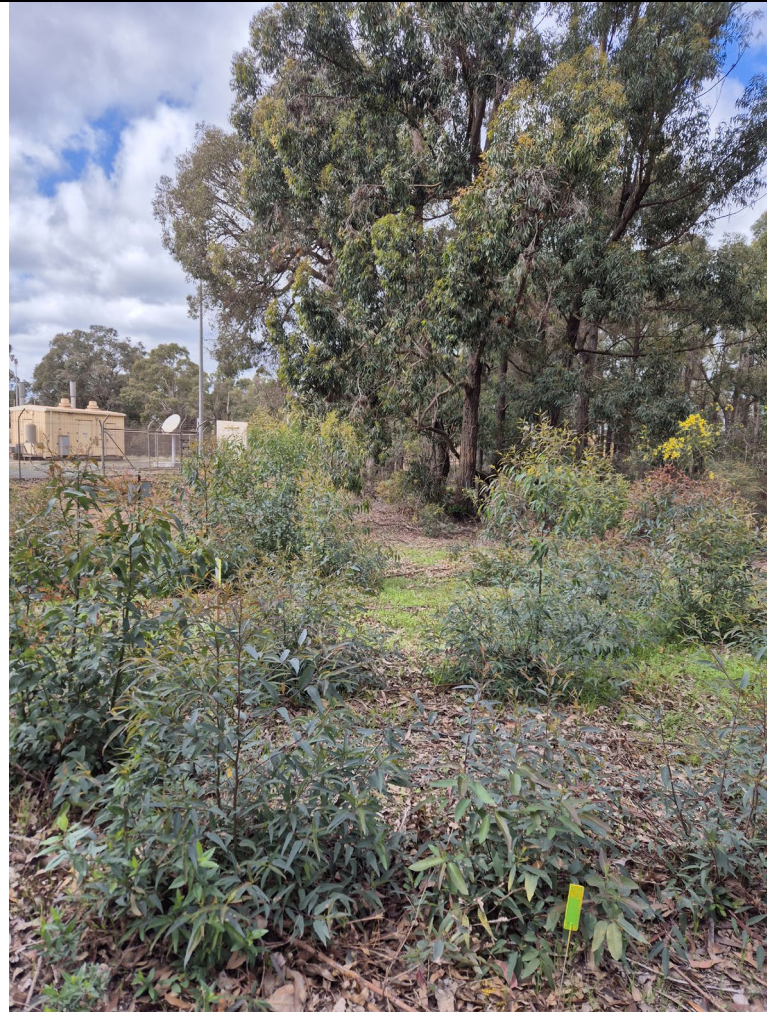
Photograph 4: Looking south-eastwards from Gas Pipeline towards southwest corner of the current Gas Facility

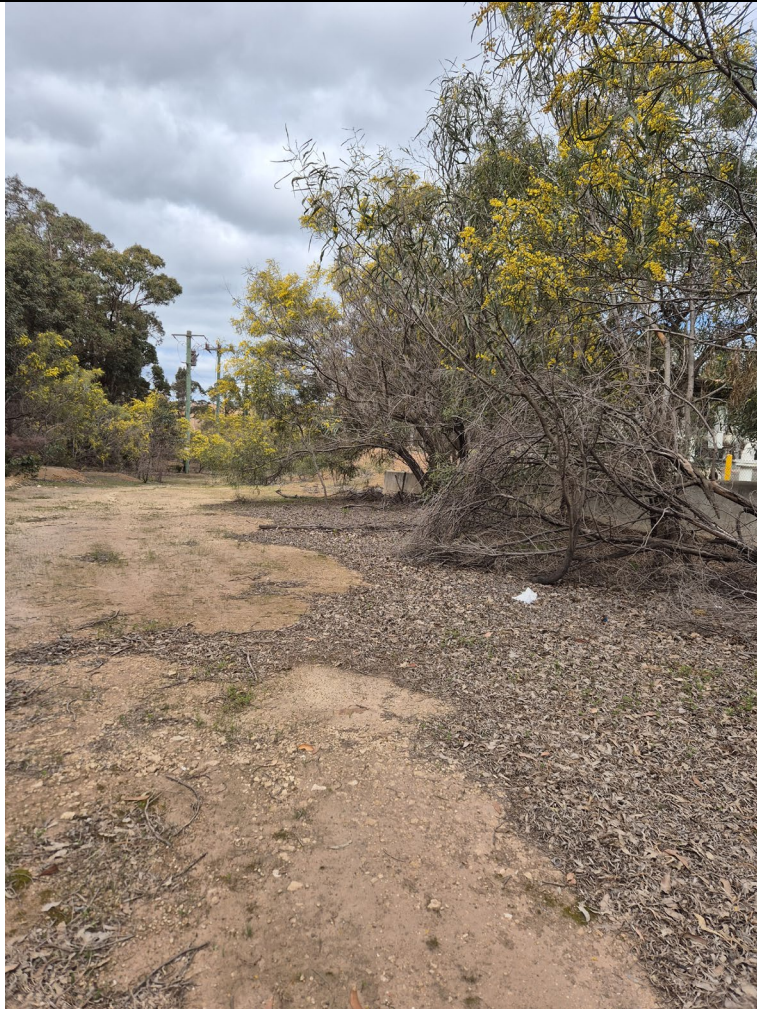
Photograph 5: Looking southwards along eastern fringes of the current Gas Facility

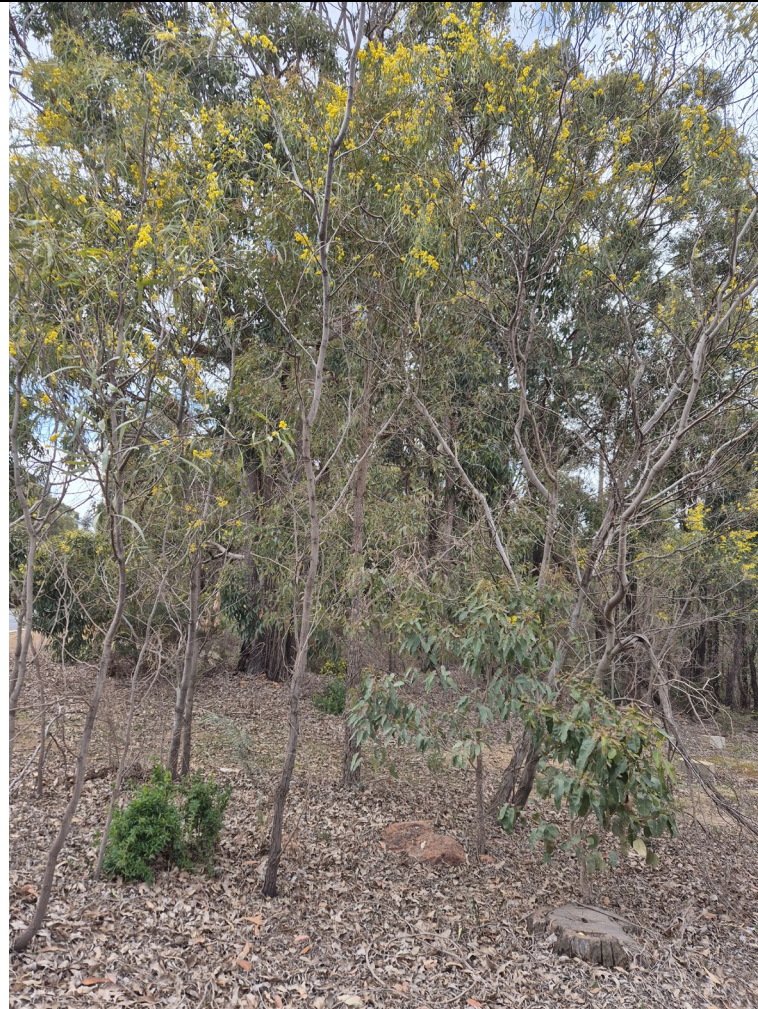
Photograph 6: Stands of *Acacia saligna* on eastern sides of the current Gas Facility

1. Mostly cleared areas around the current Gas Facilities with localised patches of *Acacia saligna* establishing in previously cleared fringes of the facilities.

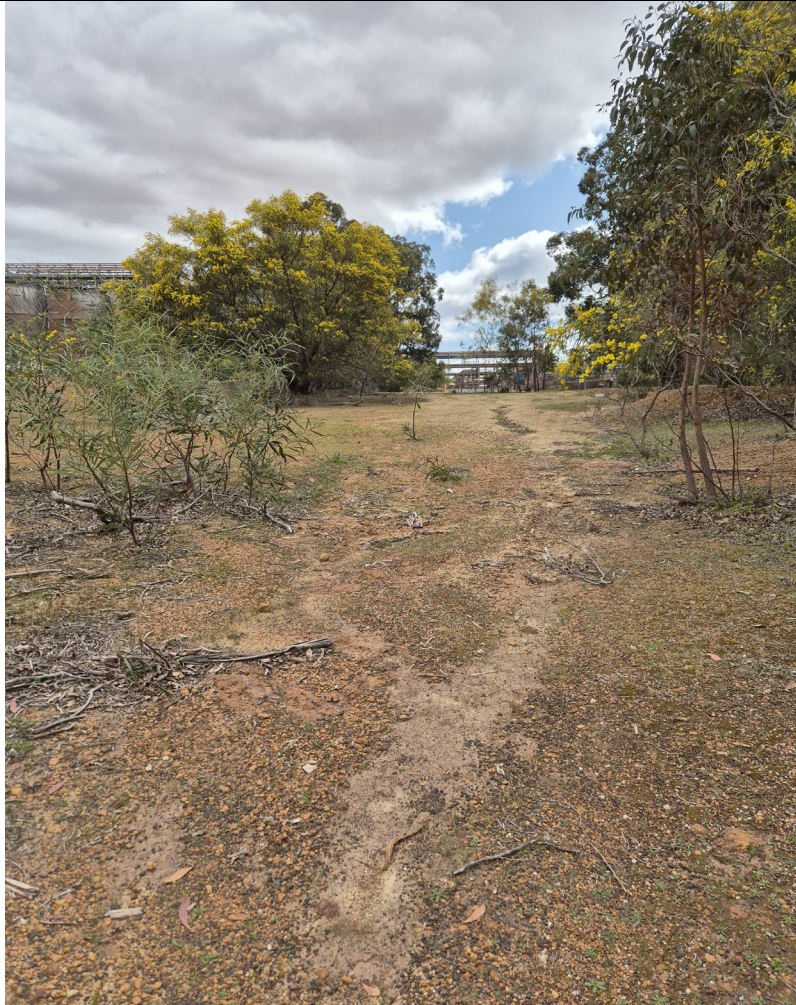
Photograph 7: Looking north along eastern fringes of the current Gas Facility

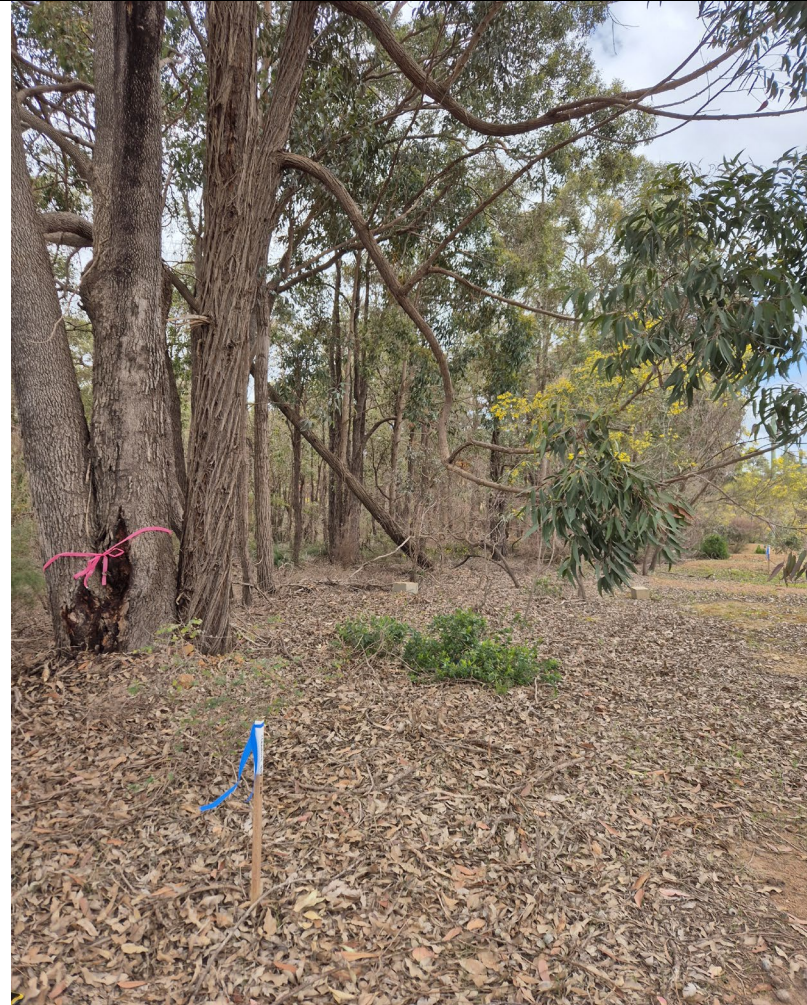
Photograph 8: Large *Corymbia calophylla* (left of *Eucalyptus resinifera*) on the north-eastern corner of proposed clearing area on eastern side – flagged to avoid during clearing activities

There were 3 Marri (*Corymbia calophylla*) trees that occur on the road verges that have been used for foraging by the listed Black Cockatoos. In the local and regional context these are not significant. Nevertheless every effort will be made to avoid the larger *Corymbia calophylla* on the north-eastern corner of the proposed expansion area (hence the flagging as illustrated in Appendix A – Photograph 8). The other Marri trees on the north-western corner
