Clifton Street Chidlow

Clifton Street – Northern side

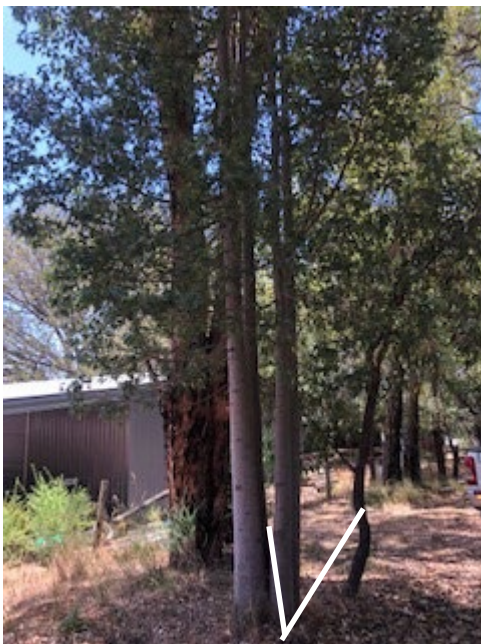
Photo 1 (left): Kurrojong tree and one small Marri sapling with a DBH of 5cm proposed to be removed. Larger trees to be retained. No natives species underneath the trees.

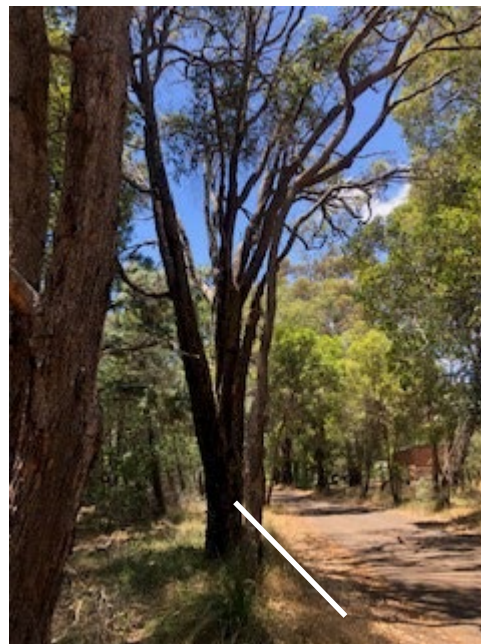
Photo 2 (right): Marri tree on the edge of the road to be removed. The tree is in severe decline with dead branches, possible canker and evidence of borers in the tree.

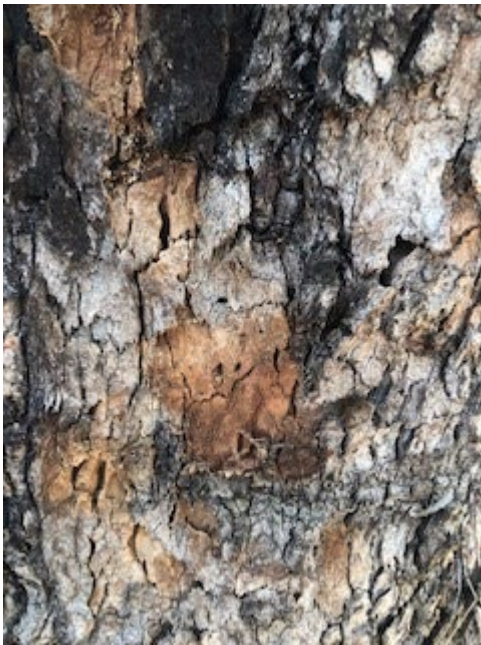
Photo 3 (left): Borer activity on the tree shown in photo 2.

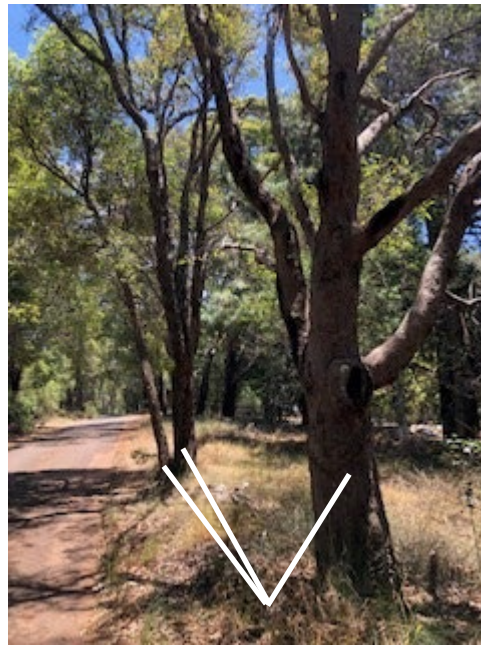
Photo 4 (right): Jarrah trees with a DBH 15cm and 30cm and a Marri tree proposed to be removed. Marri tree is in decline with canker and borer activity. No native shrubs underneath any of the trees.

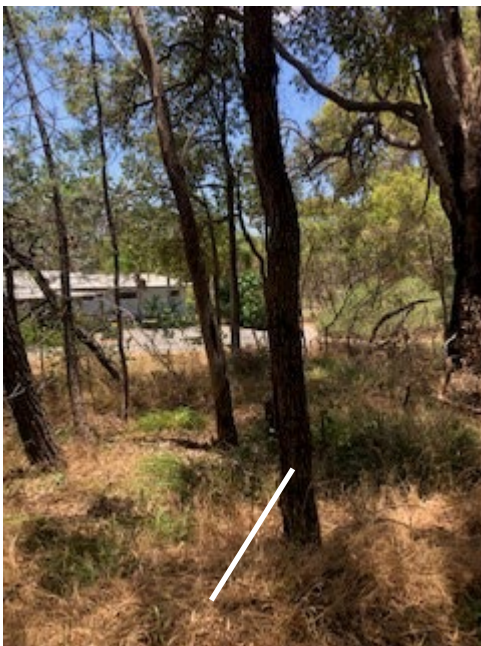
Photo 5 (left): *Eucalyptus patens* (Blackbutt) with a DBH 15cm to be removed. Weeds underneath.

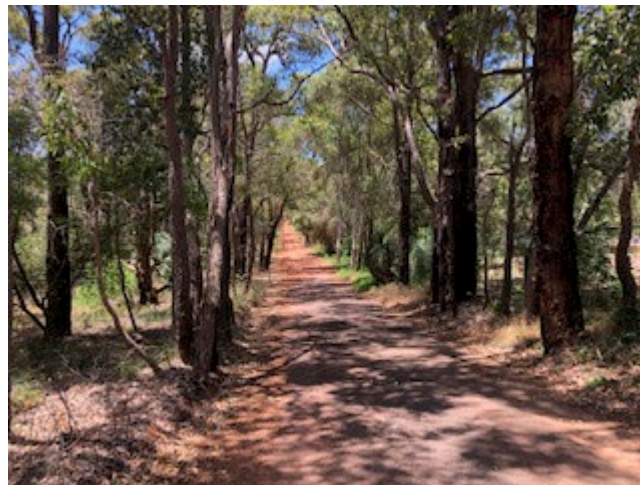
Photo 6 (right): View of Clifton Road. Vegetation as seen on the right side of the photo will be retained with the road constructed to avoid the removal of any mature trees. This alignment will therefore impact the smaller trees on the northern side of Clifton Street, with a total of 19 trees that range from a DBH of 5cm to 20cm.

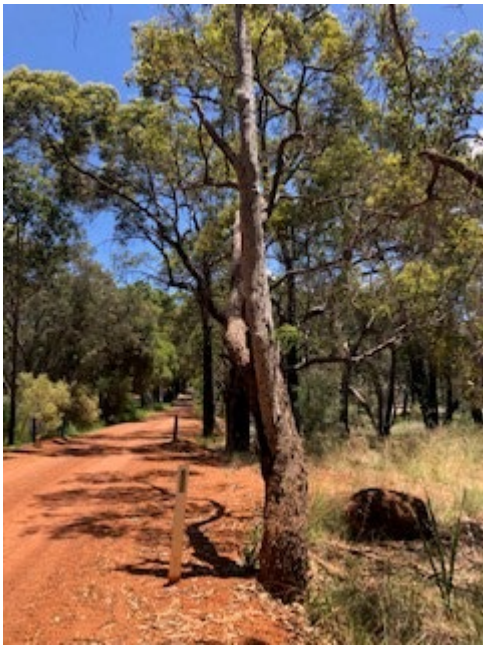
Photo 7 (left): Dead tree removed.

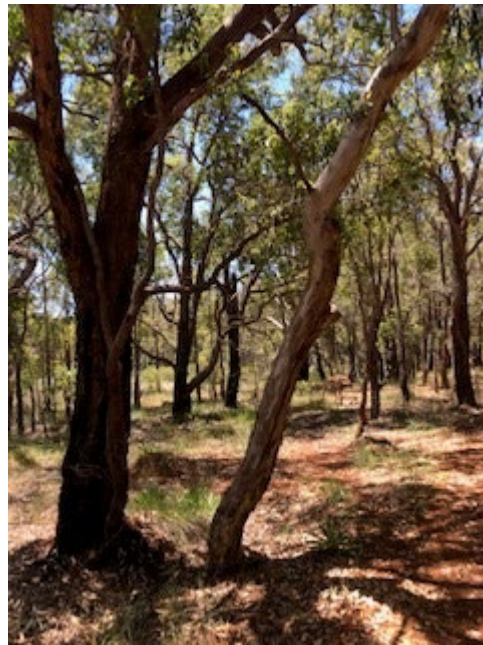
Photo 8 (right): Wandoo tree on a lean and overhanging the road. Tree required to be removed as pruning will cause a weak canopy and failure in the future. Wandoo tree has a DBH of 20cm.

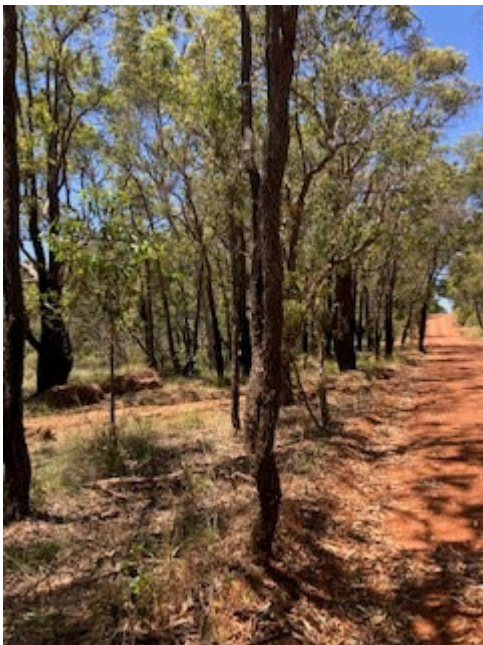
Photo 9 (left): Small Marri sapling showing damage (possibility from vehicles) to be removed.

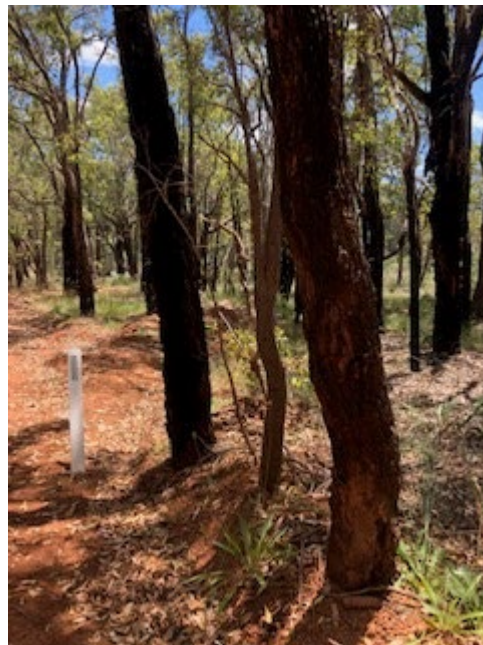
Photo 10 (right): 3 x Marri trees with a DBH of 20cm, 10cm and 20cm respectively. All proposed to be removed.

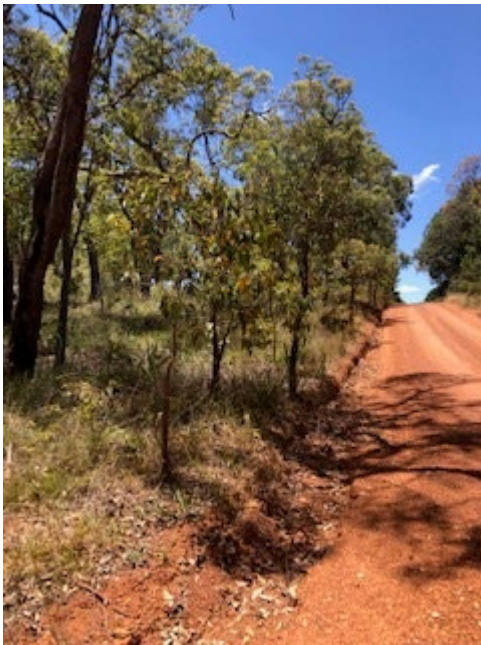
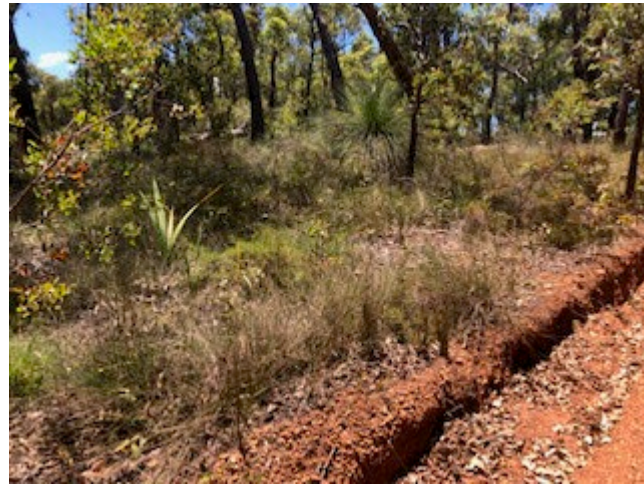
Photo 11 & 12: An area measuring 1m x 70m (70sqm total) may be required to be removed to widen the road. All efforts will be made to retain this vegetation and has been included as a worst-case scenario, for the purpose of the clearing permit application. The vegetation is a mix of small Marri saplings, sedges and ground covers. Some weedy grasses and bulbs.

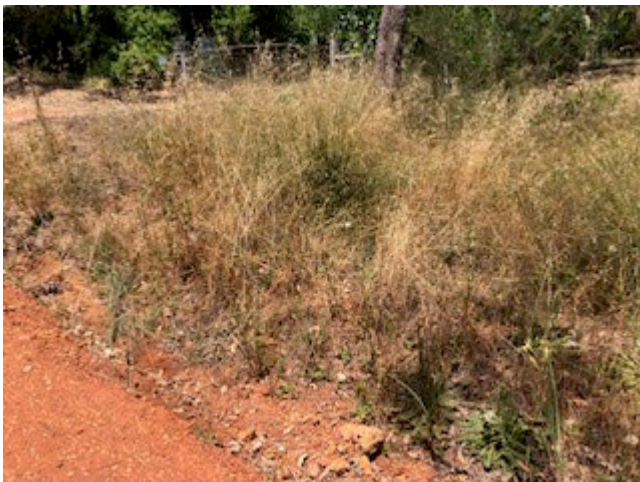
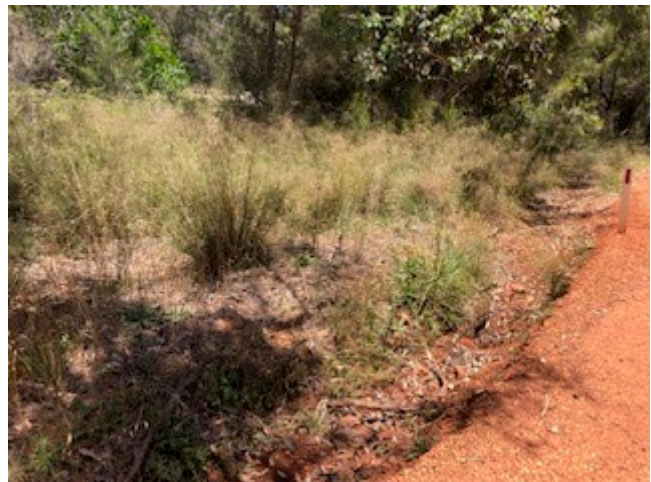
Photo 13 & 14: View of vegetation along Clifton Street and along the existing drain. Mainly weedy grasses and leaf litter. Has been historically cleared for drainage maintenance.

Proposed works include a section of drainage maintenance. This will involve the removal of vegetation in the drain that is interfering with performance, the pruning of overhanging branches, and work along the shoulder of the road. Vegetation impacted is mainly weedy grasses and leaf litter. There is one small sapling that is growing in the headwall and will be removed. All works on the southern side should be considered to be exempt under Regulation 5, Item 22.
