Technical Memorandum

To	Fulton Hogan Construction Pty Ltd	Tel	
Copy to		Email	
From		Ref. No.	12525136
Subject	Flora and Fauna Survey – Lot 3003		
Reference	R8129_CKIAF_SWD_EN_MM_DD_0006

Fulton Hogan
COCOS (KEELING) ISLAND
AIRFIELD UPGRADE

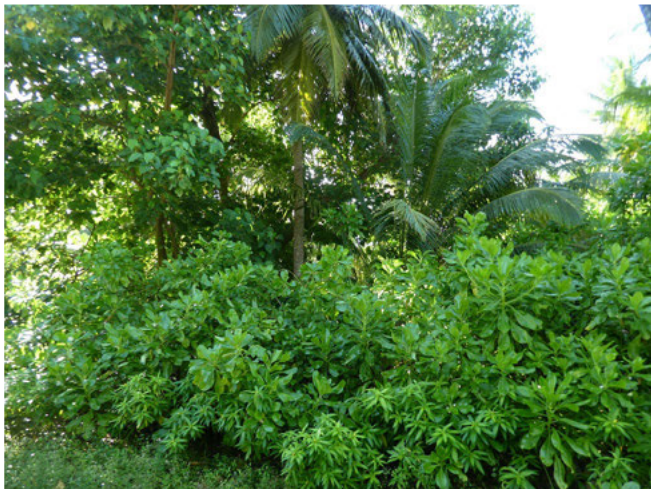
Vegetation type description	Representative photograph
<p><u>VT01 - <i>Cocos nucifera</i> open forest</u></p> <p><i>Cocos nucifera</i> open forest over <i>Scaevola taccada</i> and <i>Morinda citrifolia</i> tall closed shrubland over *<i>Turnera ulmifolia</i> low open shrubland.</p>

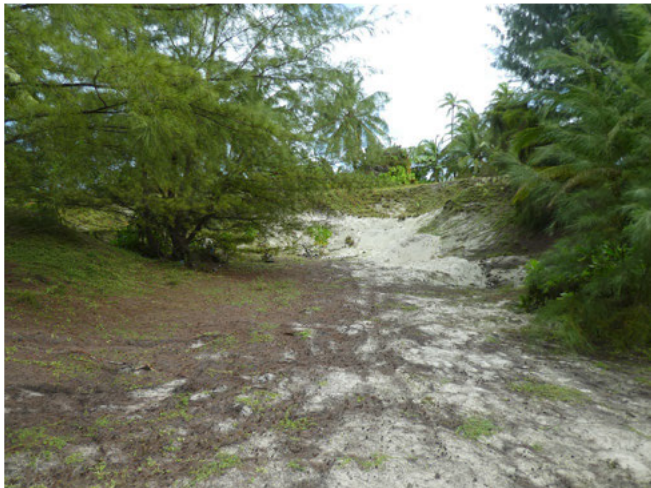
<p><u>VT02 - Occasional natives over weeds</u></p> <p>Occasional isolated occurrences of <i>Cocos nucifera</i> and/ or <i>Casuarina equisetifolia</i> over various grassy and herbaceous weeds, however *<i>Tridax procumbens</i>, *<i>Cynodon arcuatus</i> and *<i>Cyanthillium cinereum</i> were dominant</p>

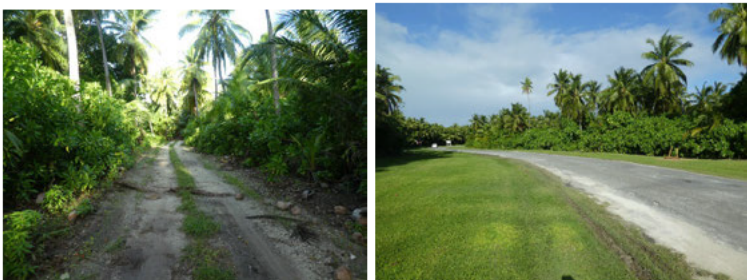
<p><u>Roads and access areas</u></p>

Two vegetation types were recorded within the investigation area, VT01 - *Cocos* palm closed forest and VT02 – Occasional natives over weeds (Table 1 and Figure 2). Within the investigation area was Beacon Heights Road and several tracks. Beacons Heights Road was a dirt road, whilst the tracks were cut down vegetation that had been coarsely mulched. These areas have been mapped as Access tracks/road.

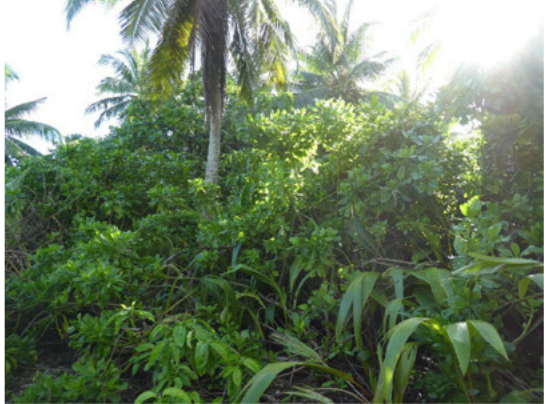
Fauna habitat description	Representative photograph
<p><u>Coconut palm forest with tall shrubs</u></p> <p>This habitat contains a forest of Coconut palms over a dense tall shrubland. Not much light can penetrate through the shrub layer. The ground layer is comprised fallen palm fronds, coconuts and an very thick layer of leaf litter</p> <p>This habitat provides moderate value to fauna and may be used by avian and ground dwelling species for foraging. The vegetation would be too dense for the nesting of significant fauna.</p> <p>This habitat may provide foraging habitat for listed species including <i>Hirundo rustica</i> (Barn swallow), <i>Motacilla flava</i> (Yellow wagtail) and <i>Motacilla cinerea</i> (Grey wagtail).</p>

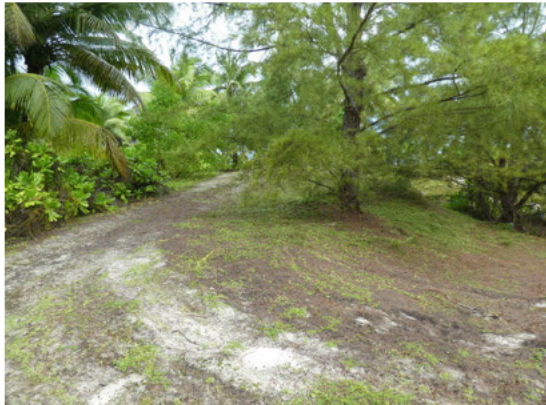
<p><u>Isolated trees/ grassland</u></p> <p>This habitat contained the occasional isolated stands of Coconut palms and Sheoak over grass.</p> <p>This habitat provides low value to fauna it was used by ground dwelling fauna for foraging. This habitat is unlikely to be used by significant fauna.</p>

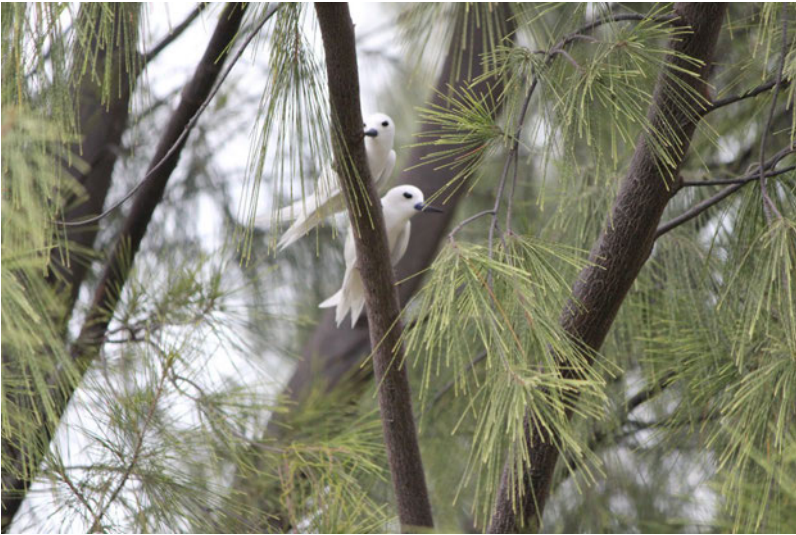
Five fauna species were observed at the investigation area, the White tern (*Gygis alba*), White-breasted waterhen (*Amauronis phoenicurus*), Green jungle fowl (*Gallus varius*), Land crab (*Cardisoma carnifex*) and a Feral Cat (*Felis catus*). A pair of White terns in a large Sheoak became agitated when approached within the investigation area. They swooped a number of times so its assumed they had laid eggs on some branches nearby (Plate 1).

Plate 1 *A pair of White terns observed resting in a large Casuarina equisetifolia*

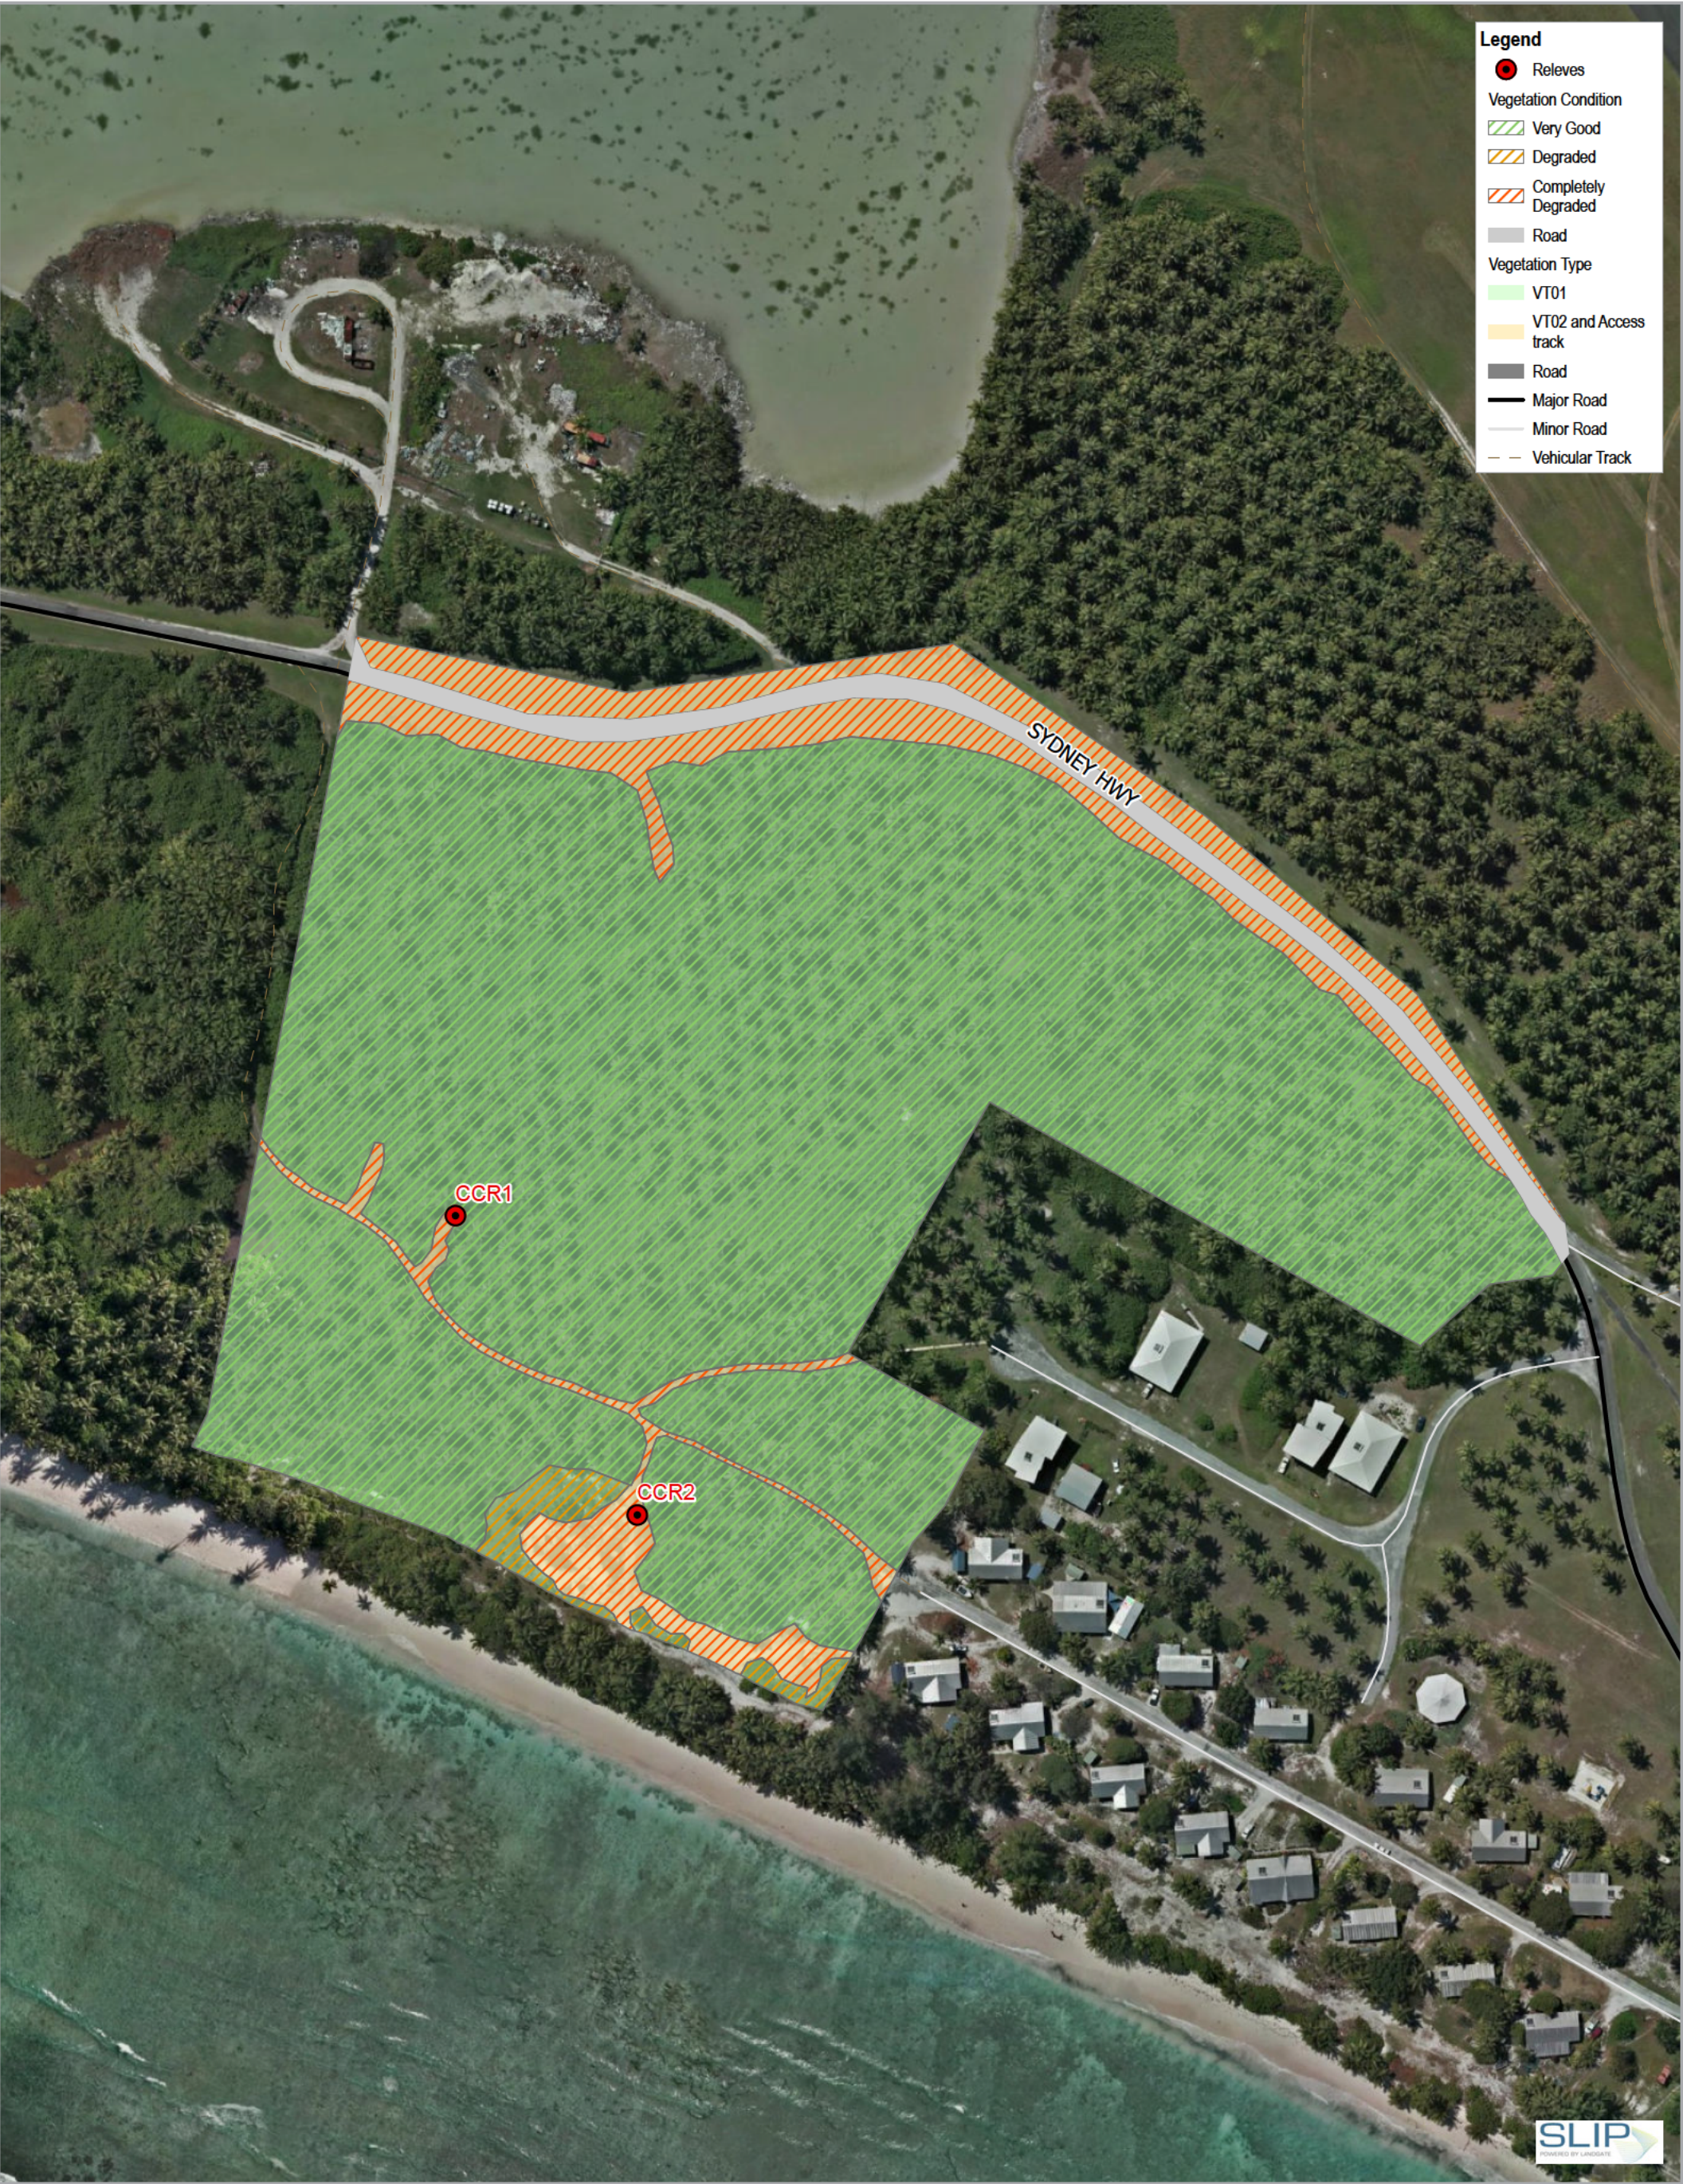
The vegetation condition at the investigation area ranged from Completely Degraded to Very Good (Figure 2). Access tracks were rated Completely Degraded due to little to no native species present. A small disturbed area towards the coast was mapped as Degraded, this area had scattered occurrences of native shrubs and trees but the understorey was cleared and looked to be being used as a playground. The remainder of the investigation area was rated Very Good; the vegetation structure was intact and in most places impenetrable, the ground was covered in dense leaf and debris, which has reduced weed incursion.

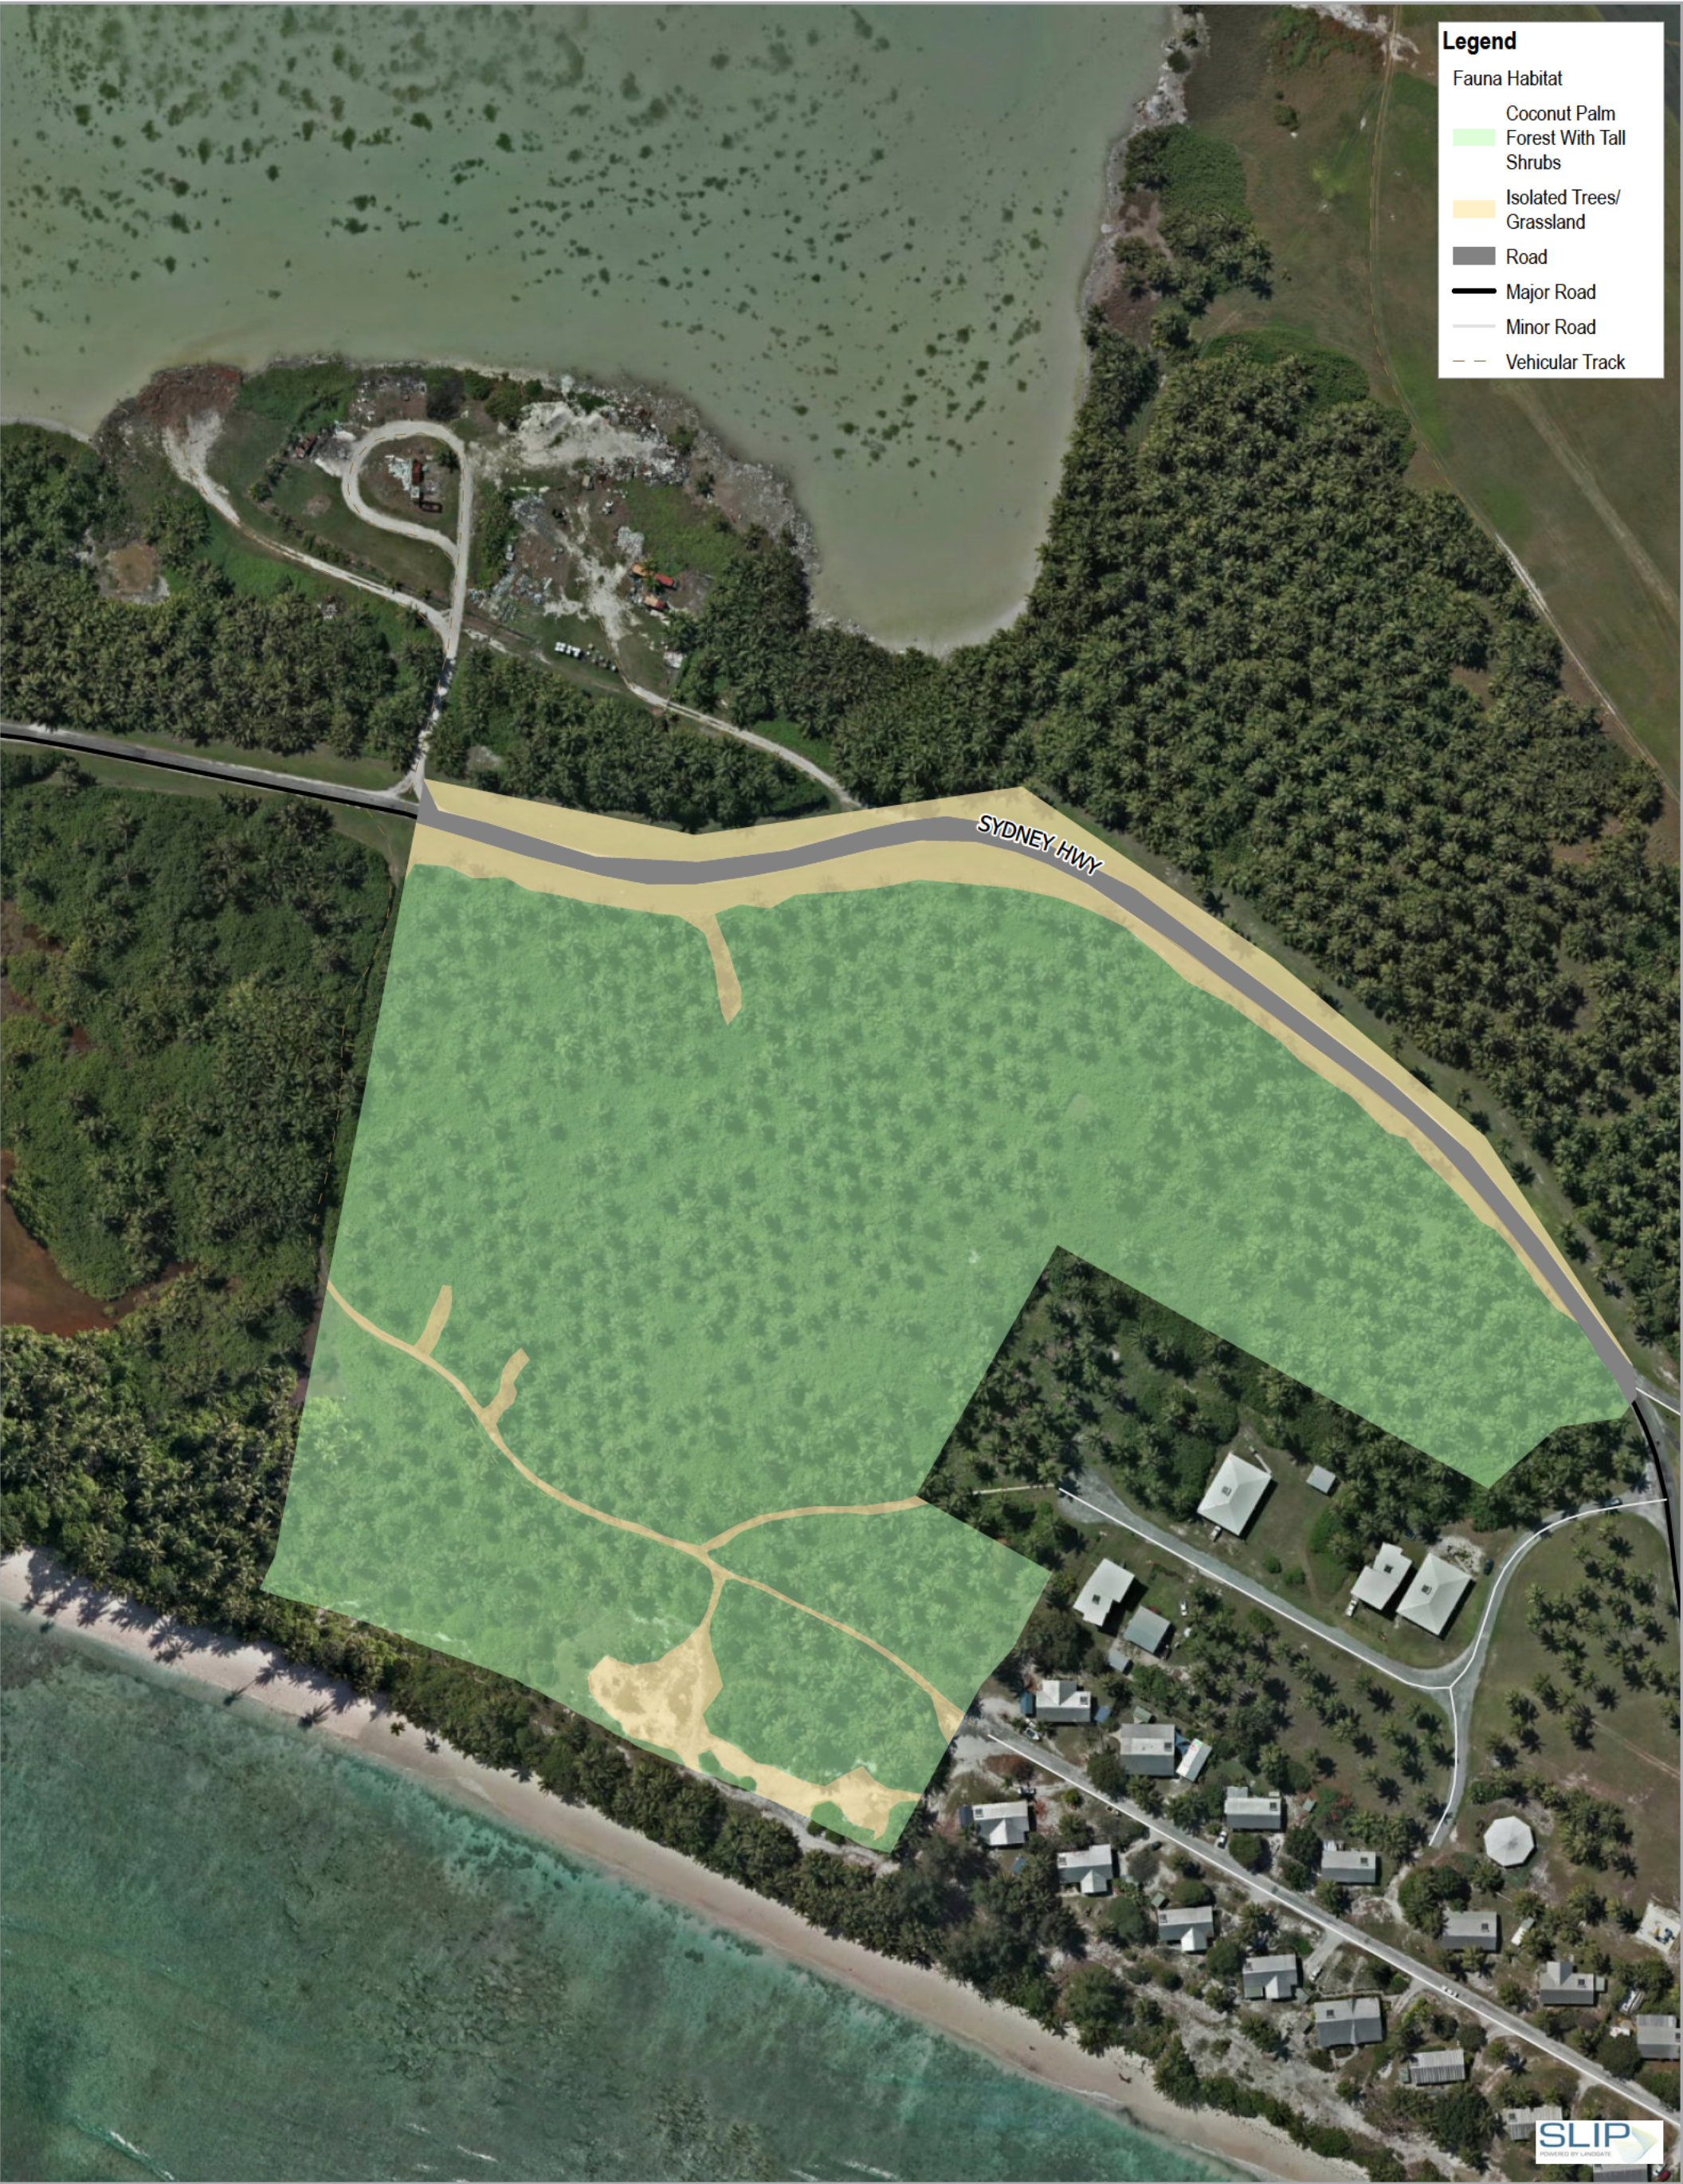
The investigation area comprised of two fauna habitats, Coconut palm forest with tall shrubs and Isolated trees/ grassland (Table 3 and Figure 3). The fauna habitats align with the mapped vegetation type. The habitat provided moderate to low value to fauna.
