**VEGETATION CONDITION SURVEY:
KELLERBERRIN – YELBENI ROAD,
SHIRE OF KELLERBERRIN. SLK 0 - SLK 22**

RECONNAISSANCE SURVEY CONDUCTED ON 1.10.20

TARGETED SURVEY CONDUCTED ON 25.11.20

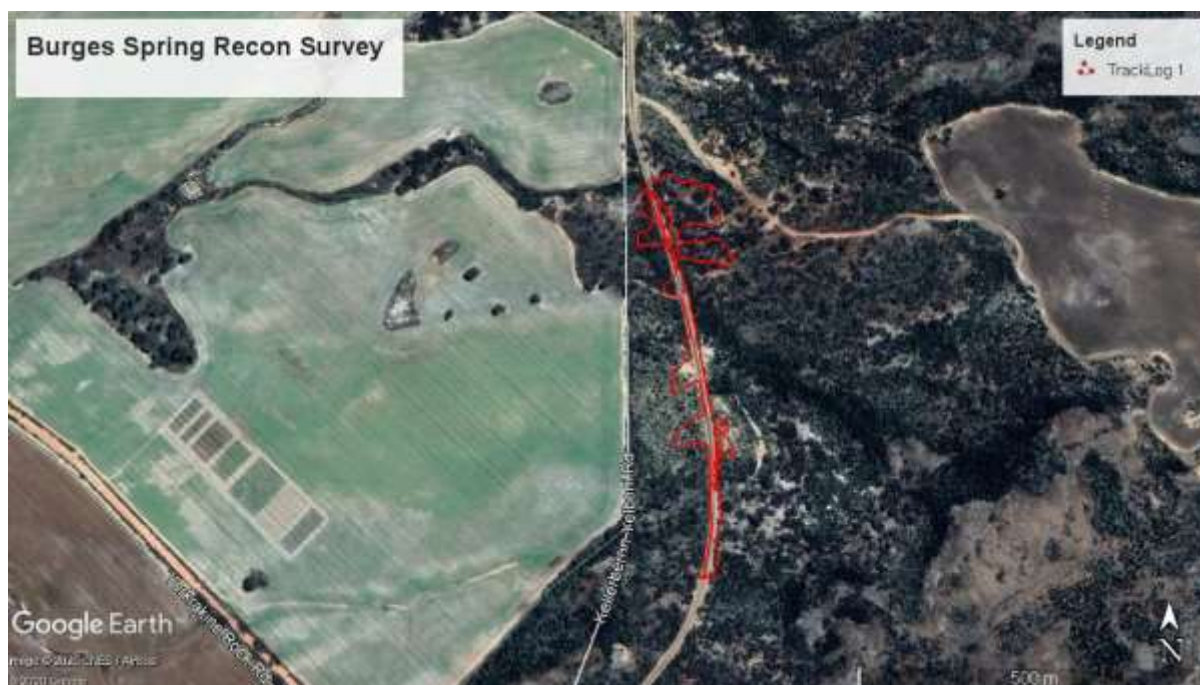
As this was initially a road side survey in support of a clearing permit application, vegetation immediately impacted by any proposed road work disturbance was a priority. The track log does not explore further into the Reserve than was necessary to report on the likely impact of proposed roadworks. All track logs chart the progress of two surveyors walking ten metres apart. Visibility was at least 10 metres and sometimes 50 metres in open country. Therefore, each track log is surveying a 20 metre strip as a minimum. Whilst the track log can be seen as following the road in some cases, this was often because the most diversity at the site was within those disturbed areas as a consequence of road maintenance activities. Species diversity declined the further from the road we surveyed and displayed a very common set of species.

The northern portion of the track log above was White Gum dominated on the east side and York Gum dominated mostly on the west side. The gully running through the northern section was very much dominated by *Melaleuca marginata*, a dense and spreading prickly shrub to 2 metres and impenetrable by foot. This species was very dominant on the slopes leading down to all the white sand valleys. Halfway, the vegetation shifted to a plateau of clayey sand over coffee rock clay and was dominated by *Allocasuarina campestris*, *Acacia neurophylla* and sedges. This was generally the case until it reached a breakaway, below which, occurred sandy clay valleys dominated again by *E. capillosa* and *A. acuminata*.

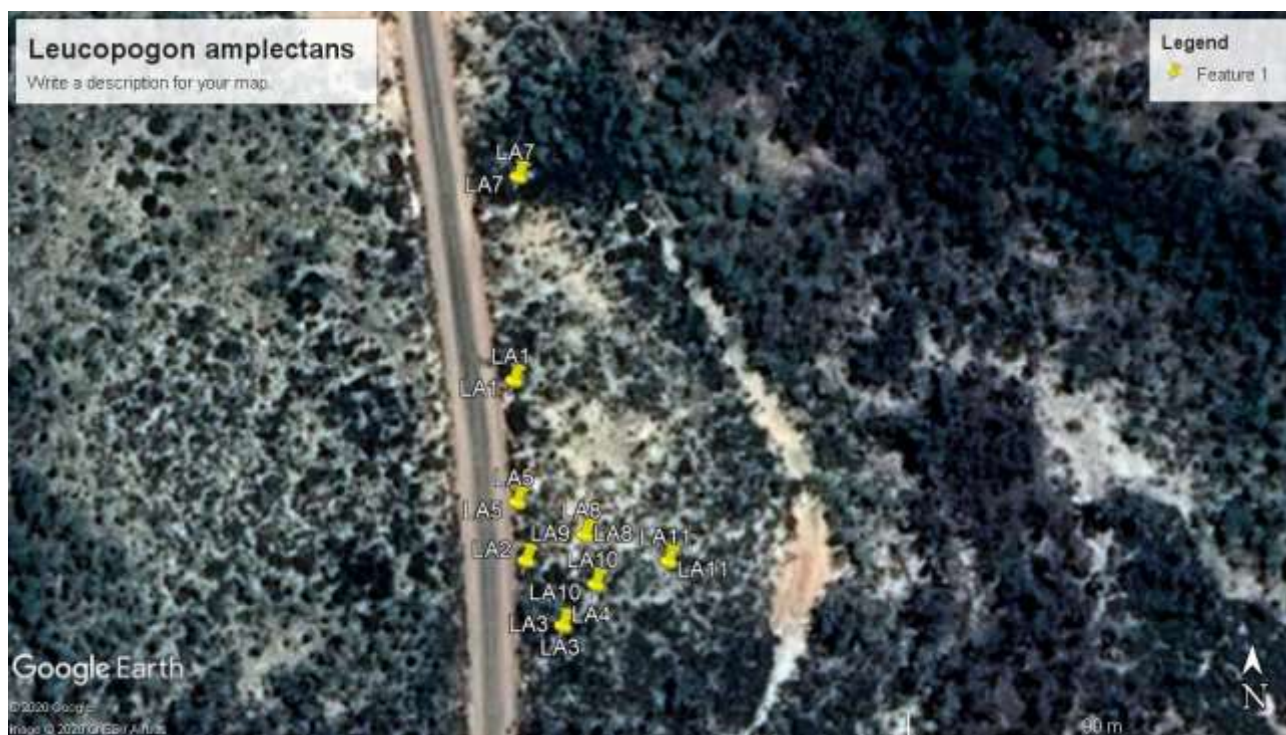
Leucopogon amplexans was found in a very small location on the east side of the road at SLK 12.22 or South 31.474620° and East 117.683625°. The occurrence extends 30 metres east from the edge of the constructed road reserve and 100 metres along a north south direction. Eleven plants were found within this area and three plants are vulnerable to disturbance during planned roadworks. The map below places each plant in relation to the road. Plants 1,2 and 5 occur within the current spoil lines from maintenance grading.

The balance of the plant occurrences are well outside any proposed disturbance from road construction.

The plants are found on specific soils; shallow, white sandy clay over coffee rock. This is open shrub land dominated by *Allocasuarina campestris* and various sedges. It is a small plateau which falls away on a breakaway to deeper sandy white soils, dominated by mature *Eucalyptus capillosa* with very little understorey or second storey.

Leucopogon amplexans occurs in a small area adjacent to the road on the east side, with 3 plants vulnerable to disturbance from proposed roadworks. *Acacia merrickiae* occurs in two distinct populations at either end of the reserve. The larger population to the north is mostly removed from the clearing footprint, with 2 plants vulnerable to disturbance.

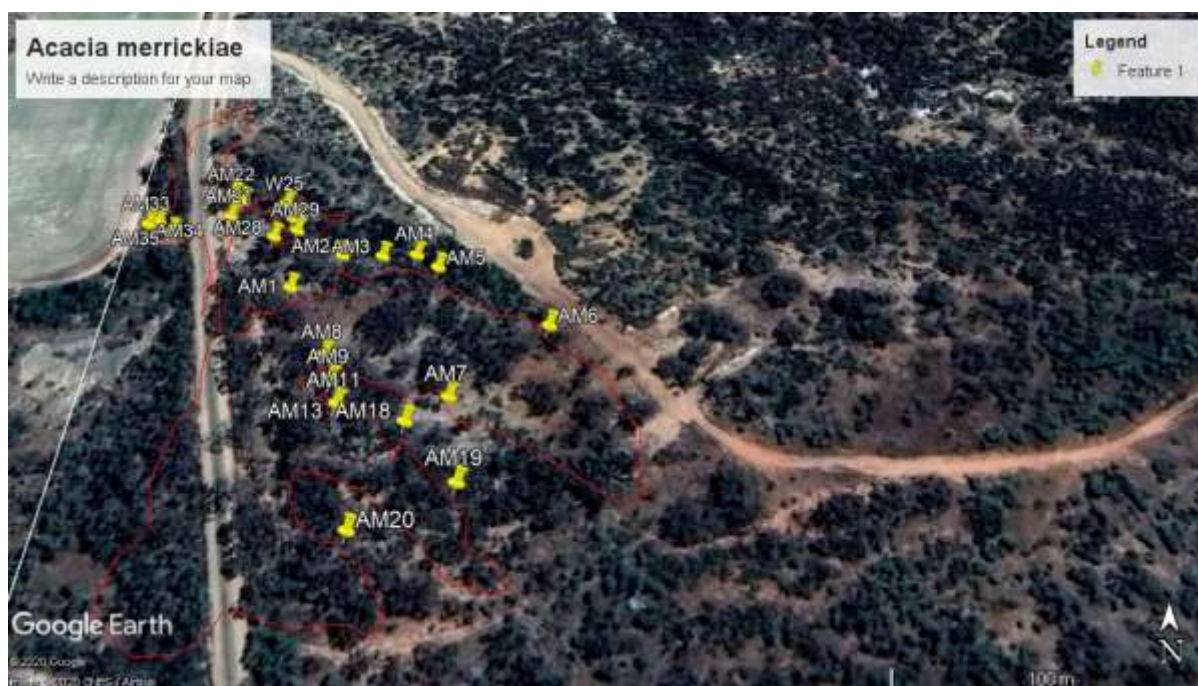
At SLK 12.56 or 31.474620s and 117.683625e, a population of *Acacia merrickiae* was found, consisting of 35 individual plants spread over an area 200 metres square. Apart from 33,34 and 35 on the following map, all plants were on the eastern side of the road.

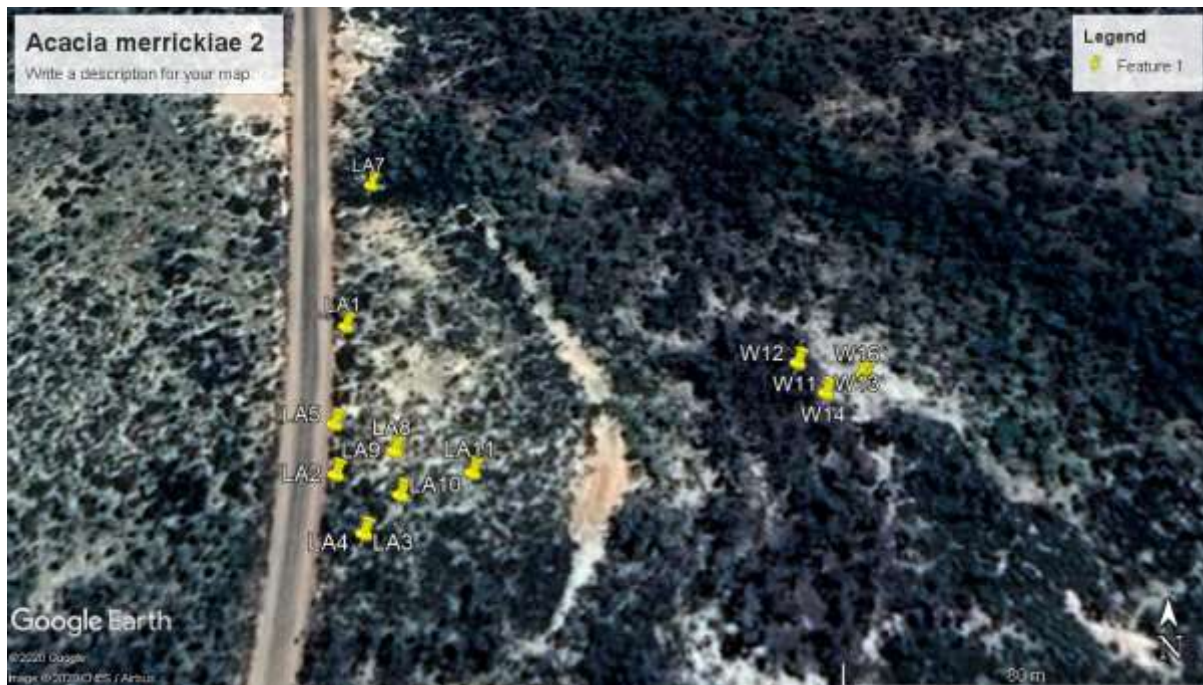
A further population was discovered 130 metres east of the Leucopogon population, below a breakaway and in exactly the same vegetation type as detailed for the larger population to the north. The map below shows the position of this occurrence of 6 plants (W11-W16).

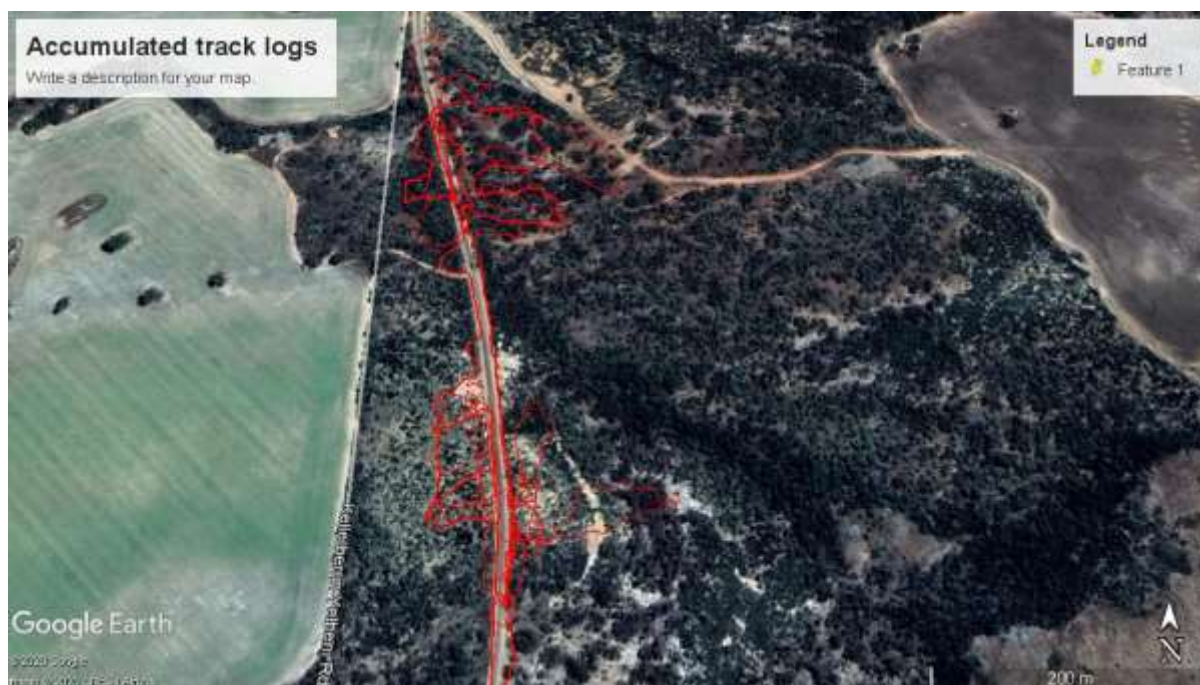
The Reserve was searched extensively, especially because of the existence of these plants and the map below shows the accumulated track logs from both survey visits. The third Priority species which is noted to occur in the vicinity of the reserve, *Guichenotia seorsifolia*, was not found during our surveys.

The verges at Burges Spring are on the whole free of introduced weeds, apart from the creekline at the north end of the Reserve, on the western side where it abuts granite. Everywhere else is in a very healthy state. The area between the Leucopogon occurrence and the smaller Acacia occurrence has had a disturbance where an historical attempt to drain water has been made. This has not, however encouraged weeds and has generally settled down without further erosion, but still free of any vegetation. The scar can be seen on the last photo.
