**Environmental Survey**  
**Proposed Road Widening, William Road Mount Helena**  
**May 2025**

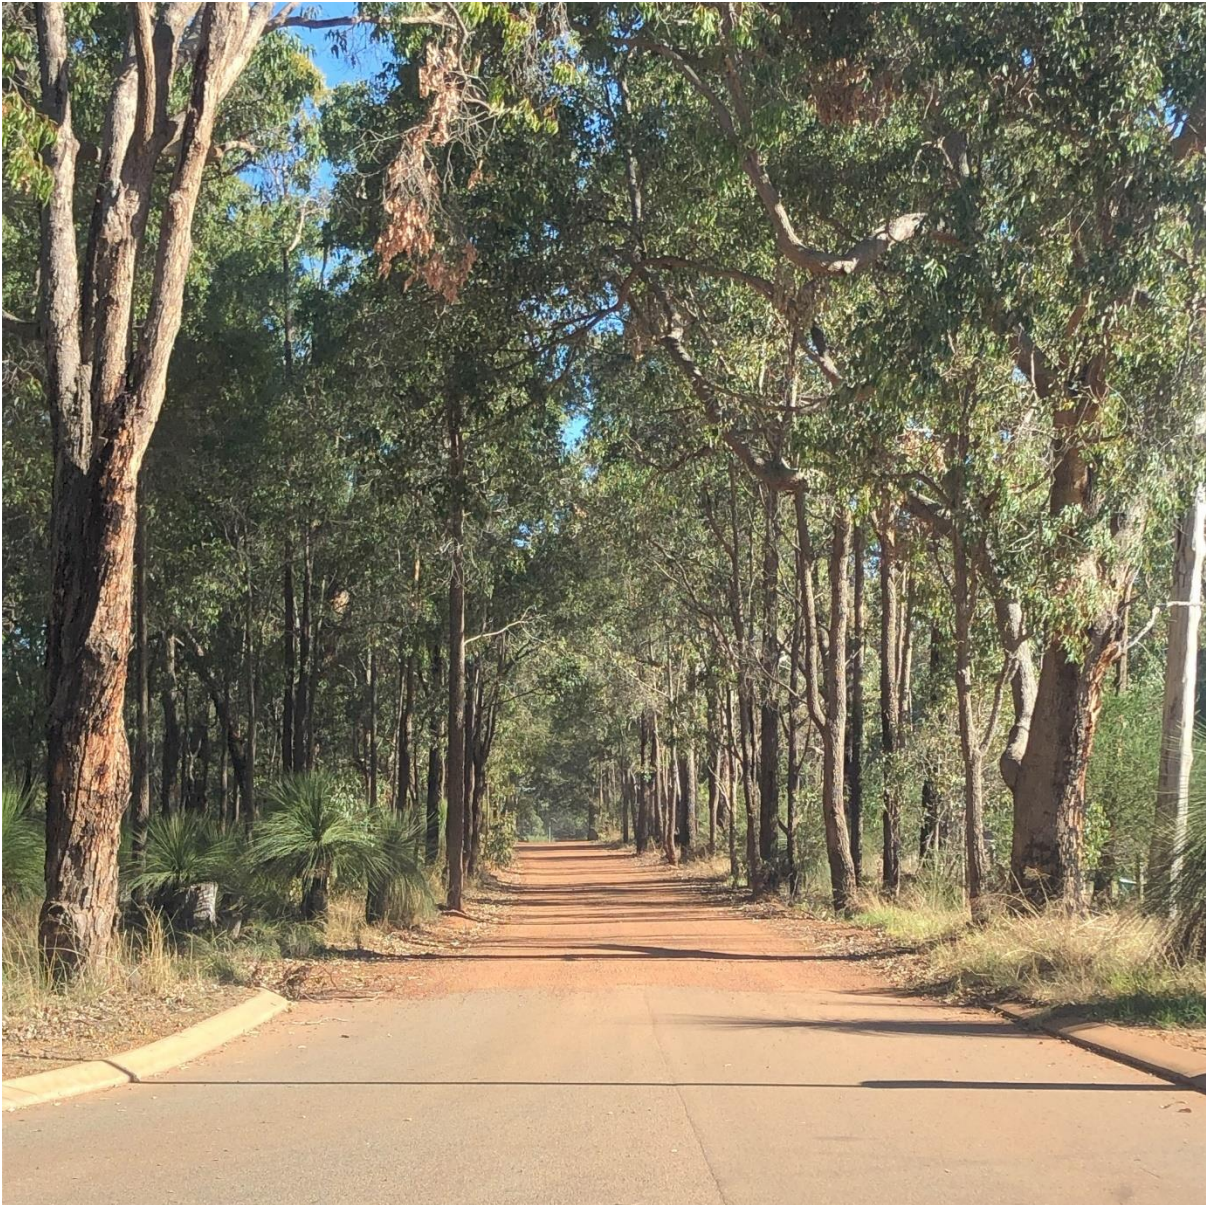
**Photo 1:** View of William Rd looking in a northwestern direction. It is proposed to seal the gravel road. The proposed alignment impacts vegetation along the southern side of Williams Road and looks to minimise tree removal and avoid significant / habitat trees (as those that can be seen in the photo on either side of the road). As part of the works it is recommend that there are tree protection zones (TPZ) or physical barriers placed around significant trees to ensure they are protected during the construction phase.

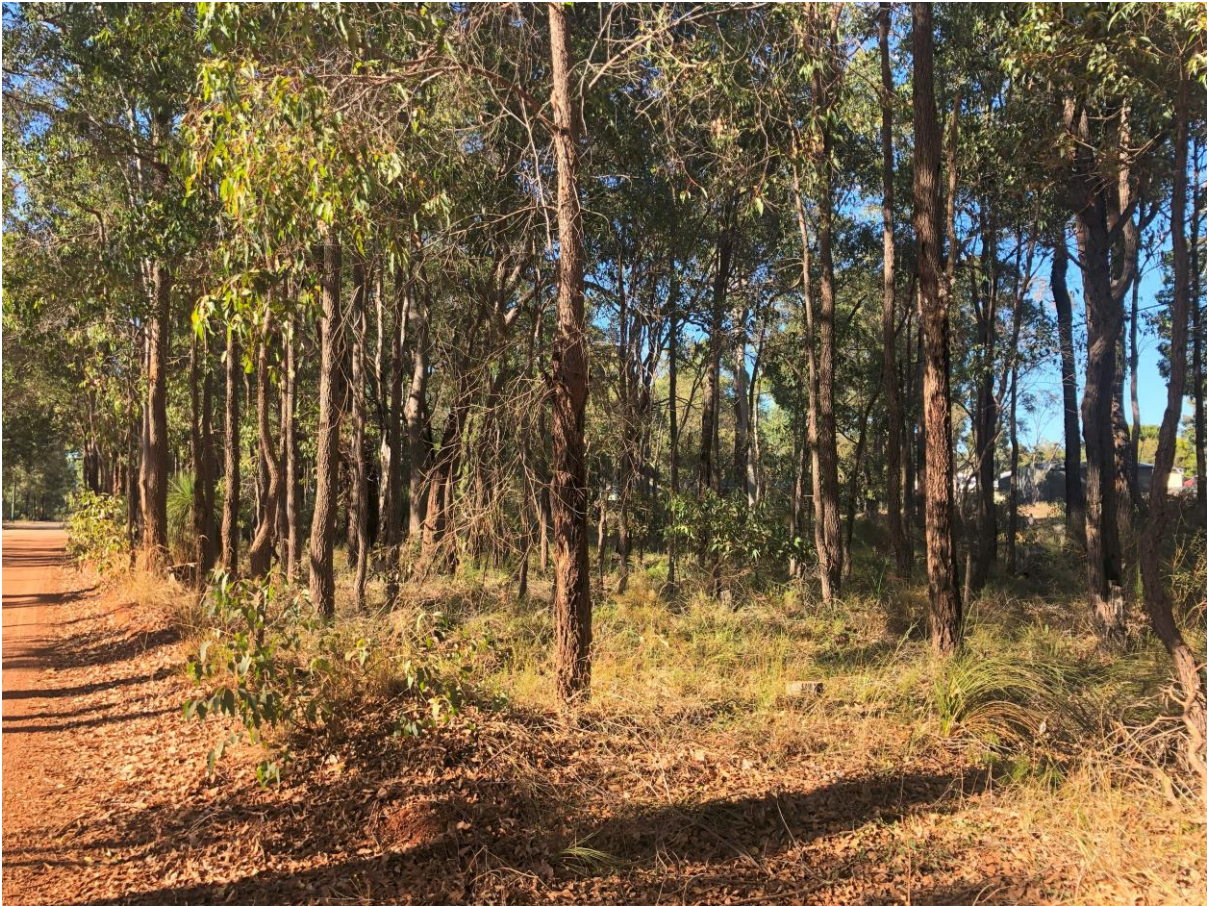
**Photo 2:** Clearing proposed on the southern side of the road verge. Vegetation along both sides of William Road is a mix *Eucalyptus marginata* (Jarrah) and *Corymbia calophylla* (Marri), *Xanthorrhoea* (grass trees) in the midstory and diverse native understory.

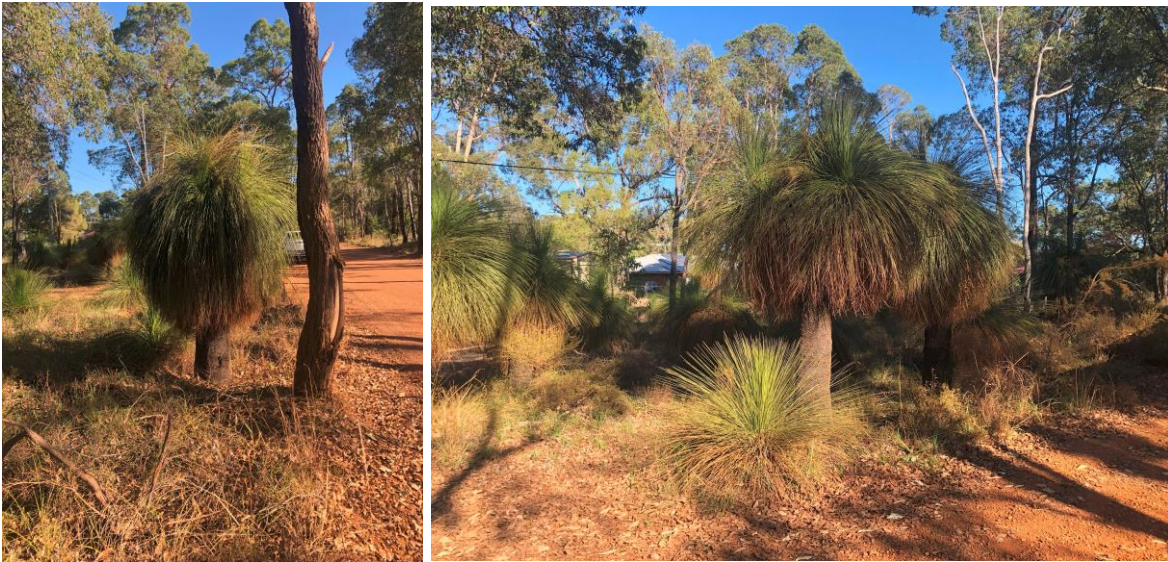
**Photo 3 (above left):** Grass tree that will be impacted by the proposed works.

**Photo 4 (above right):** Cluster of grass trees that can all be retained with the alignment of the works.

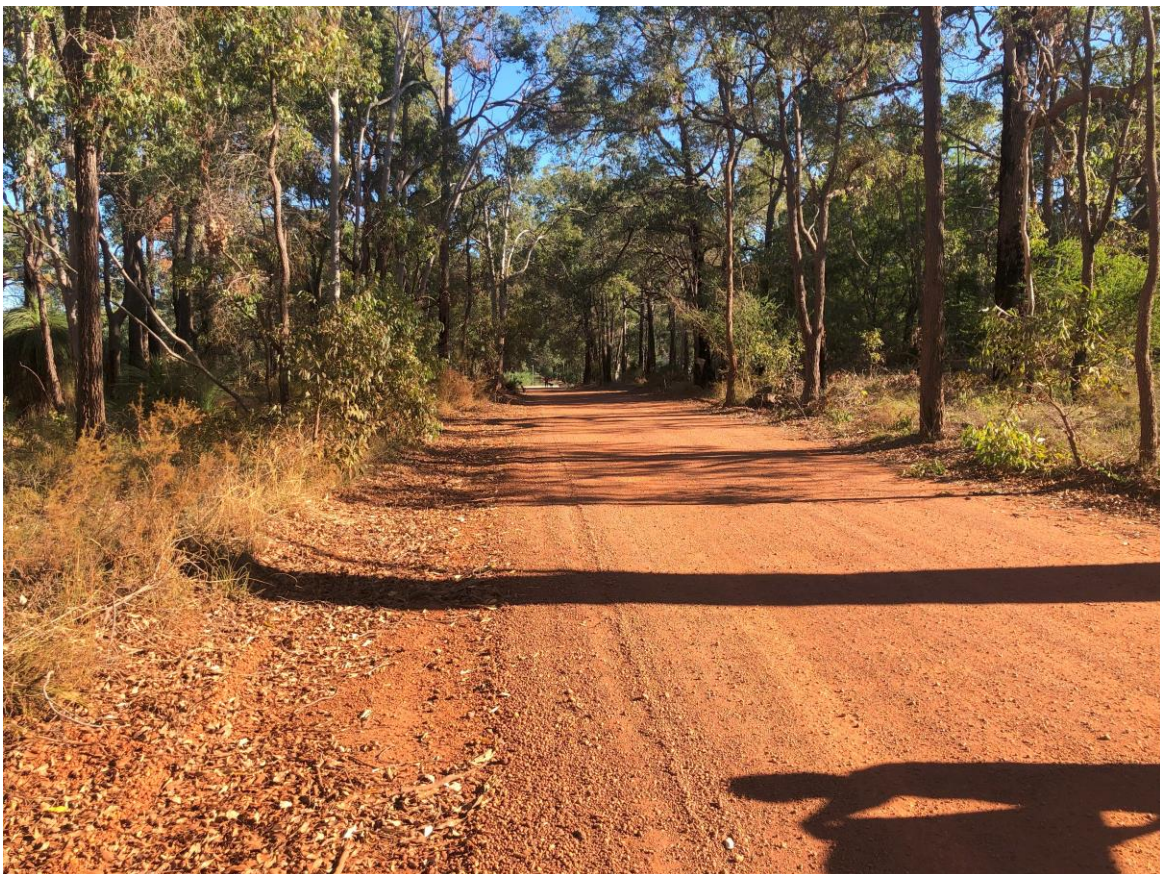
**Photo 5:** William Road widens heading towards Bunning Road on the southern side, with no clearing proposed in this section and minimal clearing as the road advances further to the west (as seen in the photos below).

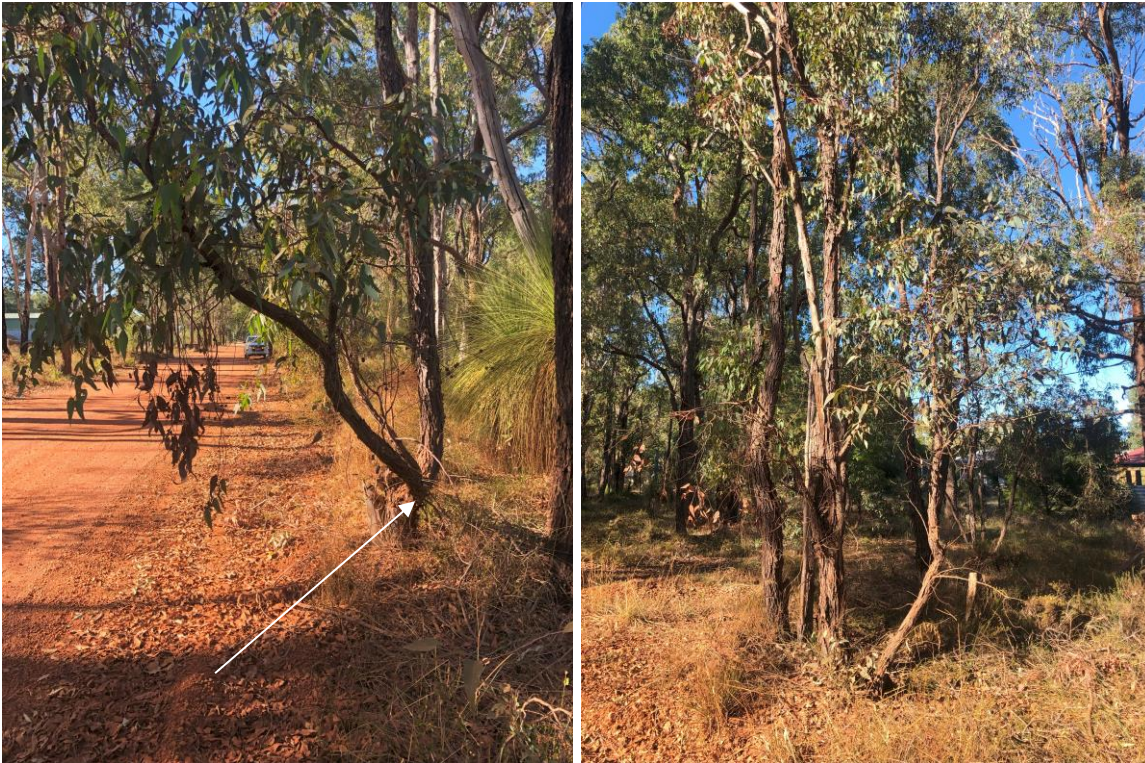
**Photo 6 (above left):** Minimal clearing proposed with the alignment impacting the small, coppiced Jarrah, weedy understorey and some native ground covers species.

**Photo 7 (above right):** Removal of several small dead trees proposed (DBH under 10cm).

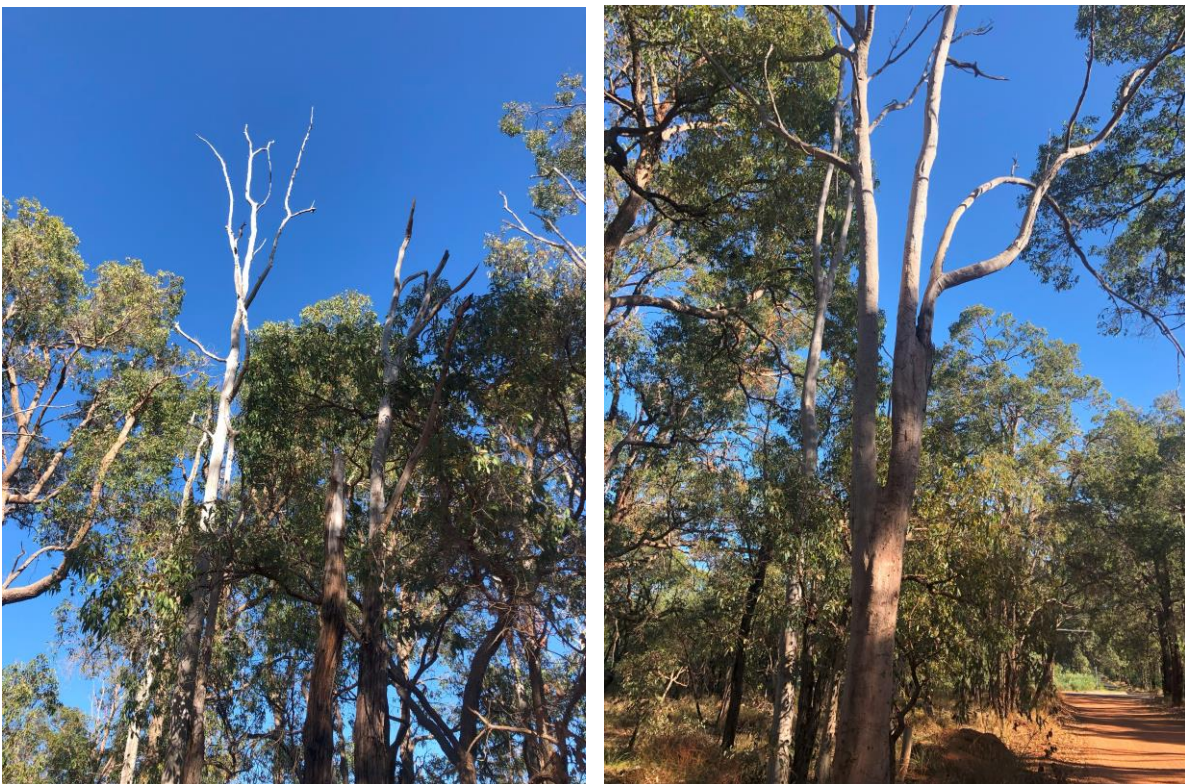
**Photo 8 and 9:** Several trees in decline or senescent will be removed for the road widening.

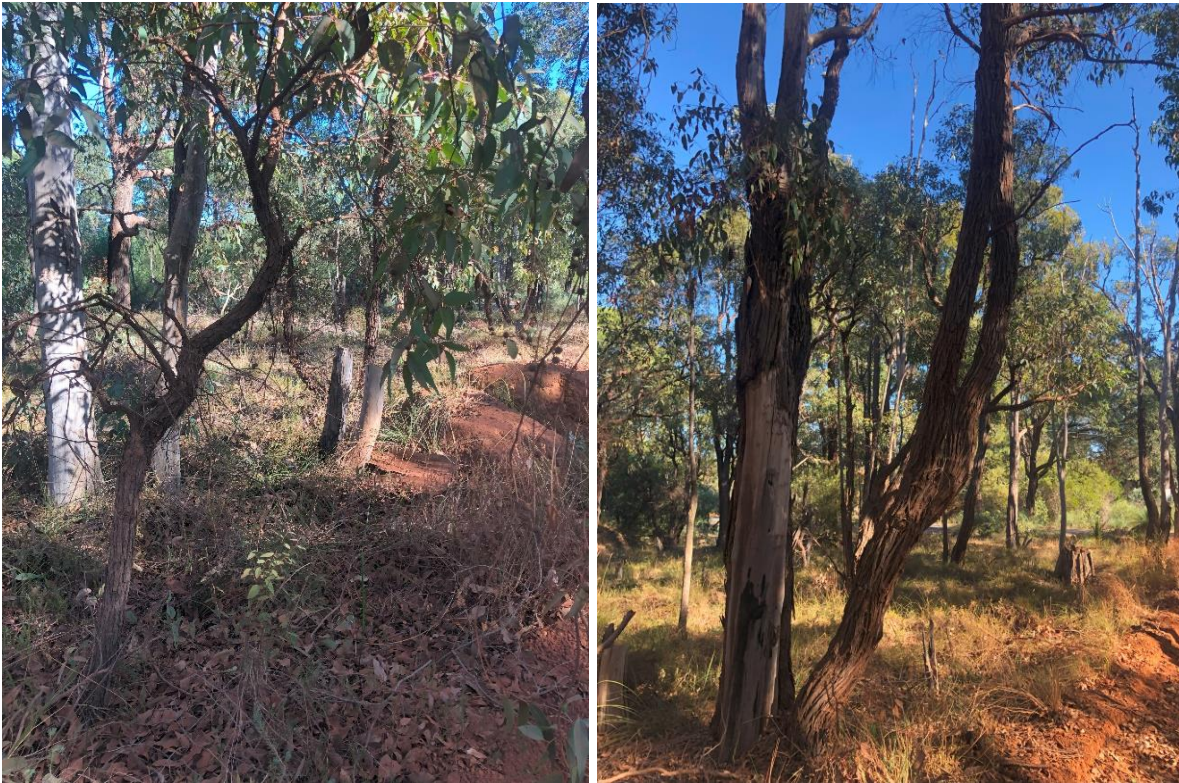
**Photo 10:** Another view of the trees that are in decline. Several tree deaths on the southern side of the road near the intersection of Bunning Road. Most of the vegetation is degraded in poor health, with evidence of borers in the trees. **Dieback may be present.** Recommend hygiene measures are put into place for the proposed works to ensure no spread of disease.

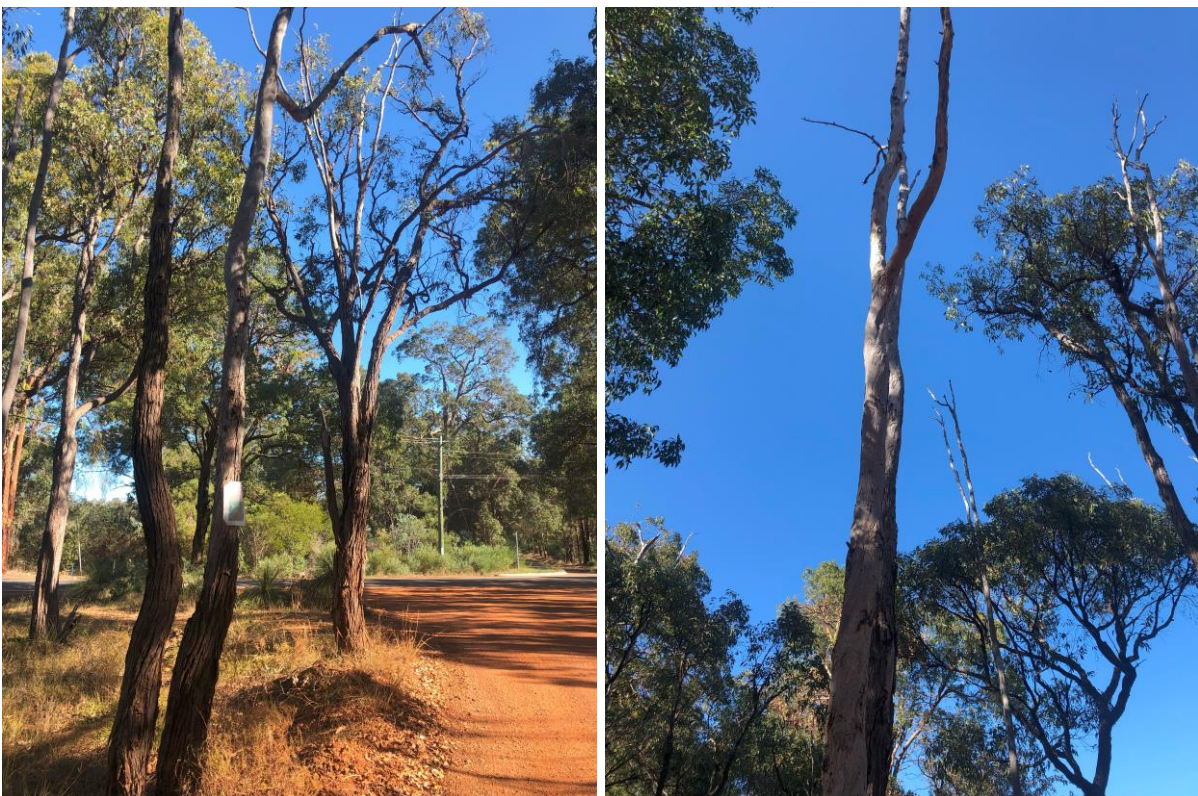
**Photo 11:** Another view of the dead trees. No hollows present.

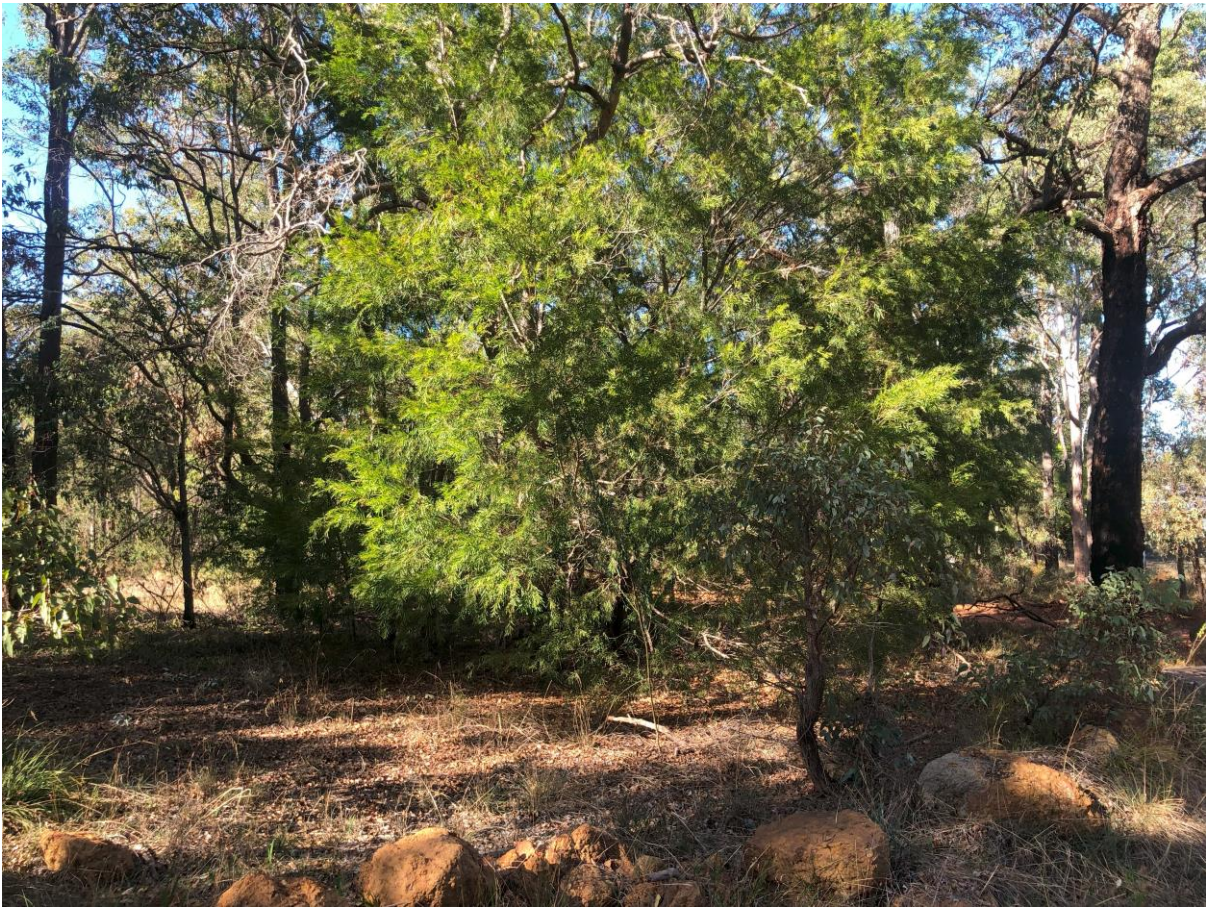
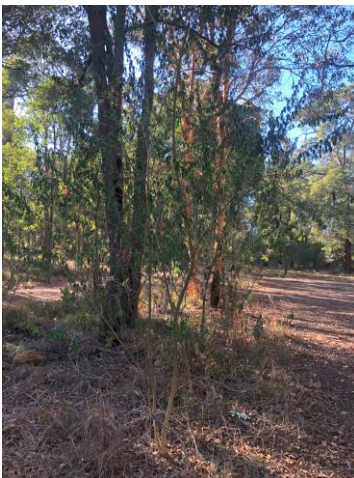
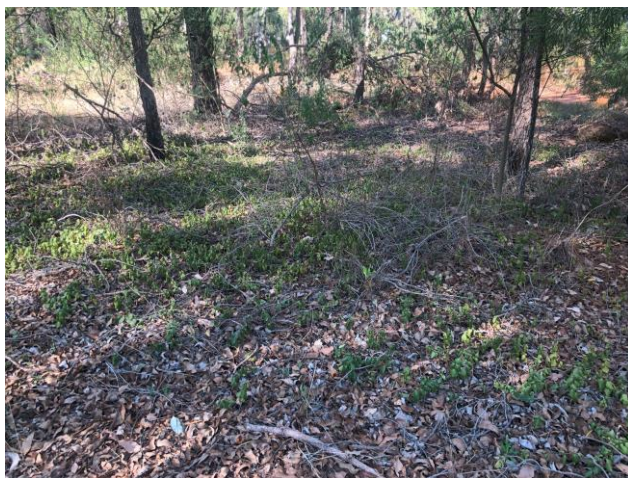
### Location 1

**Reserve 52098:** Small reserve that is weedy, which can be seen in the photos above and below. Weeds include eastern states wattles, tagasaste and periwinkle. Two mapped habitat trees in this location, that were identified as part of a subdivision application.

The location is surrounded by road reserve to the north (Alfred Street) and William Road to the south. Future development in the vicinity may impact offsets.

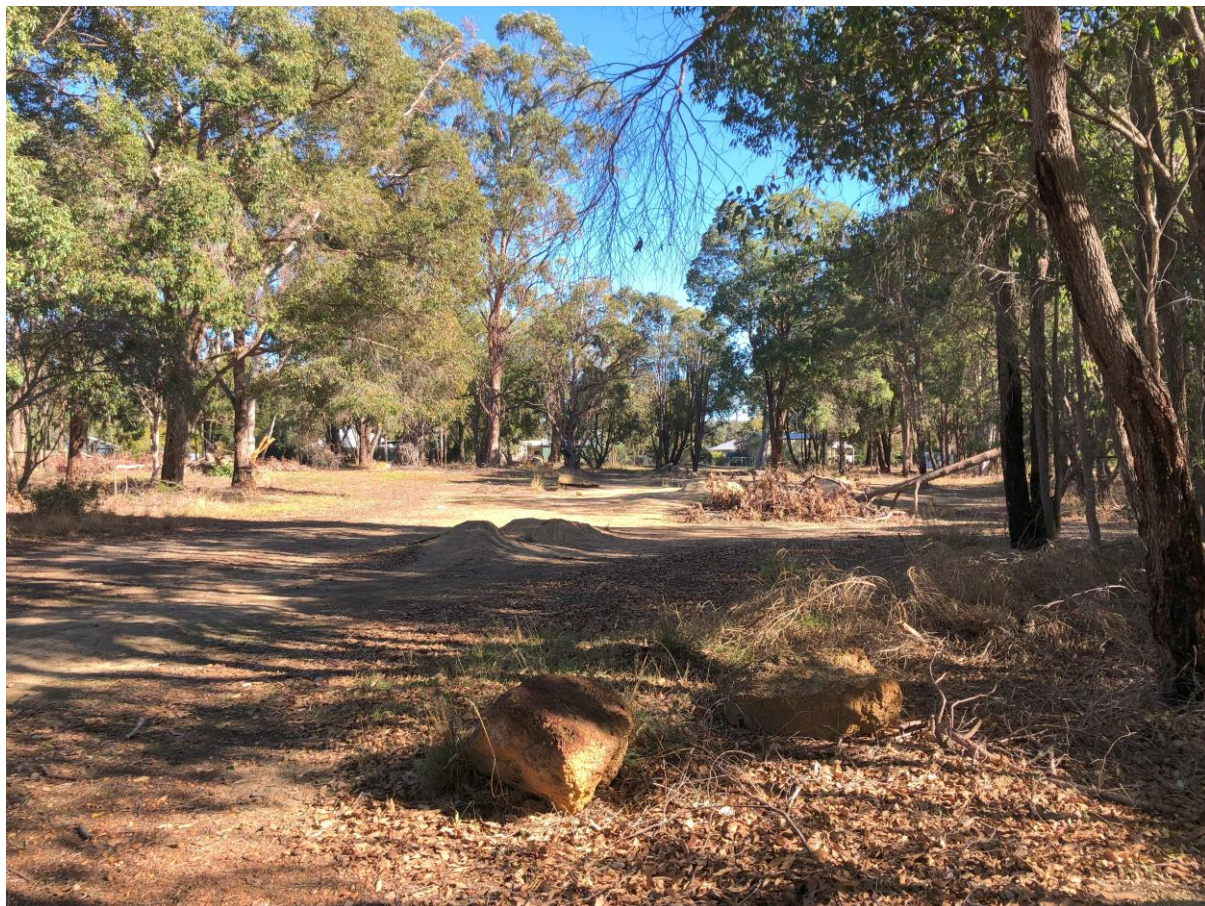
## Location 2

**Reserve 45869:** This location is degraded and would benefit from offsetting loss of vegetation from the proposed works on William Road.
