## Supporting information

### 195 Vase Yallingup Siding Road

## Trees to be removed

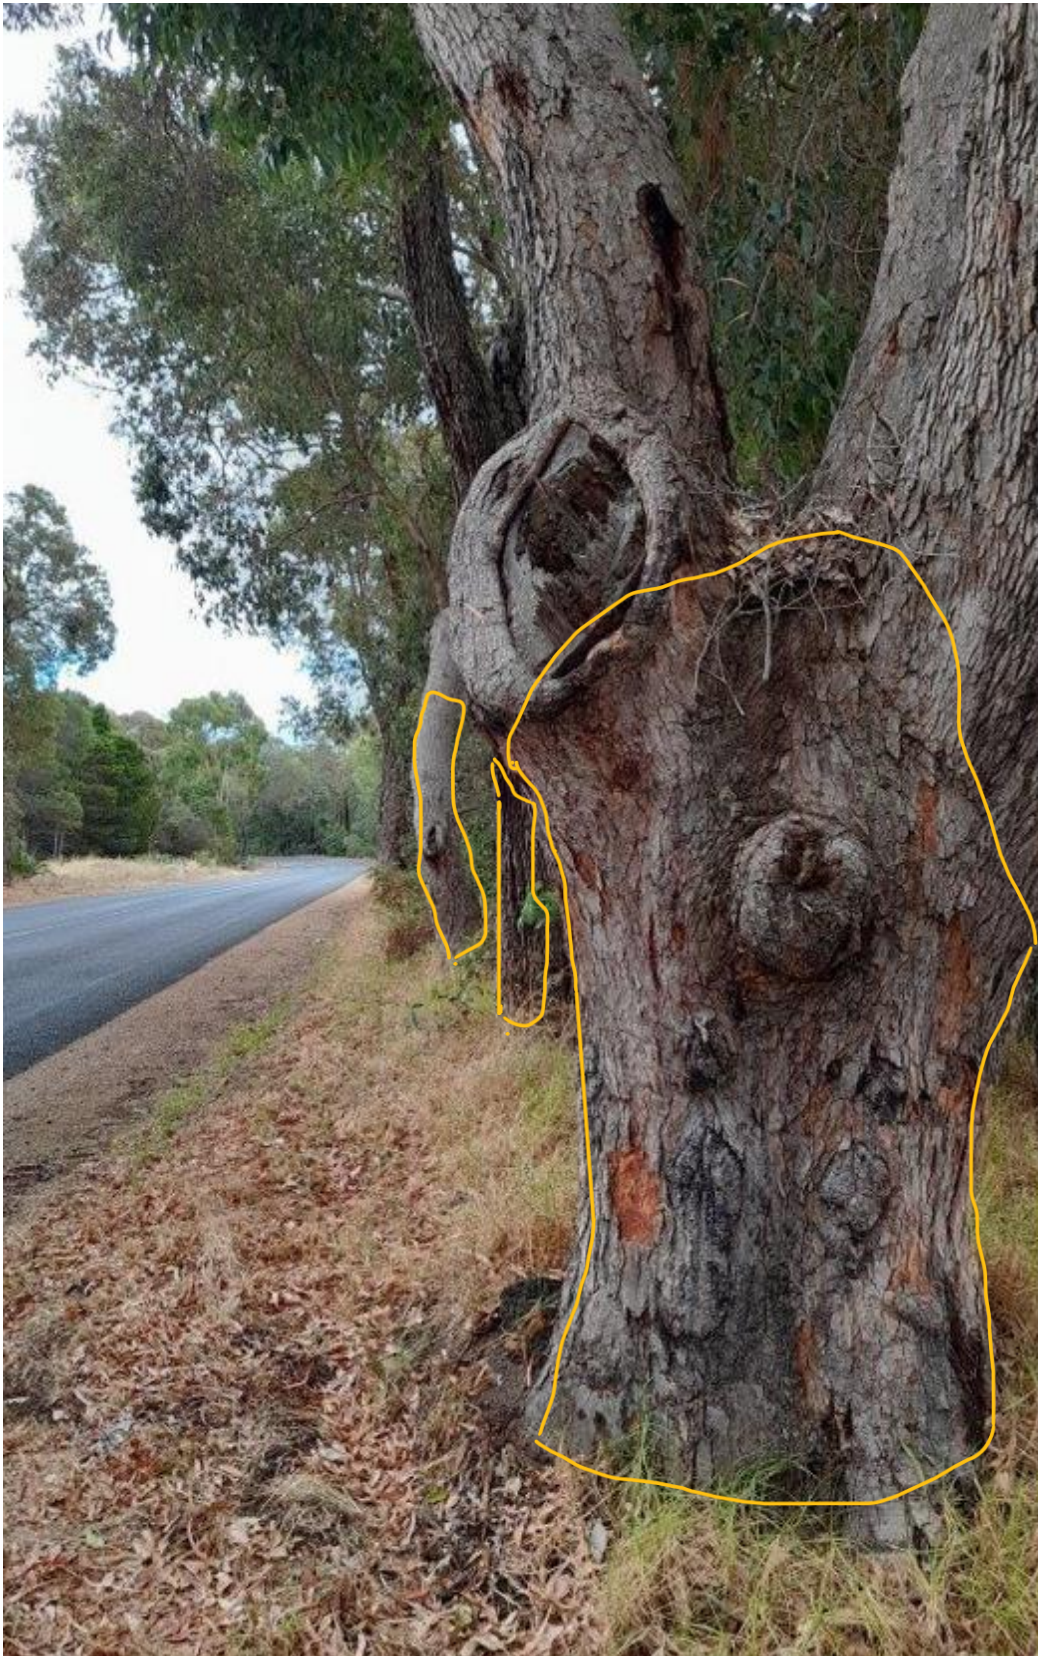
This photo is taken from a position closer to the road (than a person in a vehicle, or tractor would be when trying to enter the road) to show all 3 trees proposed to be removed.

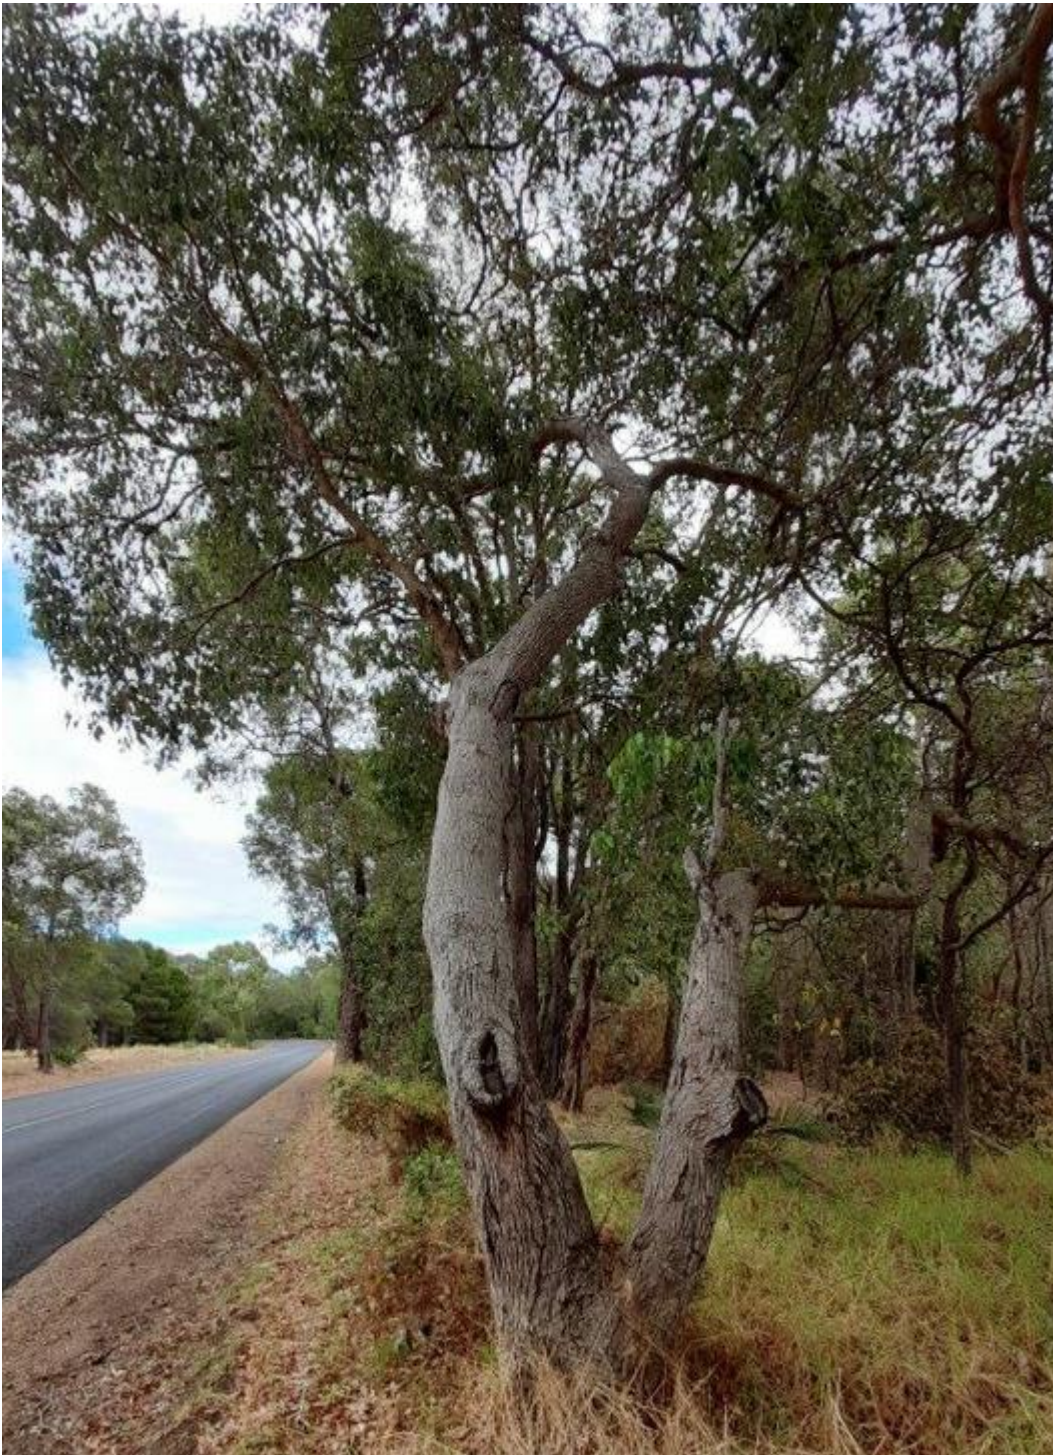
3. This is the third tree. The photo shows the entire tree. The trunk on the right side could be retained. DBH of left trunk ~450mm. The upper branches are too small to support Black Cockatoo nesting hollows.

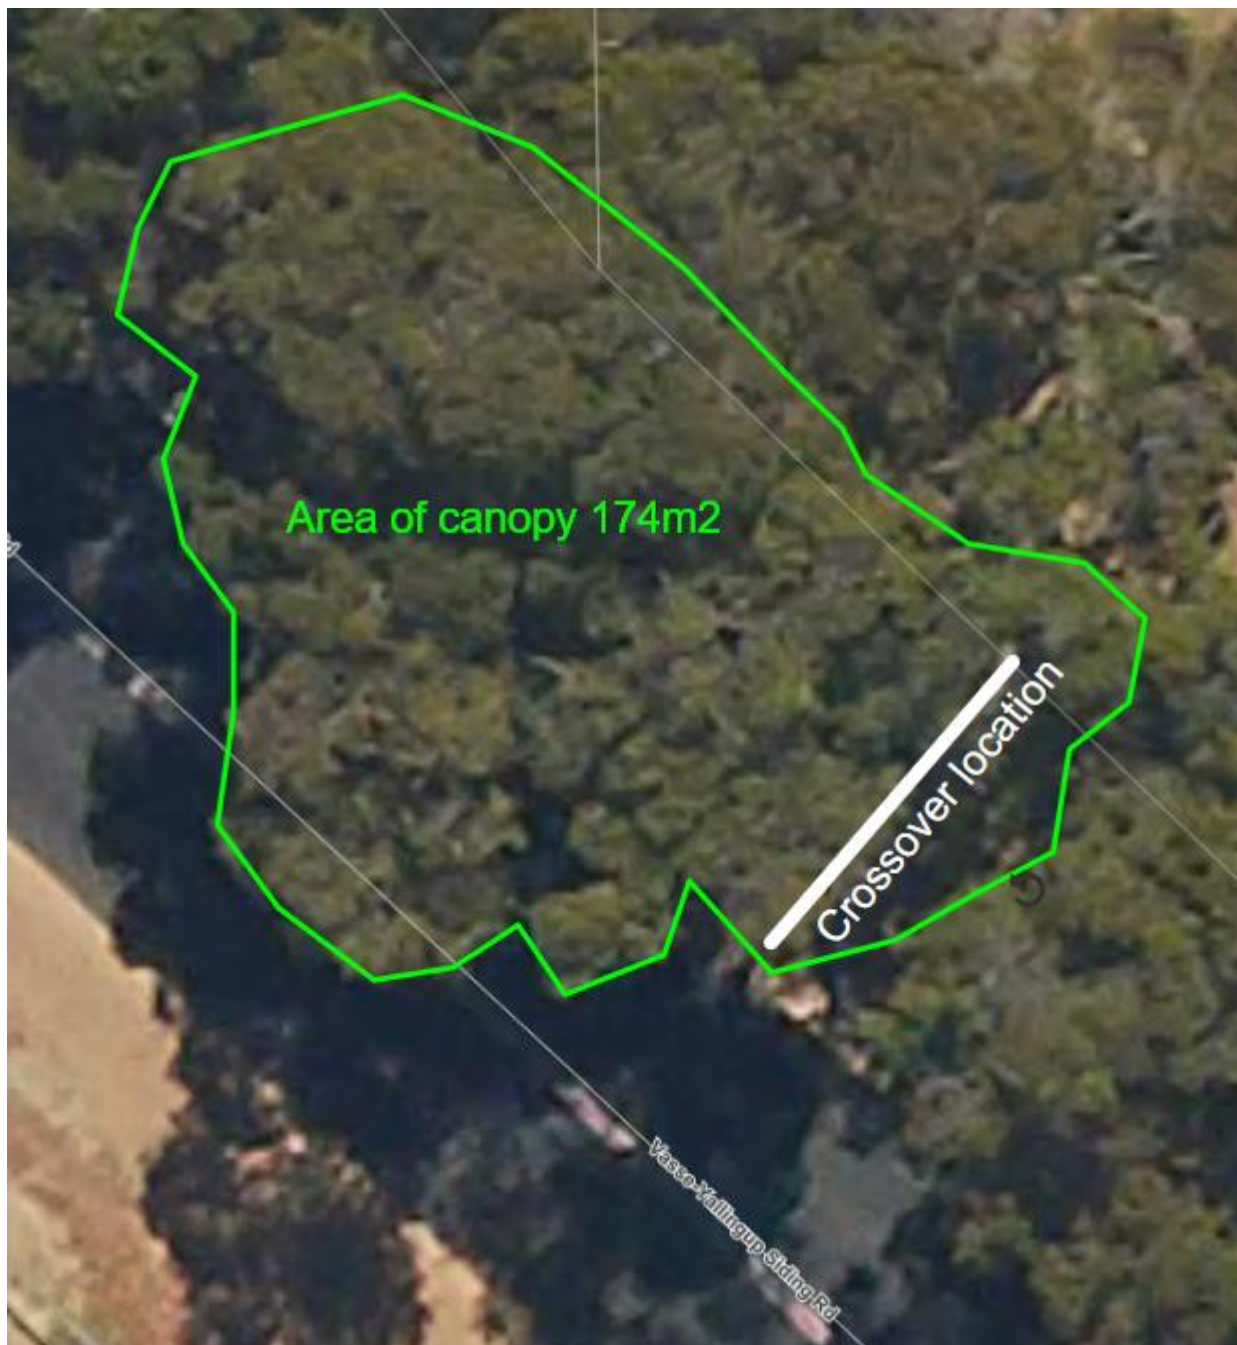
This is an approximation based on aerial photographs. Much of the canopy to be removed is underneath larger trees in the photo below.
