# Flora and Vegetation Assessment Acker Quarry Mining Lease MCI 70/2

Prepared for Acker Proprietary Limited

Acker Pty Ltd (Acker) proposes to clear 0.35 ha of highly degraded vegetation in Mining Lease MCI 70/2, adjacent to their existing quarry, for the purposes of limestone extraction.

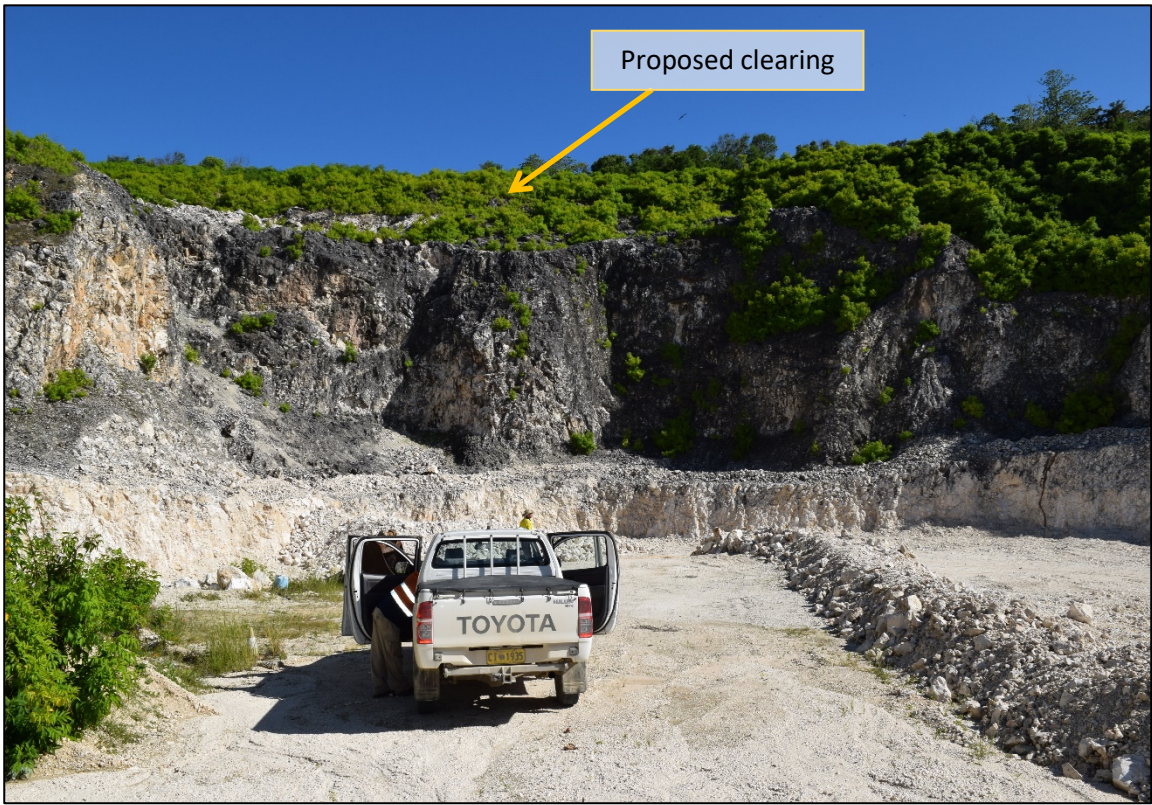
Figure 3. Photo of Quarry looking south towards proposed clearing area

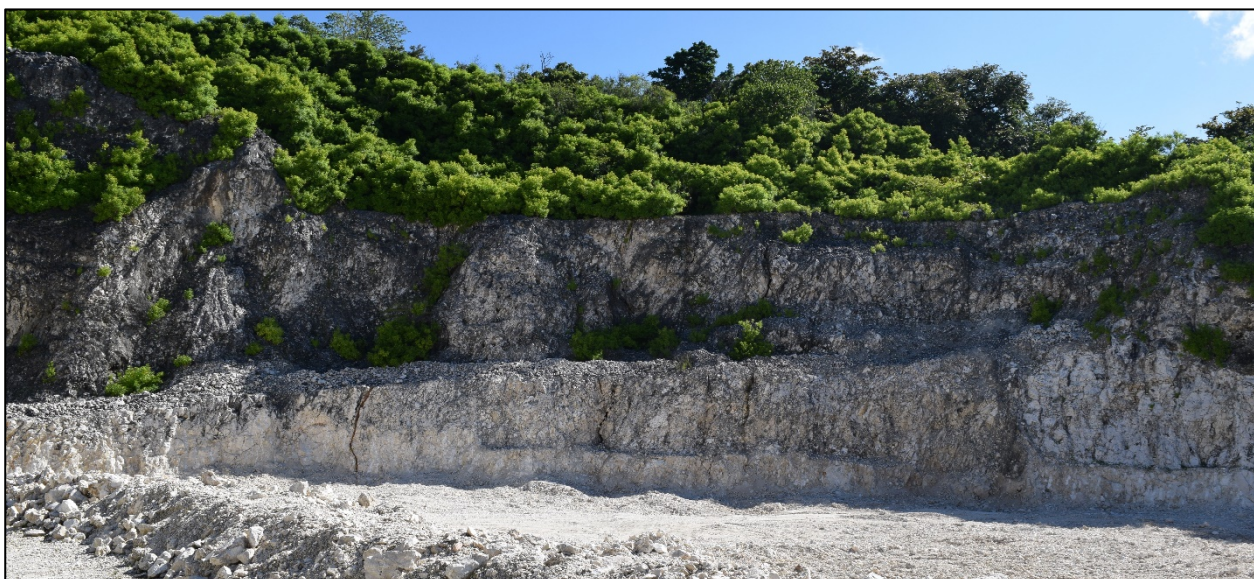
Figure 6. Existing quarry

In the application area, limestone is present close to the soil surface as evidenced in the quarry walls (Figure 6).

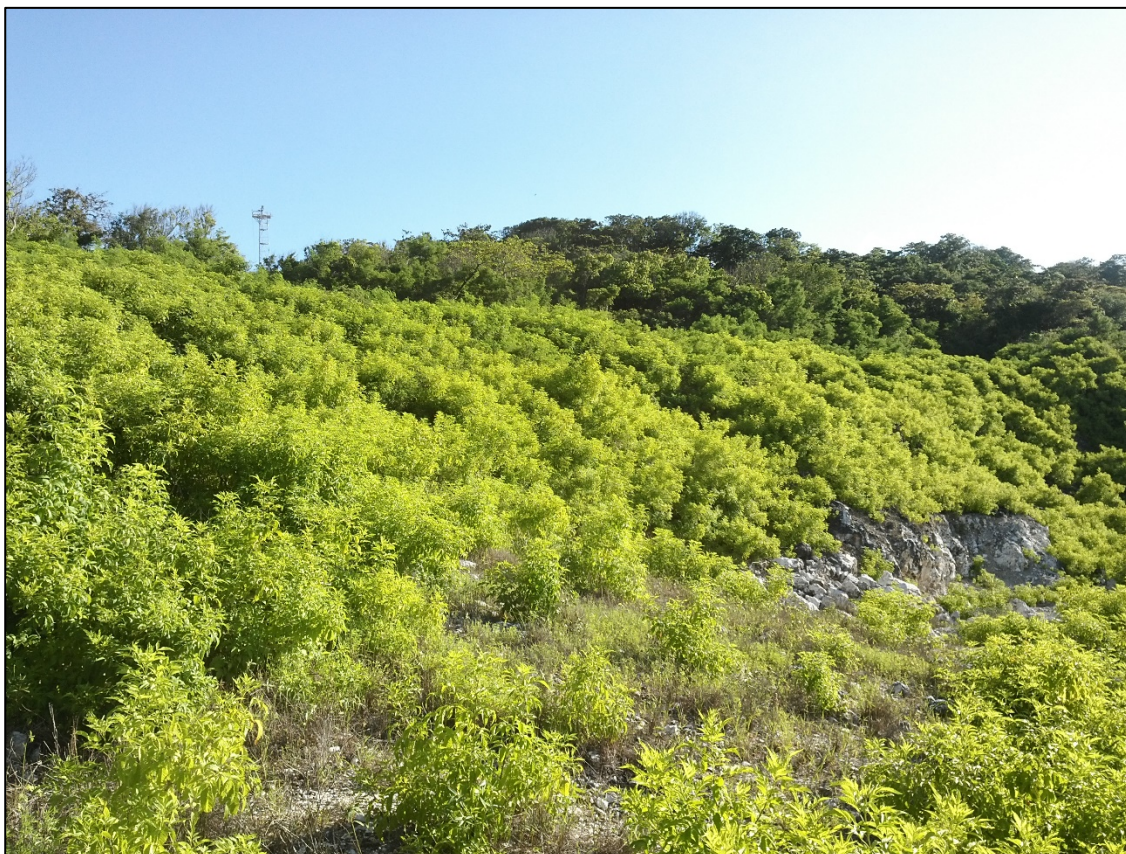
Plate 5. Exotic Thicket/shrubland 2-4 m

| Vegetation Type | Environment | Condition |
|---|---|---|
| <b>4. Exotic thicket/ shrubland 2-4m (Plate 5)</b><br>Dominated by <i>Tecoma stans</i> var. <i>stans</i> . | Gentle limestone terrace 80% rock. | Completely Degraded |

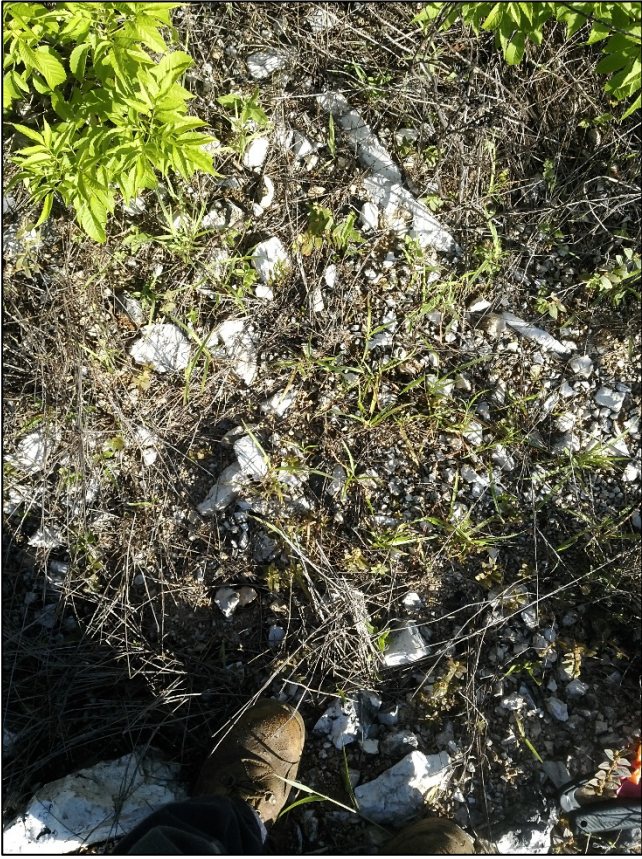
Plate 6. Exotic Grasses and Herbs

| Vegetation Type | Environment | Condition |
|---|---|---|
| <b>5. Exotic grasses and herbs (Plate 6)</b><br><i>Sporobolus fertilis</i> , <i>Ipomoea hederifolia</i> , <i>Melinis repens</i> , <i>Tridax procumbens</i> , <i>Sida acuta</i> , <i>Euphorbia heterophylla</i> , <i>Mimosa pudica</i> and <i>Mimosa invisa</i> . | Bare rock and low weeds. | Completely Degraded |
