TURNER RIVER SOLAR HUB SOIL AND LANDFORM ASSESSMENT

Fortescue Limited
December 2024

Project Number: 2211.24b

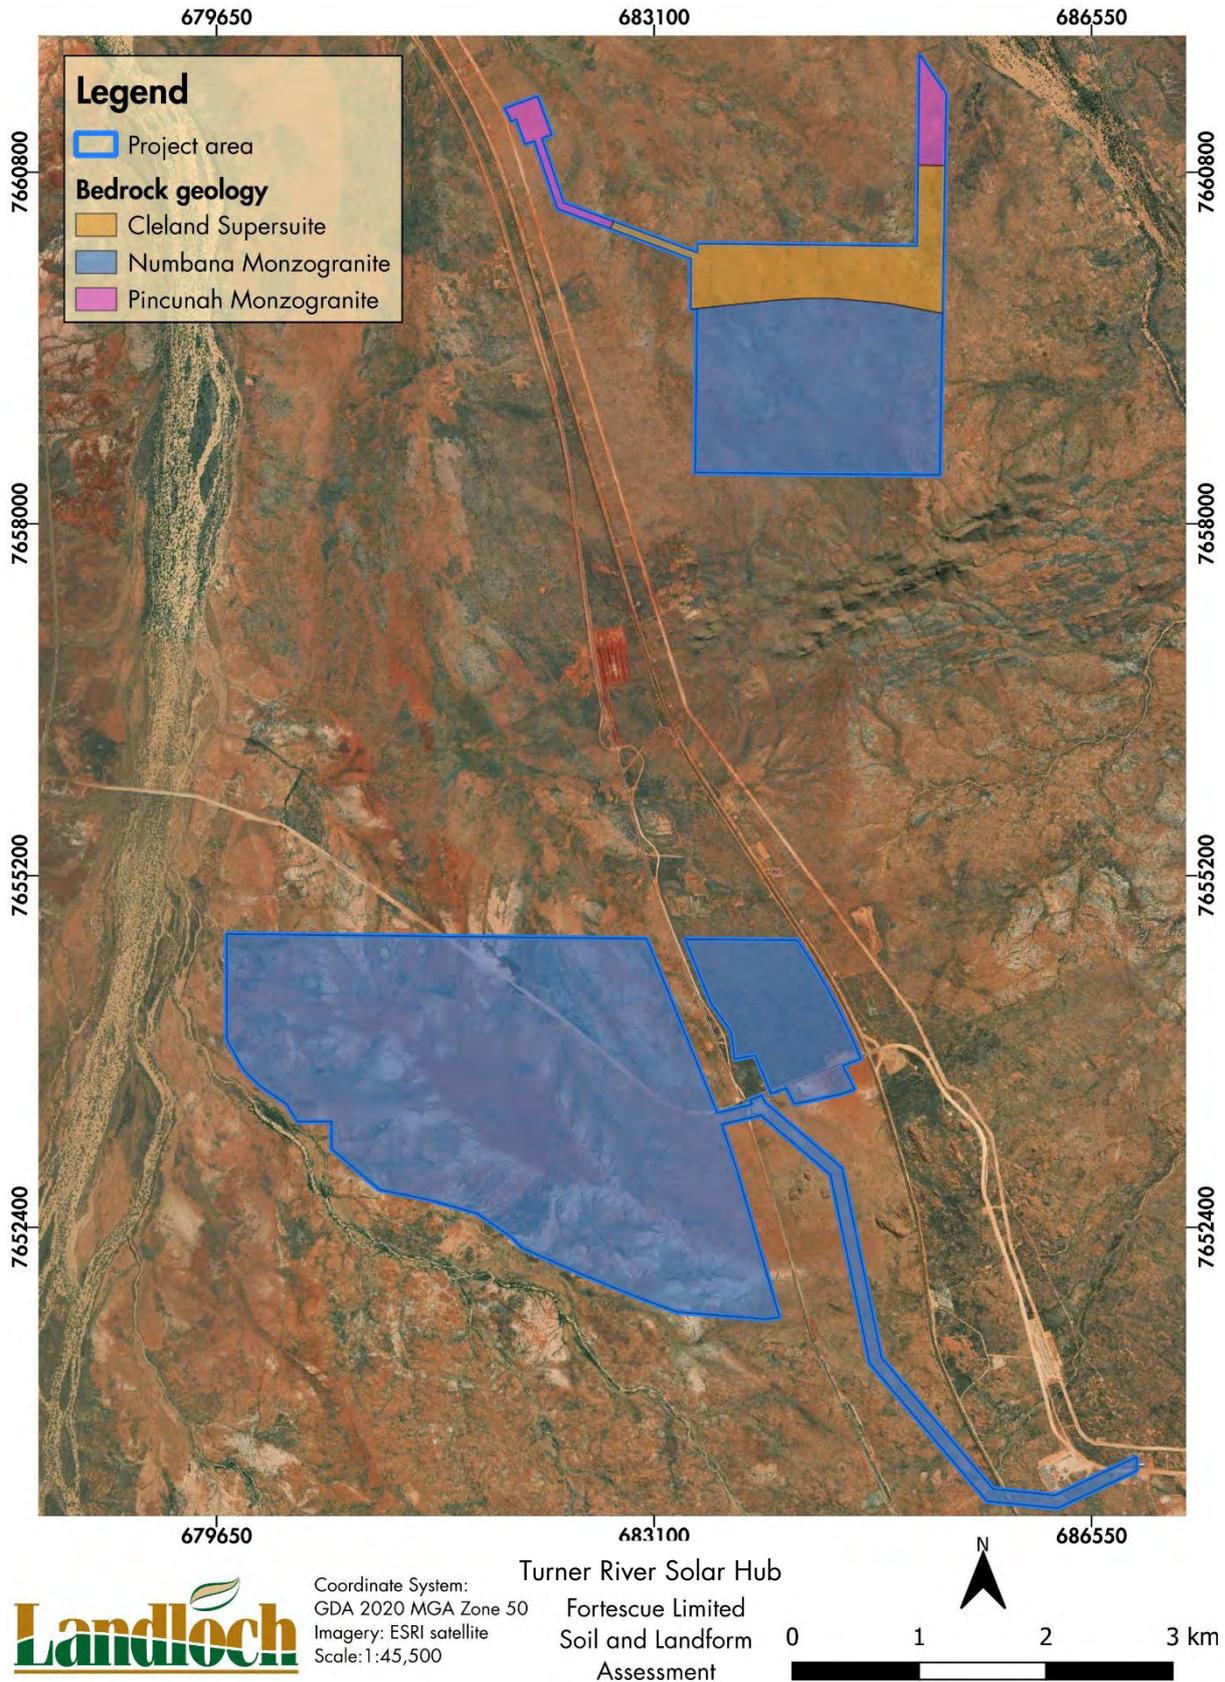
Figure 3: Bedrock geology of the Project area (Geoscience Australia 2024).

The Split Rock Supersuite is present over a majority of the Project area (90%) and is comprised of the Numbana Mozogranite formation. The Cleland Supersuite is present in the northern extent of the Project, comprising a minor proportion of the project area (8%). Although no specific formation is noted, the lithology is comprised of Monzogranites. The Sisters Supersuite accounts for 2% of the Project area, and is comprised of the Pincunah Monzogranite formation.

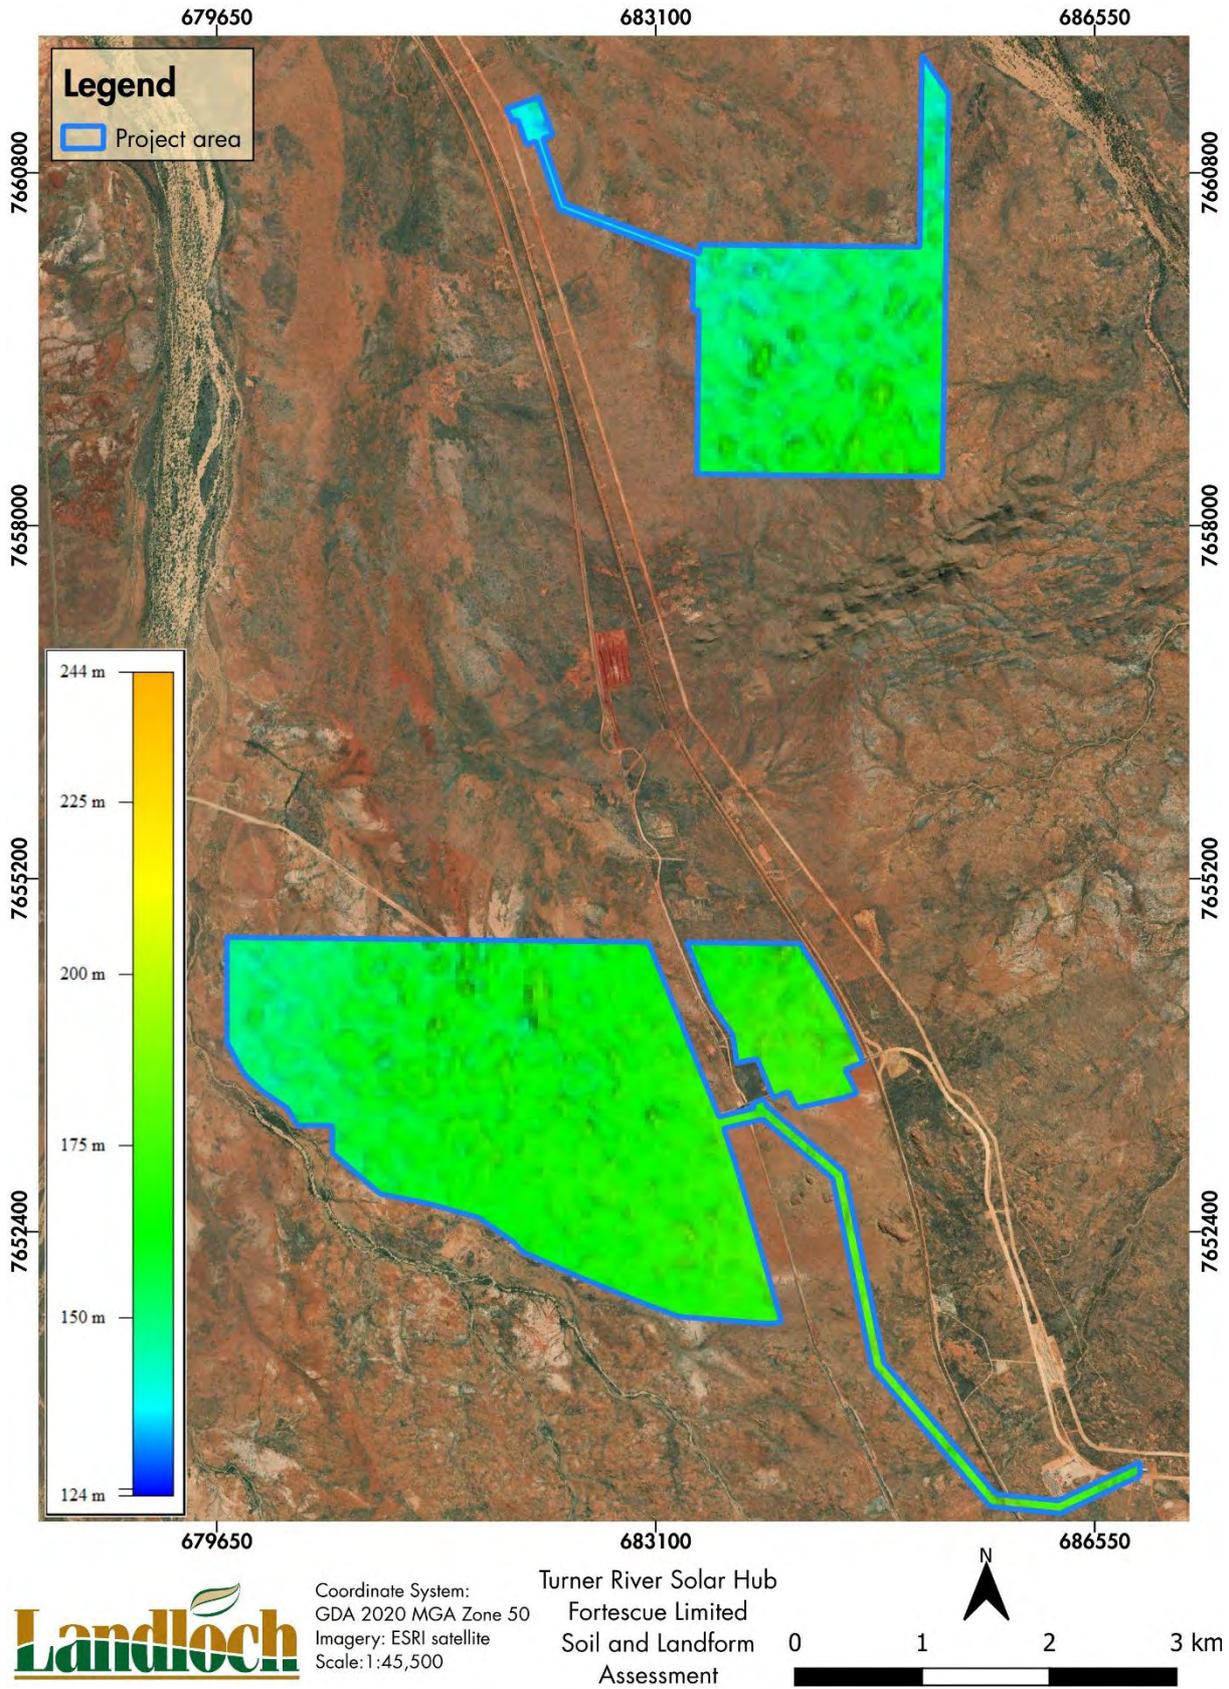
Figure 5: Digital elevation model of the Project area (Source: Fortescue).

Contour data provided by Fortescue at a 0.5m resolution was combined with DEM data sourced from the publicly available NASA DEM elevation dataset (1-arc-second resolution) and is illustrated in Figure 5. The southern section has low relief and very gently-sloping land gradients, with land sloping downwards from south-east to north-west (Figure 6) at an average gradient of $<1^\circ$. The northern section has similar characteristics, sloping from south-east to north-west at an average gradient of $<1^\circ$, and is located slightly lower in the landscape. The highest elevation in the landscape is 196m in the south-east, and lowest elevation is 154m in the north-west.

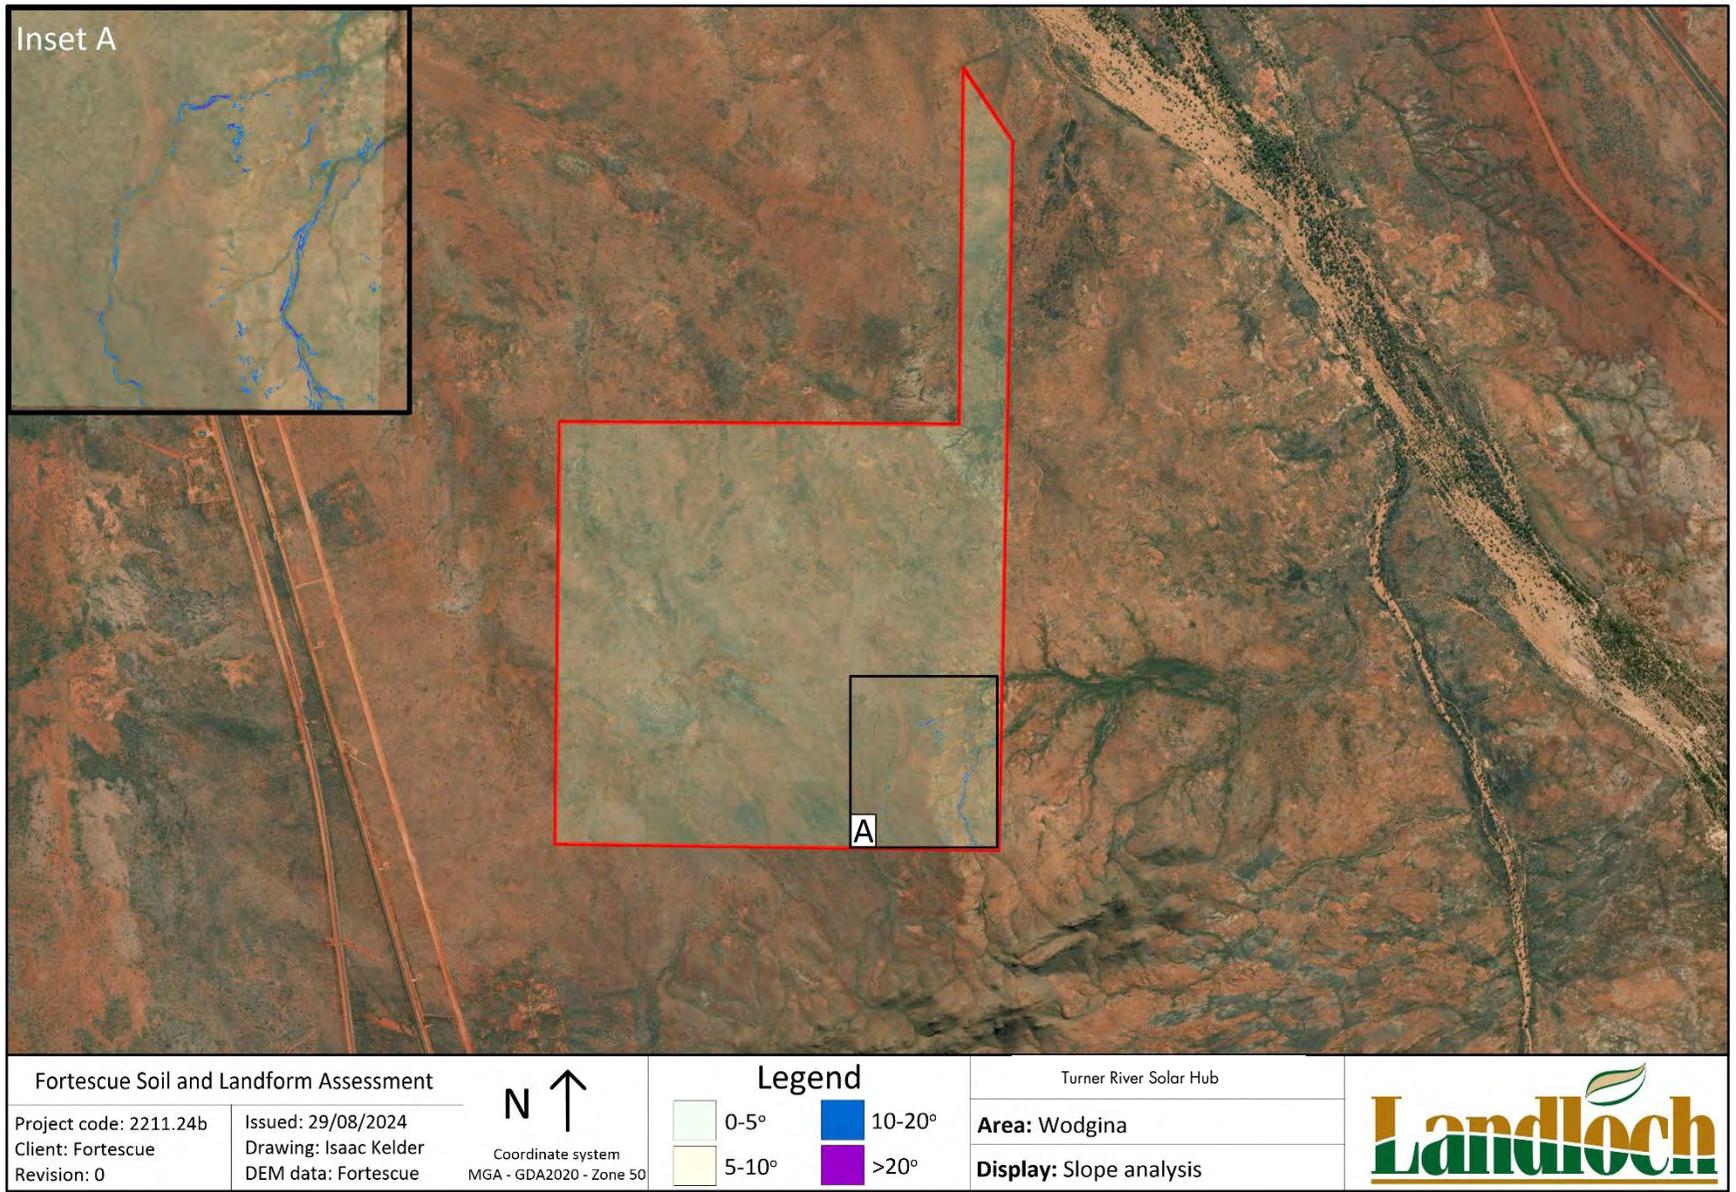
Figure 6: Slope analysis of north section (Wodgina)

A slope analysis conducted over the Project area during the desktop review (Figures 6 and 7) found that the majority of the Project area is comprised of surfaces with a gradient of $0-5^\circ$ (~89% or 1,250ha of the Project area), with a minor proportion comprised of gradients of $5-10^\circ$ (~11% or 153ha). There are very isolated locations across the Project area with gradients $>10^\circ$ which are associated with exposed bedrock, drainage line channels, and existing disturbed features ($<0.1\%$ or 1ha).

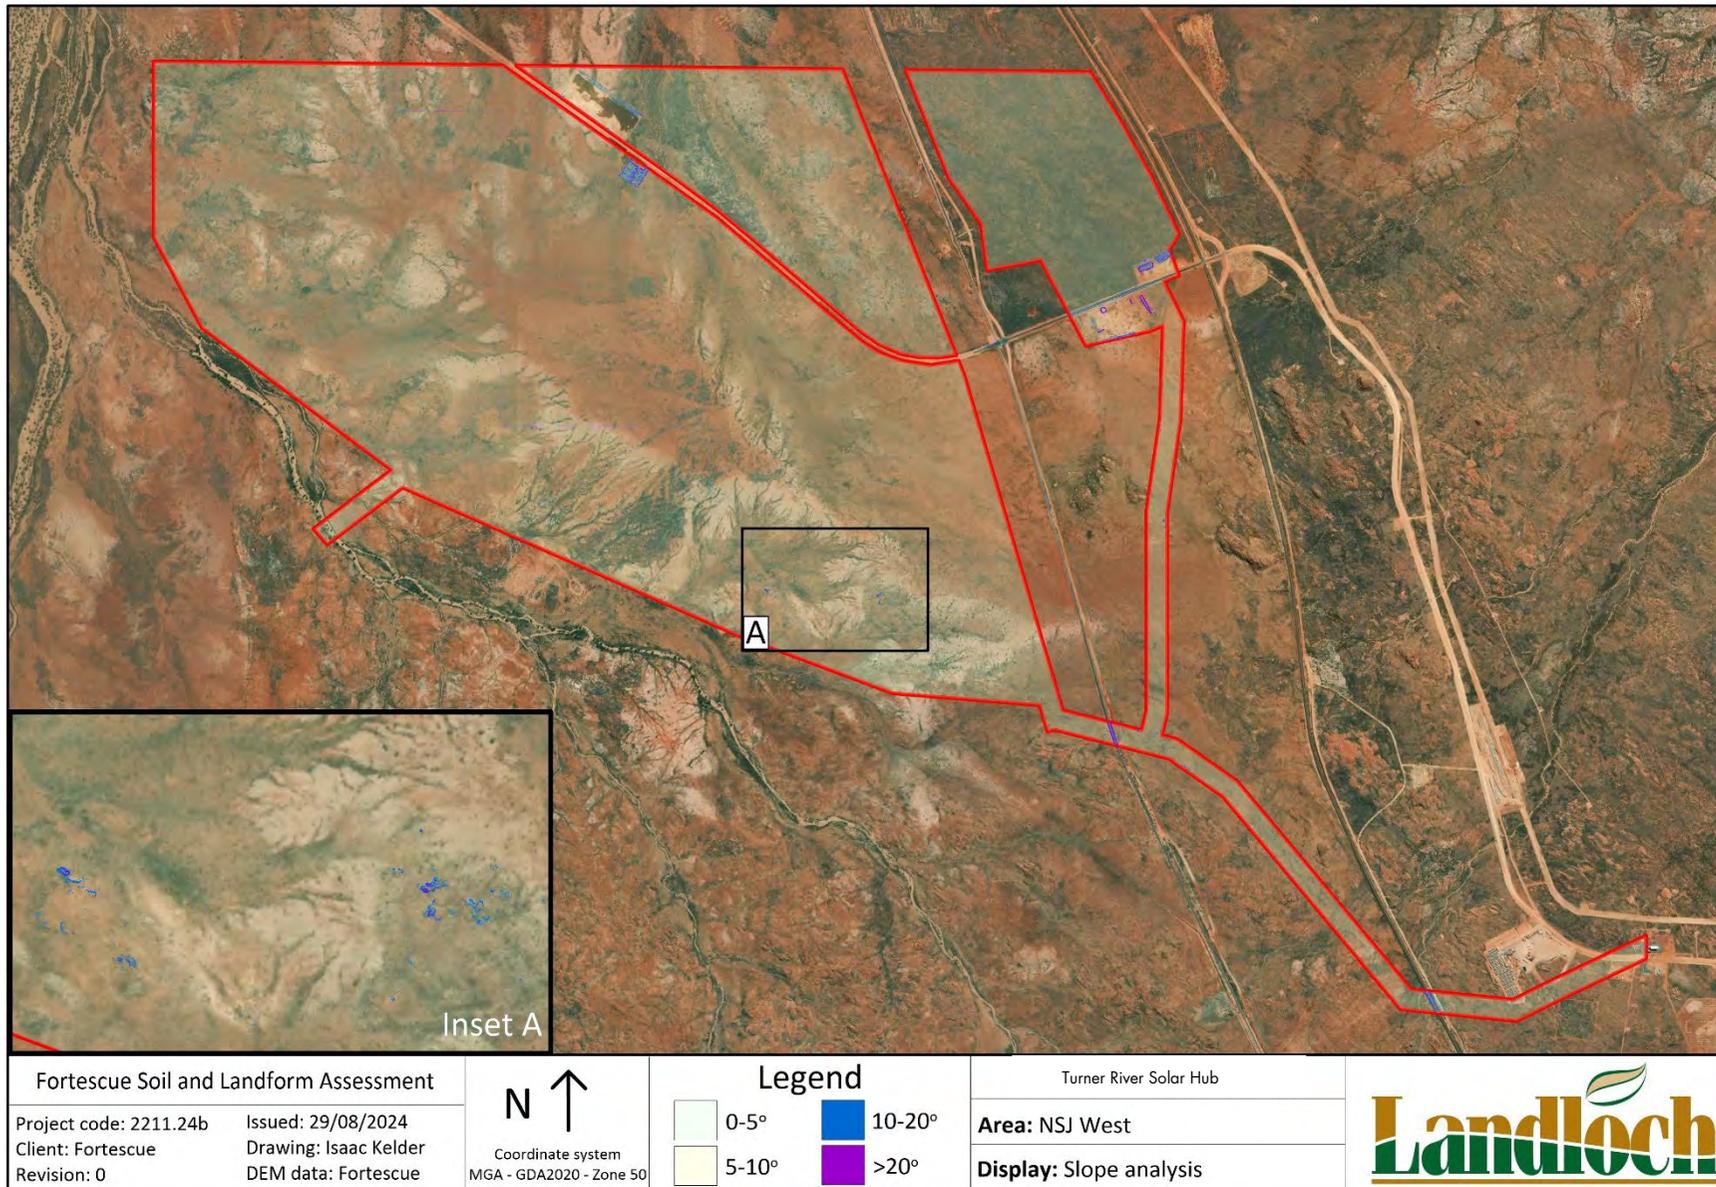
Figure 7: Slope analysis of south section (NSJ West)

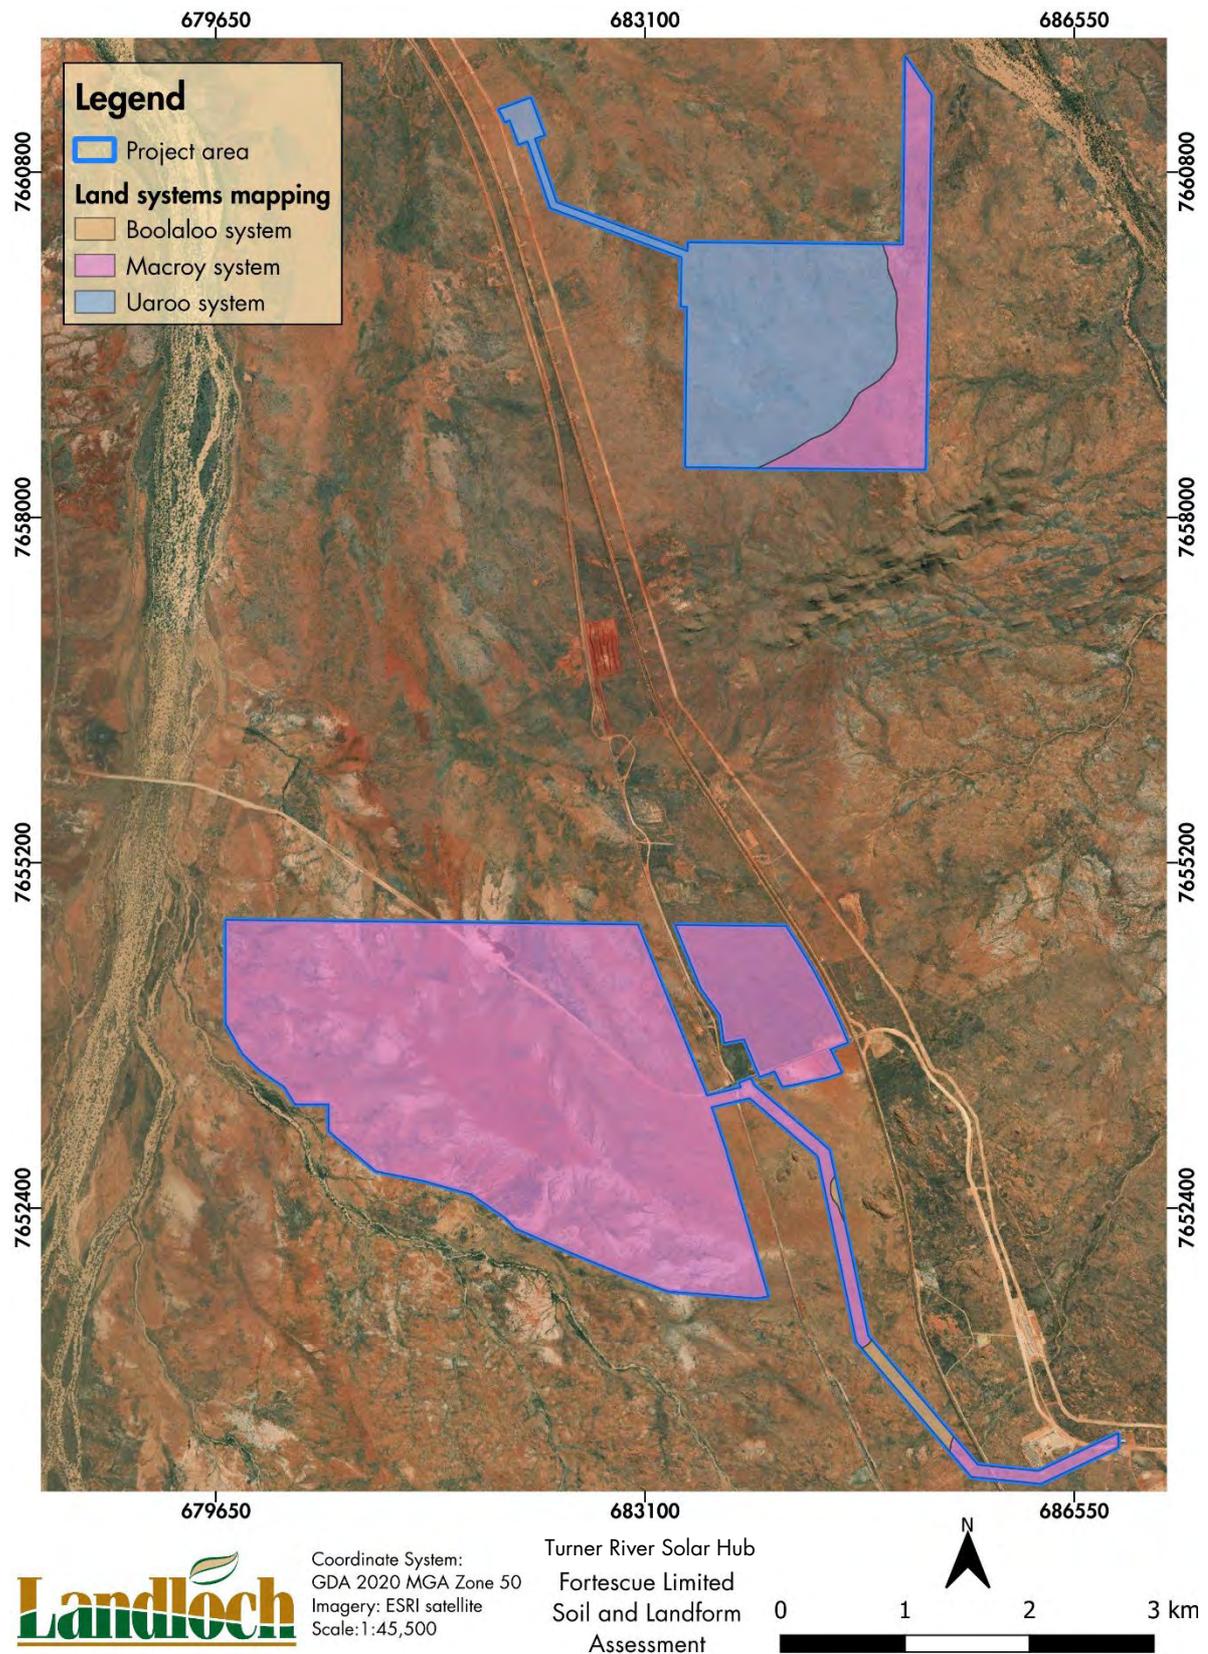
Figure 8: Land systems of the Project area.

The Macroy land system is comprised of erosional surfaces, with gently undulating stony plains and interfluves with quartz surface mantles the dominant feature. These landforms result in soils that vary from red shallow sands and loams, to red sandy earths, to red shallow sandy duplex soils. The land system also includes sandy-surfaced plains, minor calcrete plains, and closely spaced tributary drainage lines in upper parts of the system that become much wider downslope. Granite hills, tor fields and quartz ridges comprise a small portion of the landforms present.

The Uaroo land system is comprised of depositional surfaces, with level sandy plains up to 10km (or more in some places) in extent with little organised through drainage. Pebbly surfaced plains and plains with calcrete and a shallow depth are also present, with some broad unchanneled tracts receiving concentrated sheet flow. There are minor occurrences of low stony hills and rises. Soils present on these plains include red sandy earths, red deep sands, and red loamy earths.

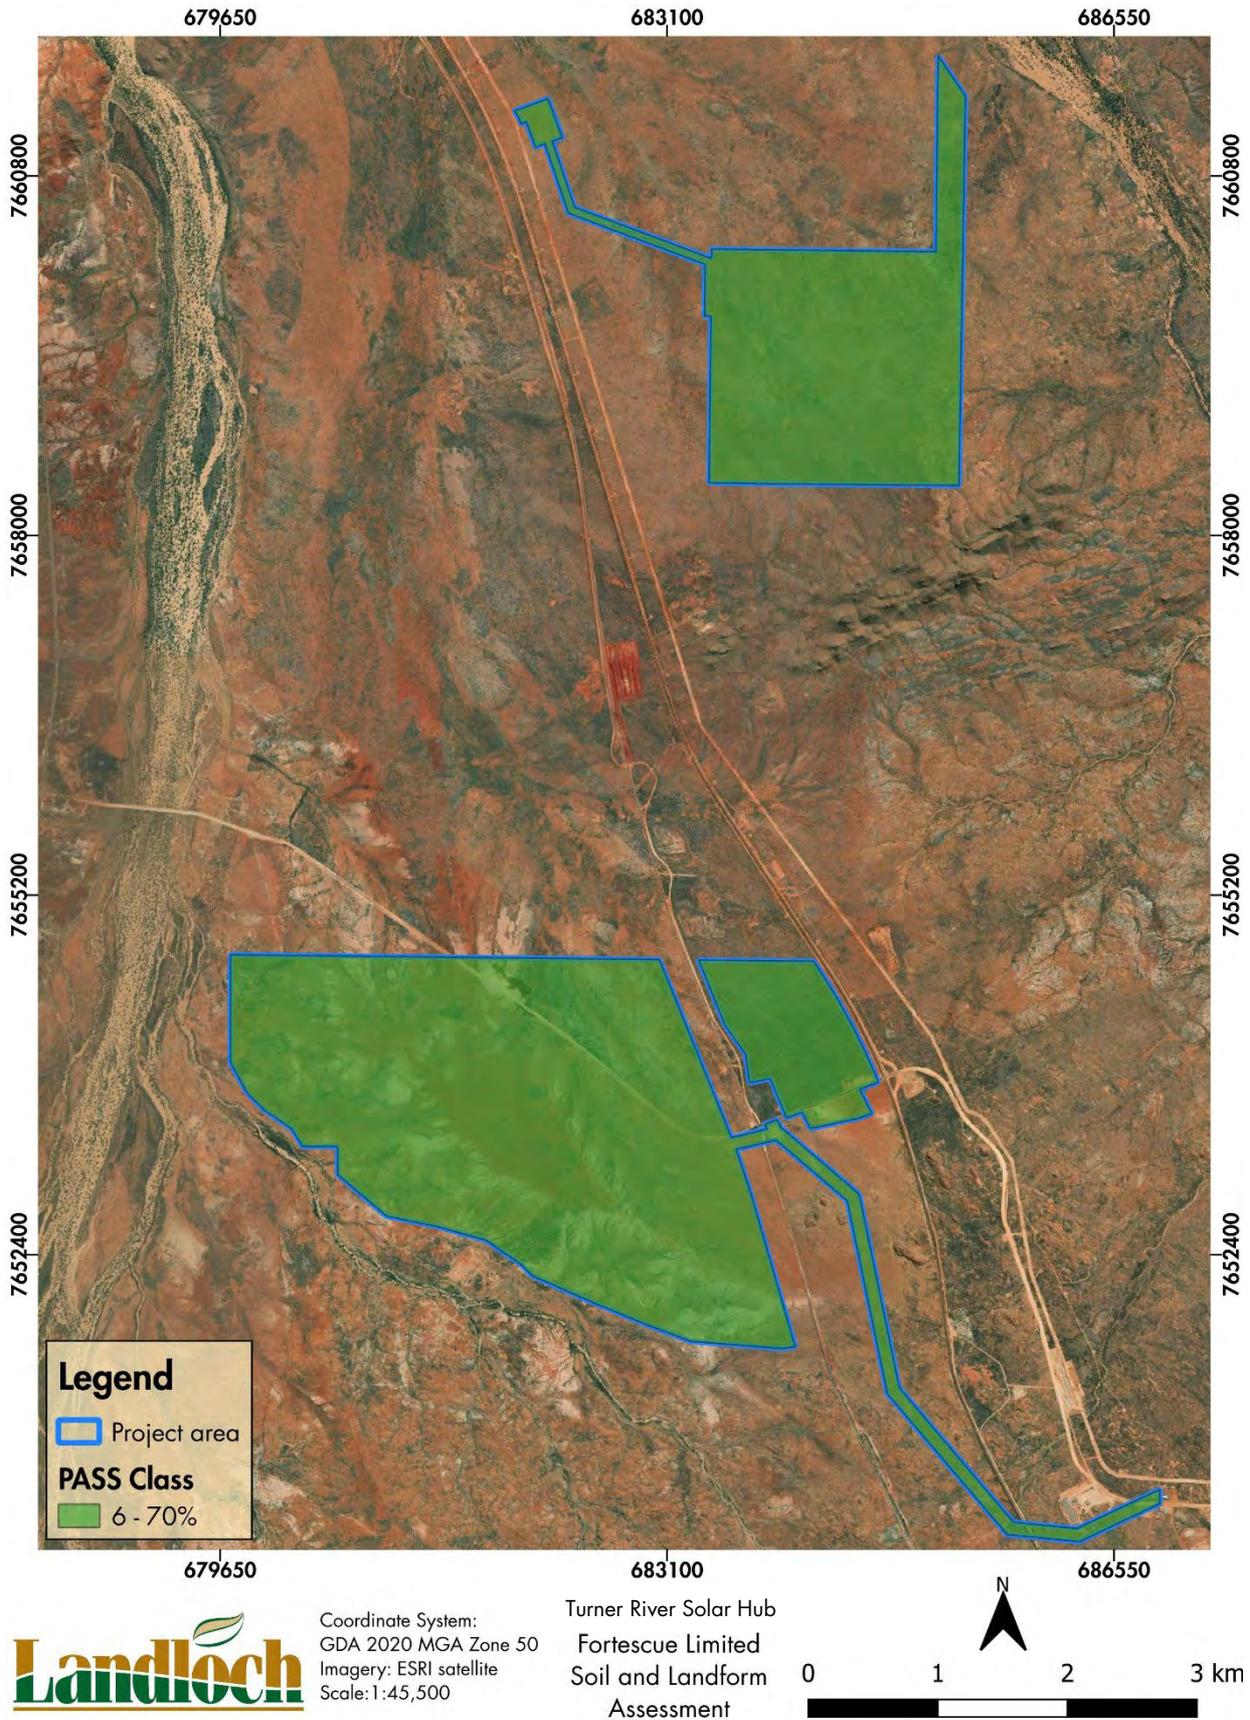
Figure 9: ASS risk mapping over the Project area.

National ASS mapping has been completed at a variable scale that provides an indication of the potential presence of ASS (Fitzpartrick *et al.* 2011). For the Project area, risk mapping indicates that there is a low probability (6-70% of mapping unit) of PASS occurring (Figure 9). The soils associated with PASS are Sodosols, Chromosols, and Dermosols, with ASS (where present) occurring in the upper 1m of the soil profile. The confidence level of this mapping is noted as *'No necessary analytical data are available, and classifier has little knowledge or experience with ASS, hence classification is provisional'*.

The underlying geology are comprised of lithologies from the Archean era. The associated lithologies (Monzogranites) are typically not associated with sulfide bearing minerals and as such do not indicate the presence of ASS. The Project area does not contain any marine or estuarine sediments or tidal lakes. This is evident by the distance of the site from the nearest coastal area (~100km). There are also no interdune swales or coastal sand dunes present, and no waterlogged areas visible from aerial imagery. Lastly, there is no indication that the dominant vegetation is comprised of mangroves, reeds, rushes, or other vegetation associated with areas of shallow water tables. Based on the desktop review, it was considered unlikely that ASS is present within the Project area. However, given that ASS trigger mapping indicates that there is a reasonable possibility (6–70% probability), a preliminary assessment of ASS was completed as part of the field survey.

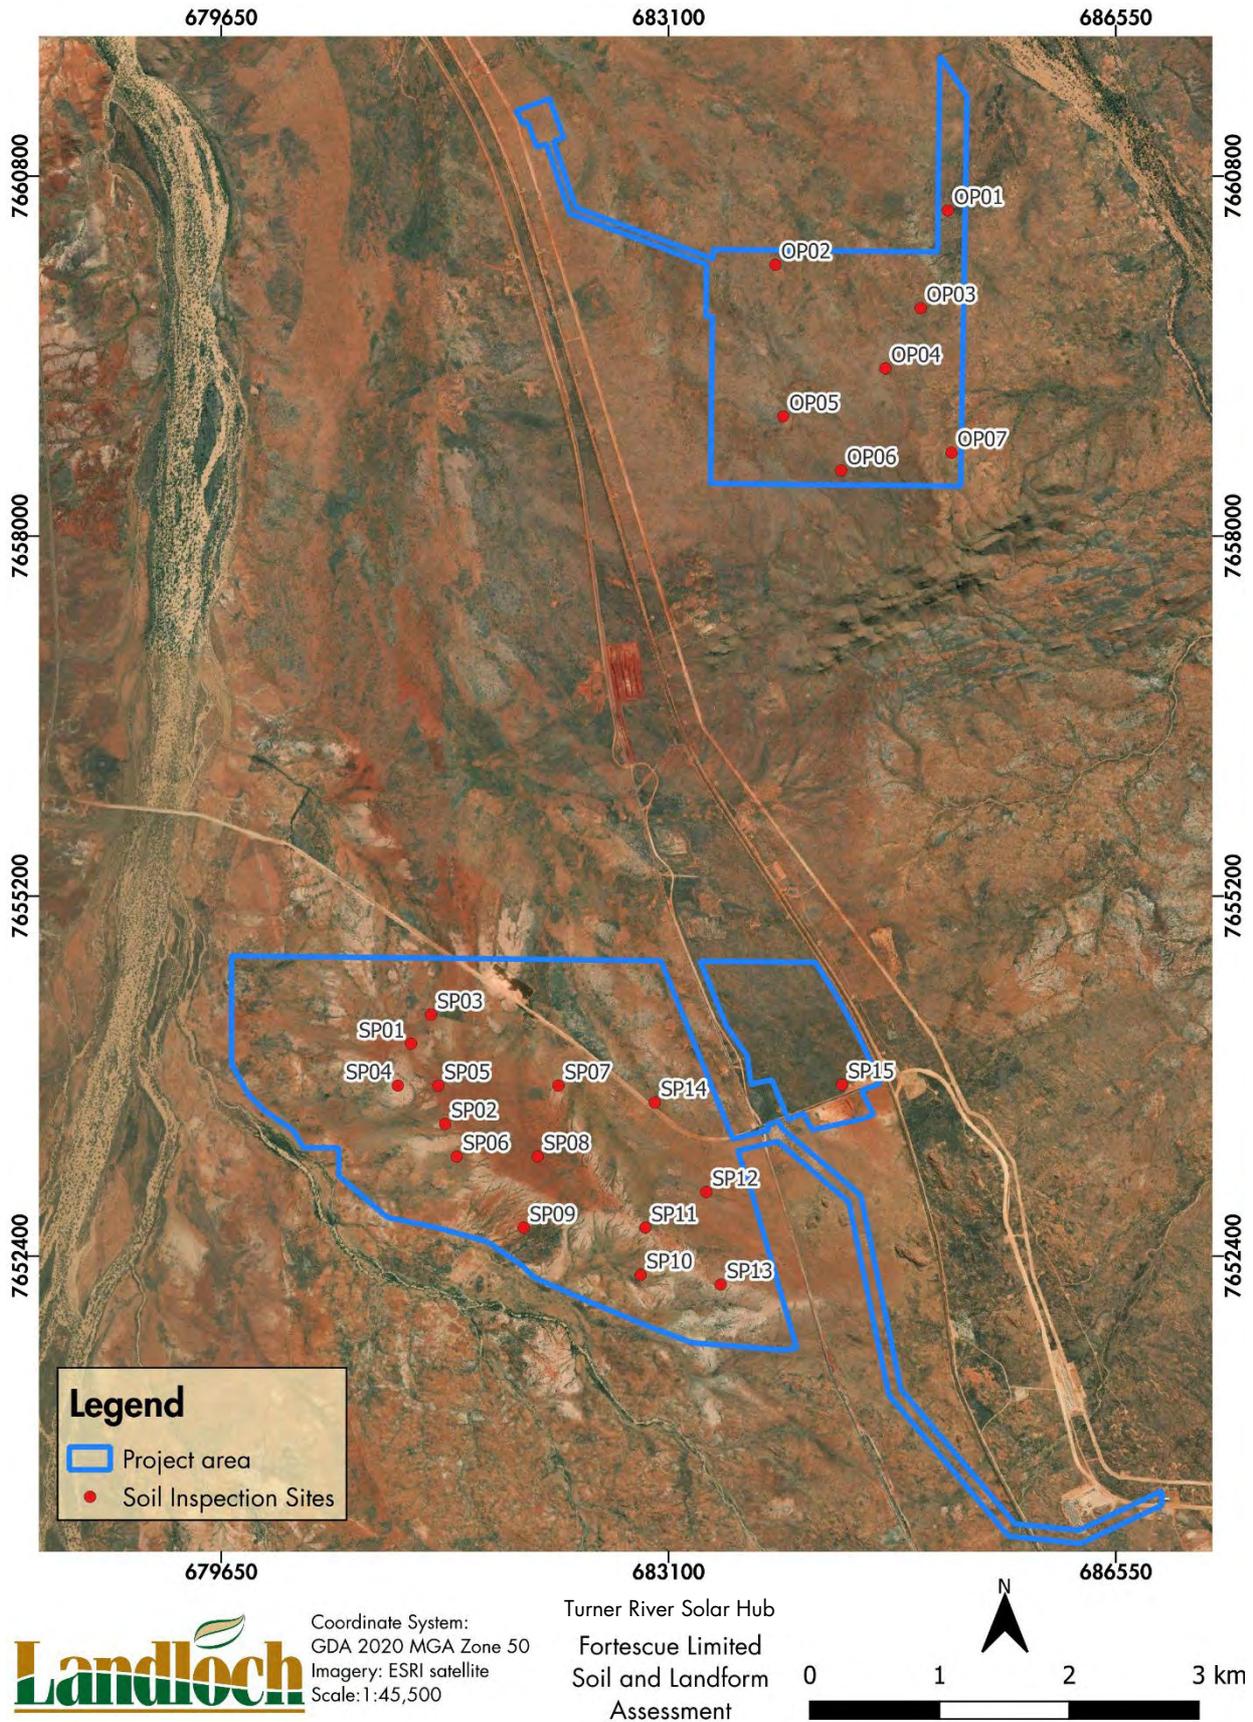
Figure 10: Location of soil inspection sites within the Project area.

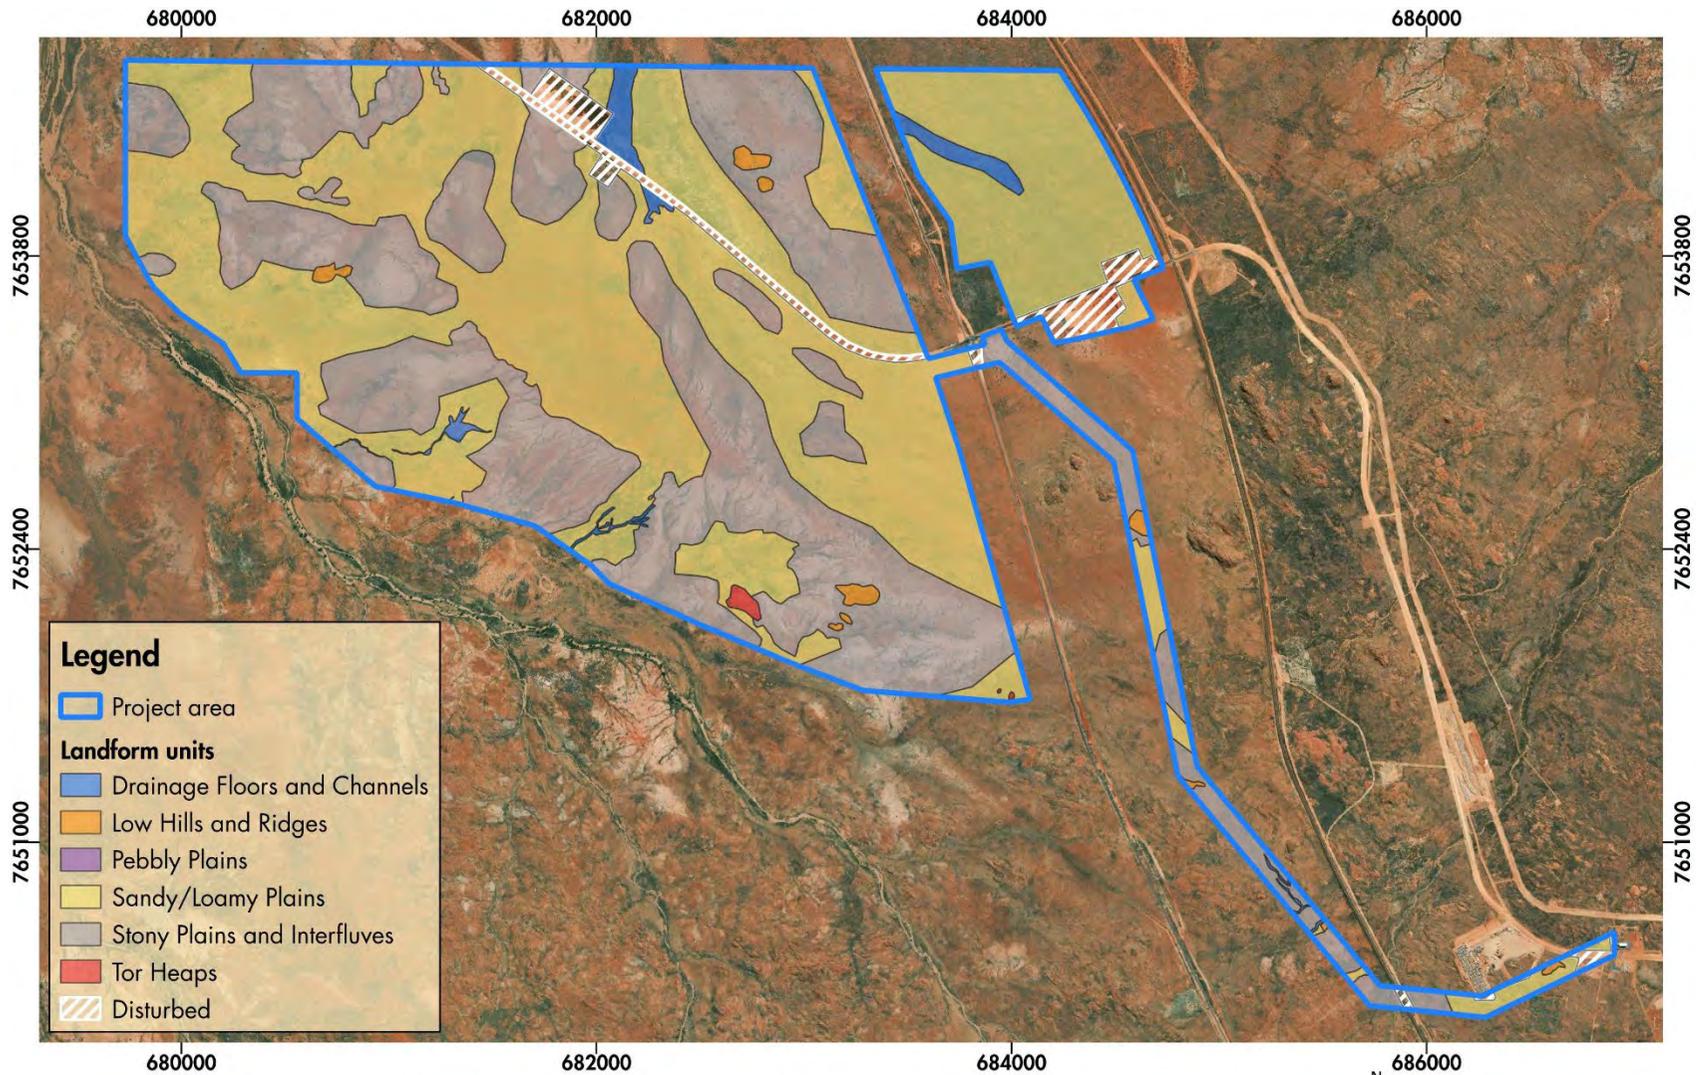
Figure 11: Landforms of the Project area (southern section)

Disturbed areas (e.g. roads and rail) were removed from the assessment. Details on each landform type are provided below, with landform mapping give in Figures 11 and 12.

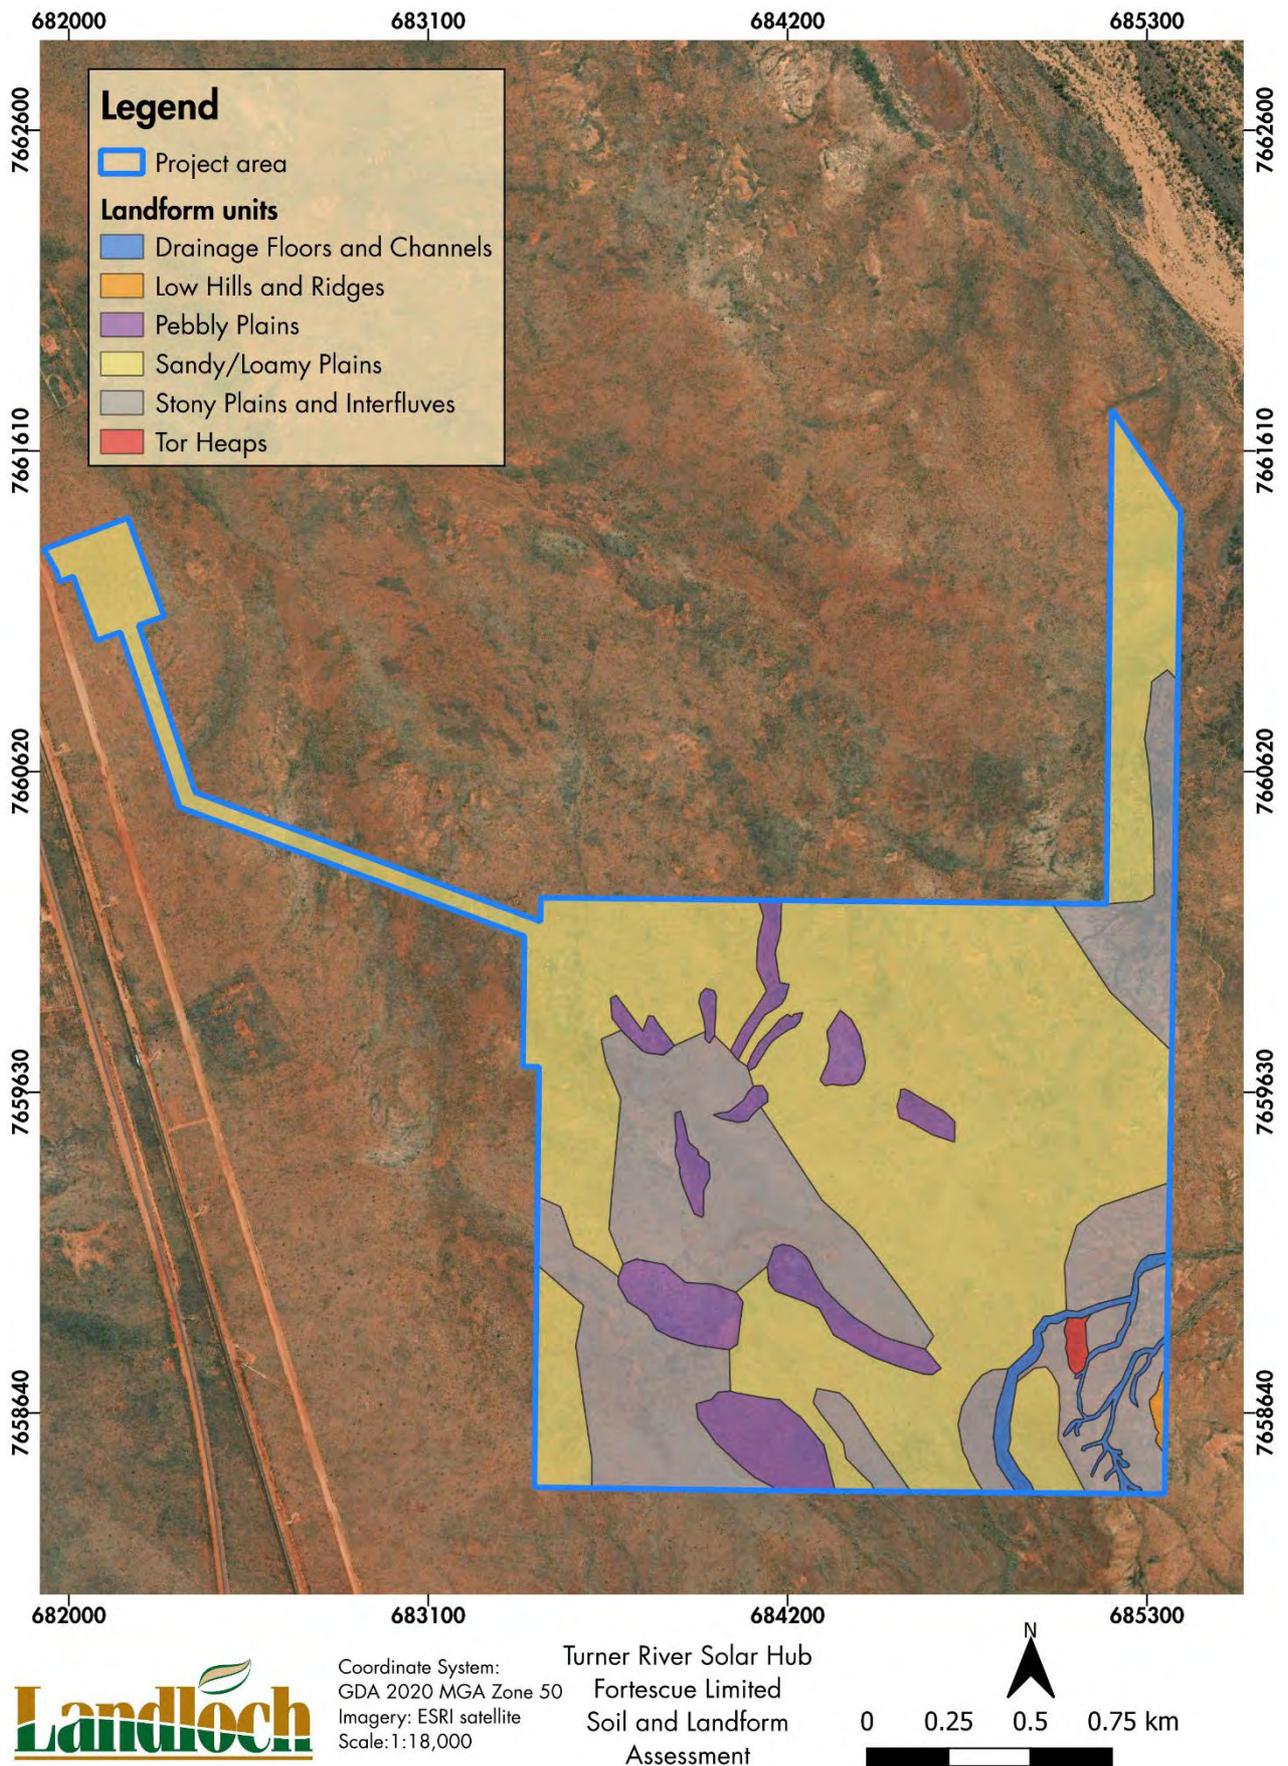
Figure 12: Landforms of the Project area (northern section).

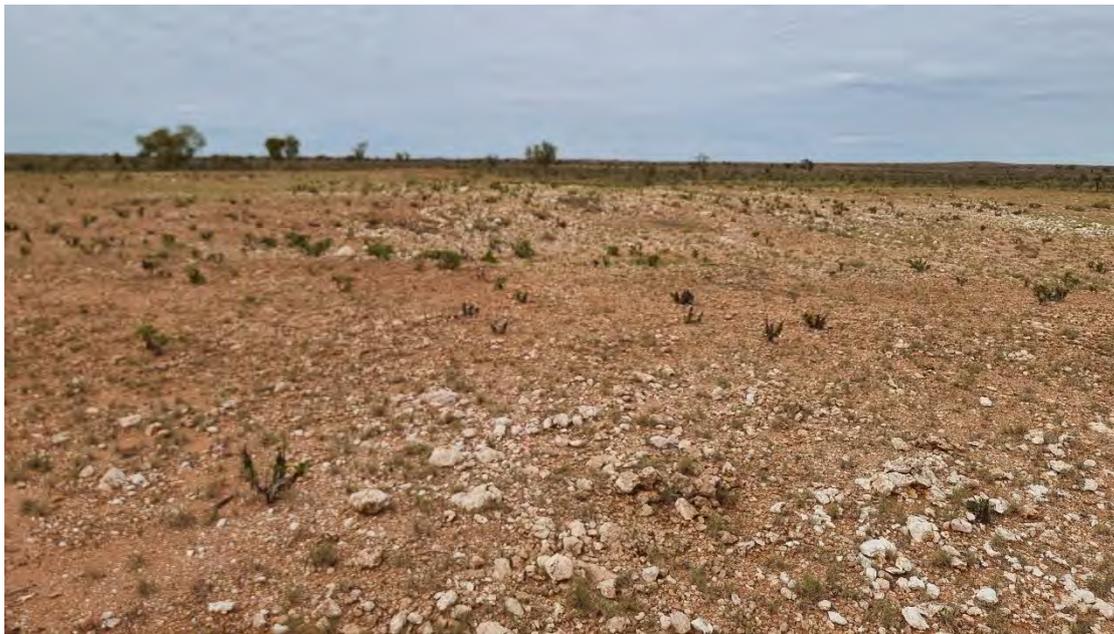
Figure 13: Typical surface cover of the Stony plains and interfluves landform.

Interspersed throughout the Project area, the stony plains and interfluves form a dominant part of the landscape, comprising 535ha (or 37.8%) of the overall Project area. They often occur adjacent to drainage floors and channels and the sandy/loamy plains. The key characteristic of this landform is the abundance of coarse fragments on the surface, with larger rock fragments typically present, and exposed bedrock often located nearby (Figure 13).

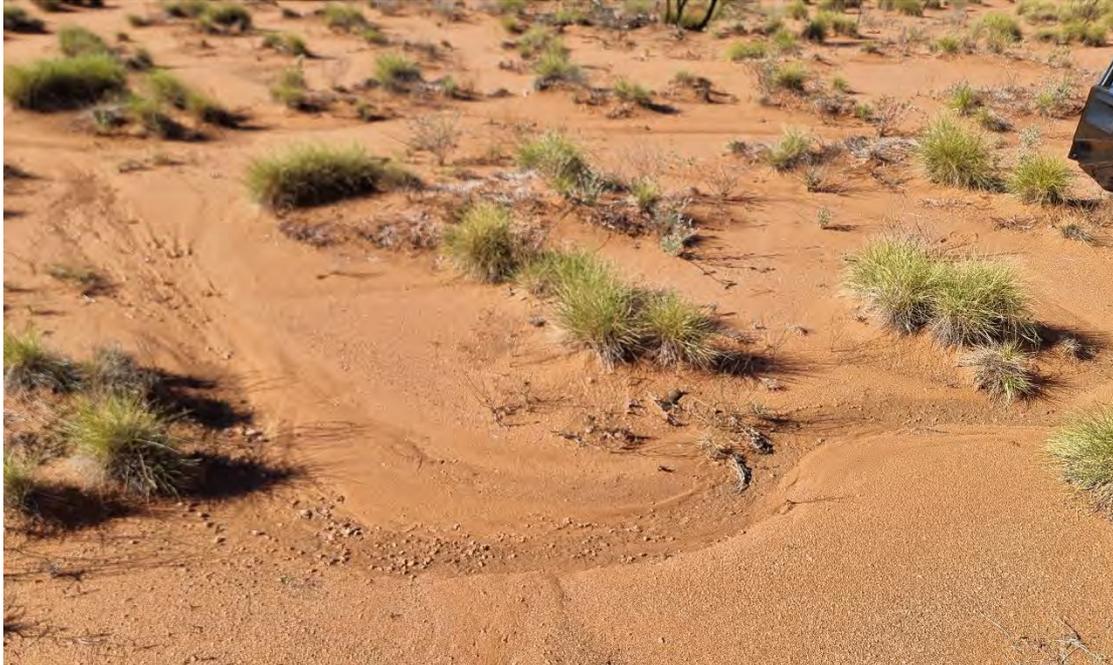
Figure 14: Sandy surface of the sandy/loamy plains landform.

Interspersed throughout the Project area, the sandy/loamy plains are the most common landform present, comprising 788ha (or 55.6%) of the Project area. They often occur adjacent to the stony plains and interfluves. The key characteristic of this landform is the lack of coarse fragments on the surface, and sandy texture of the topsoil (Figure 14).

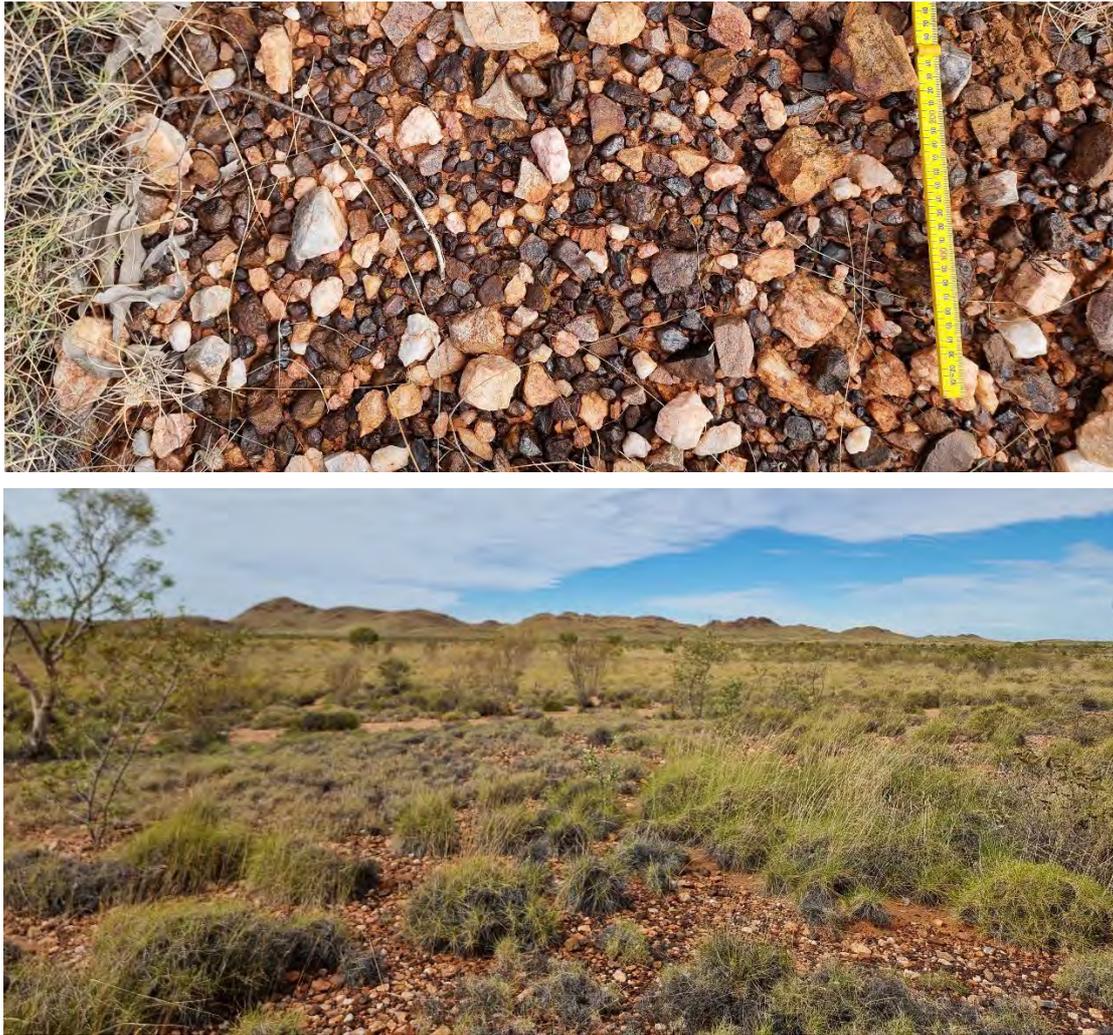
Figure 15: Top image illustrating the black rocky mantle of the Pebbly plains, and bottom image showing the general appearance of this landform.

The Pebbly plains are a relatively minor landform located in the northern section of the Project area in separated patches; it comprises 31ha (or 2.2%) of the overall area. This landform can be distinguished by the presence of a black rocky mantle (Figure 15).
